# Inspection Photos

5/19/2023

Operator: SCOUT ENERGY MANAGEMENT LLC  
- 10779

Location Number: 397603  
Rio Blanco County, CO

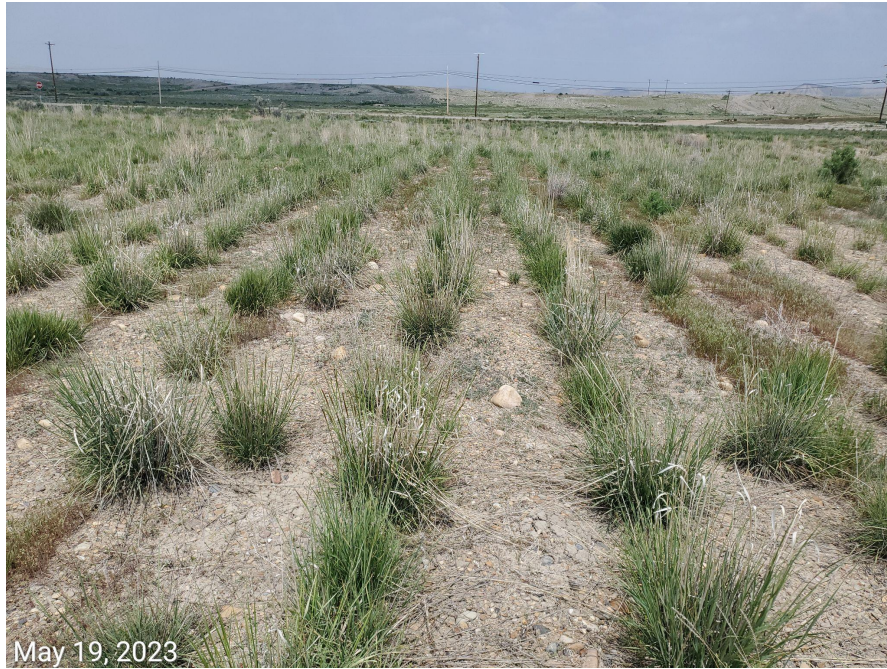
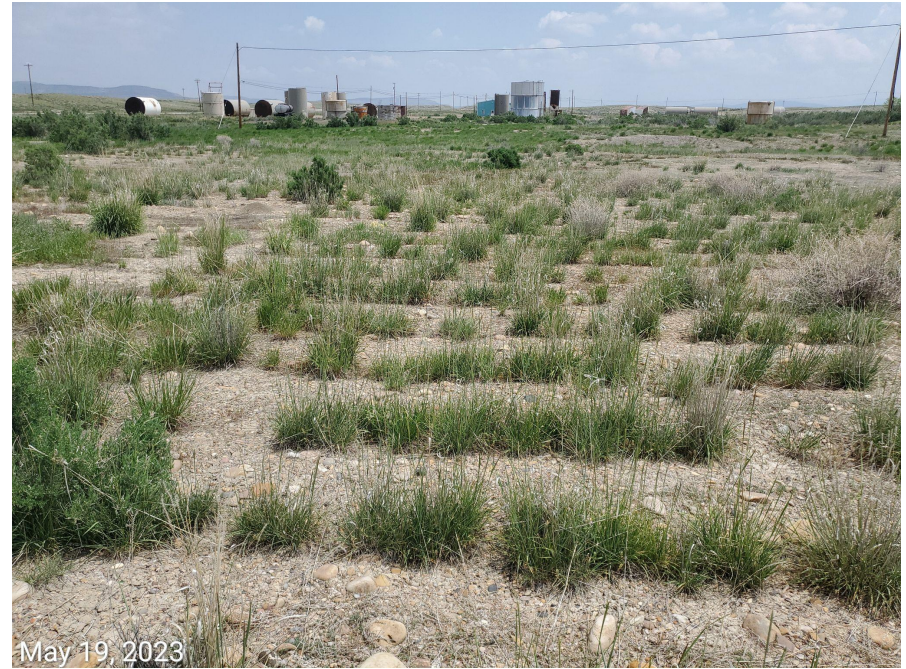
**Photo 1:** Photos 1-2 taken from the central areas of the Location facing north, east, south and west. Photos show areas of the Location that appear to be progressing towards 1004 reclamation standards; vegetation establishment beyond the drill rows will be necessary for establishment to be considered “uniform”.

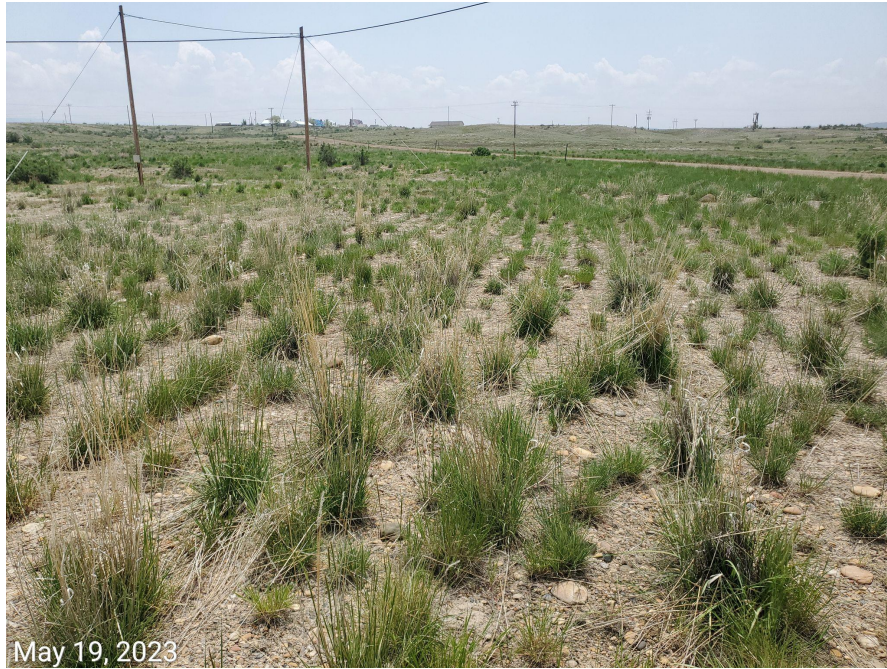
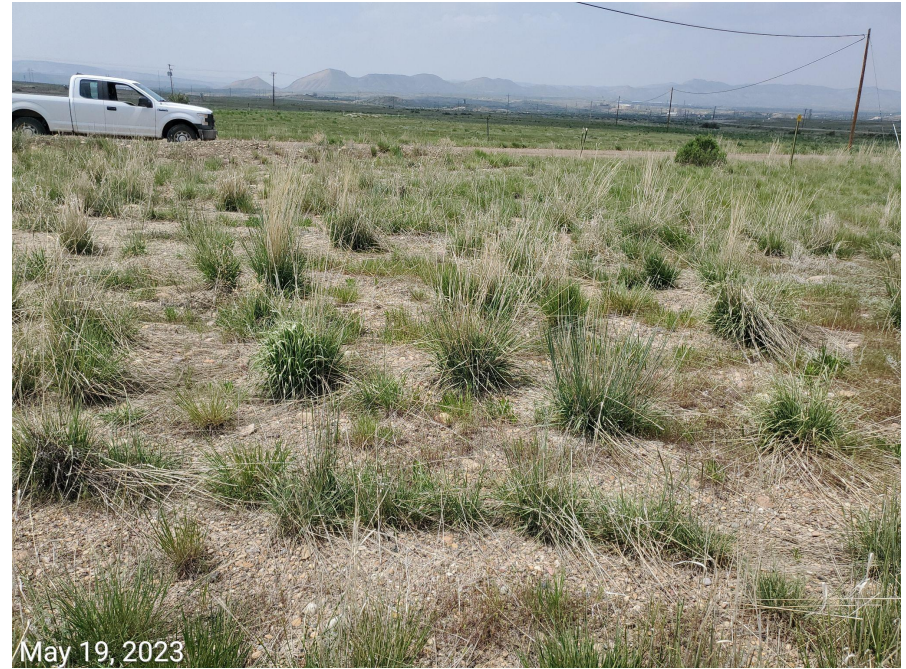
**Photo 2:** See comments under photo 1.

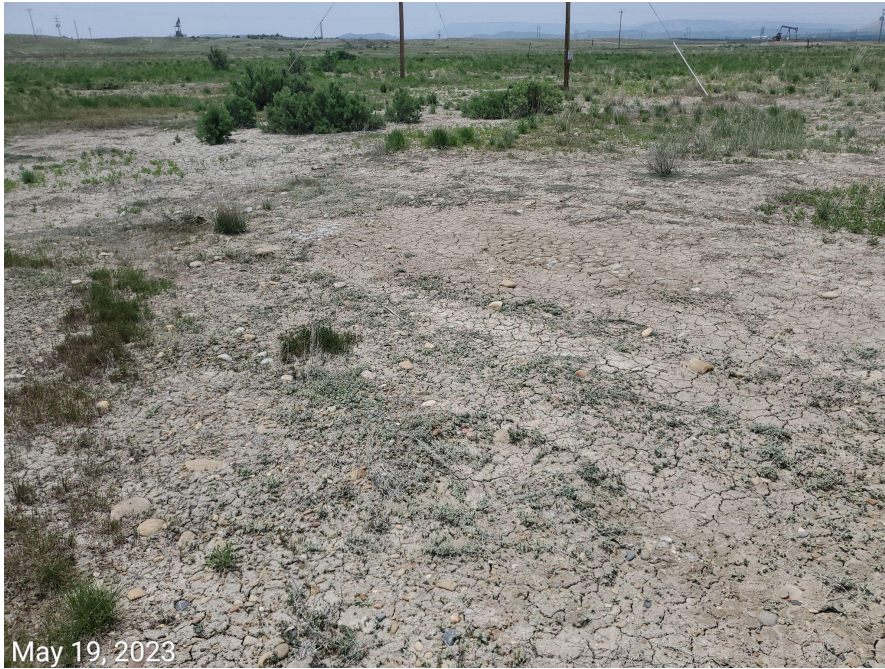
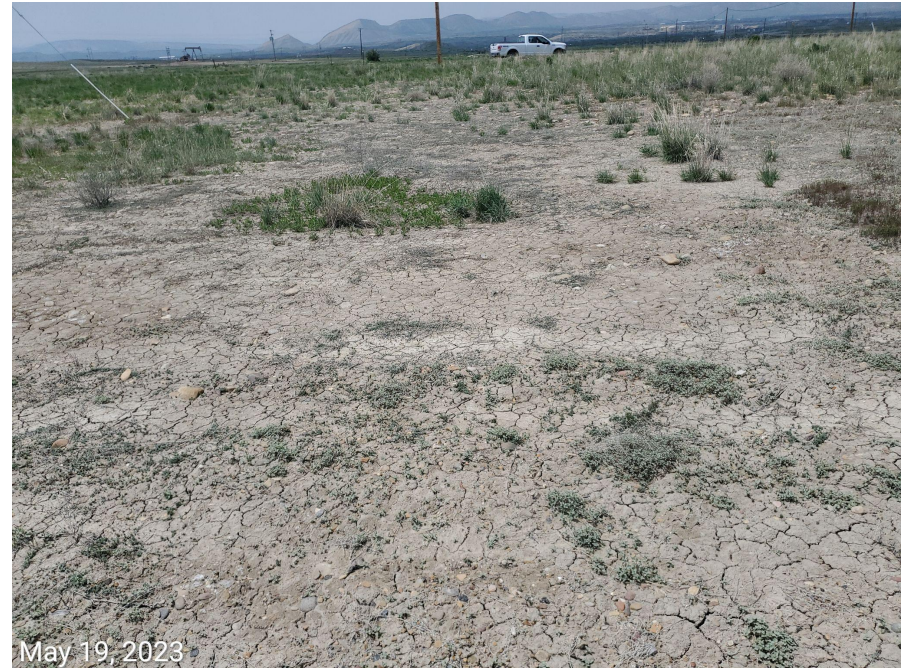
**Photo 3:** Photos taken from the east end of the Location. Photos examples showing areas of the Location where desirable vegetative establishment is not progressing towards 1004 standards.

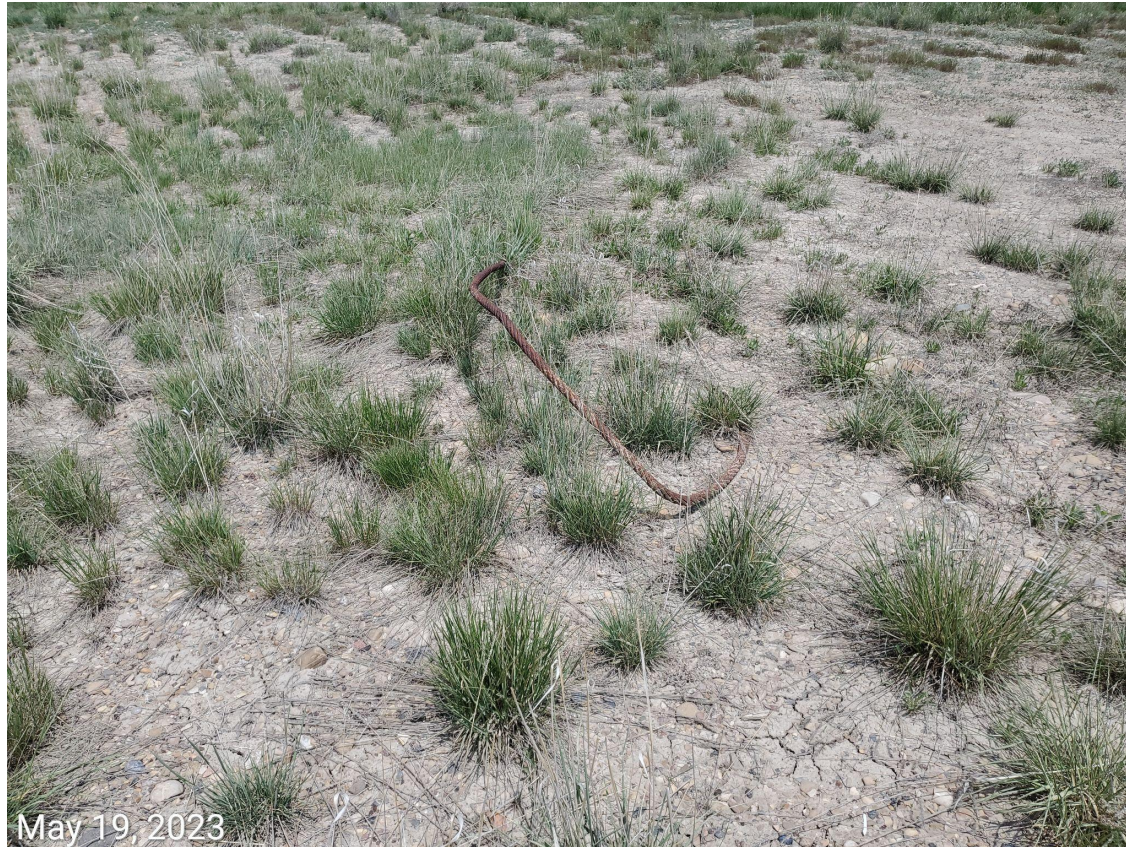
**Photo 4:** Photo shows cable debris observed on the northeast end of the Location.

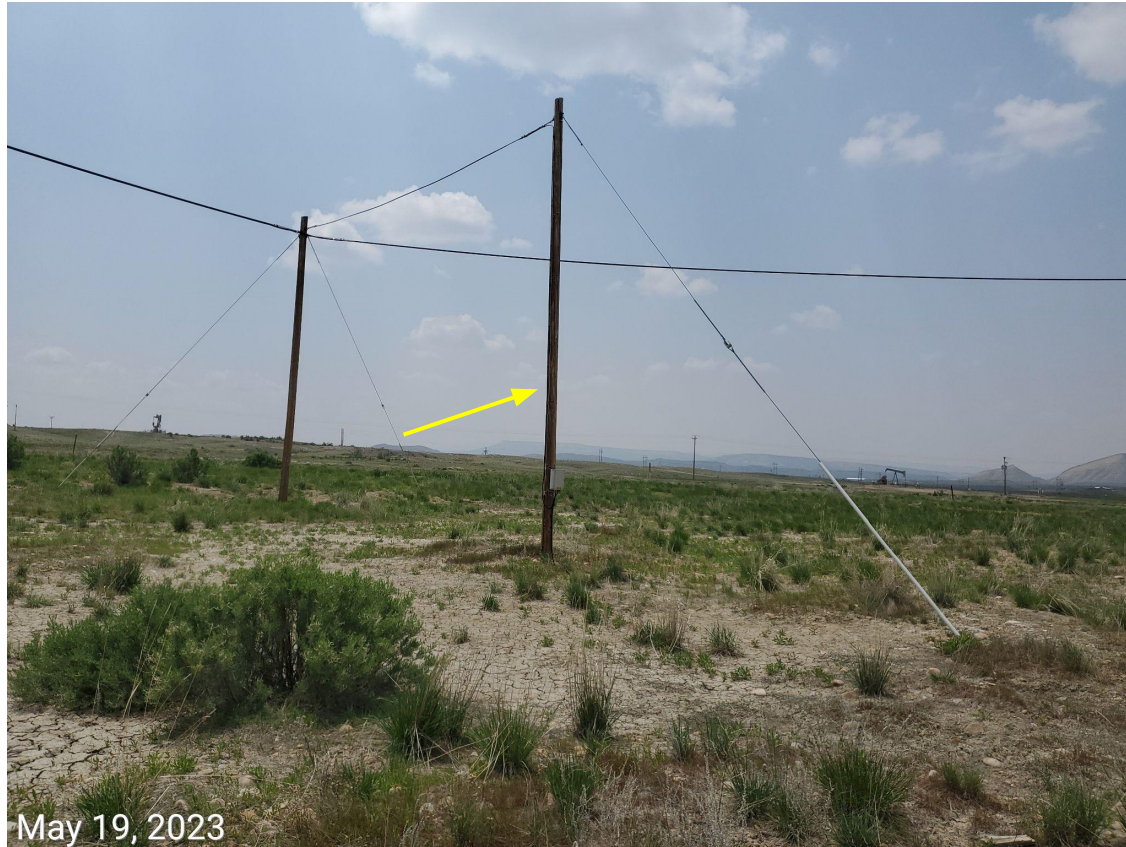
**Photo 5:** Photo shows utility pole equipment remaining on the Location.

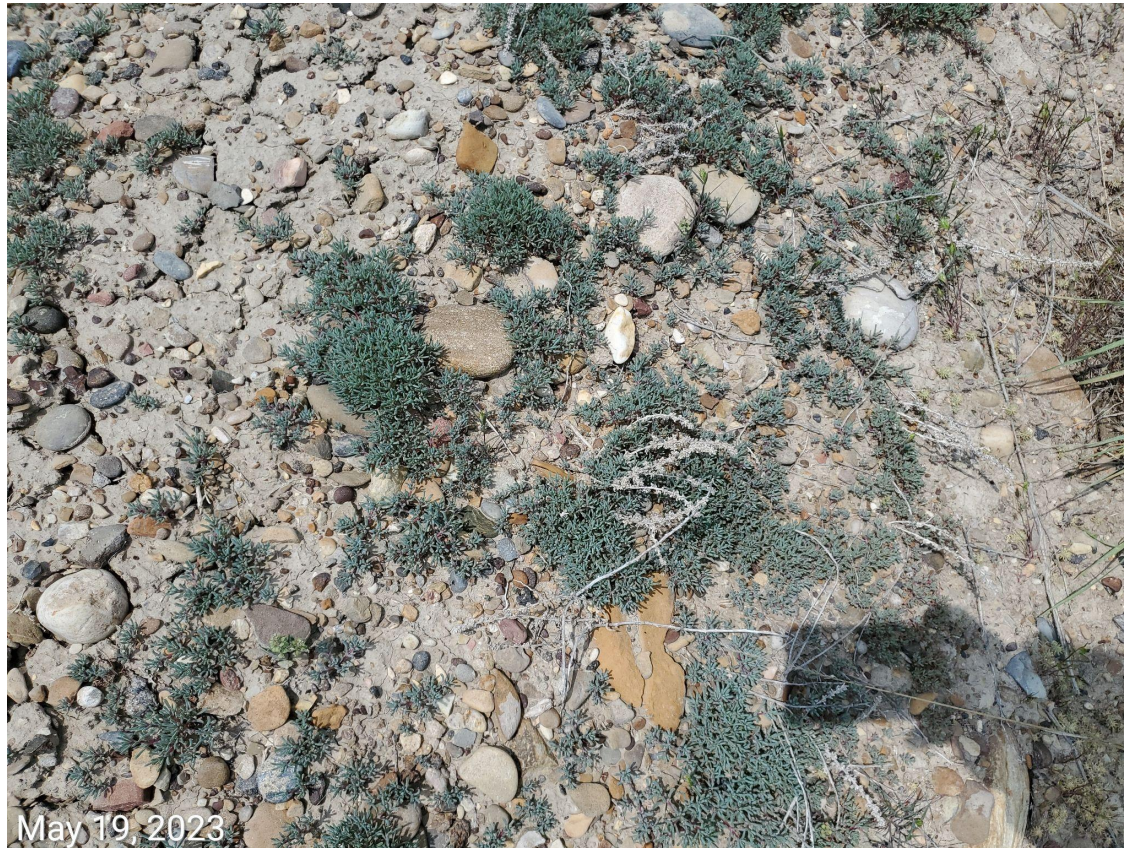
**Photo 6:** Photo examples showing Undesirable Plant Species (halogeton) observed establishing on areas of the Location.
