Inspection Photos

Operator: GRMR OIL & GAS LLC - #10524

Location Name: Durham/1-31, 2-31

Inspection Document #: 702801537

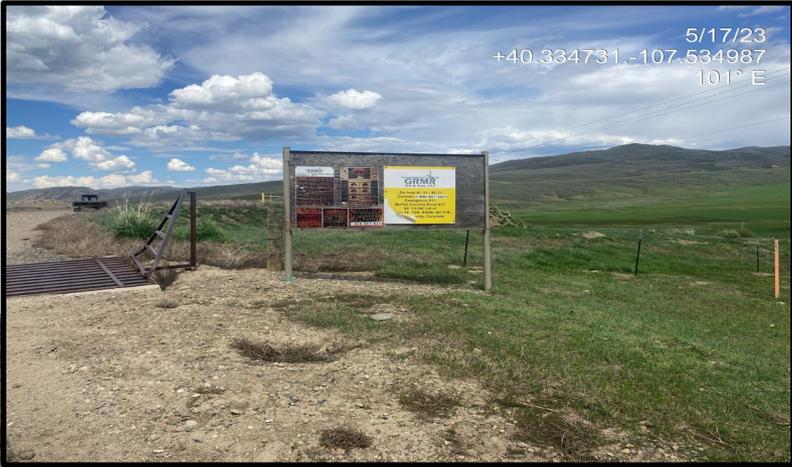
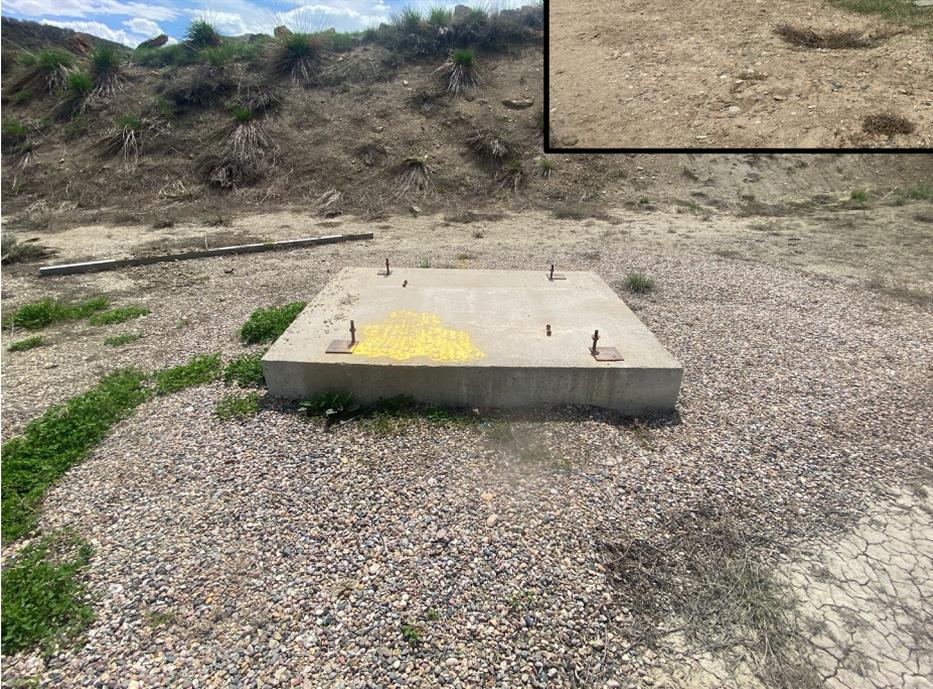
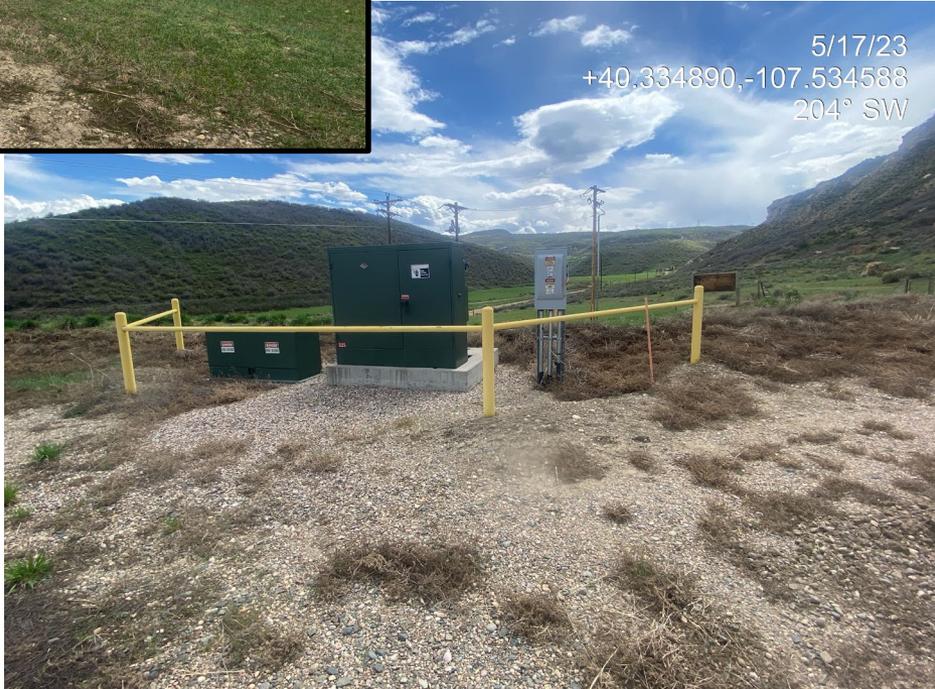
Photo 1. Photos show equipment remaining on location.

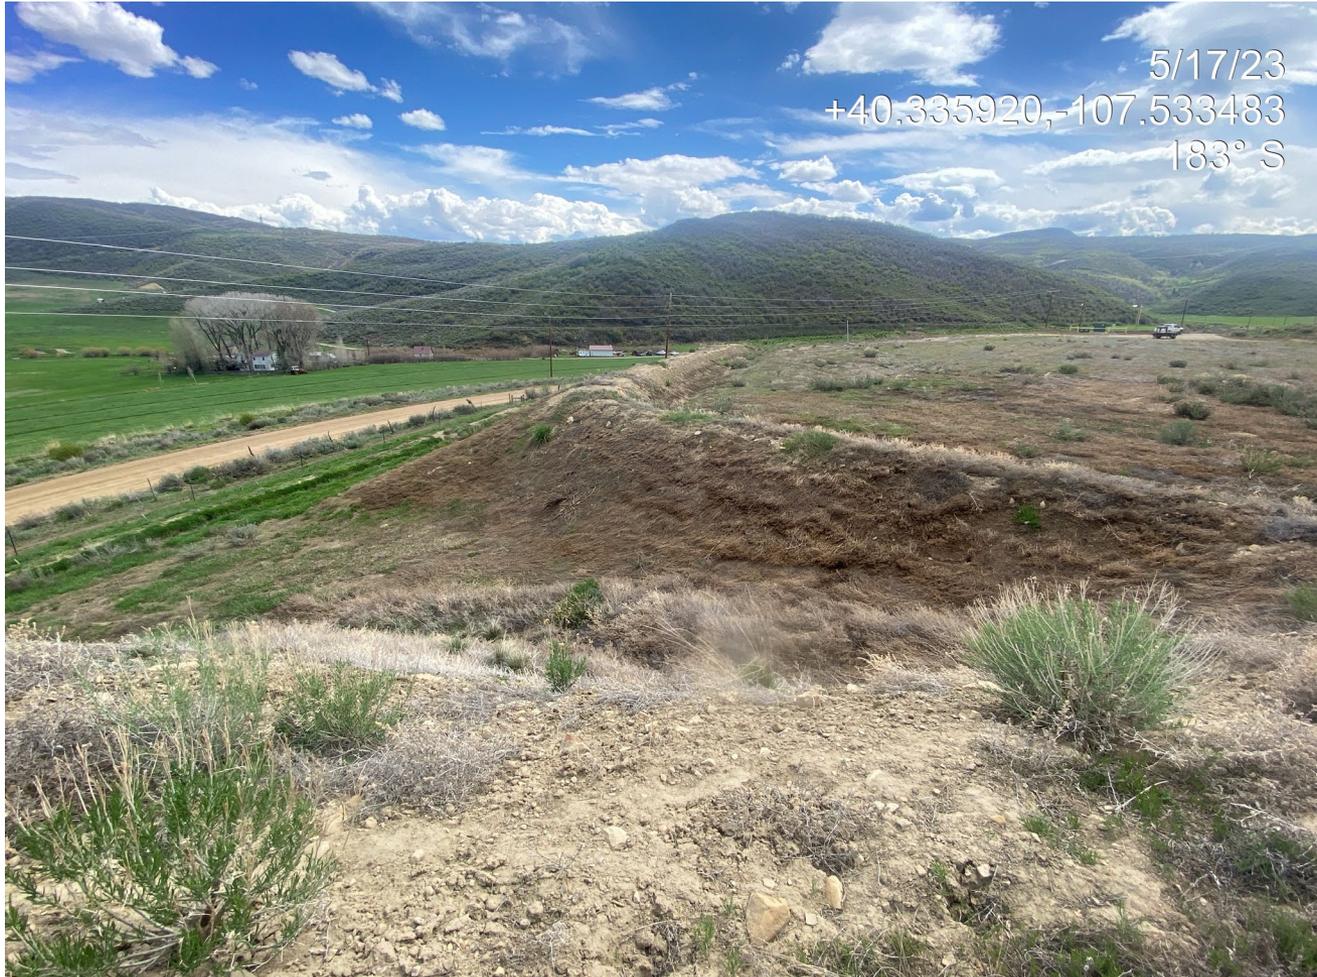
Photo 2. Photo taken from the northeast shows an overview of the southern/fill portion of the location.

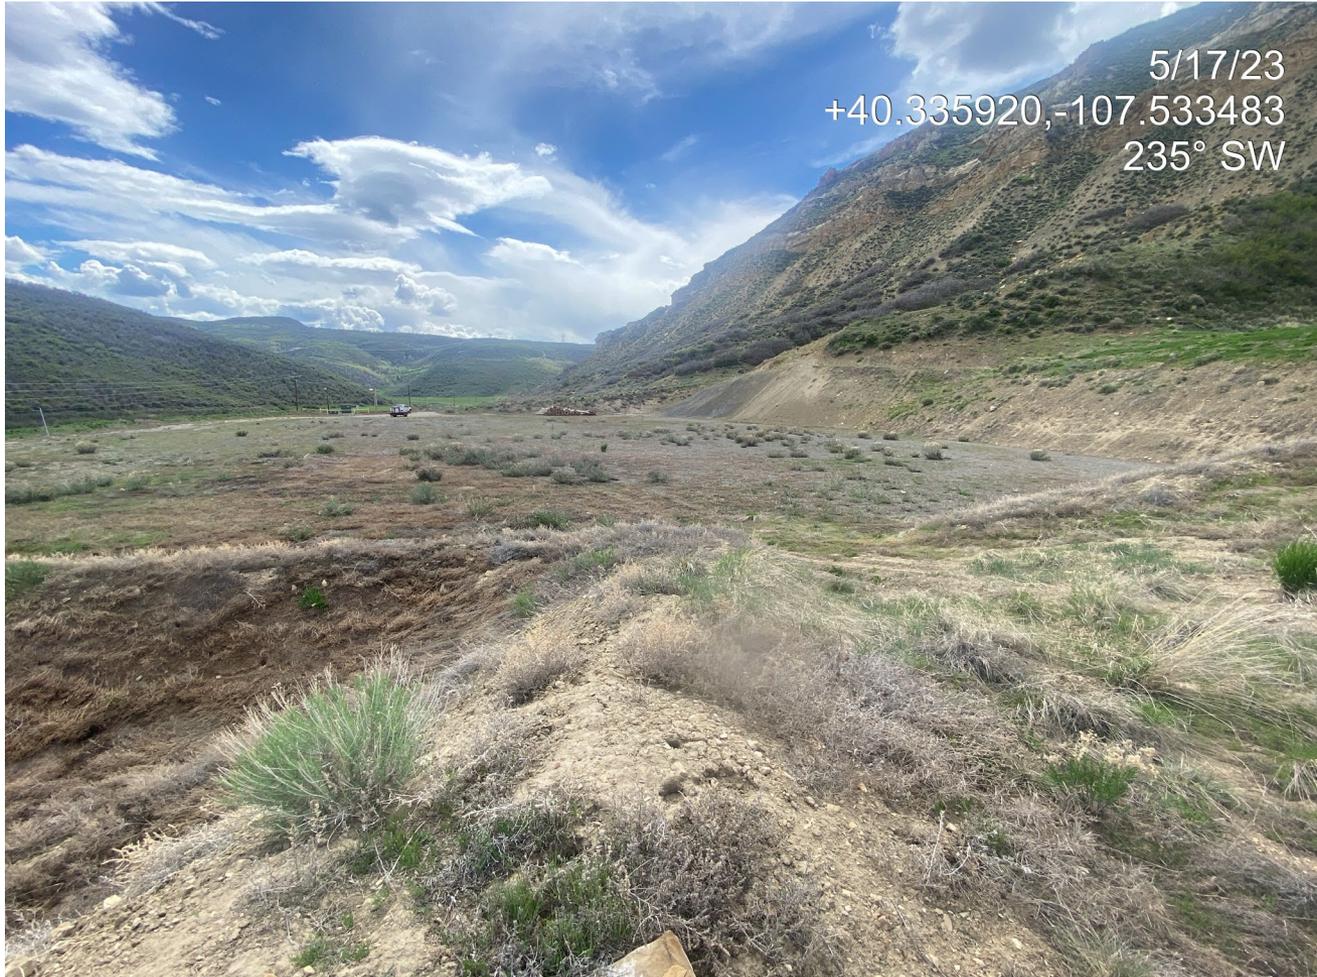
Photo 3. Photo taken from the northeast shows an overview of the northern/cut portion of the location.

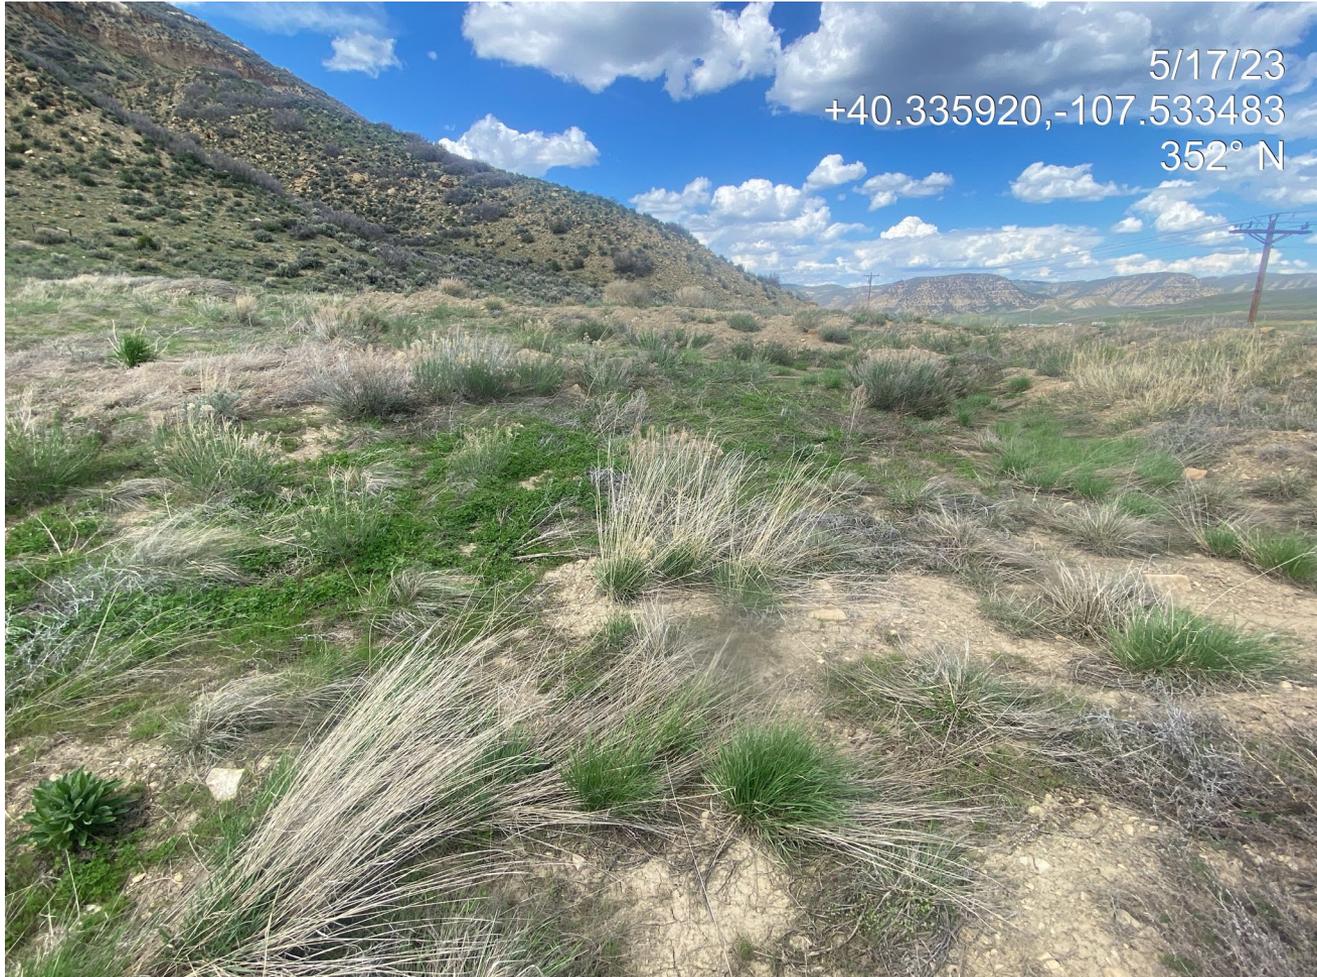
Photo 4. Photo taken from the northeast shows an overview of the eastern/more recently expanded portion of the location.

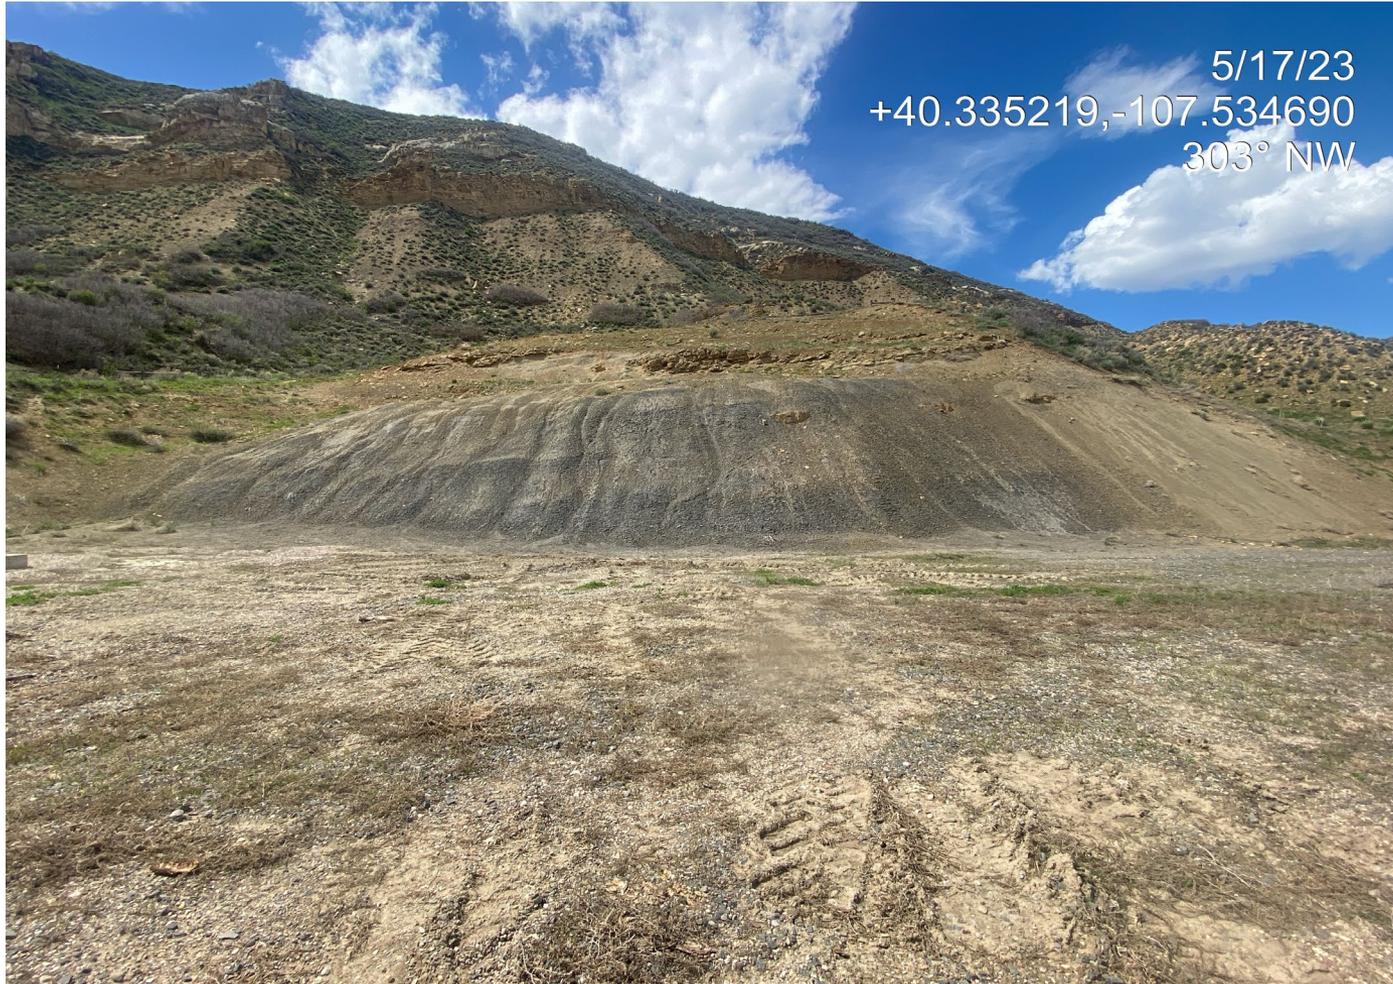
Photo 5. Photo shows the cut slope at the northwest of the location. The location has not been recontoured, slopes are bare, unvegetated and unstabilized.

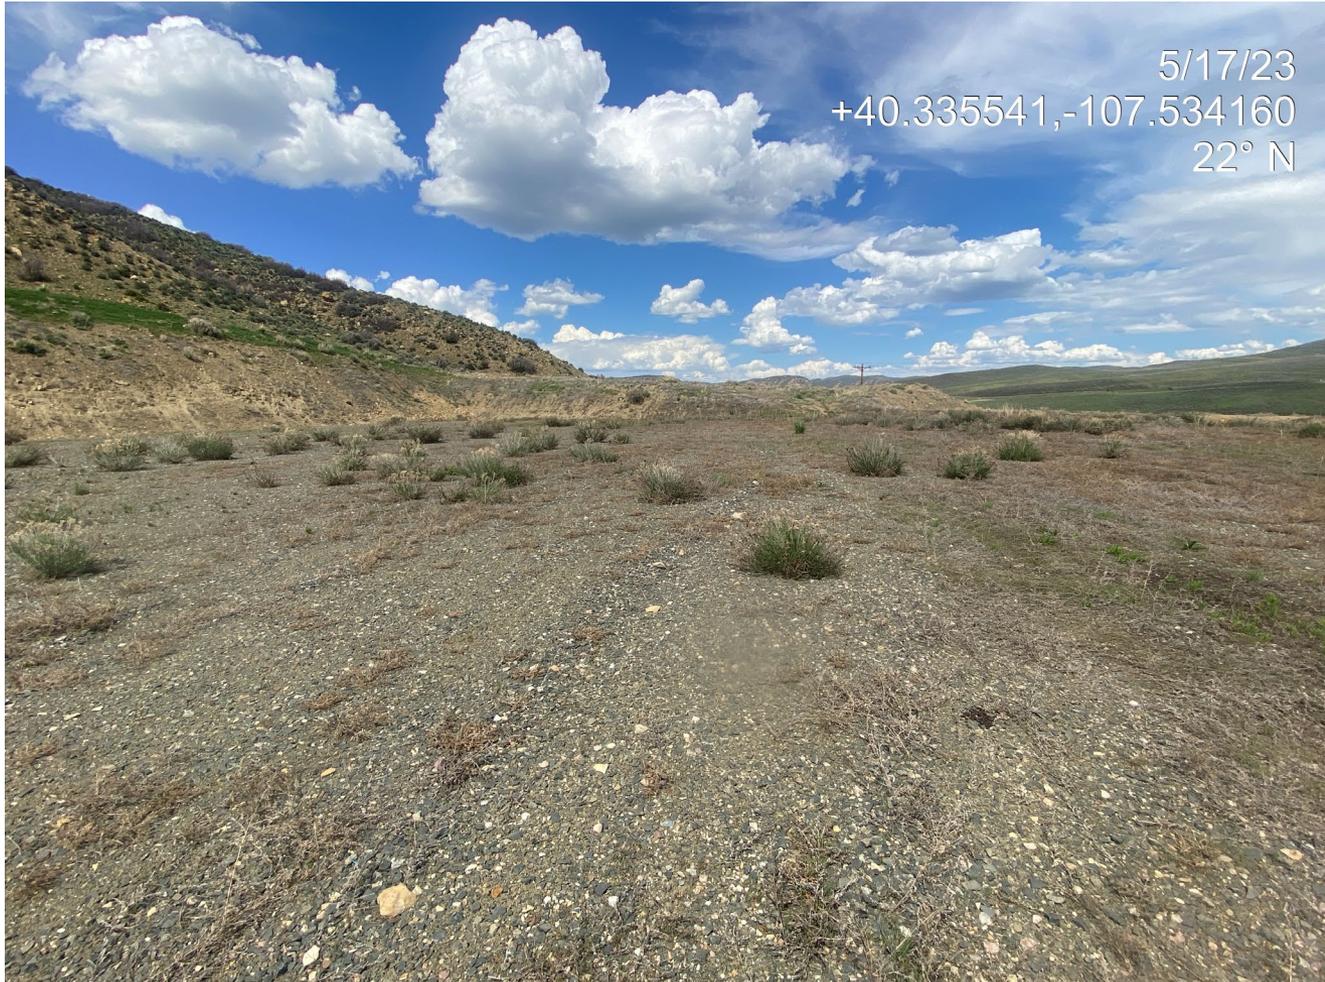
Photo 6. Photo shows the cut slope at the north of the location. The location has not been recontoured, slopes are bare, unvegetated and unstabilized.

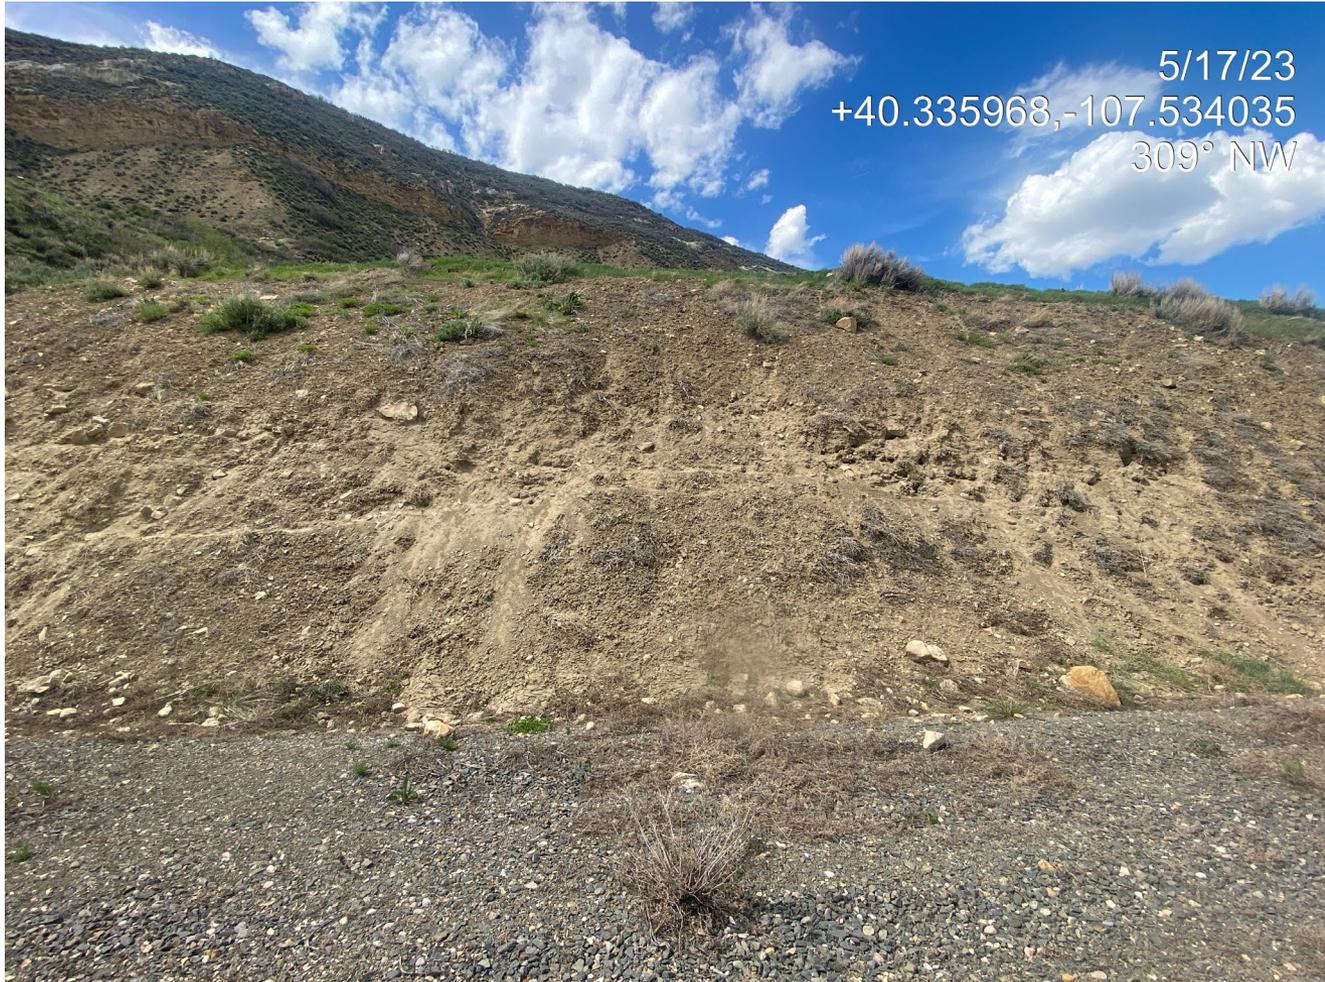
Photo 7. Photo show the cut slope at the north of the location. The location has not been recontoured, slopes are bare, unvegetated and unstabilized.

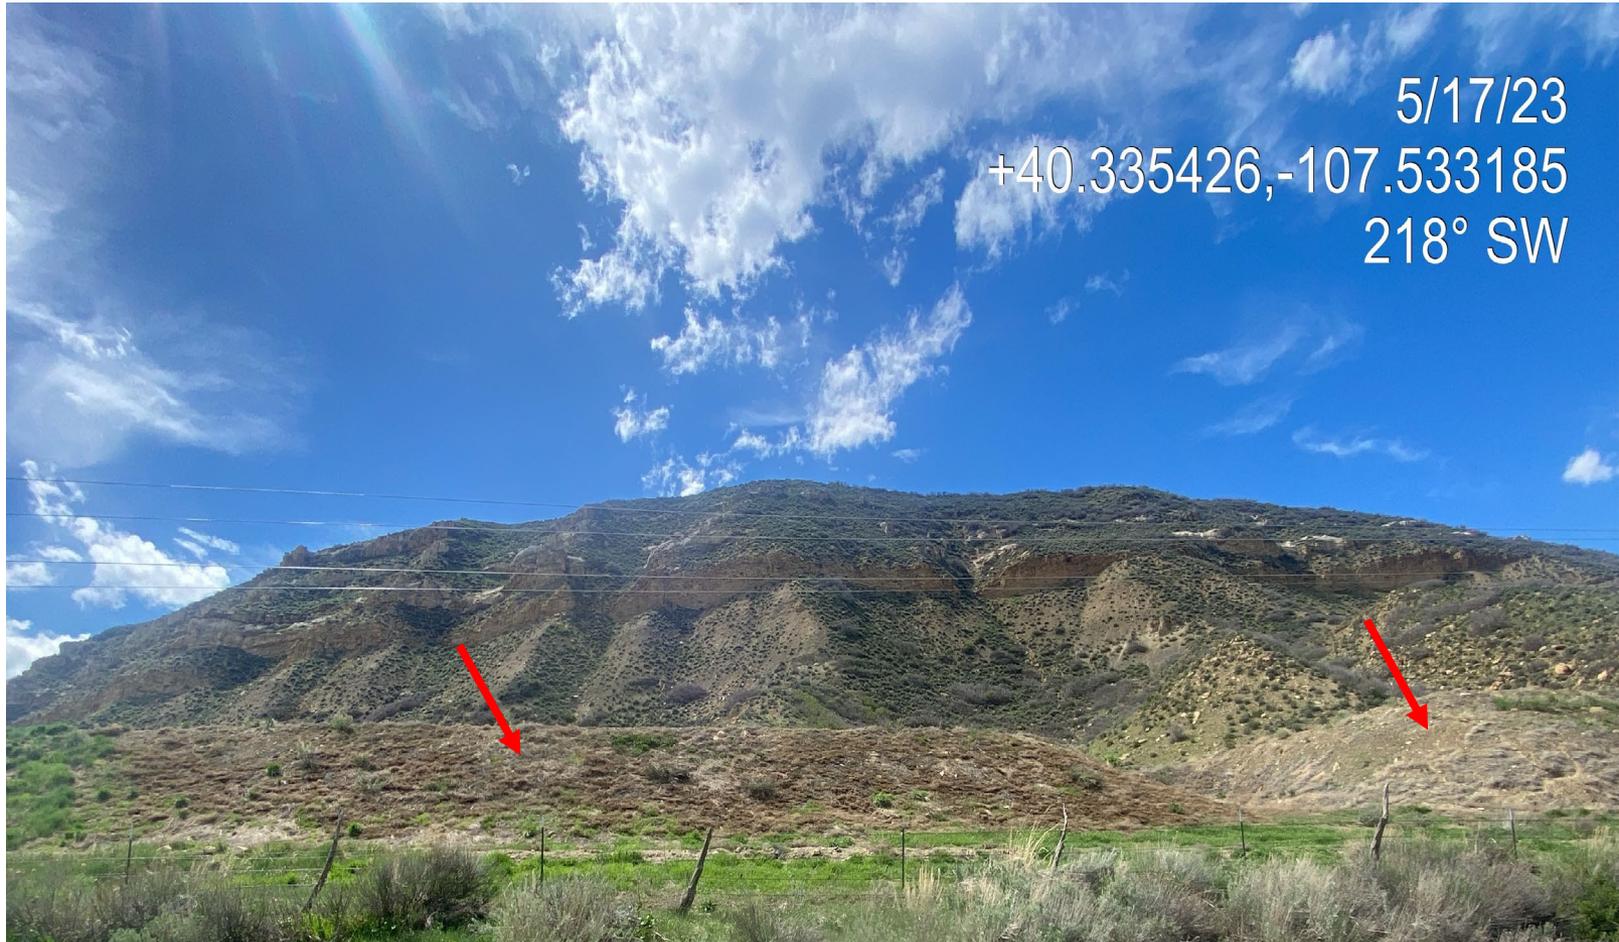
Photo 8. Photo taken from the county road to the south shows an overview of the fill slopes. The location has not been recontoured, slopes are bare, unstabilized and unvegetated or colonized by undesirable plant species/weeds.

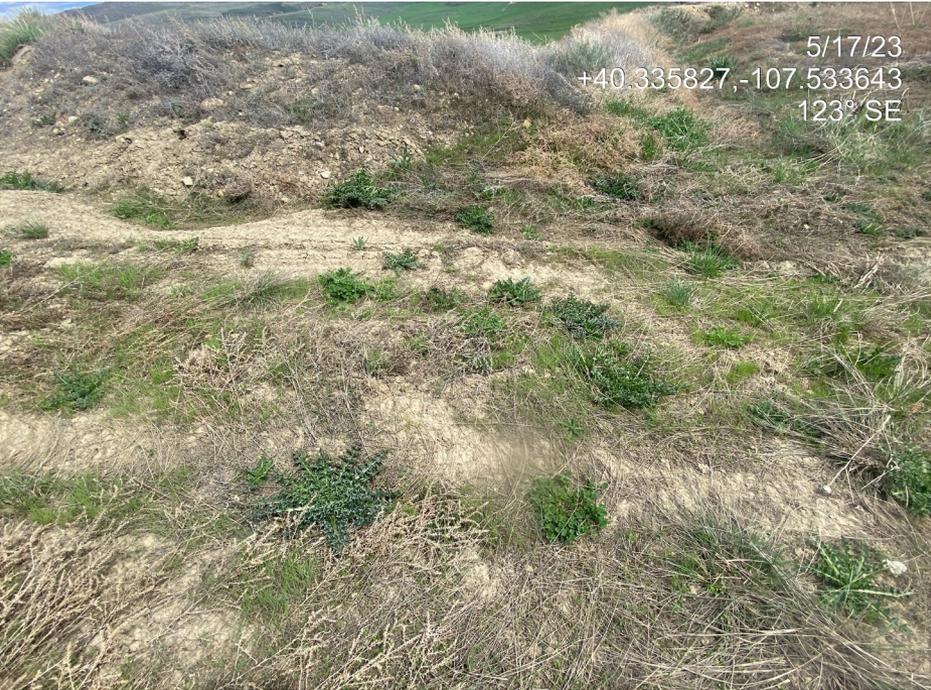
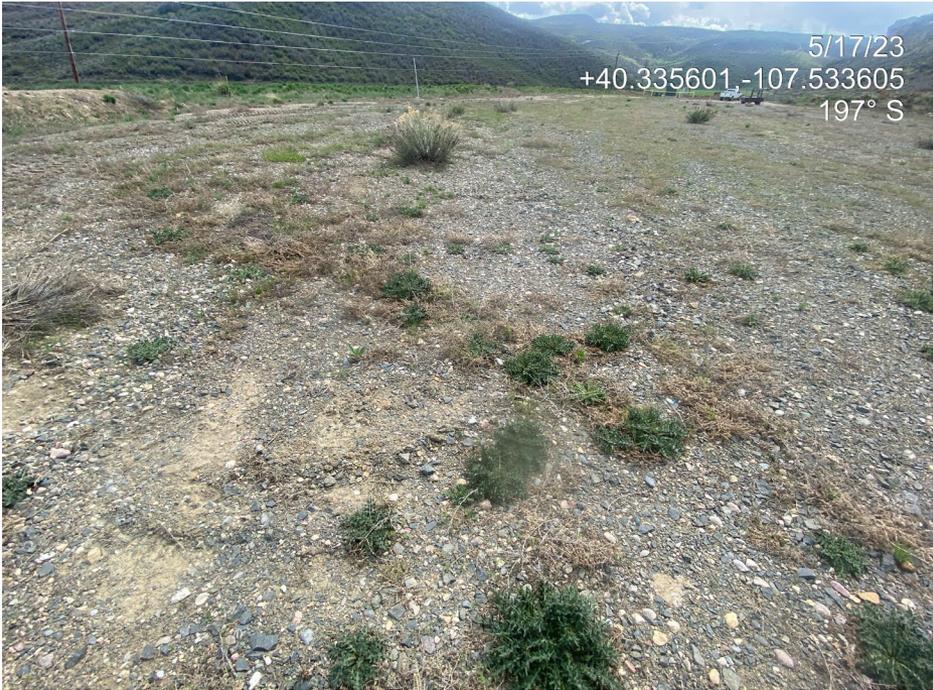
Photo 9. Photo shows the pad surface, fill slopes and berms are colonized by noxious weeds (bull, musk thistle, houndstongue and cheatgrass) and undesirable plant species/weeds (Russian thistle).

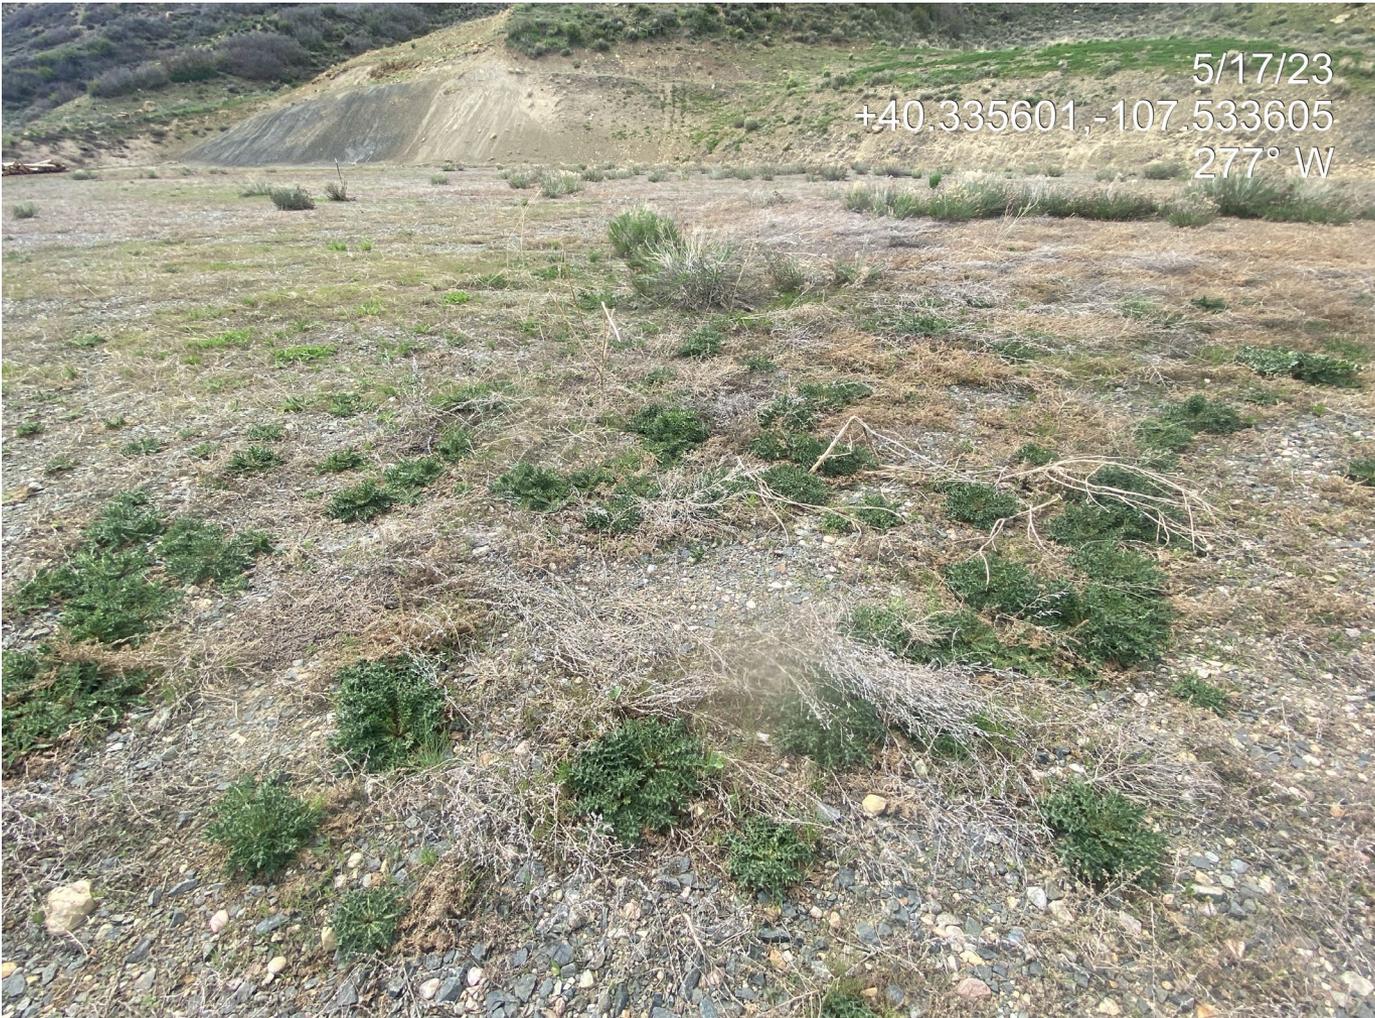
Photo 10. Photo shows noxious weeds (bull and musk thistle) and undesirable plant species/weeds (Russian thistle).
