Inspection Photos

Operator: GRMR OIL & GAS LLC - #10524

Location Name: BEAVER-DURHAM-65N90W/32NWSW

Inspection Document #: 702801541

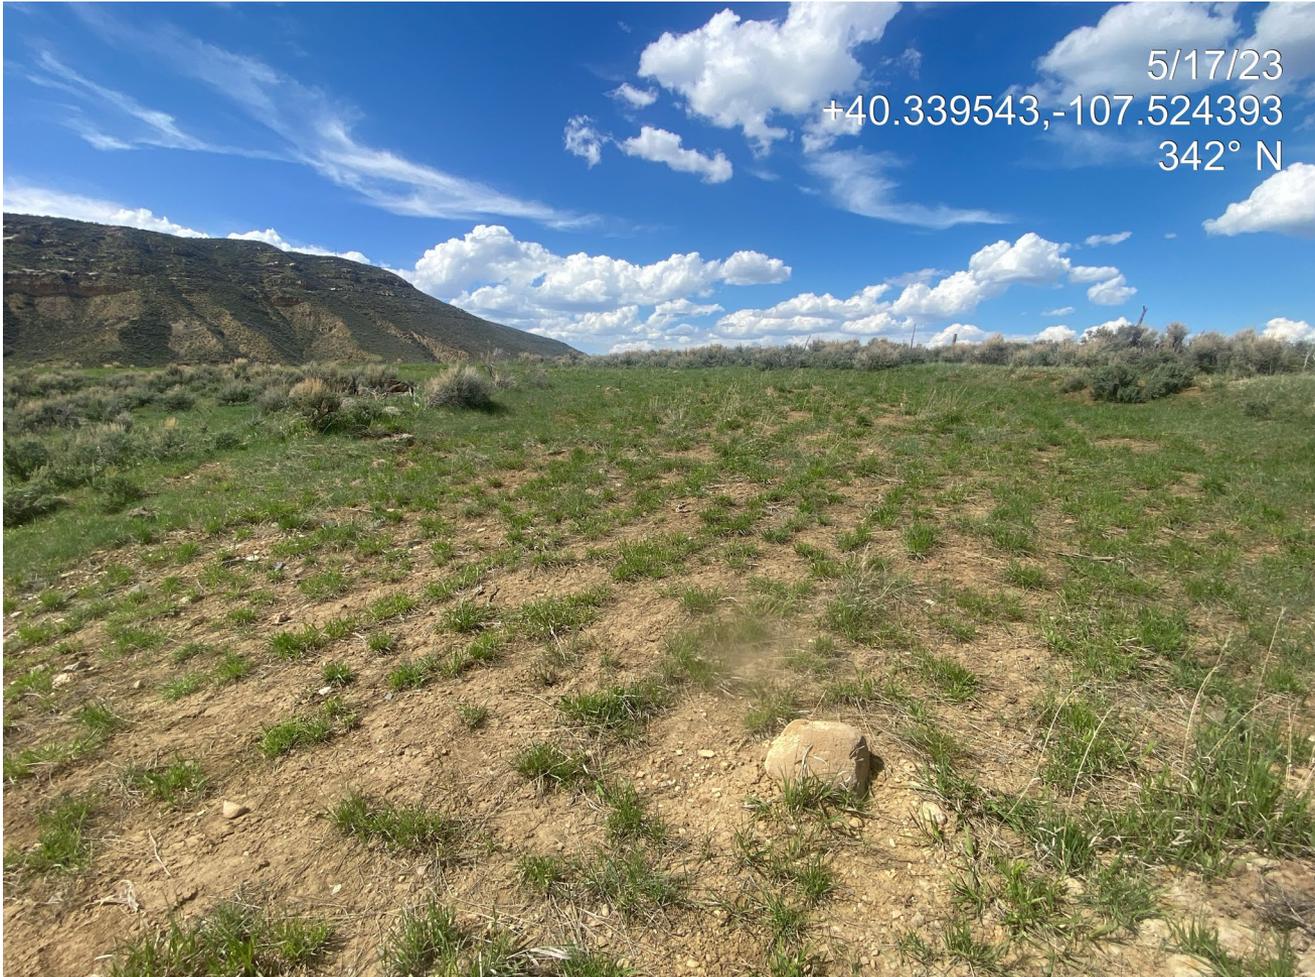
Photo 1. Photo taken from the southeast facing towards the location shows the reclaimed access road.

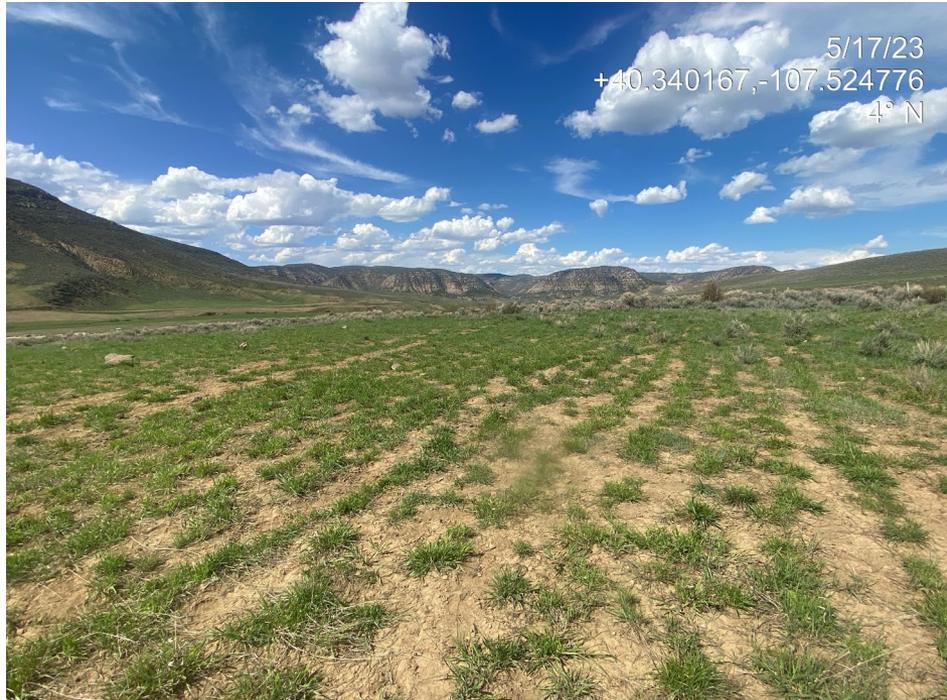
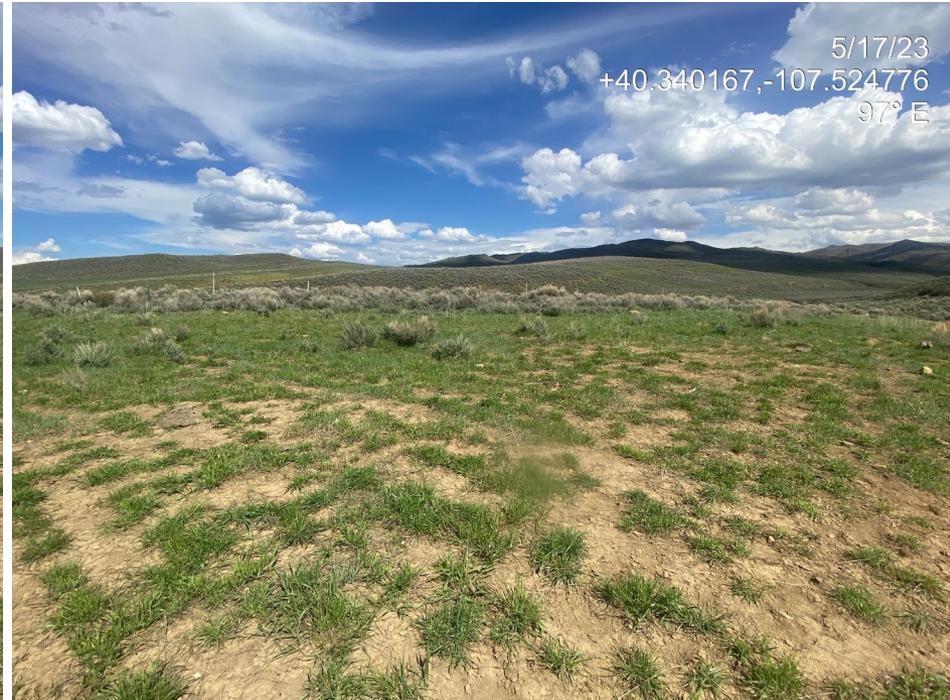
Photo 2. Photos taken from the center of the location show an overview to the north (left) and east (right). Note vegetation does not appear to be 80% of reference and presence of bare soil. Note also vegetation at the location center (in former working pad/equipment areas) is not as well established as at the edges of the location.

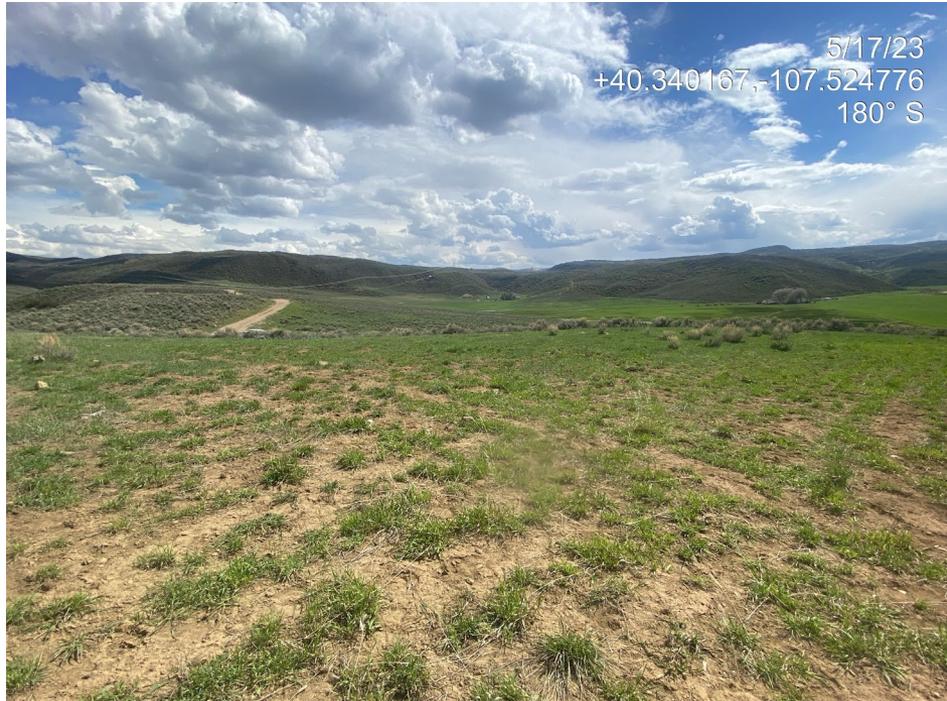
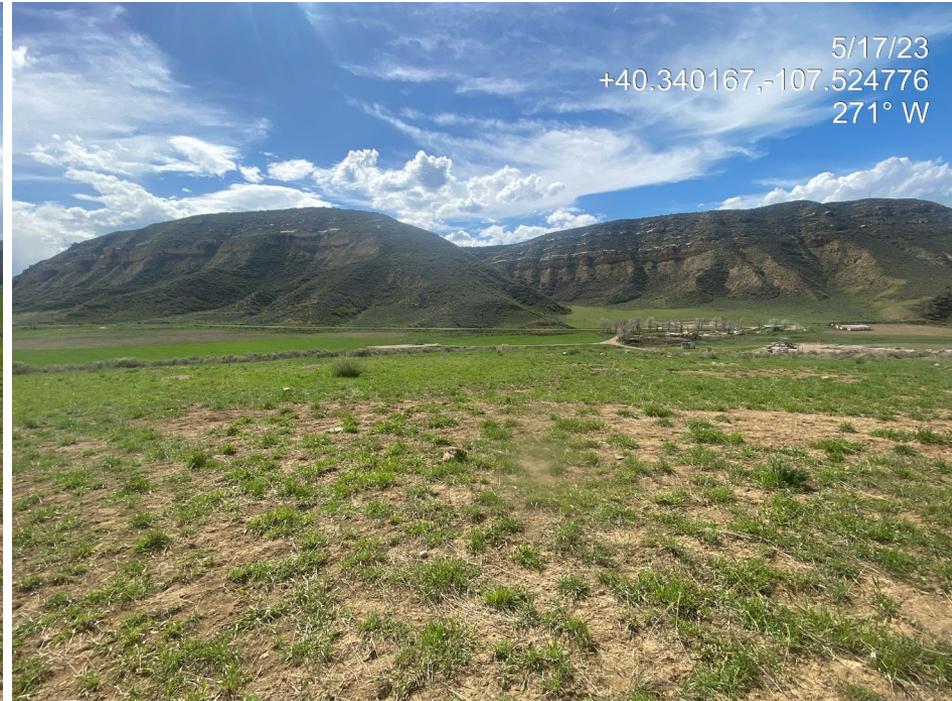
Photo 3. Photos taken from the center of the location shows an overview to the south (left) and west (right). Note vegetation does not appear to be 80% of reference and presence of bare soil. Note also vegetation at the location center (in former working pad/equipment areas) is not as well established as at the edges of the location.

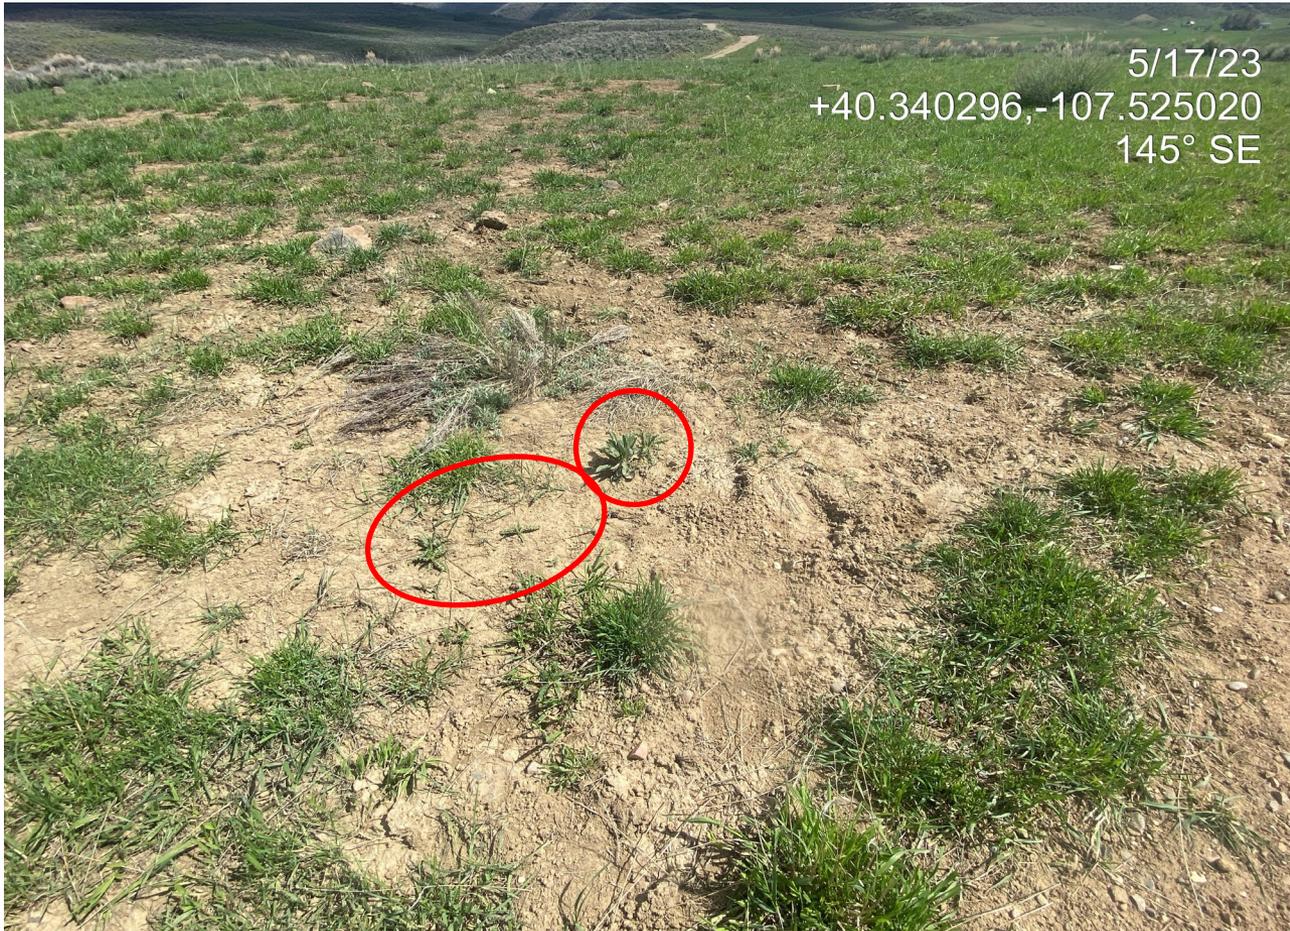
Photo 4. Photo shows an examples of areas throughout the location where vegetation establishment is not uniform. Perennial species are not established, bare ground is common and occasional noxious weeds are colonizing bare spaces (circled).

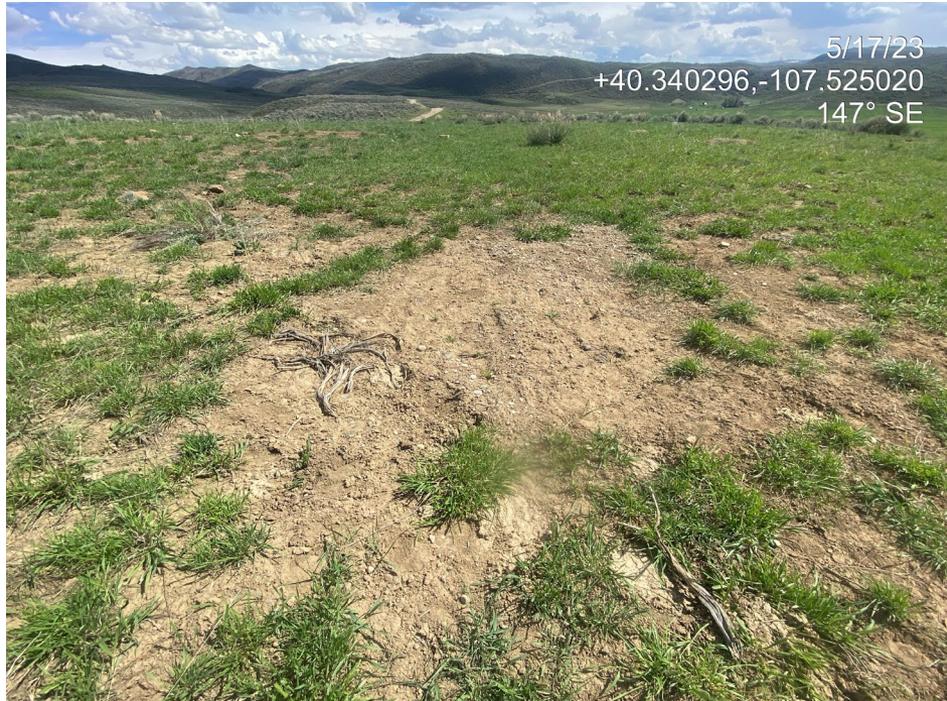
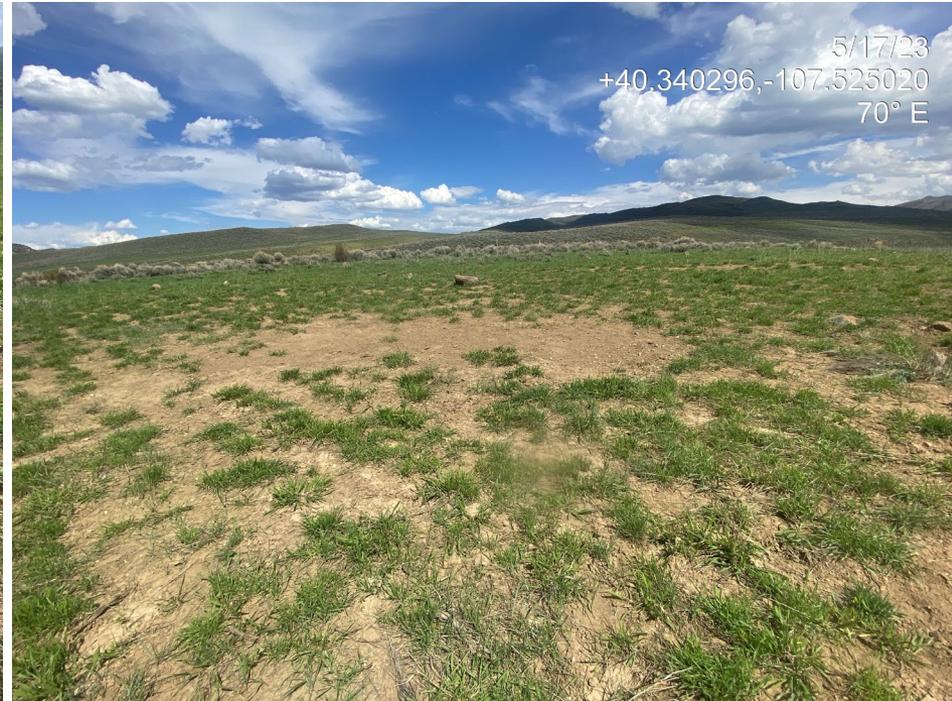
Photo 5. Photos show examples of areas throughout the location where vegetation establishment is not uniform. Perennial species are not established, bare ground is common.

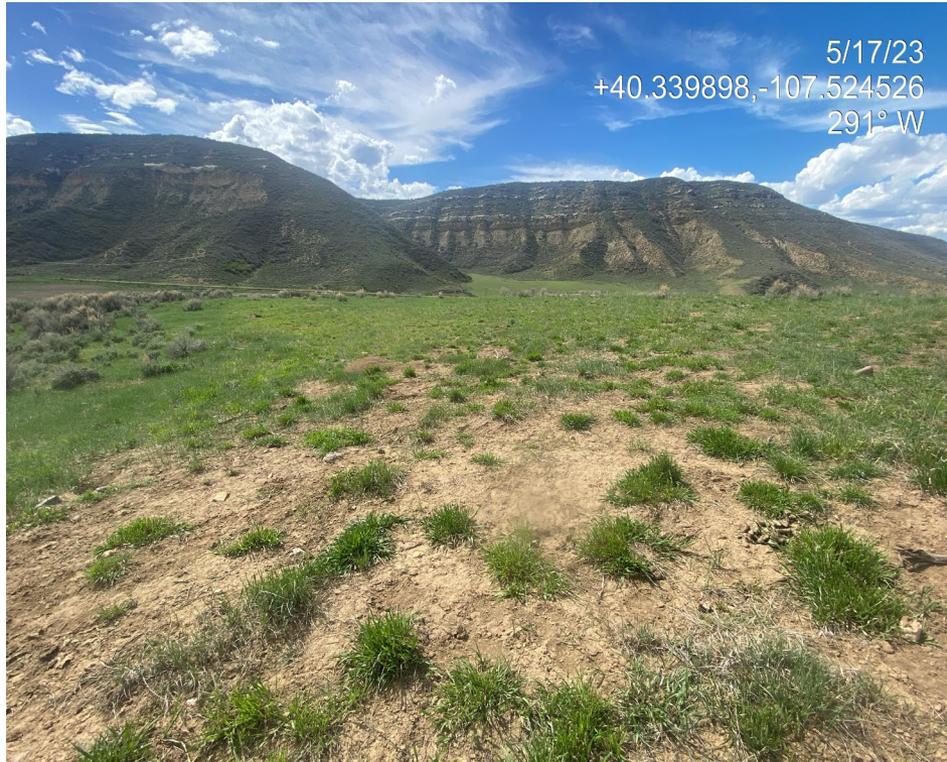
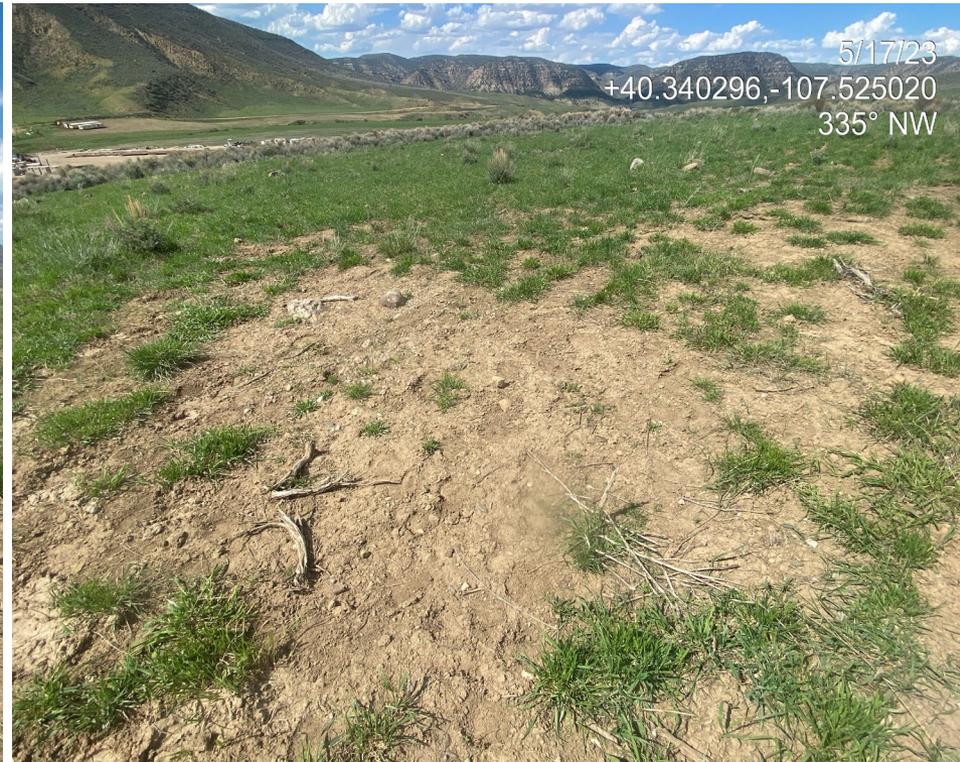
Photo 6. Photos show examples of areas throughout the location where vegetation establishment is not uniform. Perennial species are not established, bare ground is common.

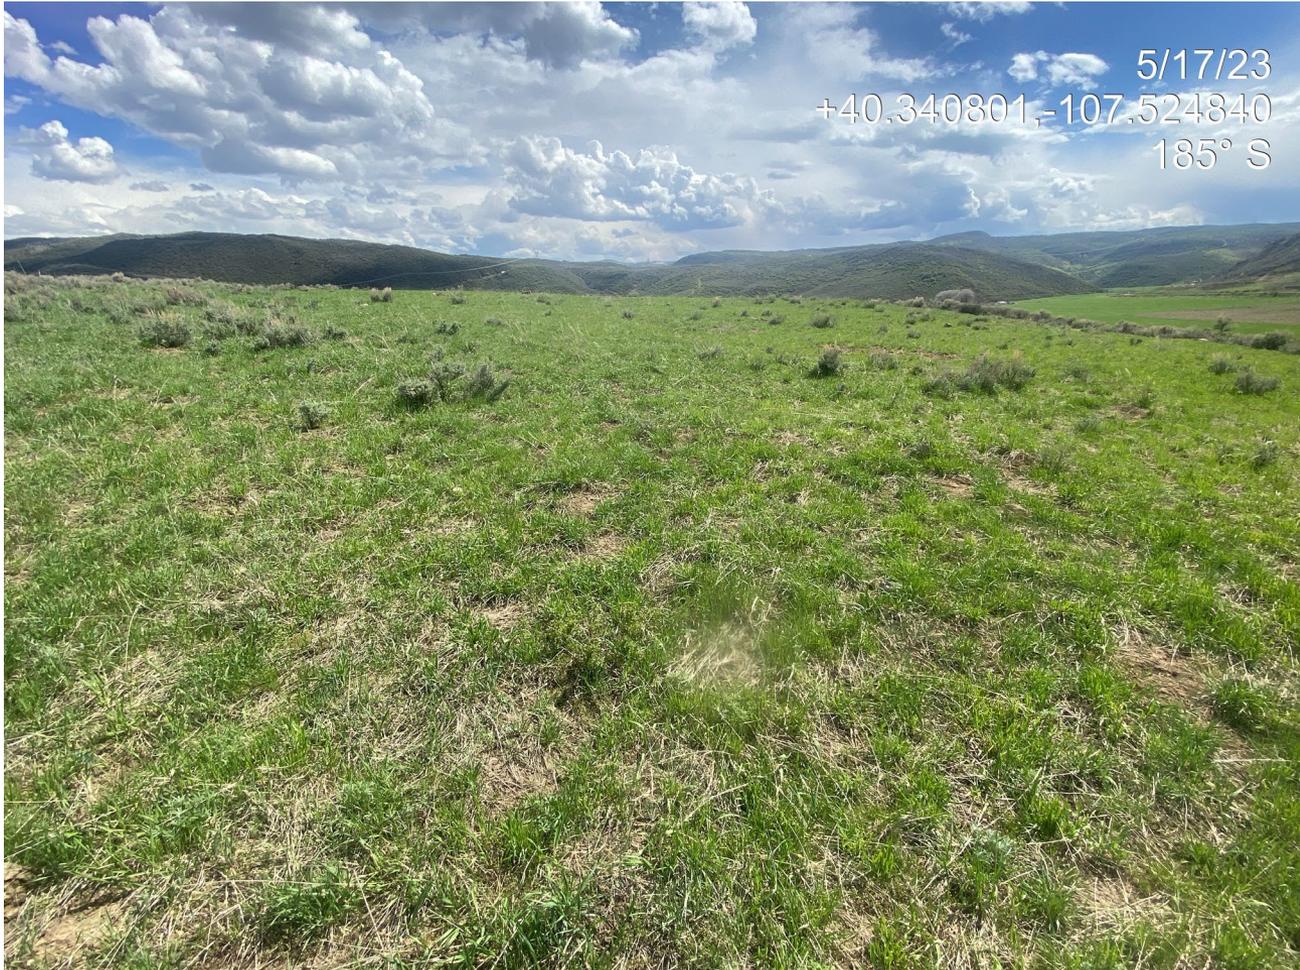
Photo 7. Photo shows an example of a portion of the location with good perennial establishment that appears comparable to reference in terms of percent coverage of perennial species.

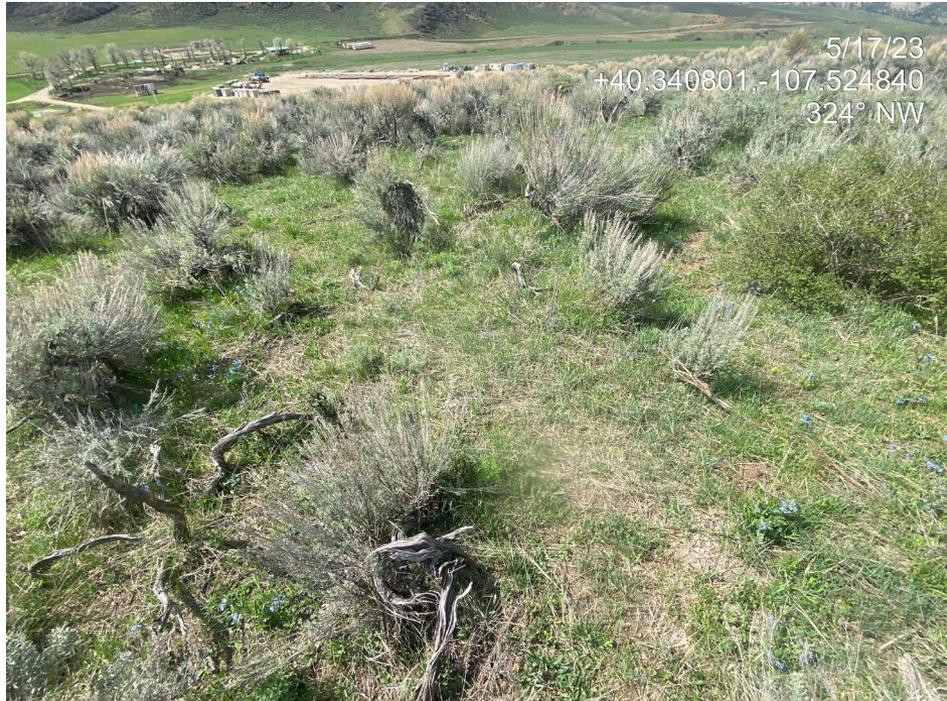
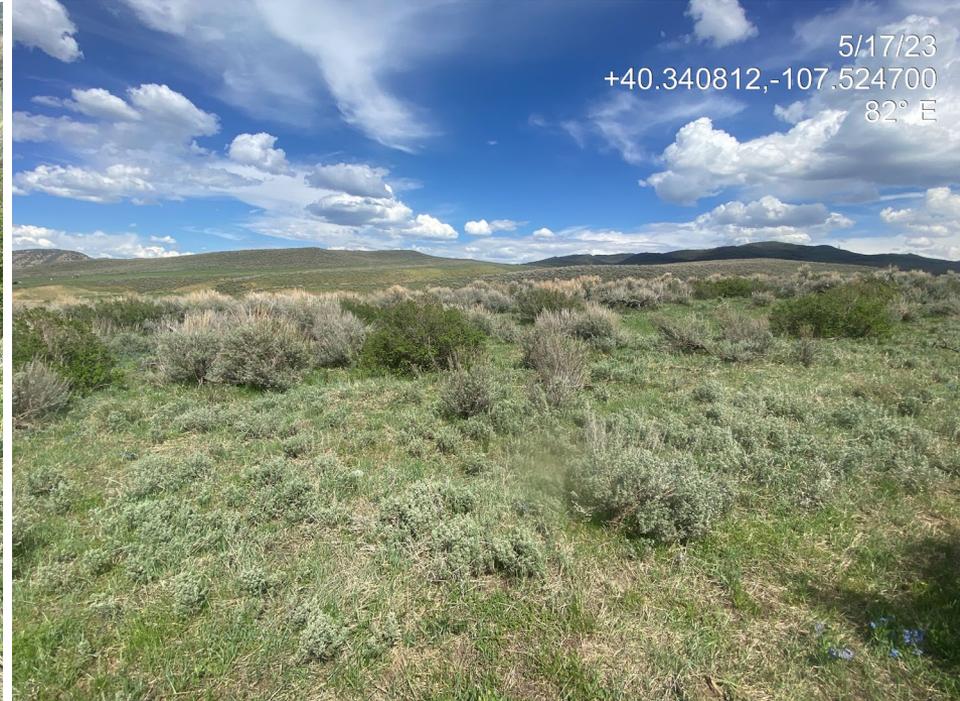
Photo 8. Photos show reference areas to the north. Note dense coverage of perennial grasses, forbs and shrubs.
