# Inspection Photos

Operator: CAERUS PICEANCE LLC - 10456

Location Number: 312686

Mesa County, CO

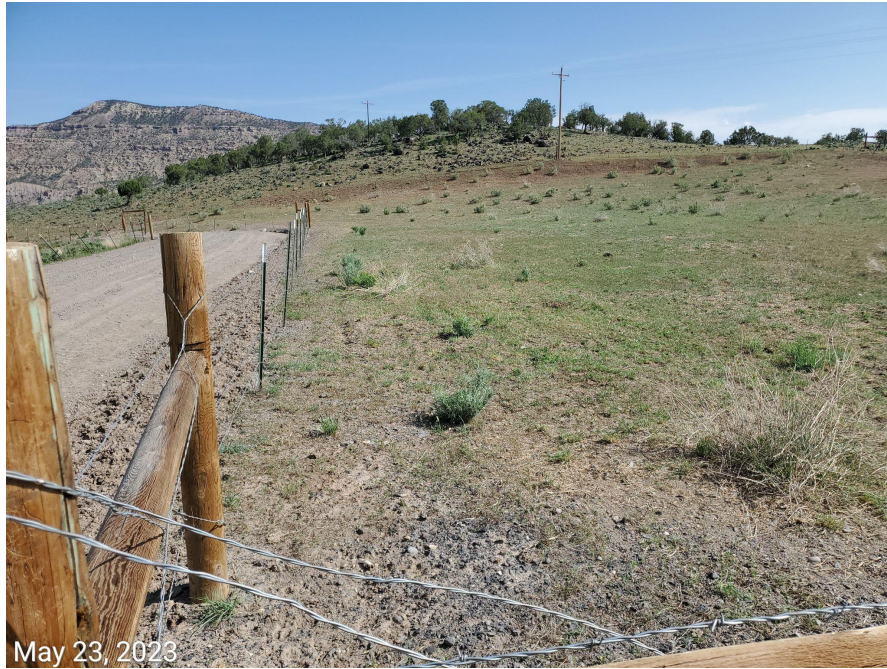
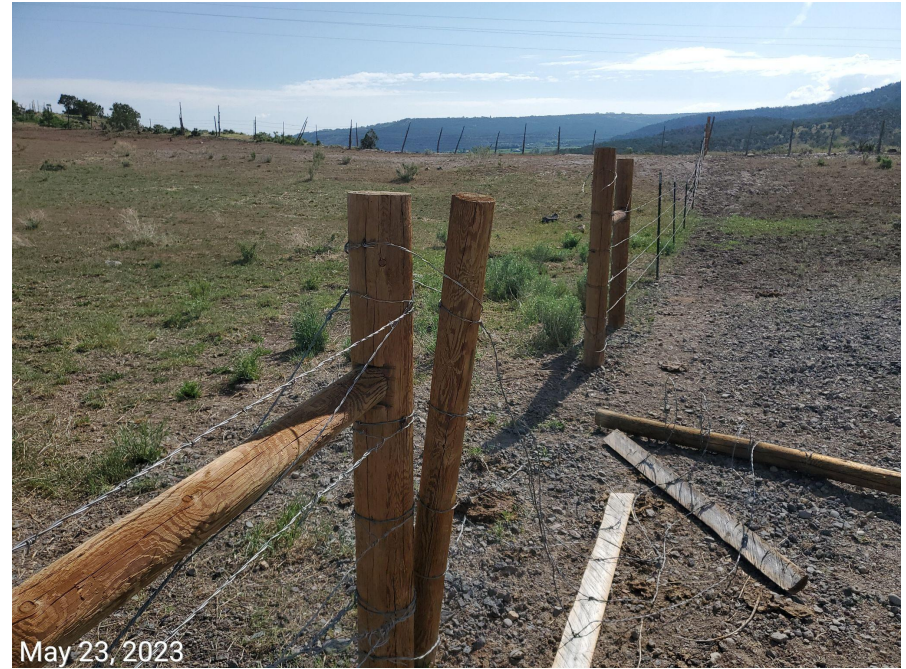
**Photo 1:** Photos 1-2 taken from the west end of the Location. Photos provide an overview of the Location facing north, northeast, southeast and south. Photo show the southern half of the Location has not been reclaimed in accordance with 1004 Rules; no variance request to waive 1004 reclamation requirements have been submitted or approved.

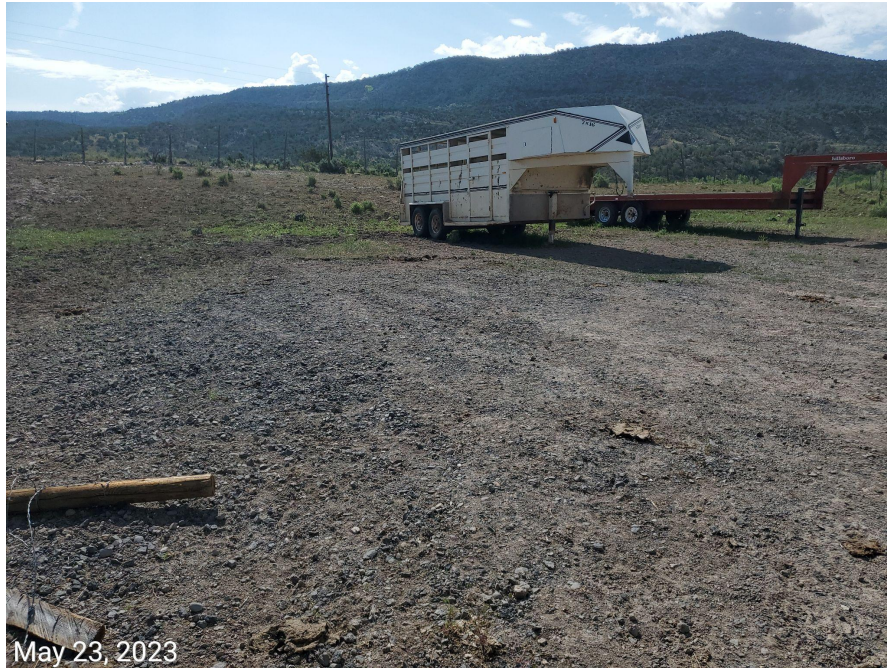
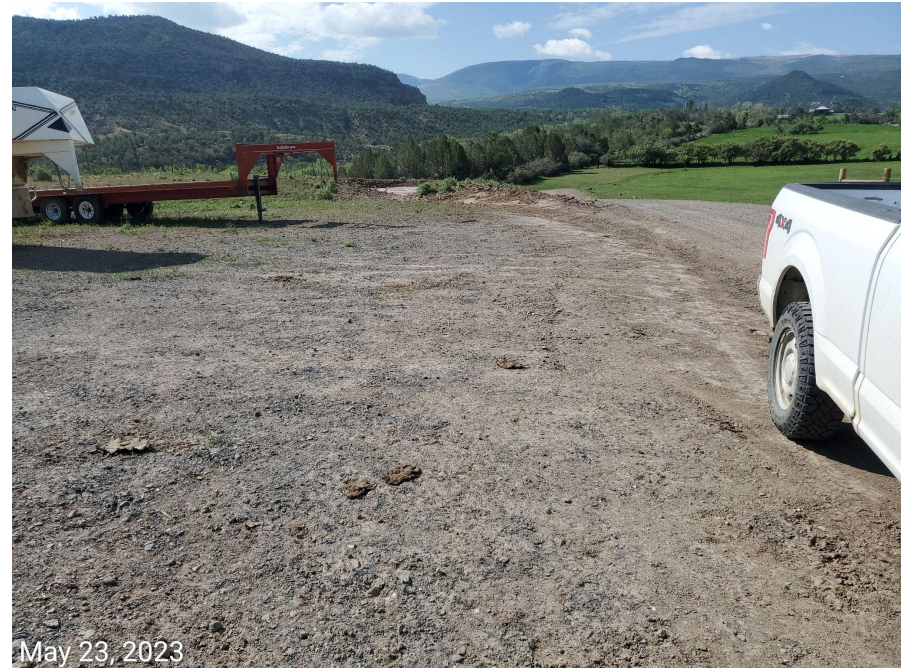
**Photo 2:** See comments under photo 1.

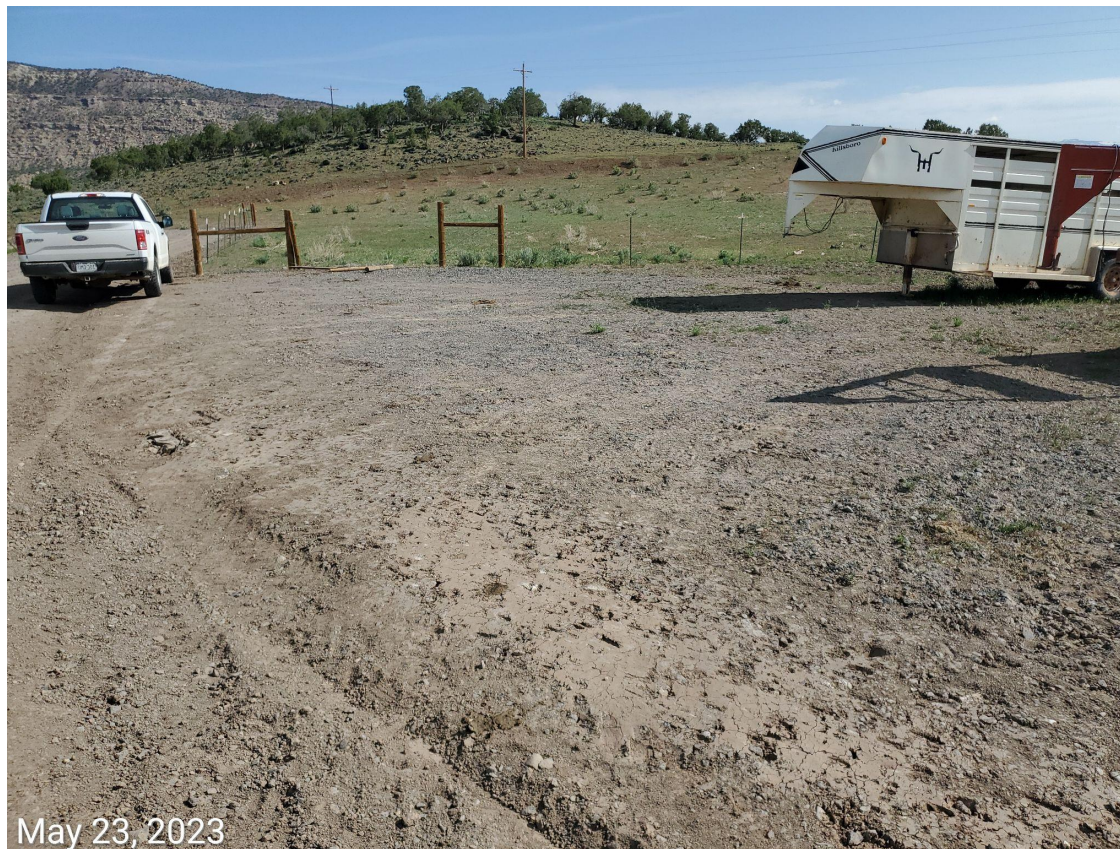
**Photo 3:** Photo taken from the south end of the Location, facing north. See comments under photo 1.

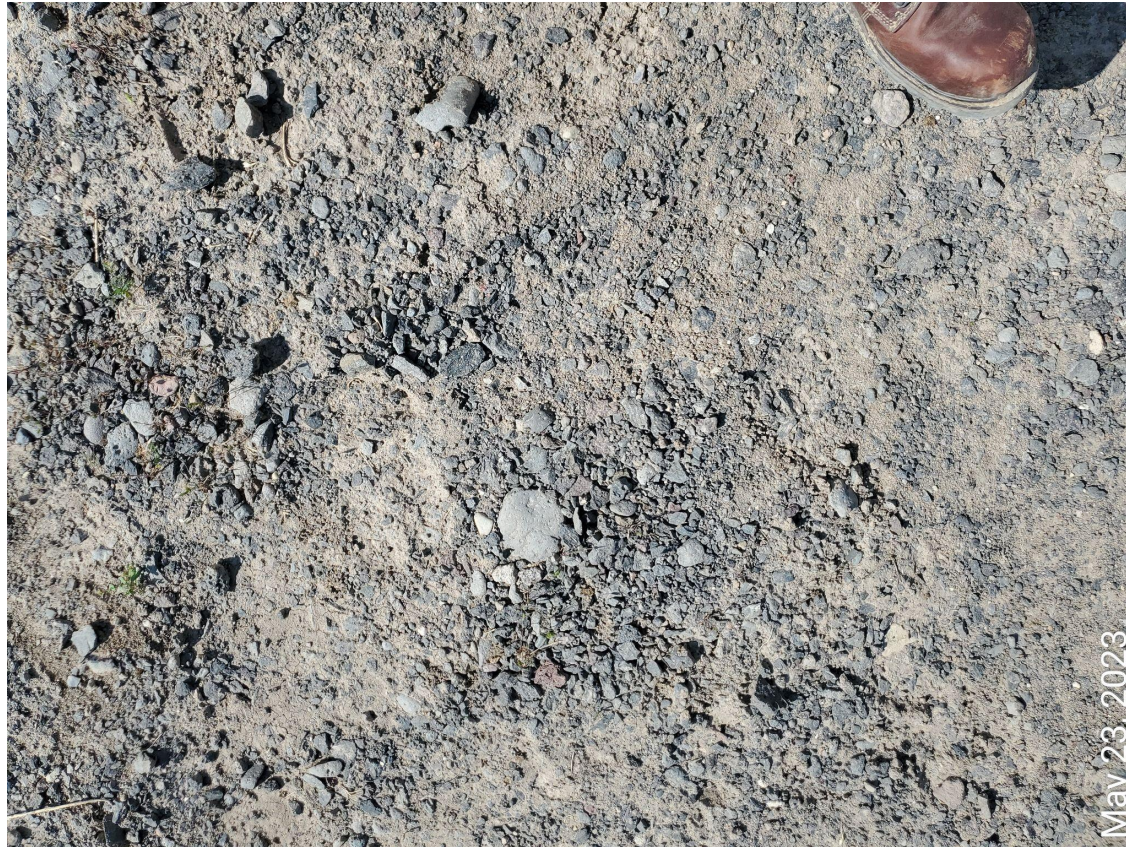
**Photo 4:** Photo taken from the south end of the Location. Photo shows road base/gravel remaining. Southern half of the Location has not been reclaimed in accordance with 1004 Rules.
