Interim Reclamation and Stormwater Inspection

Operator: WHITING OIL & GAS CORPORATION -
96155

Location ID: 435421

Inspection Photos
Location Name: Razor 26 Production
Location ID: 435421

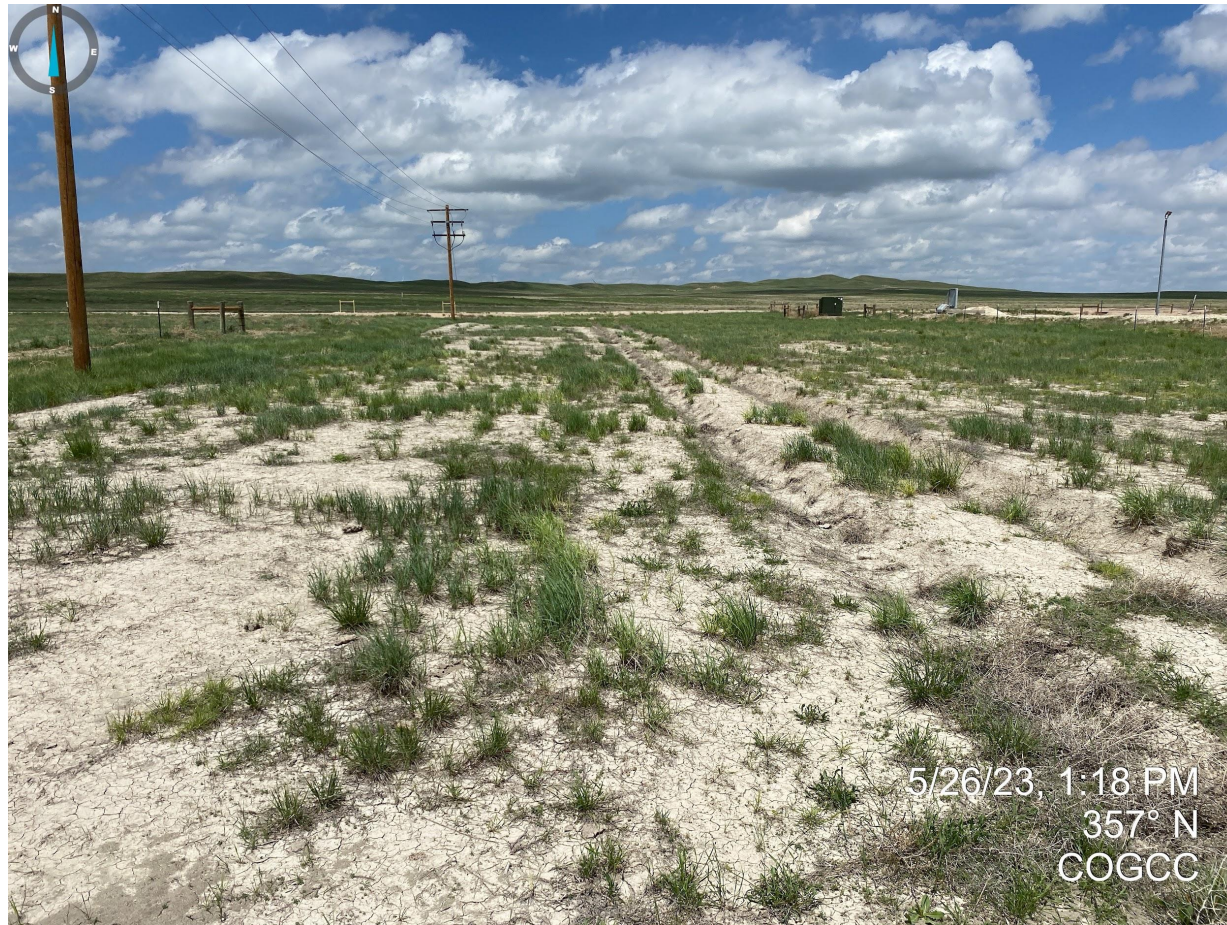
Photo 1. Western interim areas. During this inspection, Staff observed that the western interim areas do not appear to be progressing towards Rule 1003 standards as areas of non-uniform vegetation cover were evidenced by bare soil. Additional reclamation activities are required to meet Rule 1003 standards.

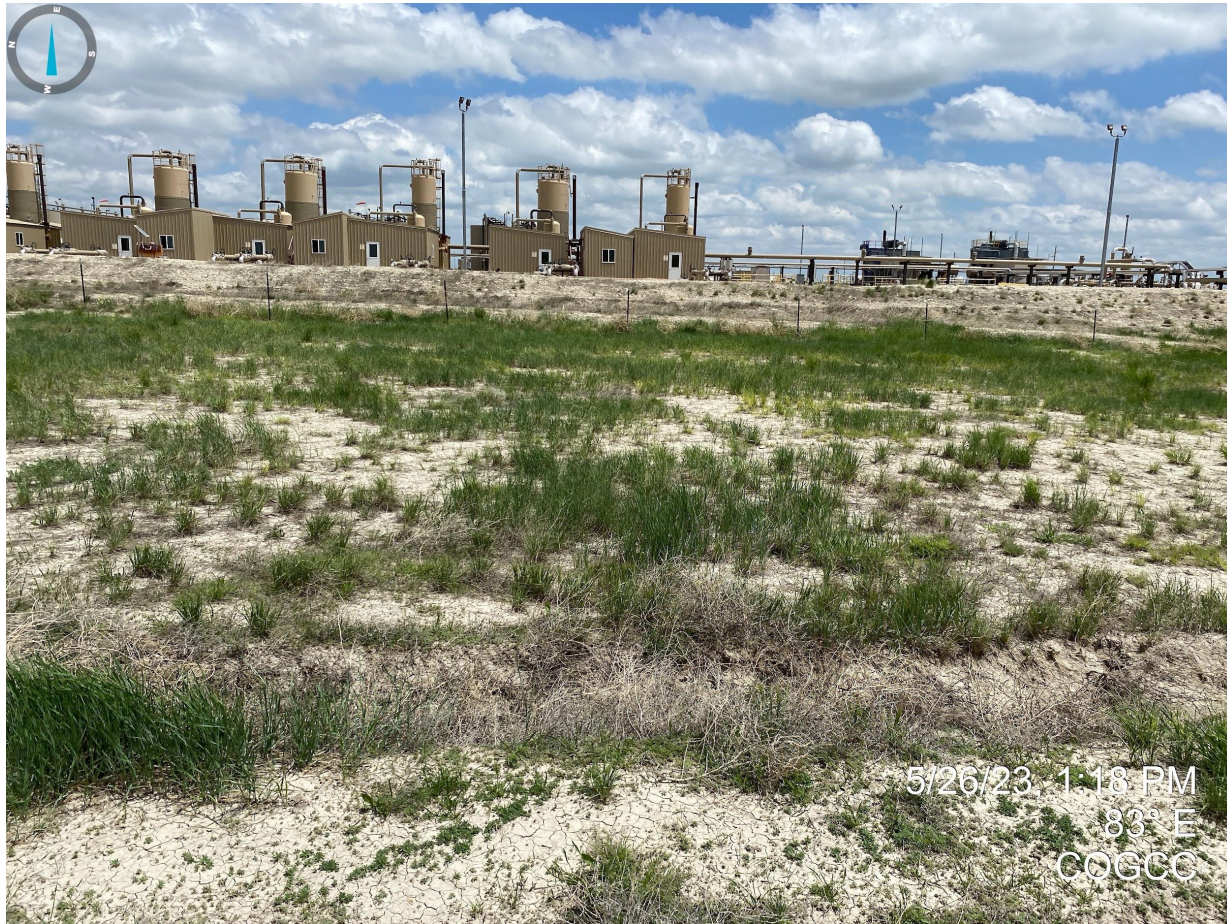
Photo 2. See comments in Photo 1.

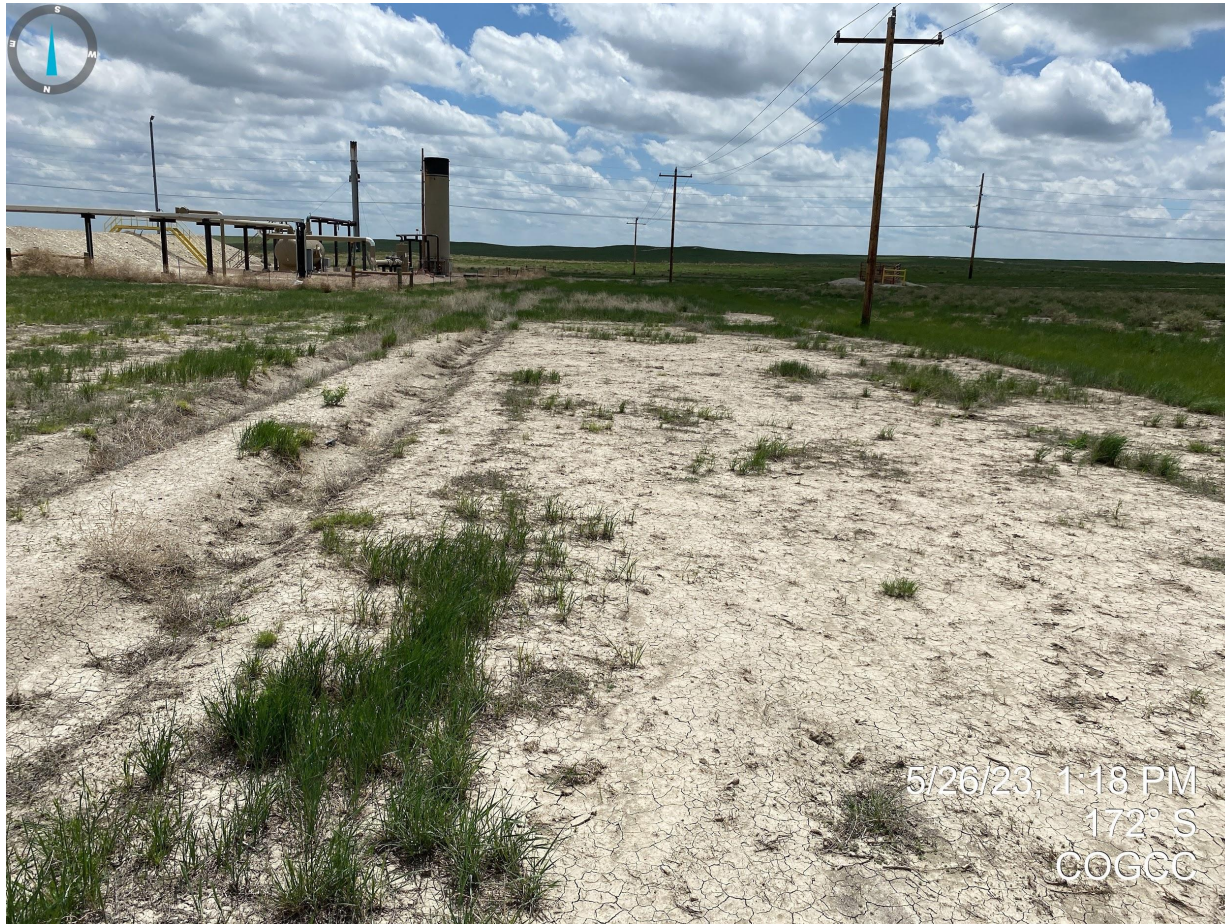
Photo 3. See comments in Photo 1.

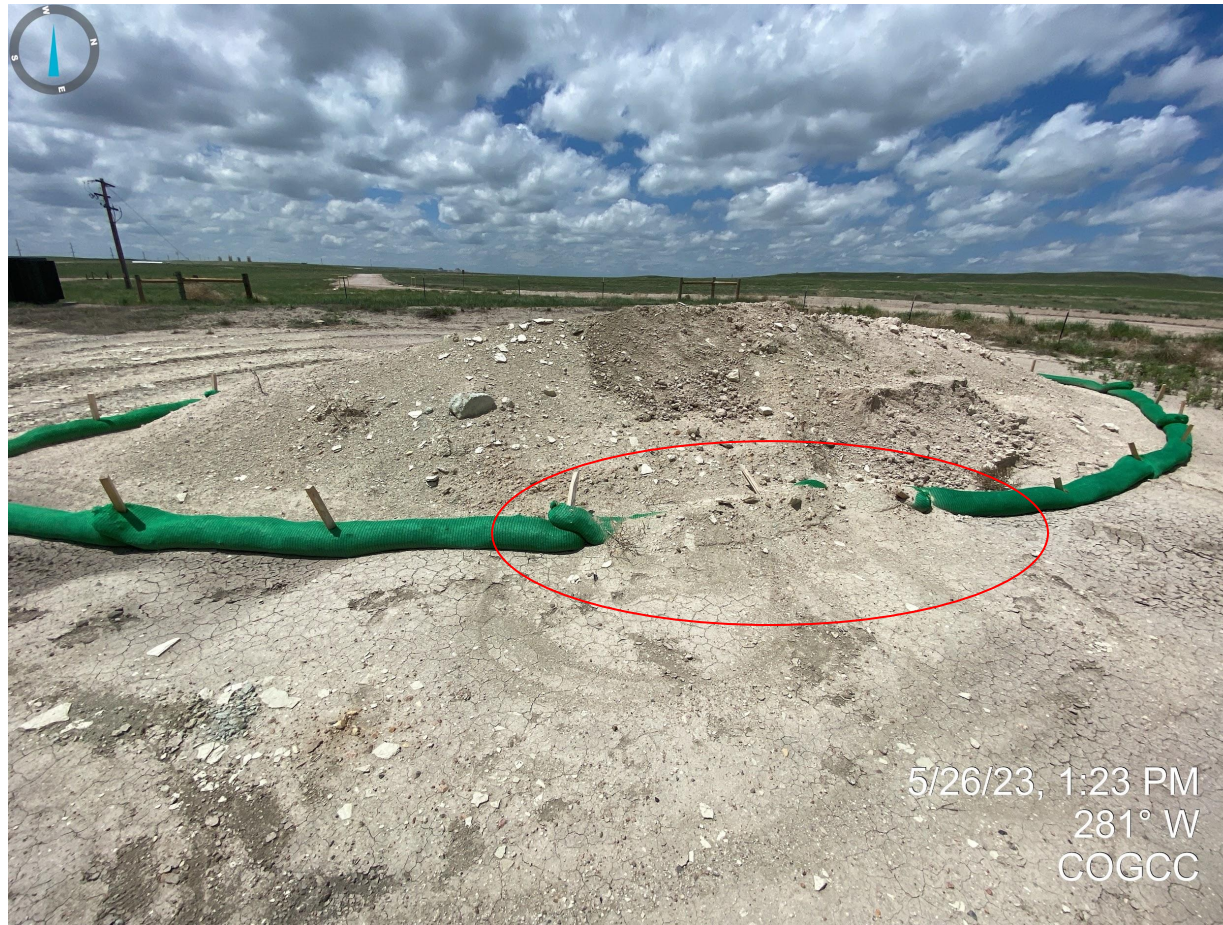
Photo 4. Northern portion of production area. Apparent impacted material being stored on the north end of the location, possibly associated with Remediation Project #29364, was not placed on a impervious liner and sediment control logs appeared inadequate with evidence of sediment transport outside of BMPs. More robust BMPs will need to be implemented to prevent impacted material from migrating outside of containment.

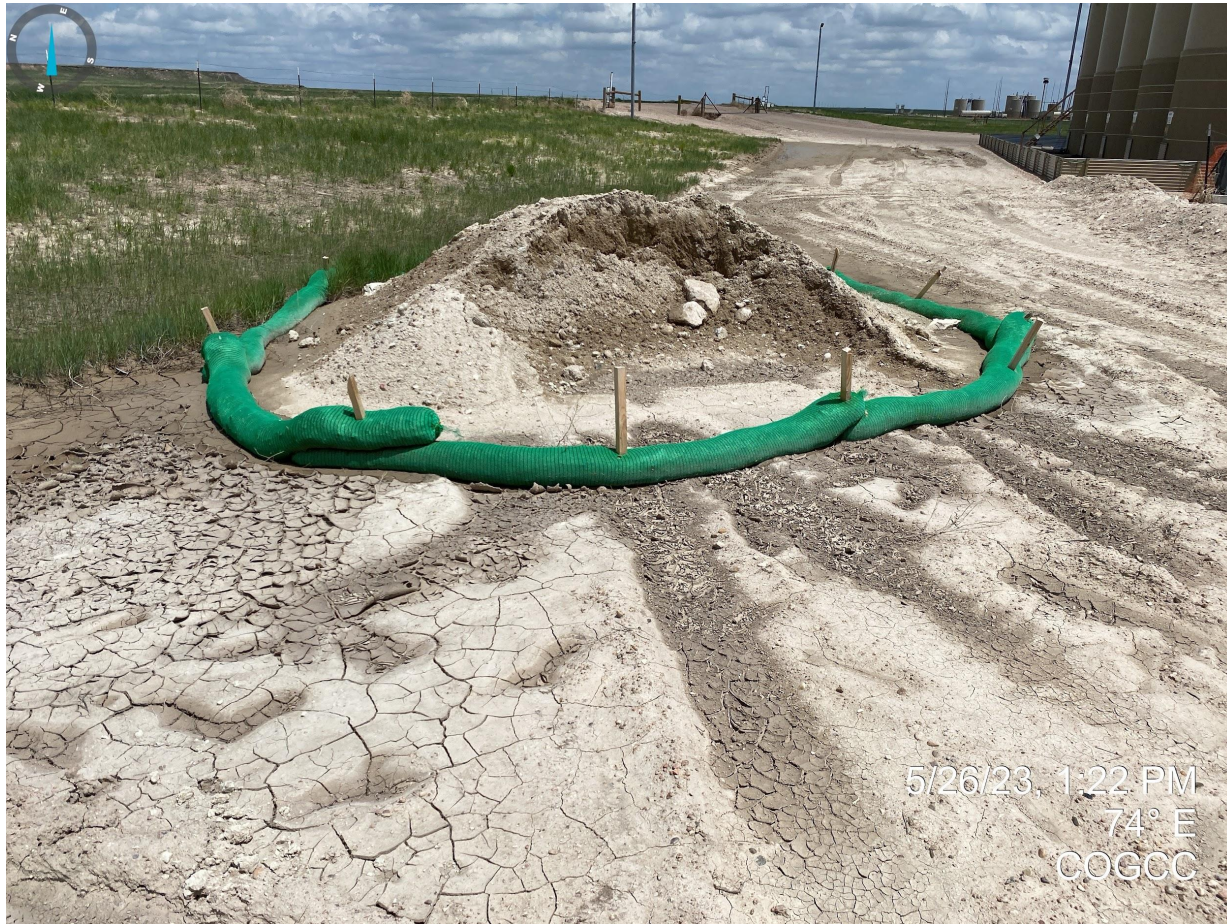
Photo 5. See comments in Photo 4.

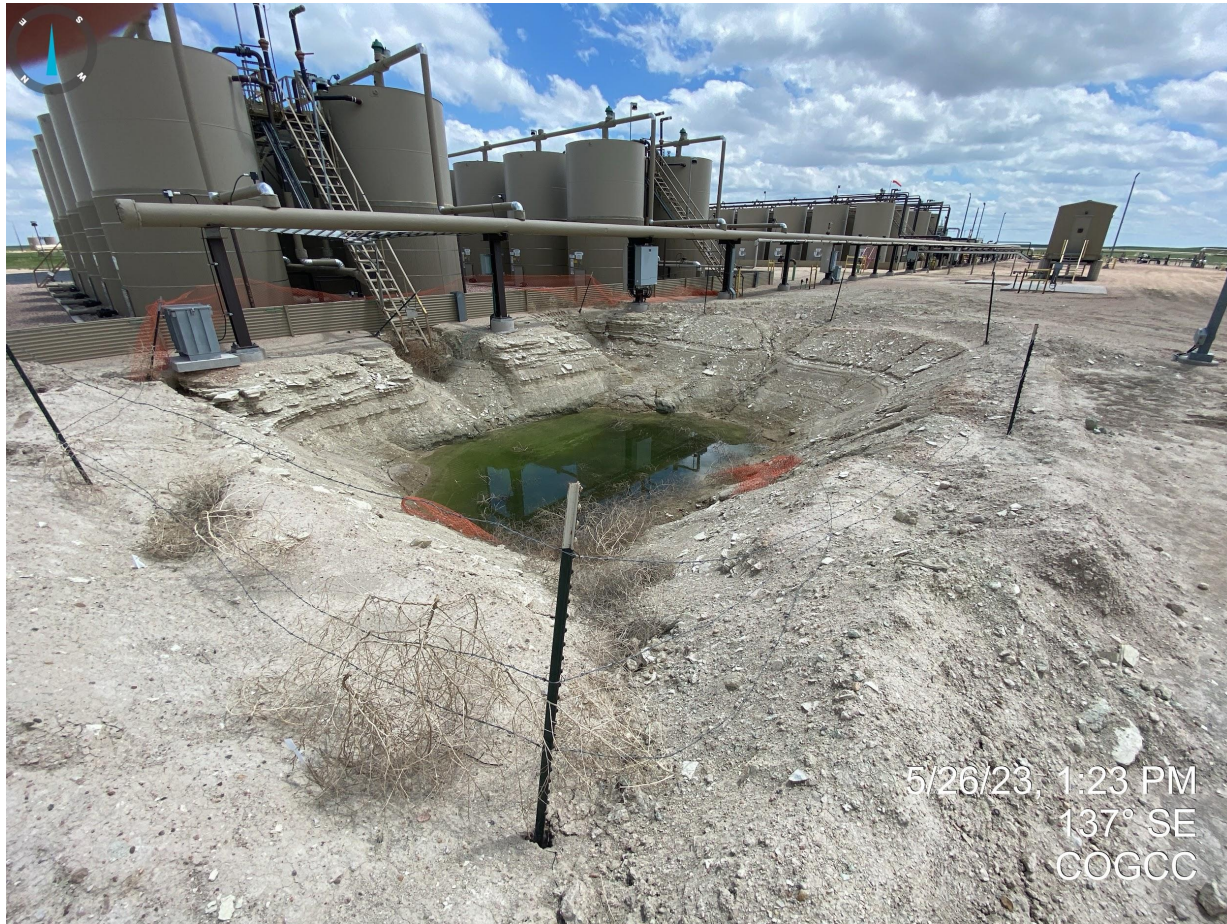
Photo 6. Perimeter fencing around open excavation associated with Remediation Project #29346 appears inadequate to exclude wildlife entry.

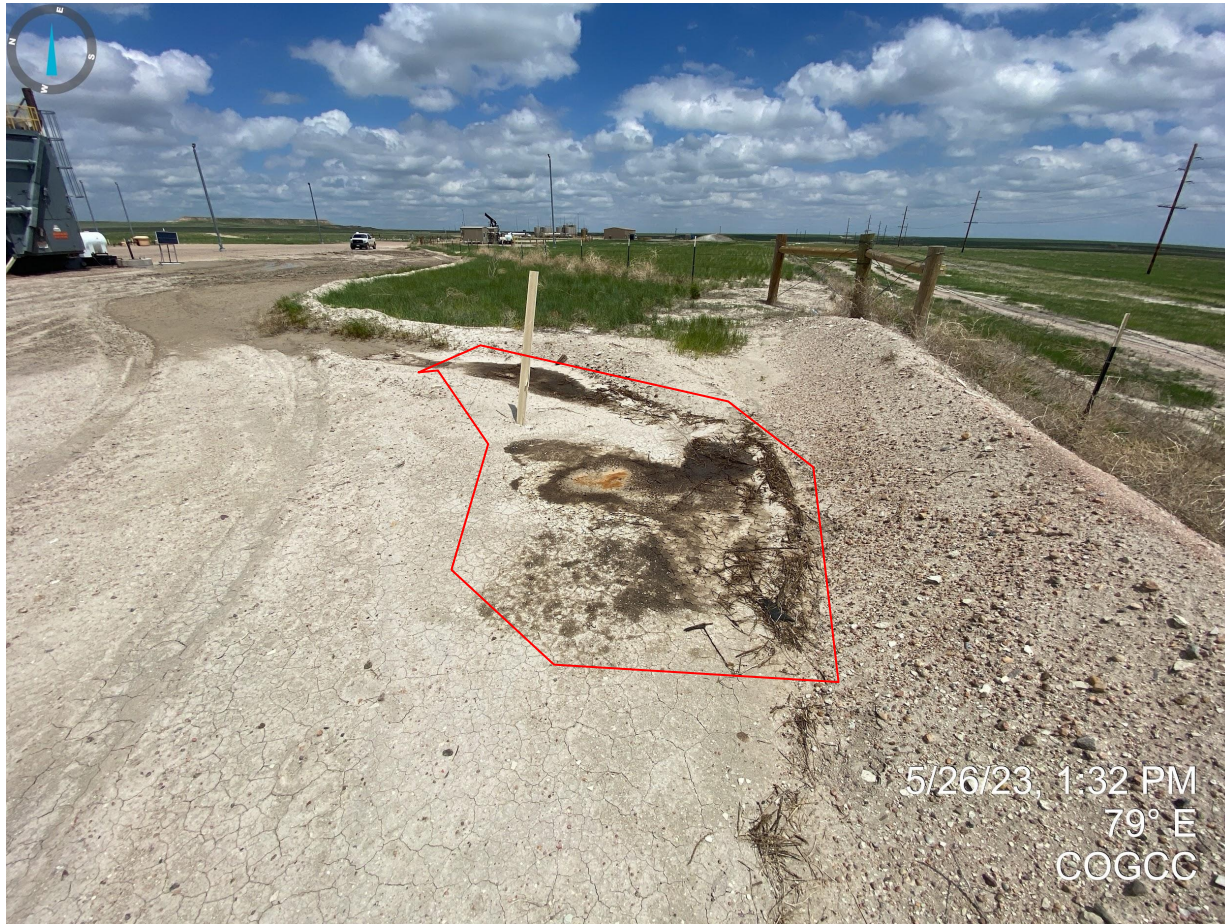
Photo 7. Stained soil observed on the southern end of the location, south of compressors, will need to be properly disposed of in accordance with 905.e.

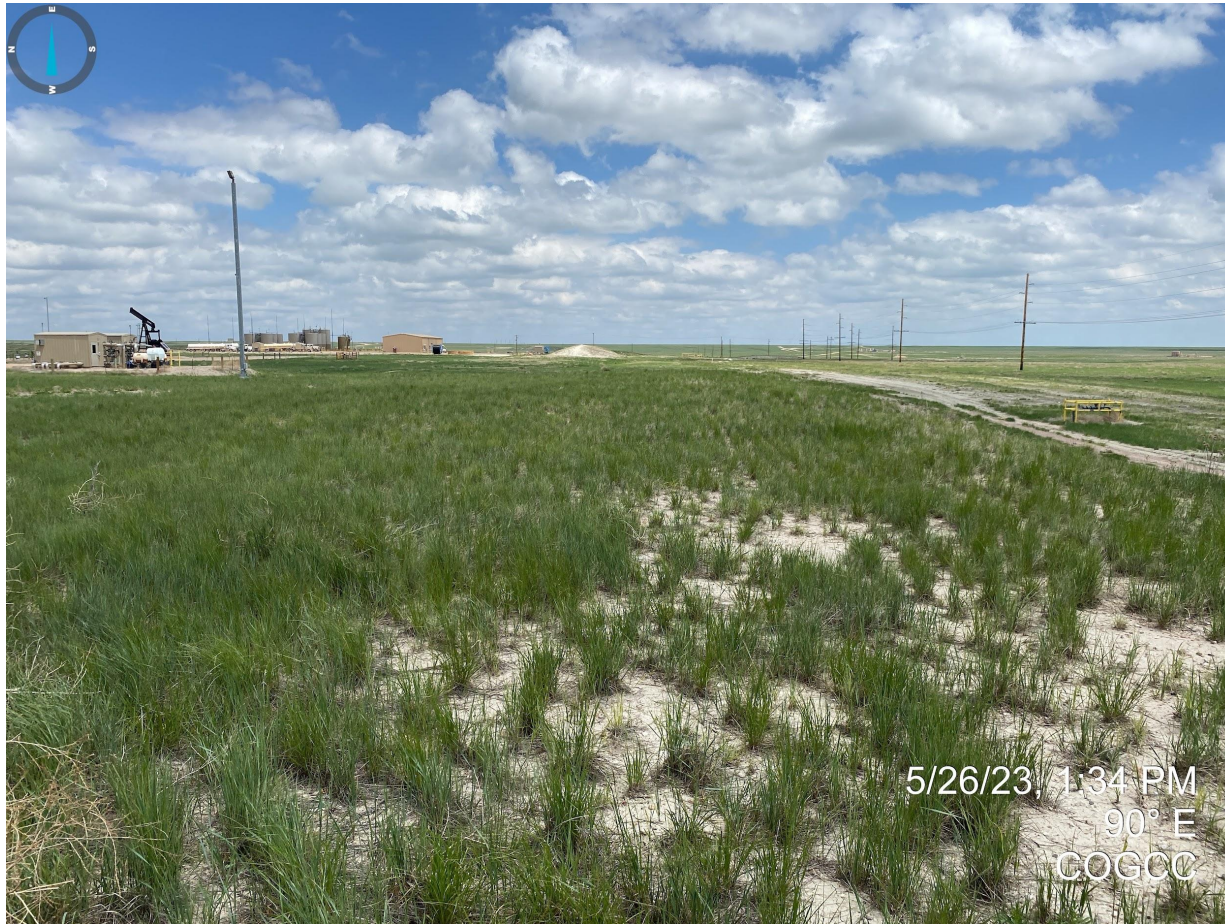
Photo 8. Southeastern interim area. This portion of the interim areas appear to be progressing towards Rule 1003 standards with uniform vegetation cover of desirable species observed.
