# Inspection Photos

API: 055-06190

Operator: EVERGREEN NATURAL RESOURCES

Inspection Date: 6/6/2023

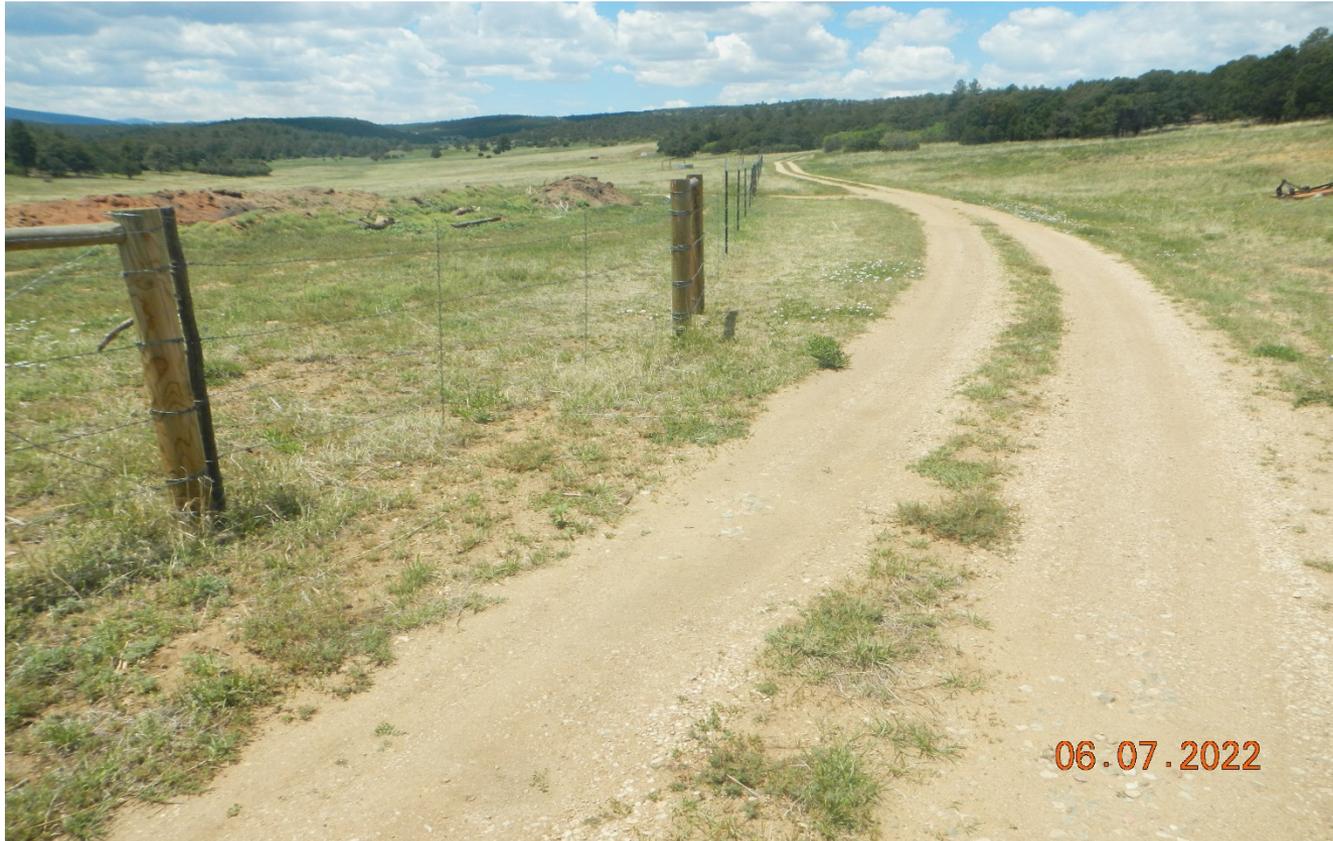
**Photo 1.** Facing west toward the location. The road travels thru the center of the location.

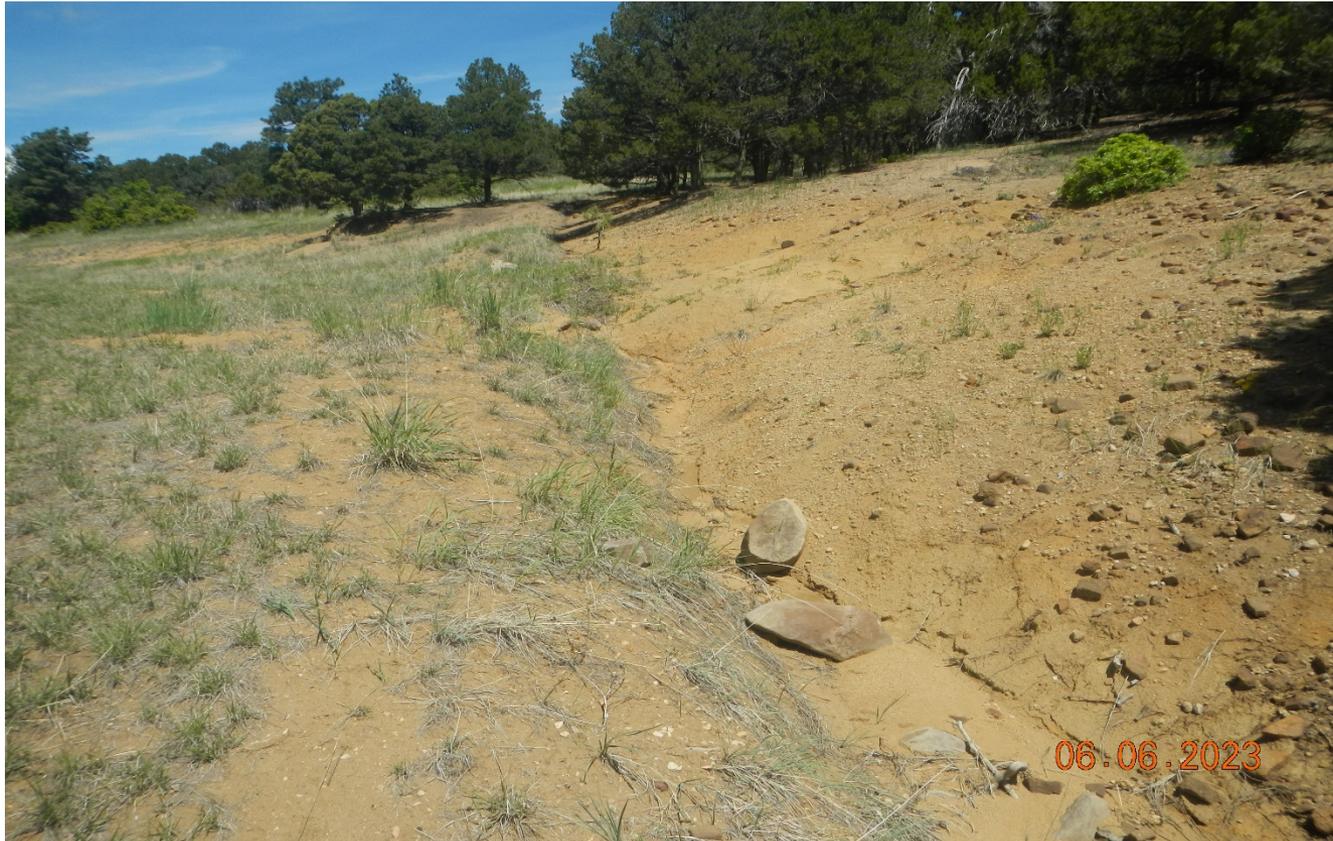
**Photo 2.** Facing northwest toward the location. The cut slope of the location is visible along the right side of photo and a run-on ditch. This area shown in right portion of the photo is not stabilized.

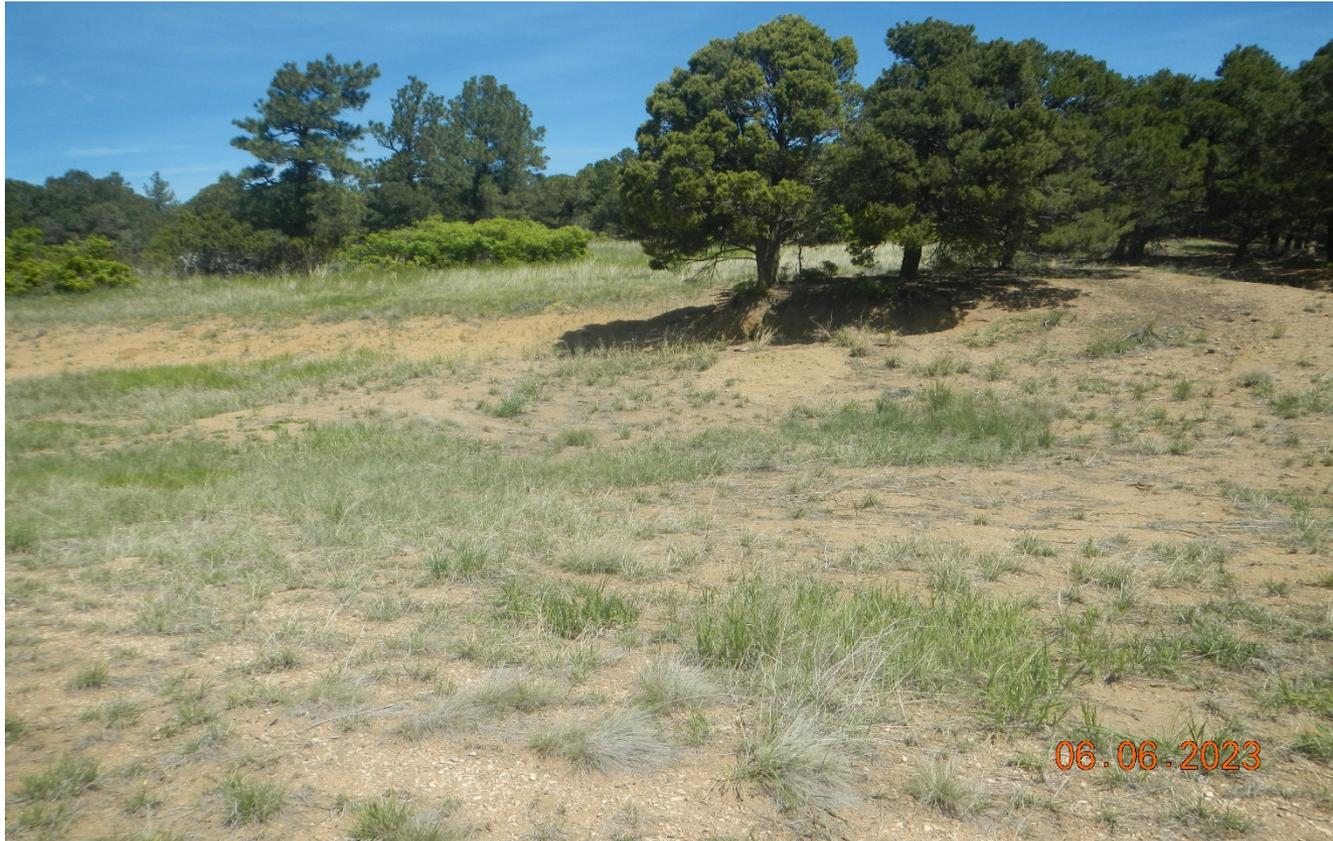
**Photo 3.** Facing north toward the location. The cut slope of the location is visible and has not sufficiently established vegetation.

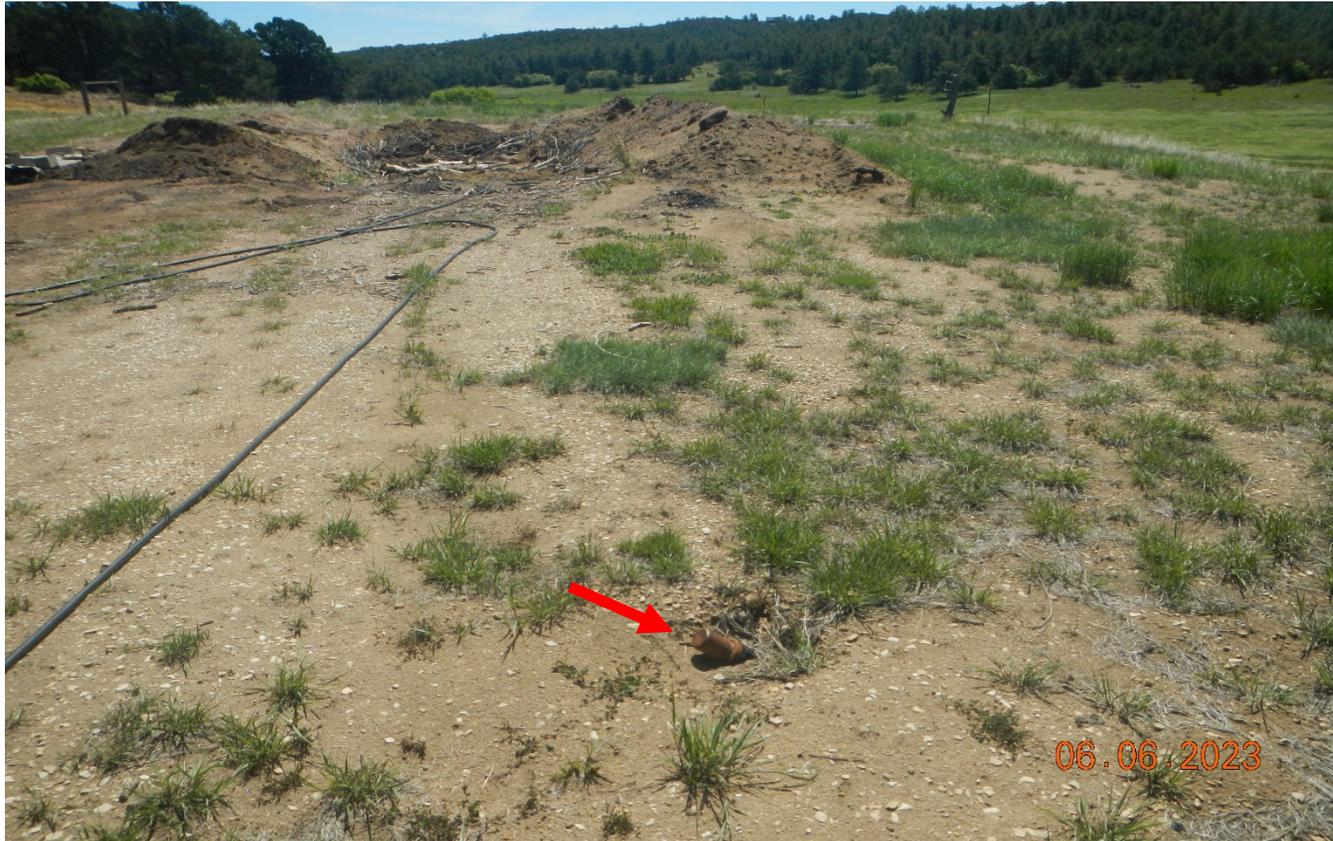
**Photo 3.** Facing southeast at the location. The surface owner is using the location for a debris burn pit. Red arrow points to pipe riser that remains and is shown in the next photo.

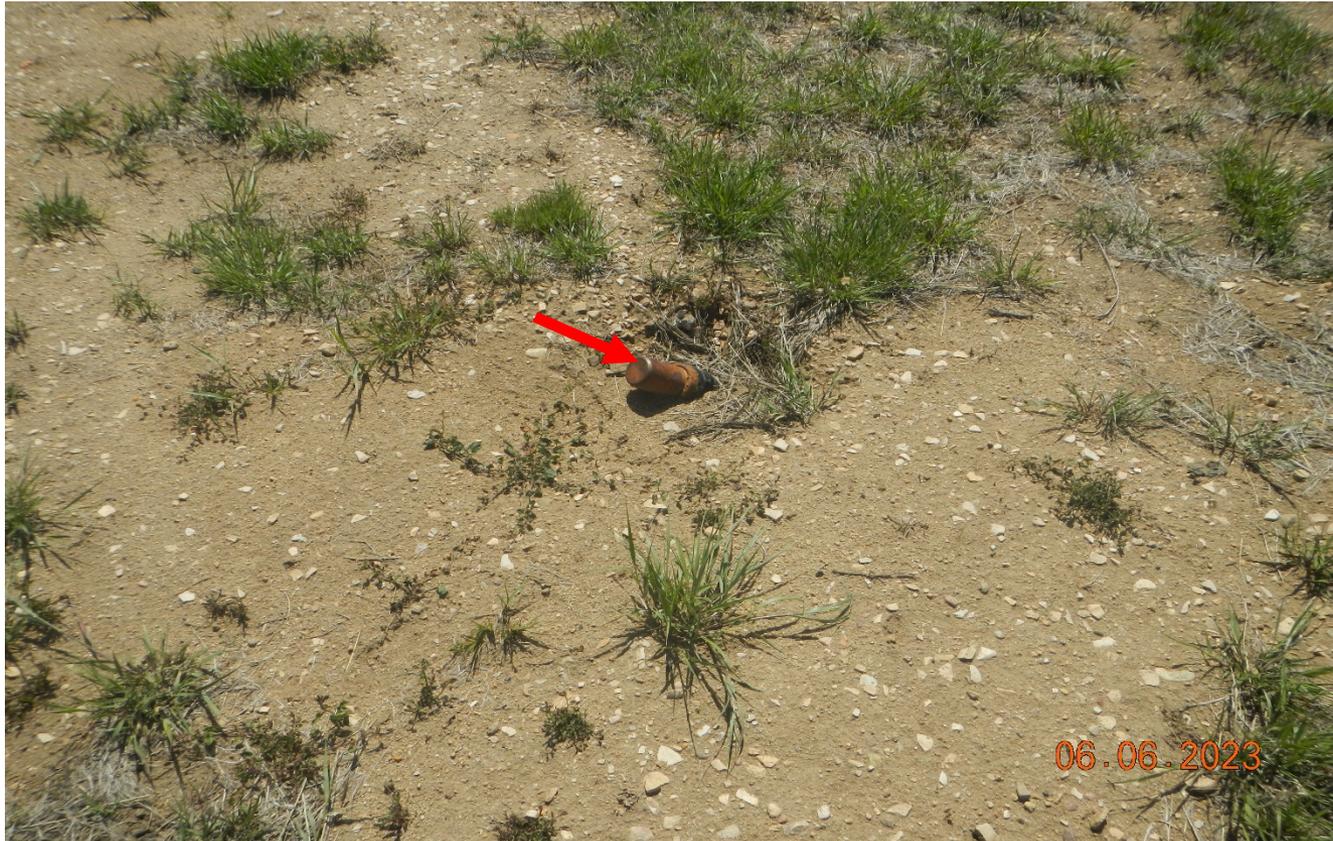
**Photo 5.** There is a pipe riser that remains at the surface of the location that needs to be properly abandoned.

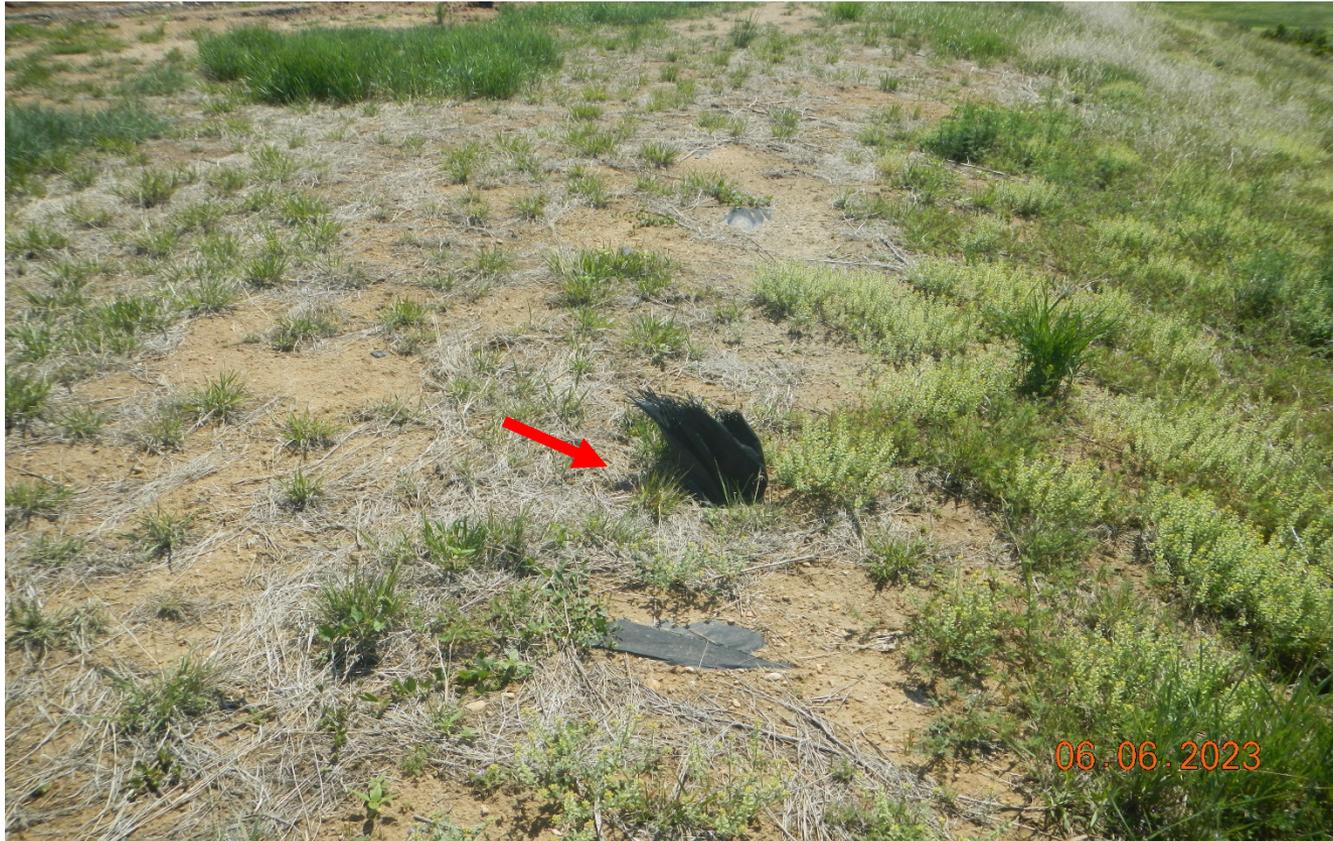
**Photo 6.** There appears to be liner debris at the surface at the southwest side of the pad.

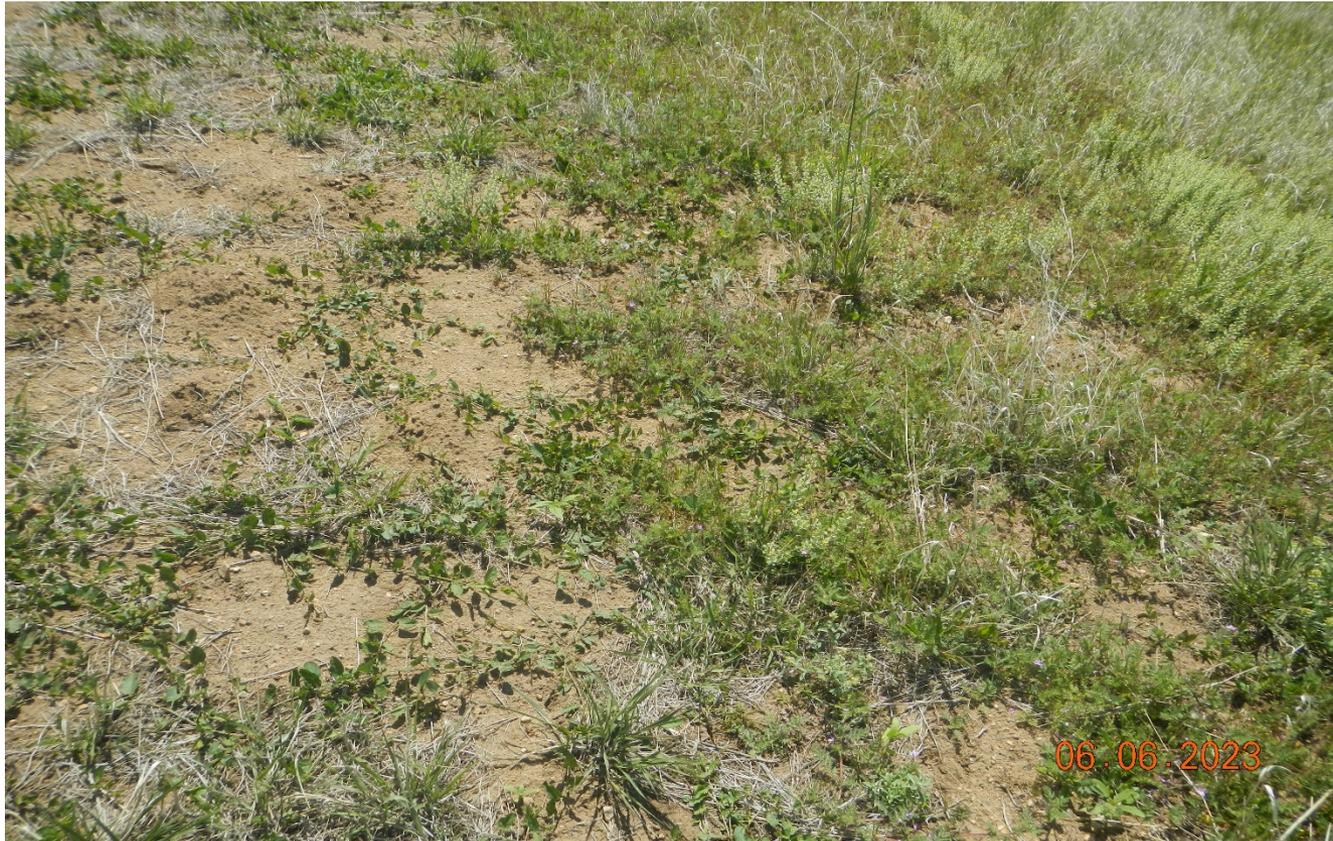
**Photo 7.** There are noxious weeds at the location which include Cheat grass, Red stem filaree, Field bind weed, and Jointed Goat grass. There was much less noxious weeds observed since previous inspection.
