Inspection Photos

Operator: UTAH GAS OP LTD DBA UTAH GAS
CORP - 10539

Location Number: 322420
Garfield County, CO

Aaron Trujillo
NW Reclamation Specialist
COGCC

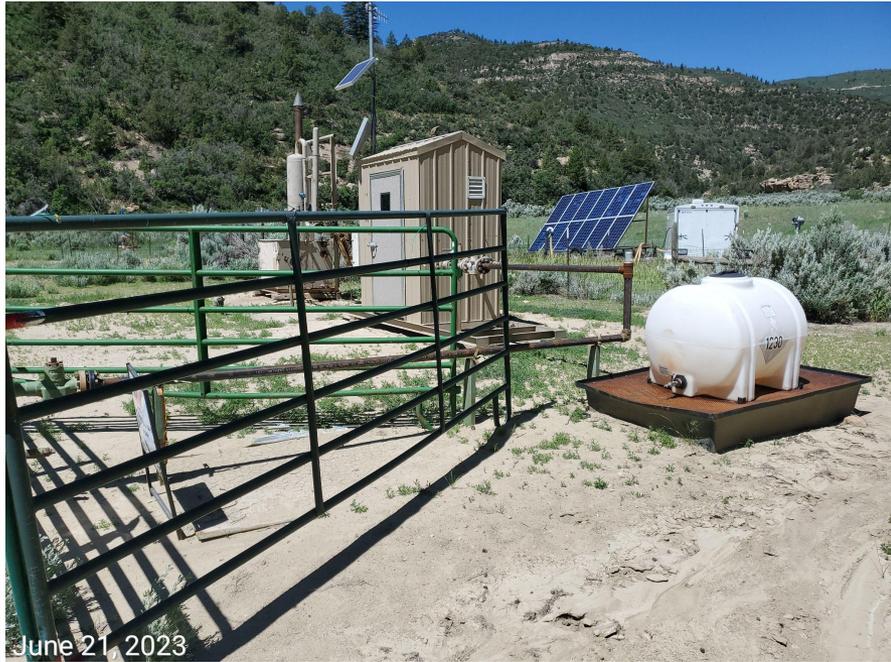
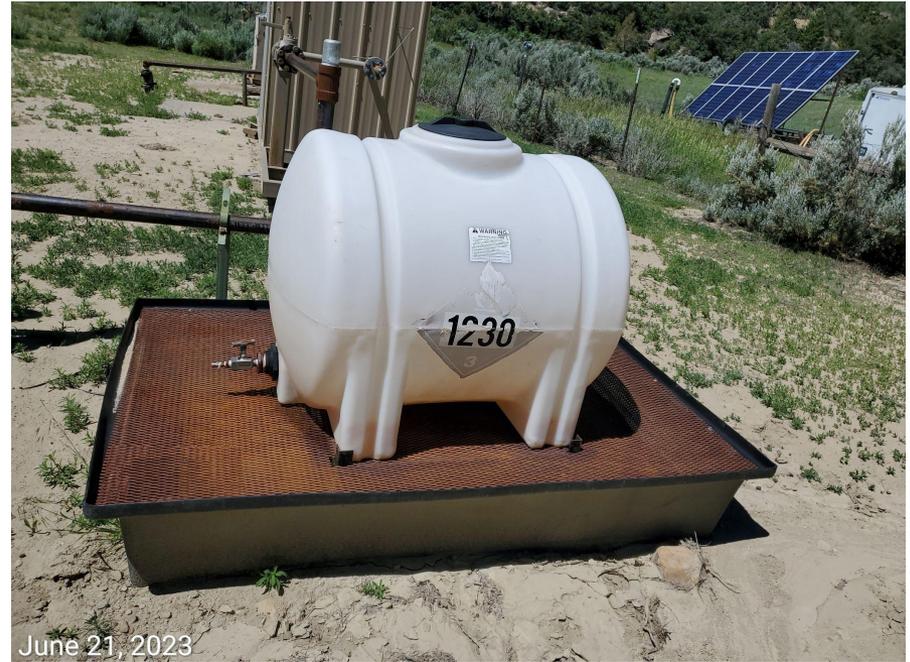
Photo 1: Container labeling missing, or no longer legible.

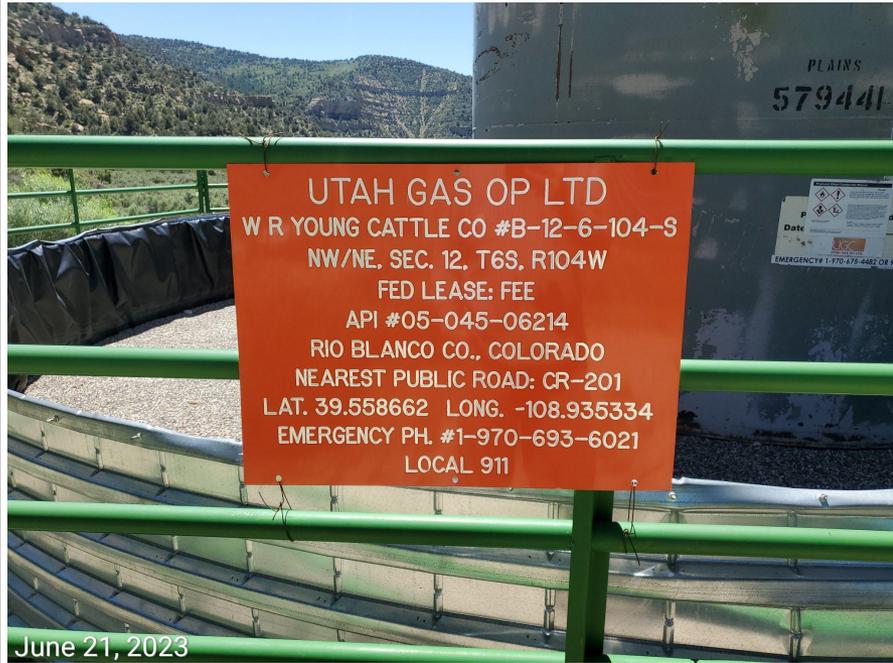
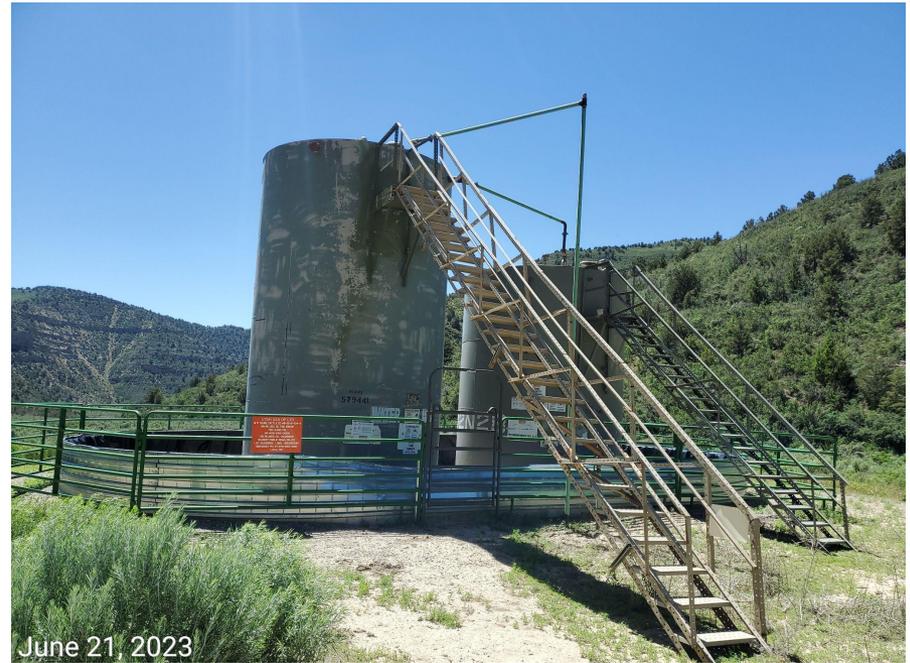
Photo 2: Signage at tank battery installed.

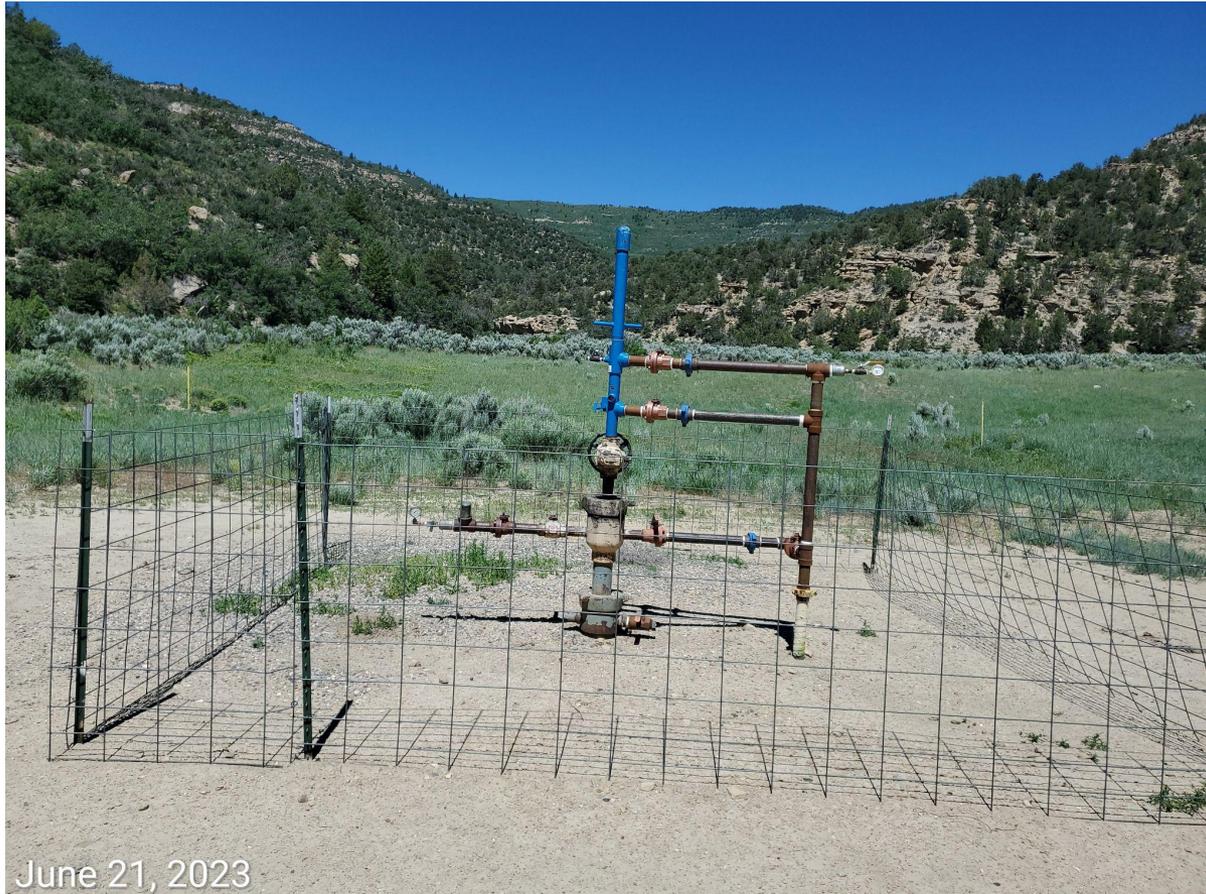
Photo 3: Wellhead signage remains missing.

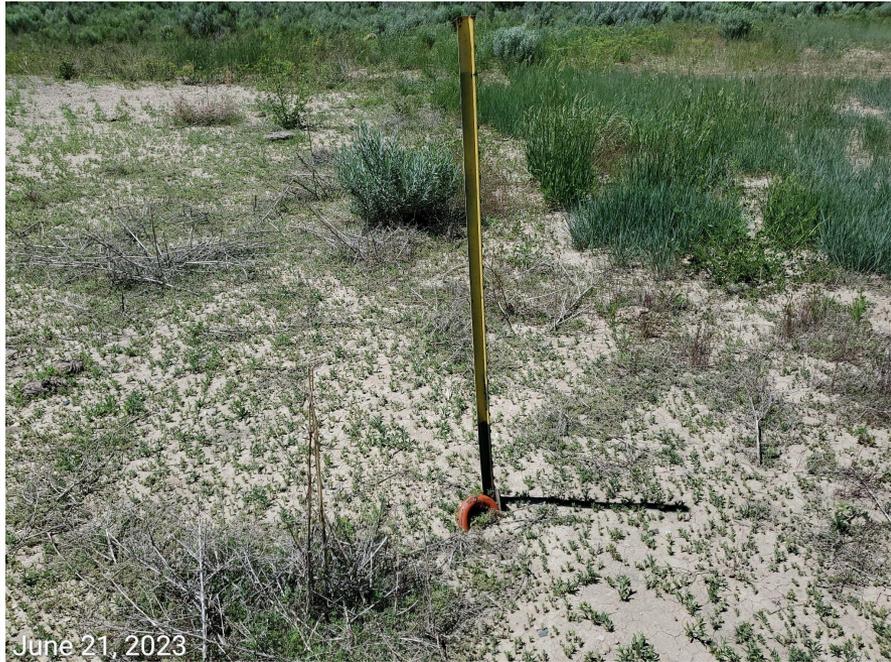
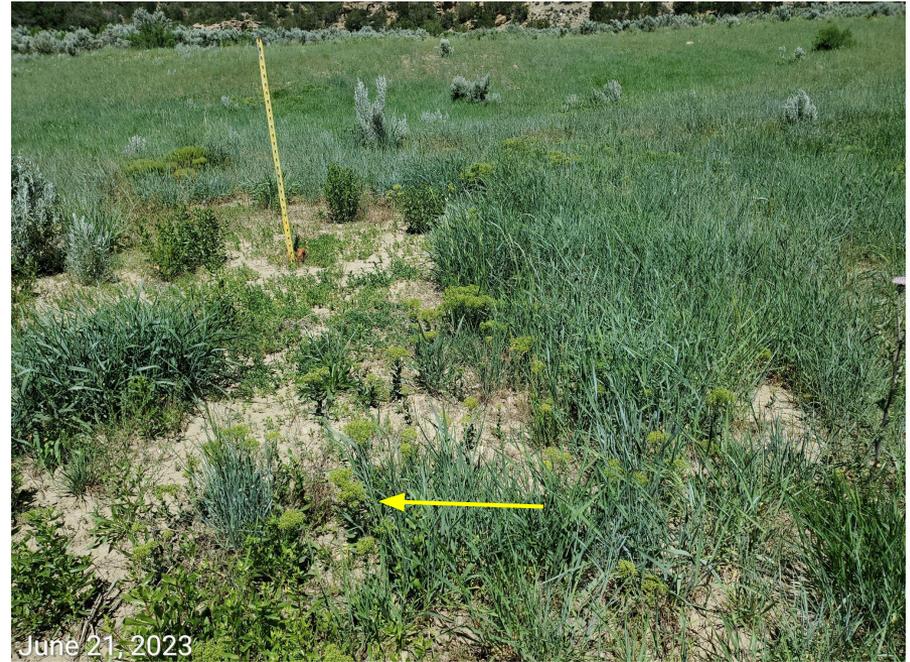
Photo 4: Photos examples showing that the 4 anchors on the Location have been marked. Photo right also example showing Undesirable Plant Species (Hoary cress, light green plants) establishing on the Location, including interim areas.

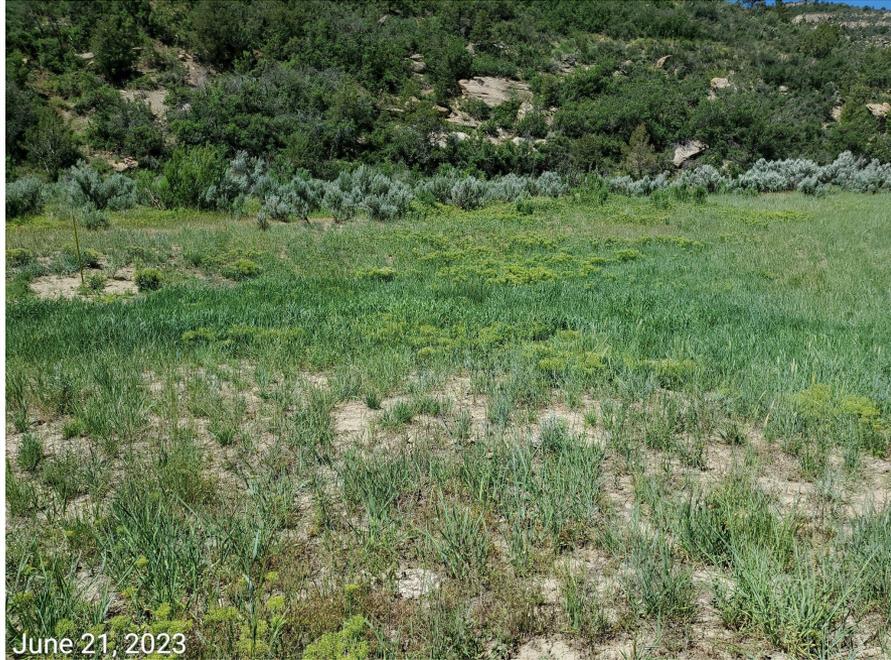
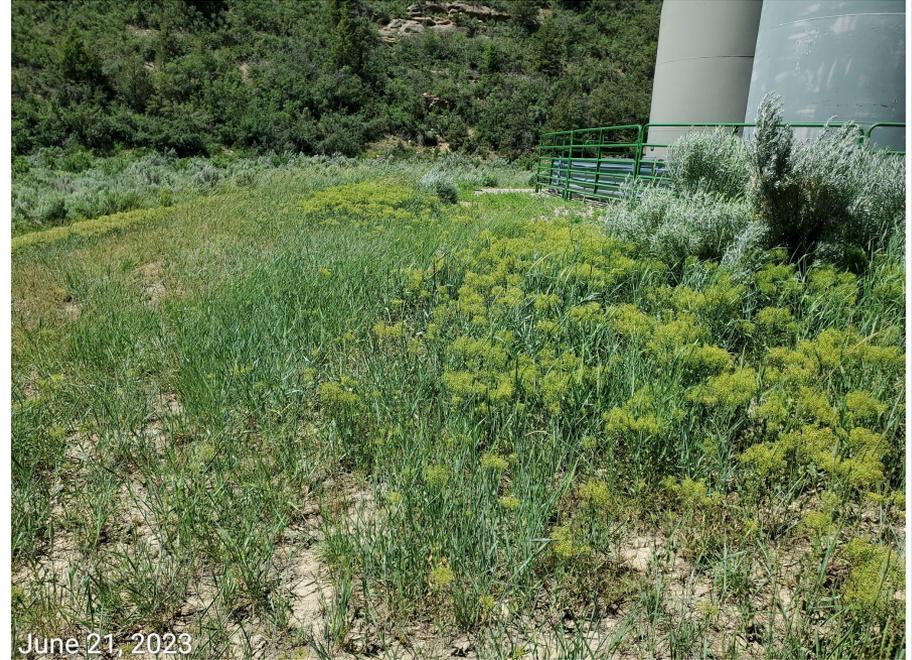
Photo 5: Photos example showing Undesirable Plant Species (Hoary cress, light green plants) establishing on the Location, including interim areas.

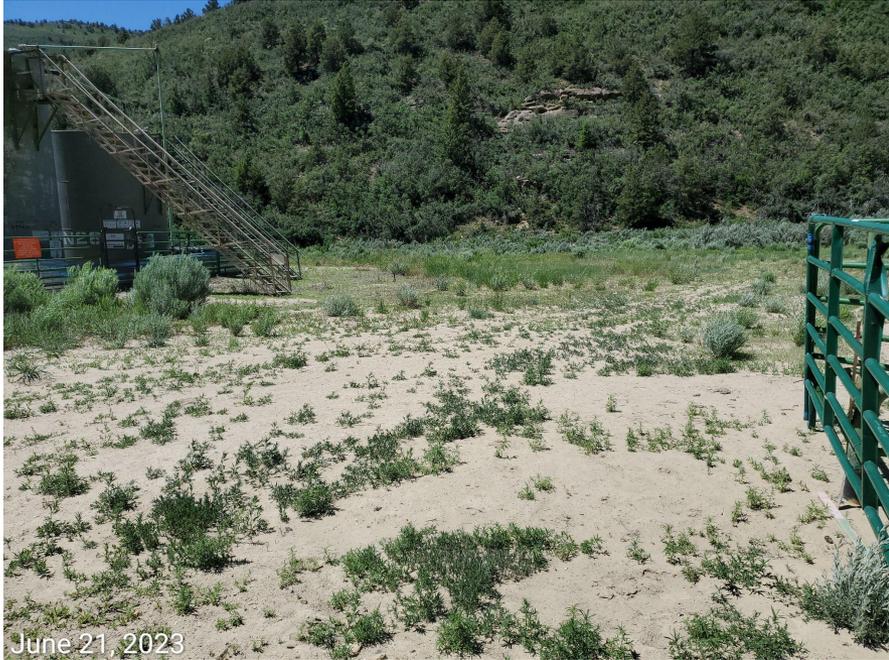
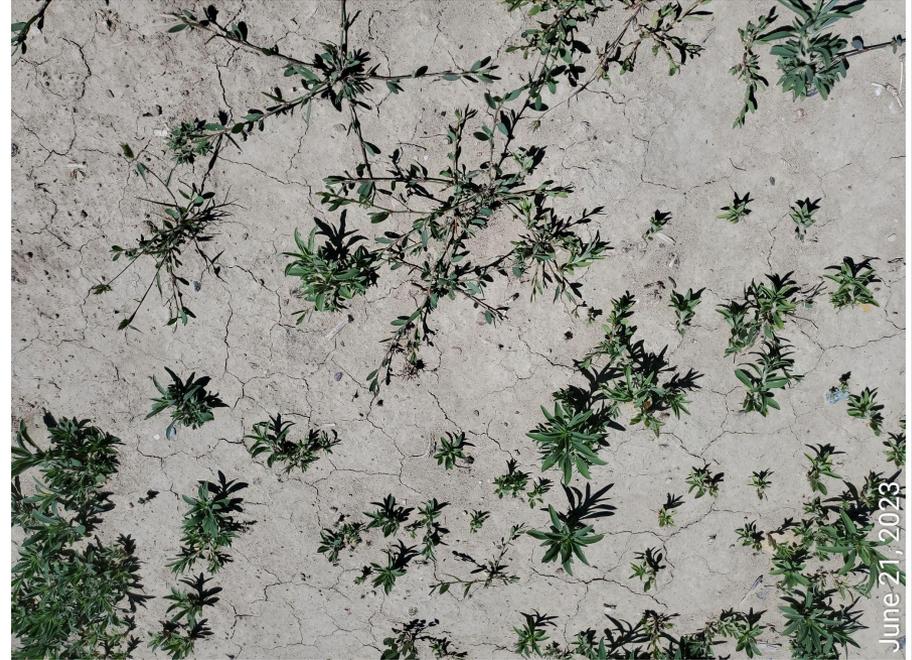
Photo 6: Photos example showing Undesirable Plant Species (Russian thistle, kochia, knotweed) establishing on the Location, including interim areas.

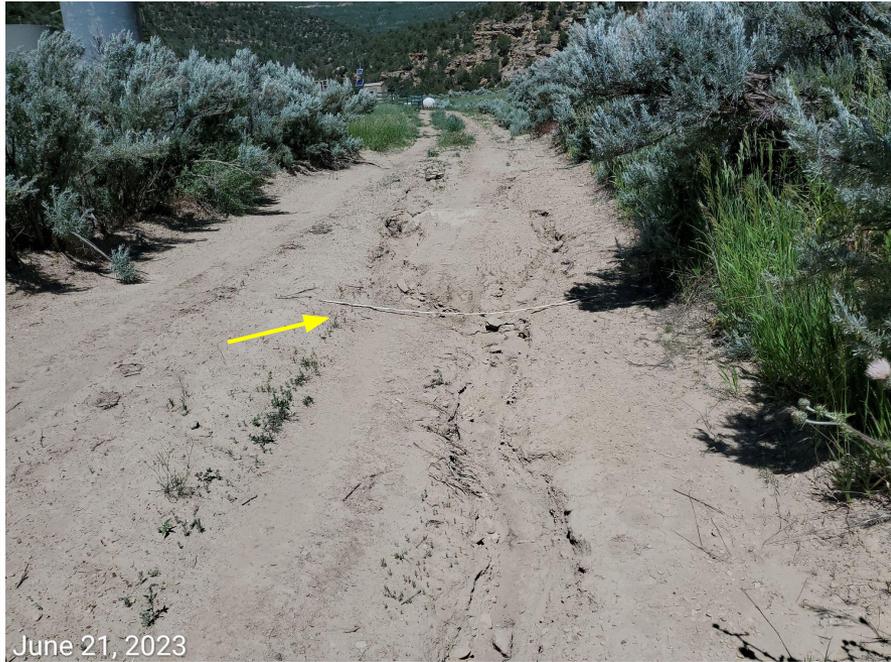
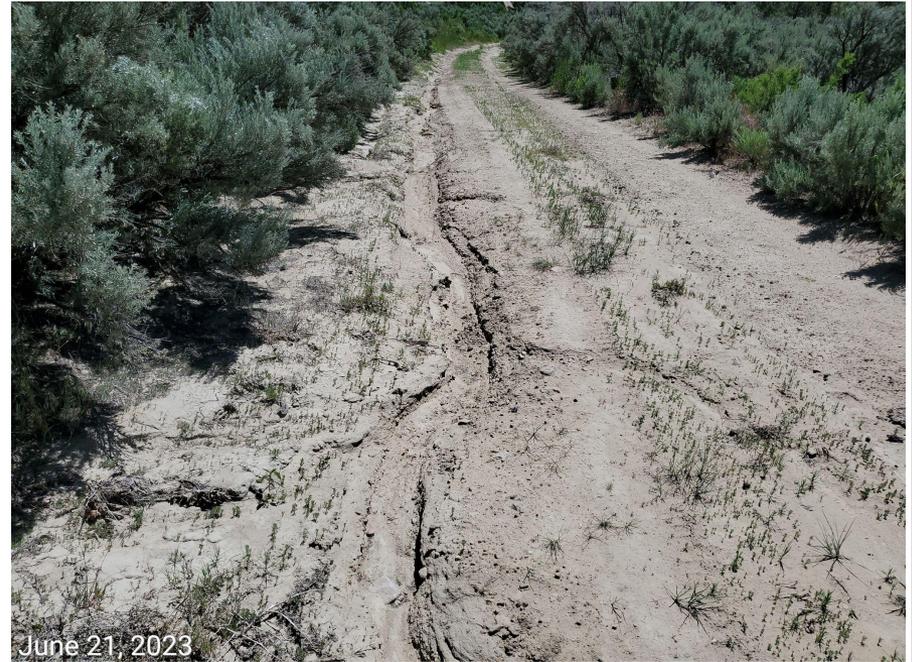
Photo 7: Photos 7-9 taken from the access road. Photos examples showing BMP to stabilize, and to manage runoff at the access road are missing or insufficient. Erosion degradation evident. 6 foot measuring stick used for reference.

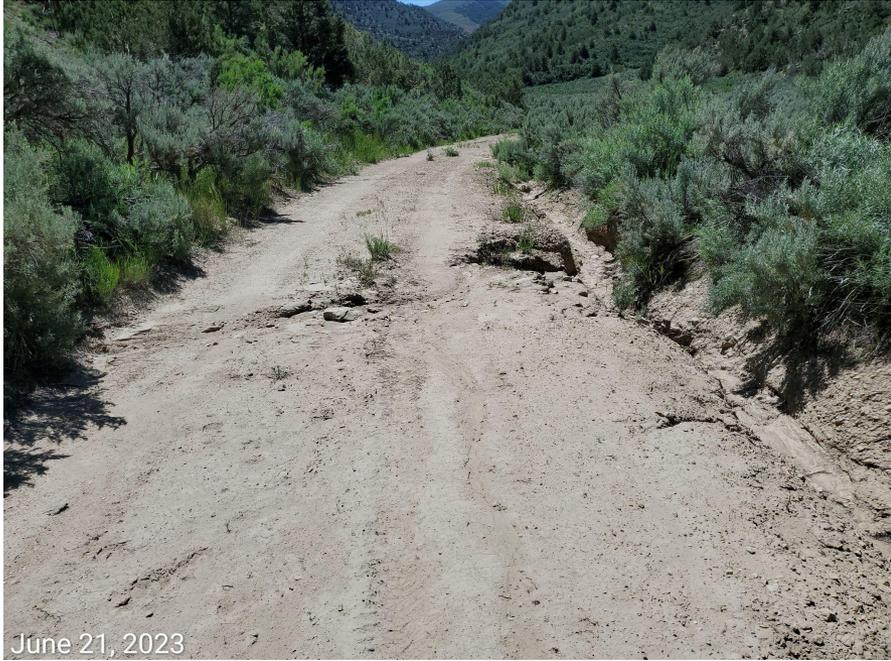
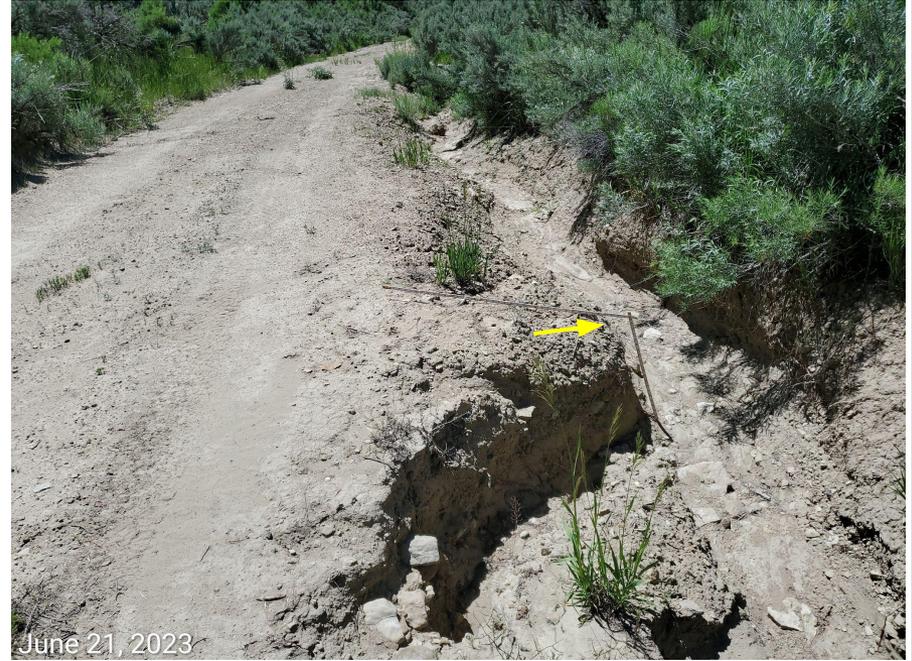
Photo 8: See comments under photo 7. Measuring stick in photo right shows gully ~2 feet in depth. Measuring stick 6 feet in length.

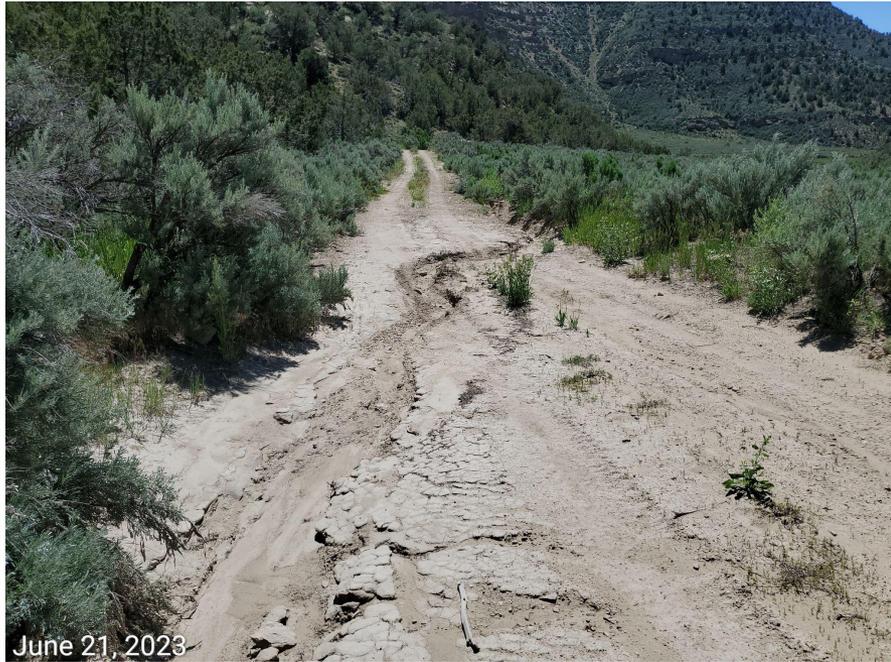
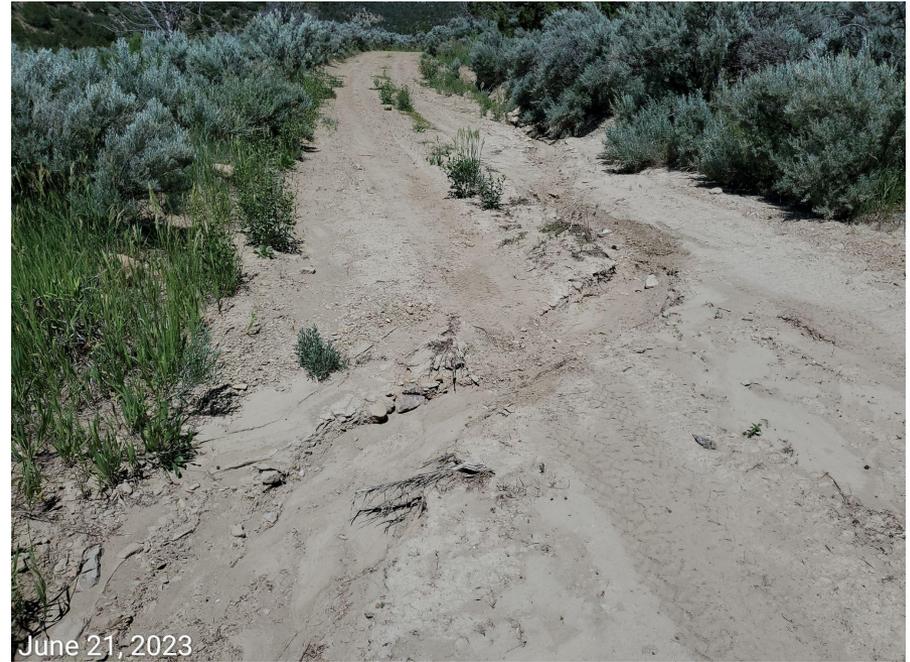
Photo 9: See comments under photo 7.
