# Inspection Photos

Operator: TEP ROCKY MOUNTAIN LLC - 96850

Location Number: 420224

Garfield County, CO

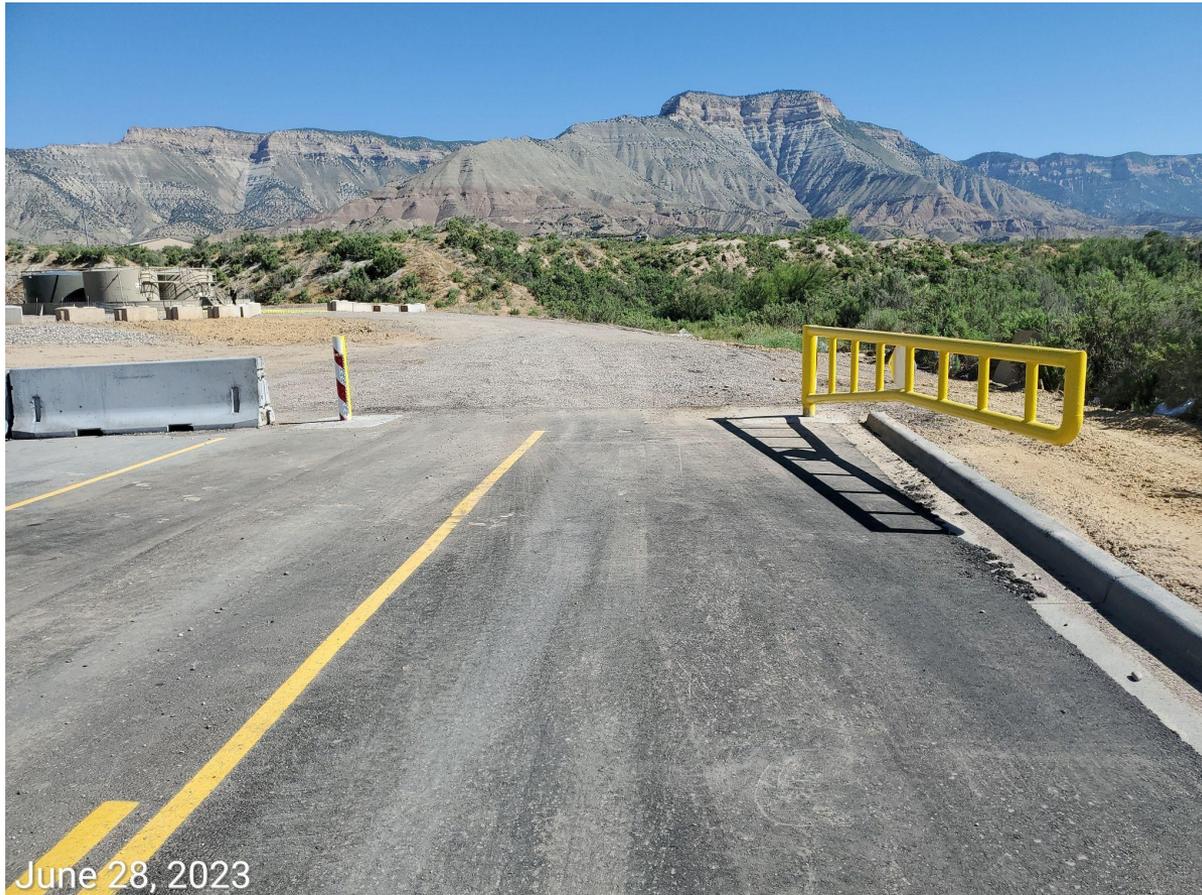
**Photo 1:** Photo shows the new entrance on the east end of the Location. Photo also shows new gate installed.

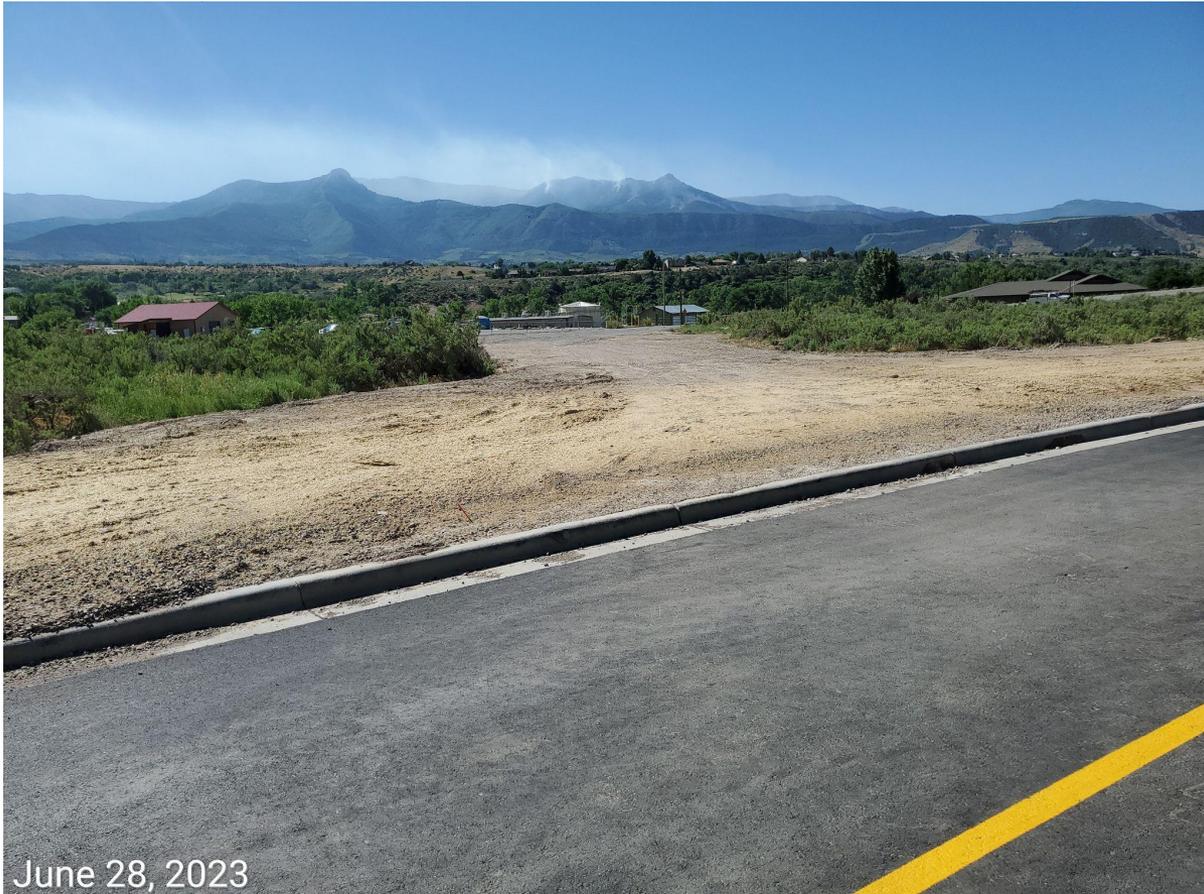
**Photo 2:** Photo taken along the newly paved road. Photo shows a remaining portion of the O&G access road that travels southeast.

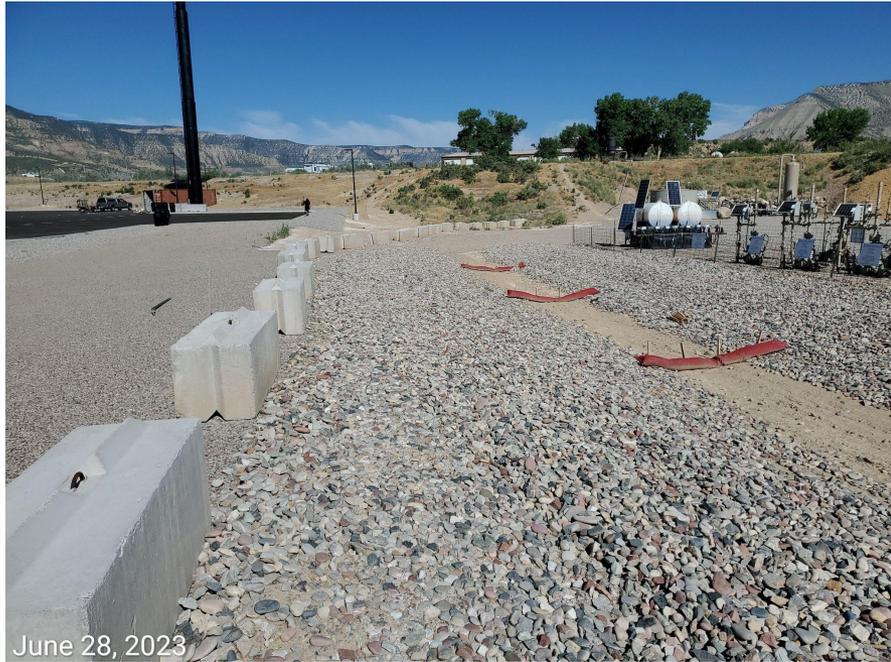
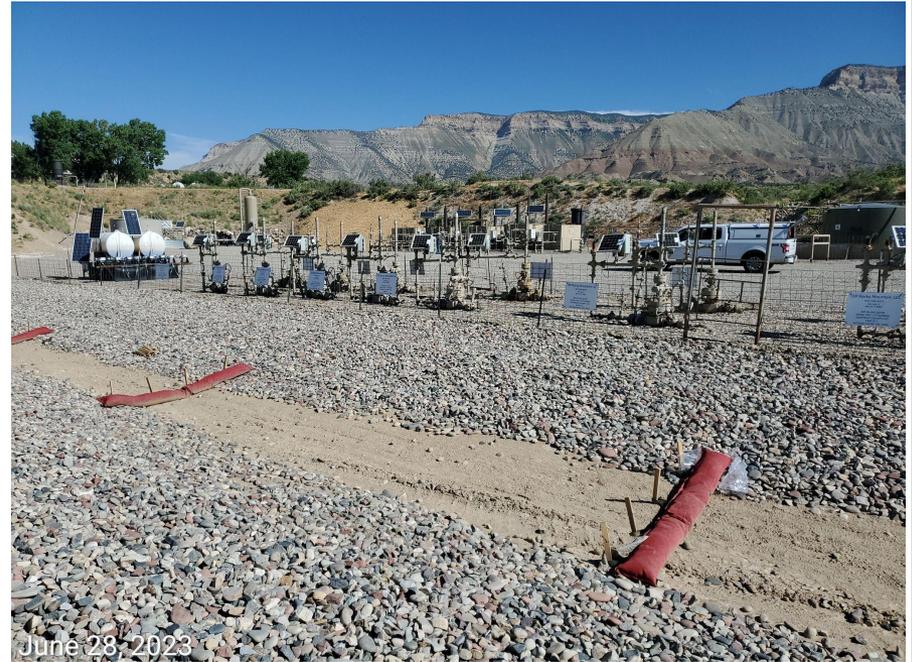
**Photo 3:** Photos 3-4 taken from the south end of the Location. Photos provide an overview of the Location from west, northwest, northeast to east. Photos also show stormwater diversion ditch with gravel armoring on the south end of the Location.

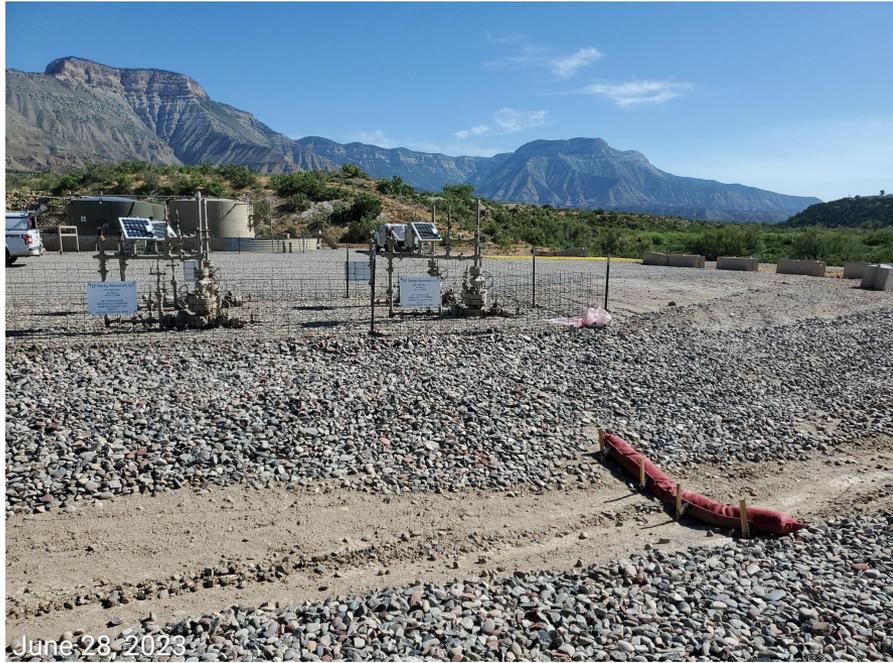
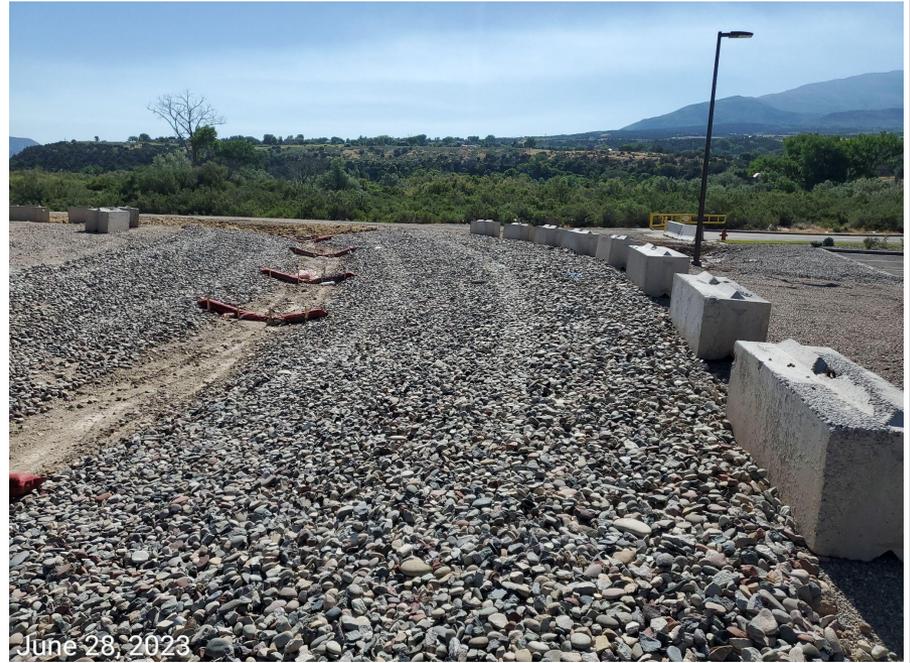
**Photo 4:** See comments under photo 13.

**Photo 13:** Photos 13-14 examples showing trash debris observed throughout the Location.

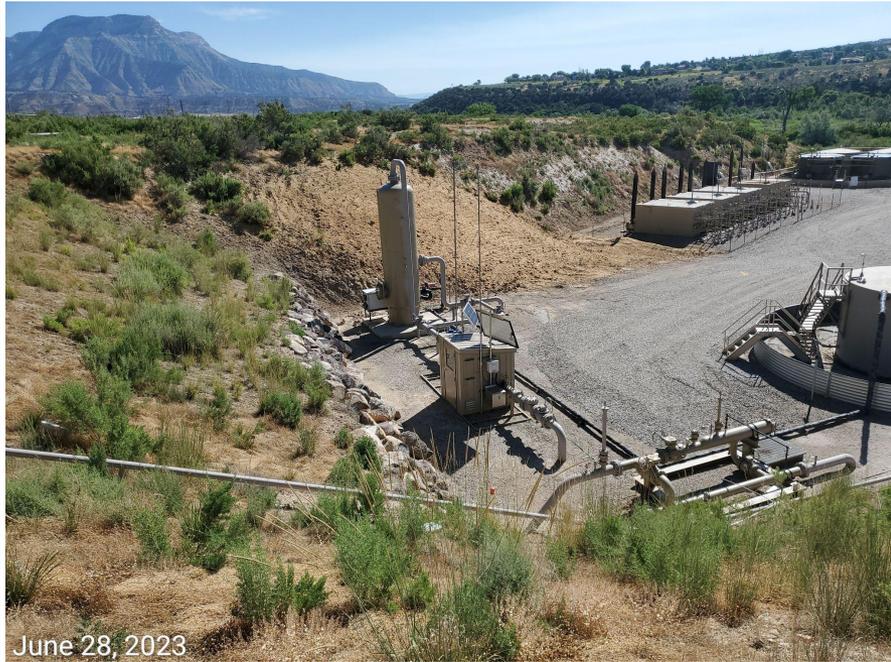
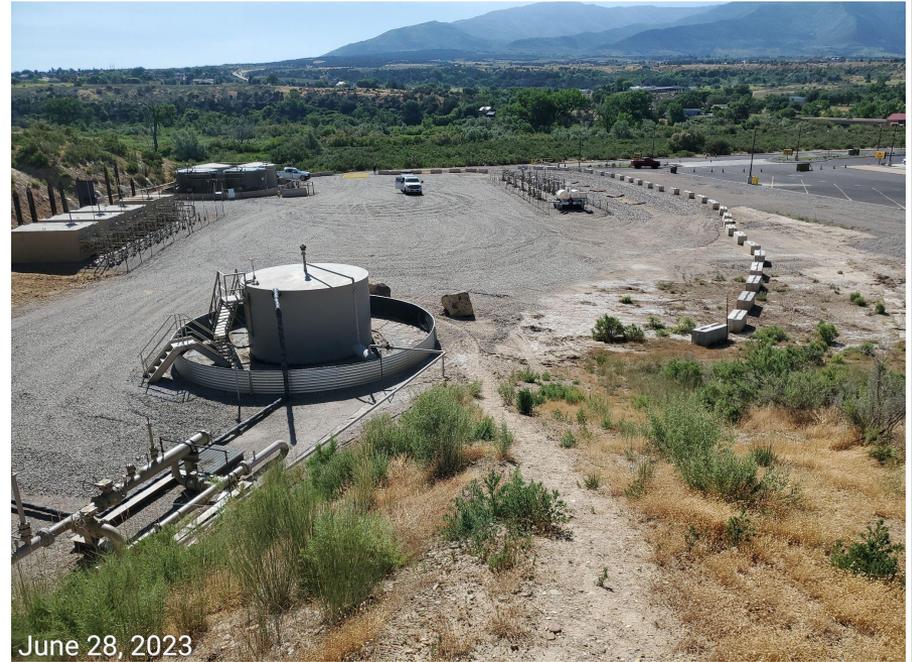
**Photo 5:** Photos taken from the west end of the Location. Photo provides an overview of the Location from northeast to east.

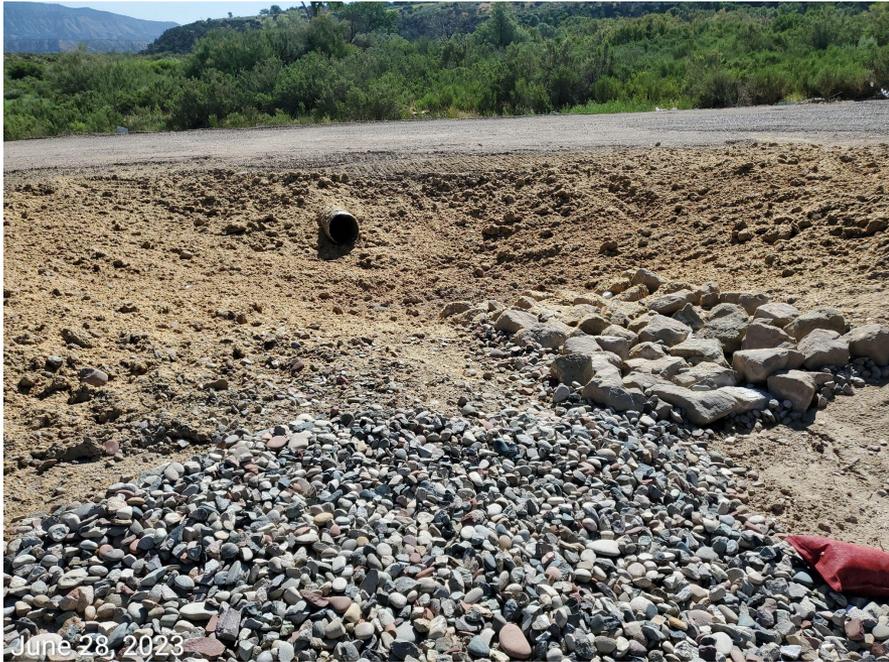
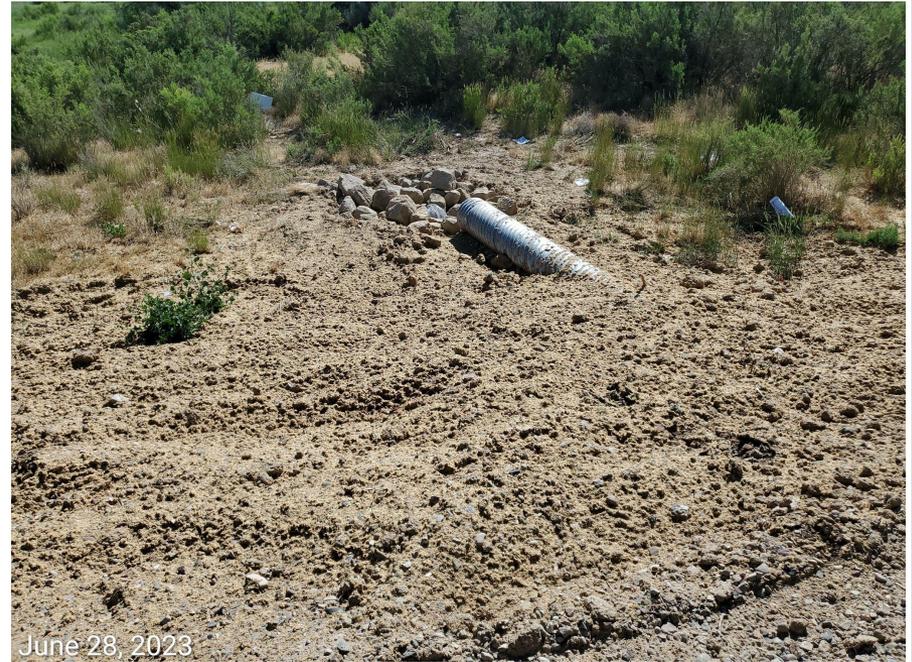
**Photo 6:** Photo shows sediment trap and culvert on the southeast end of the Location. BMP tied to the stormwater ditch on the south end of the Location.

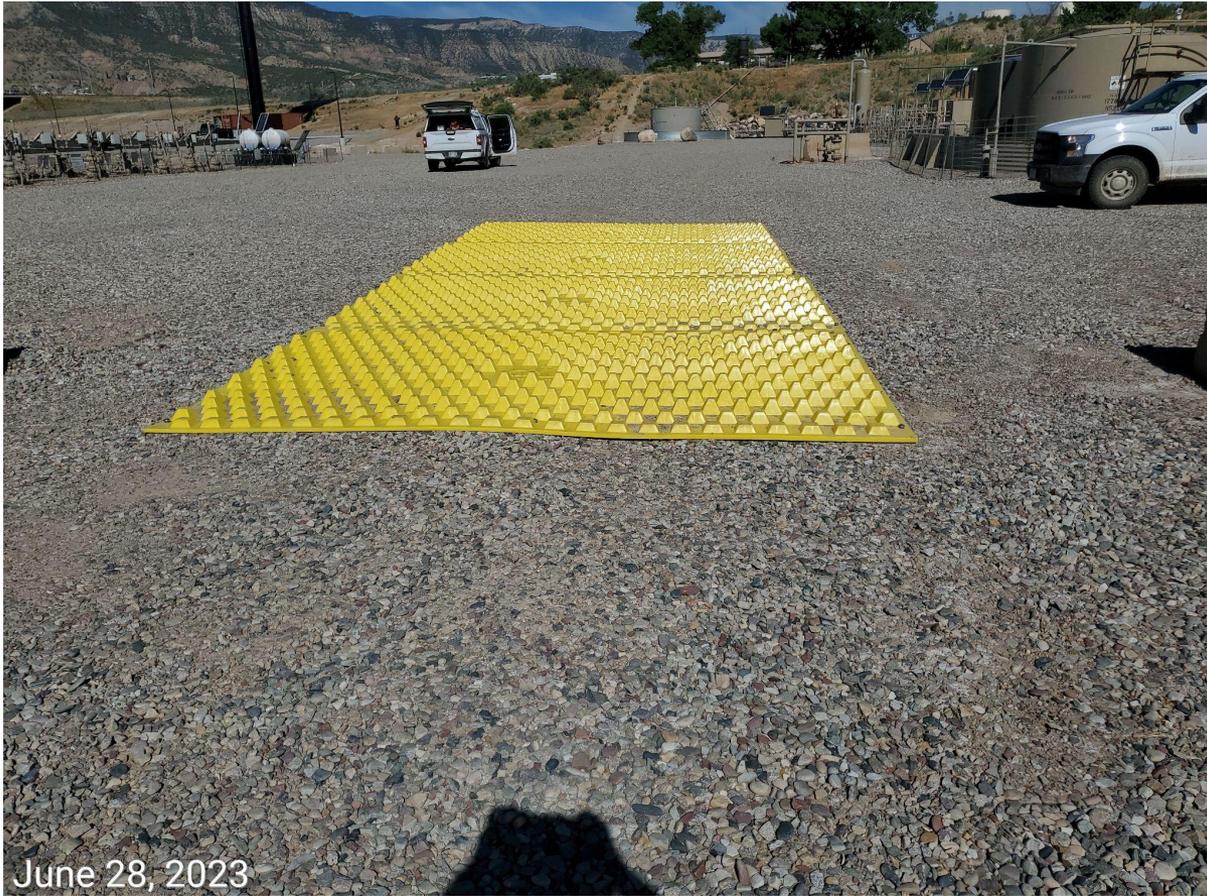
**Photo 7:** Vehicle tracking pad

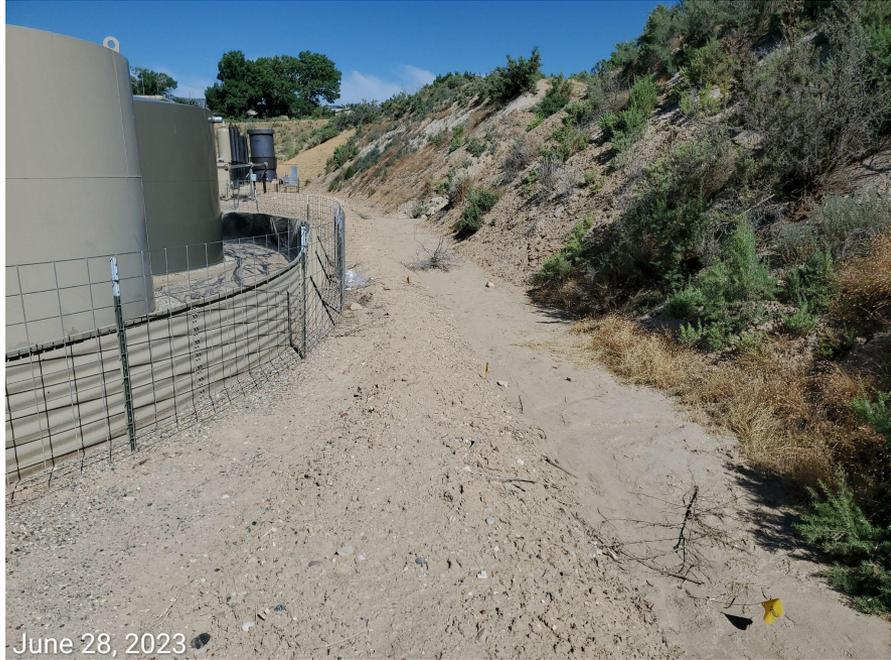
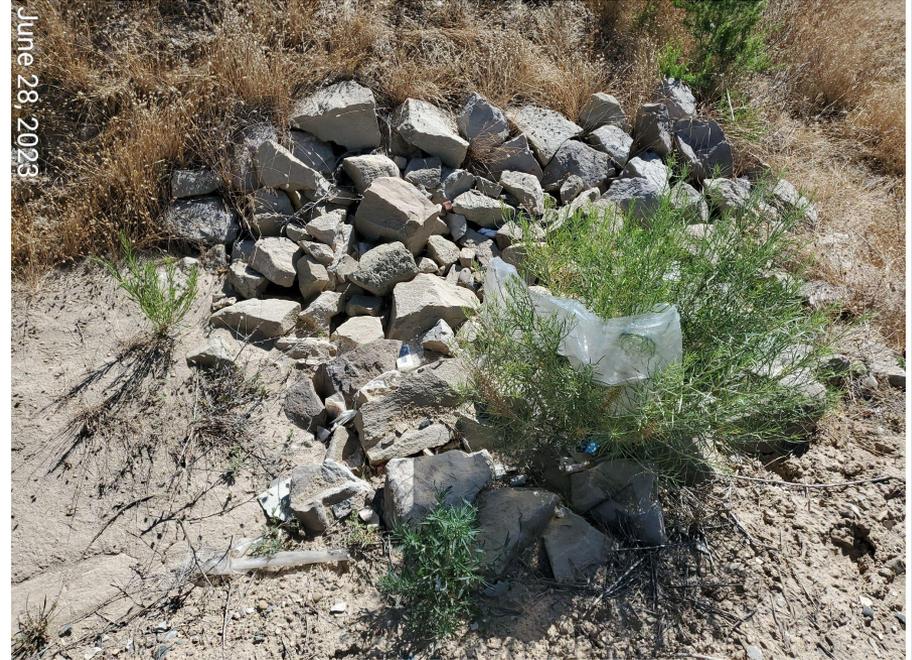
**Photo 8:** Stormwater diversion ditch and outlet on the north end of the Location. Photo right also example showing trash debris observed throughout the Location.

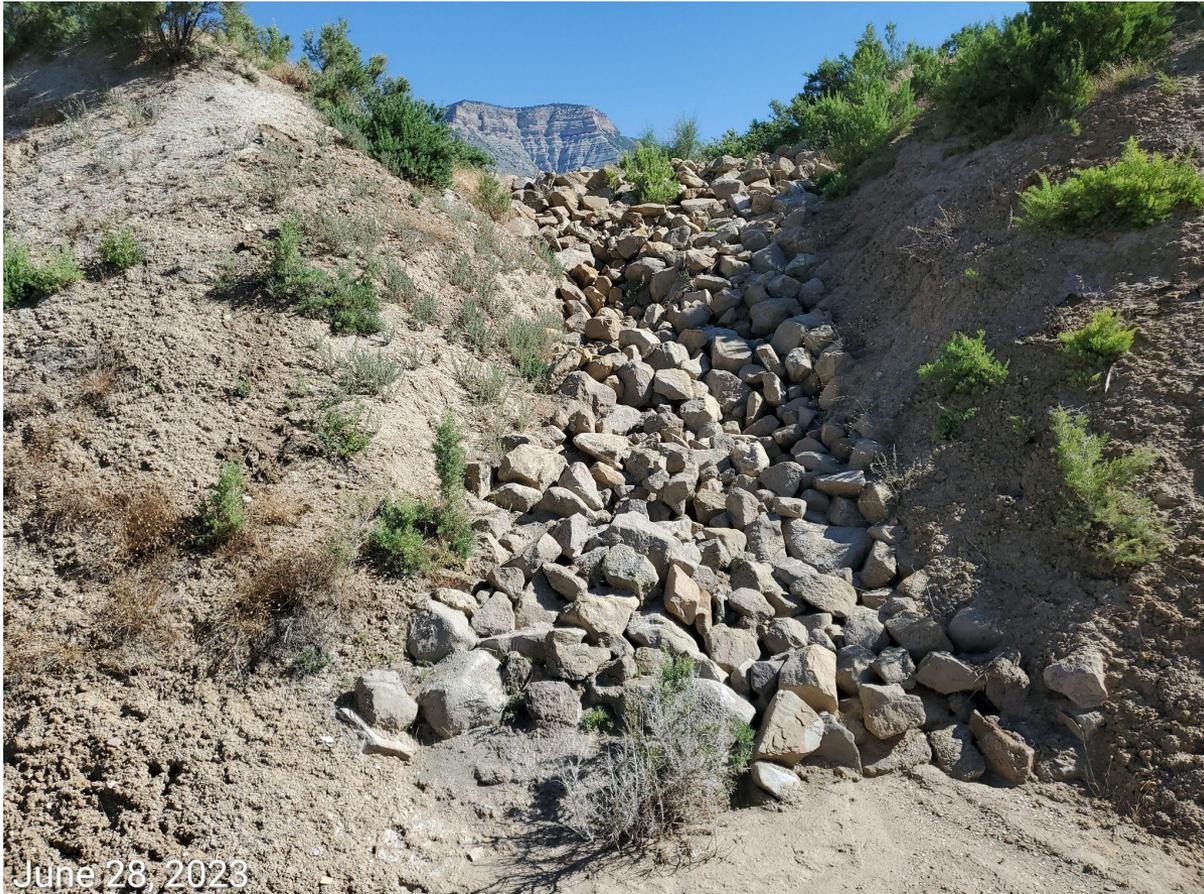
**Photo 9:** Armored inlet to manage run-on, on the north end of the Location.

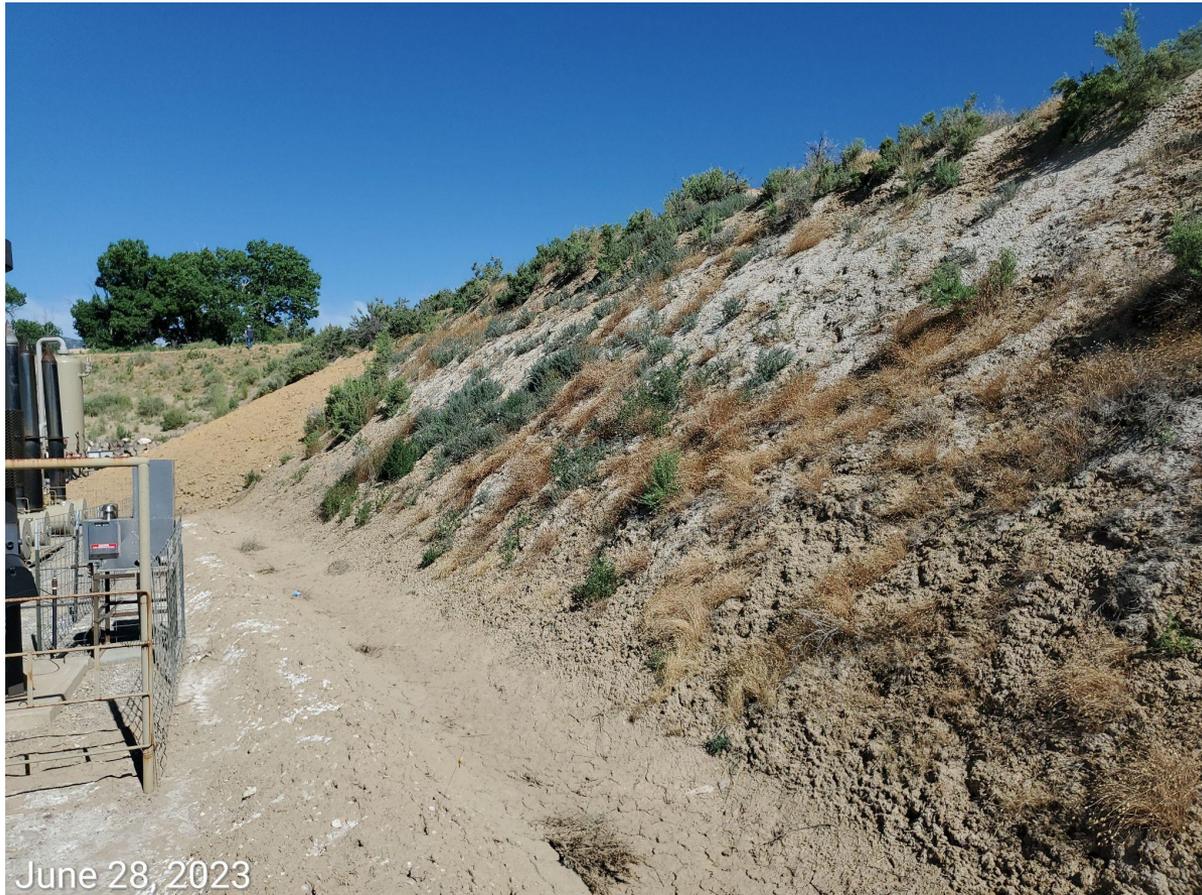
**Photo 10:** Photo taken from the north end of the Location. Hydromulch on slopes no longer in proper functioning condition; erosion/degradation beginning to recur. Photo also shows Undesirable and Noxious Plant (Halogeton, kochia) establishment on slopes.

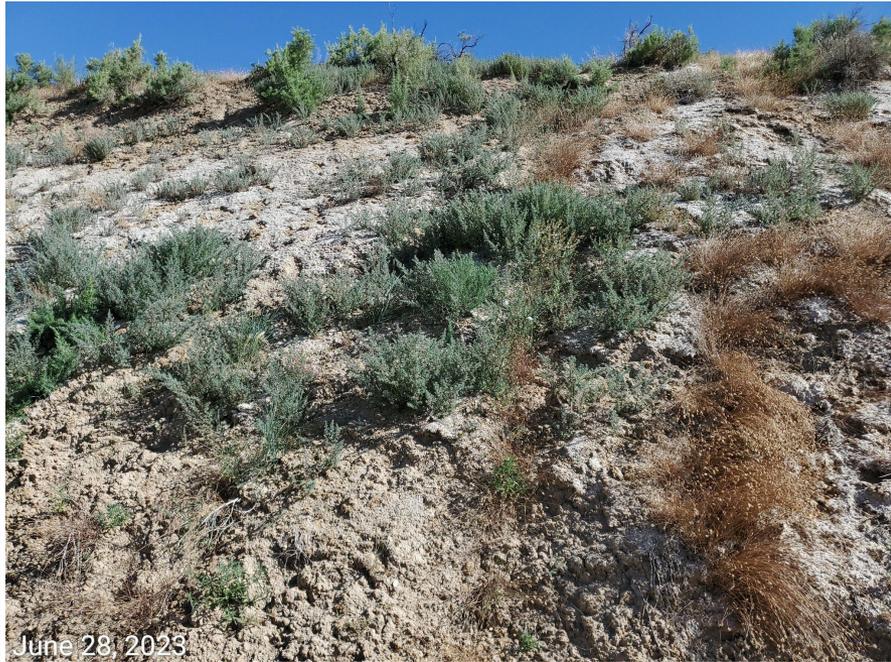
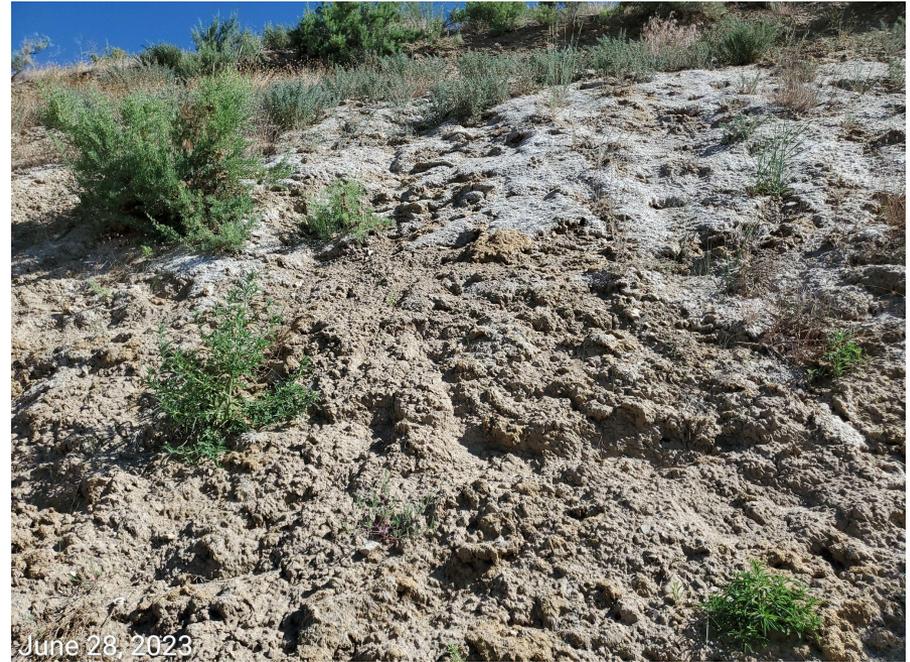
**Photo 11:** Photo taken from the north end of the Location. Hydromulch on slopes no longer in proper functioning condition; erosion/degradation beginning to recur. Photo also shows Undesirable and Noxious Plant (Halogeton, kochia) establishment on slopes.

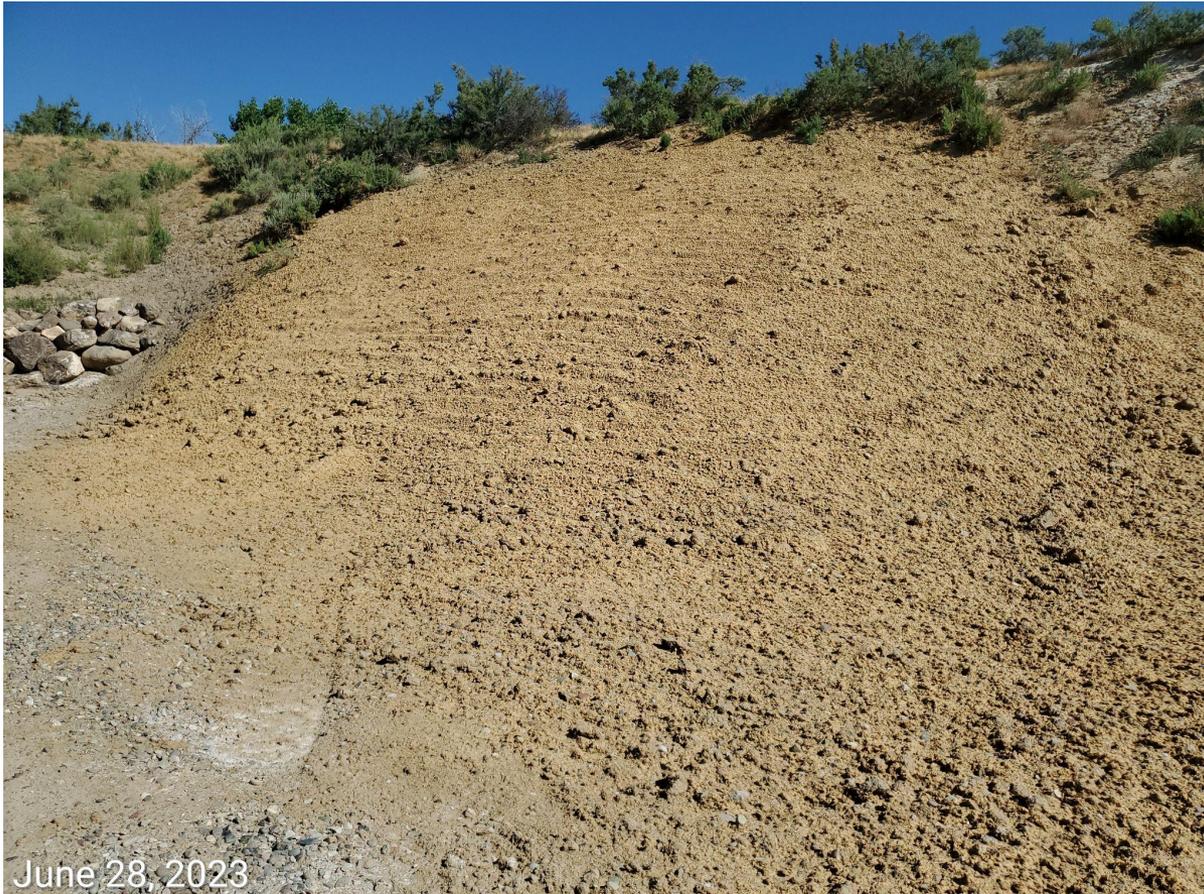
**Photo 12:** Slopes on northwest end of the Location. Slopes appear to have been recently hydromulched. BMP appears to be in proper functioning condition.

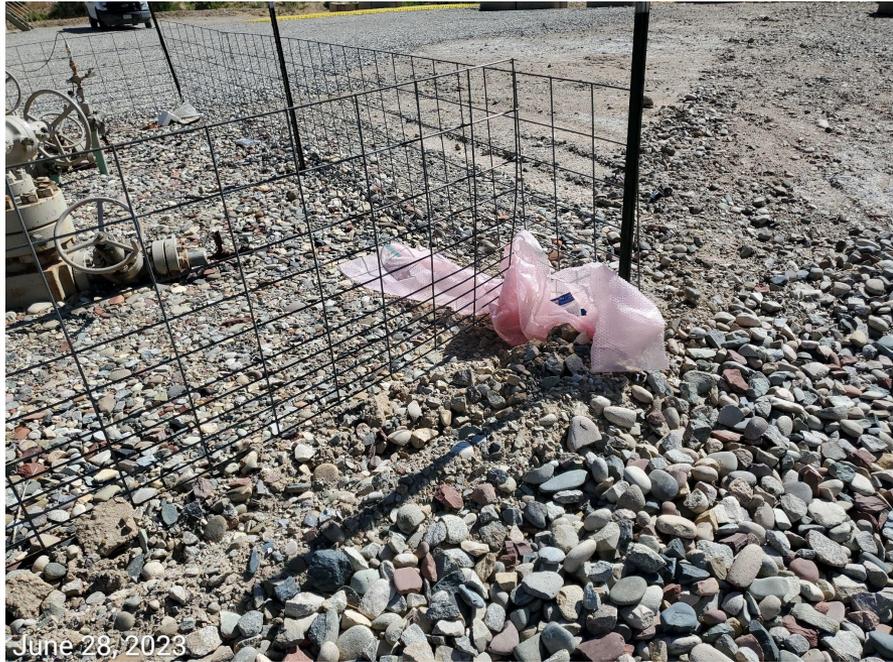
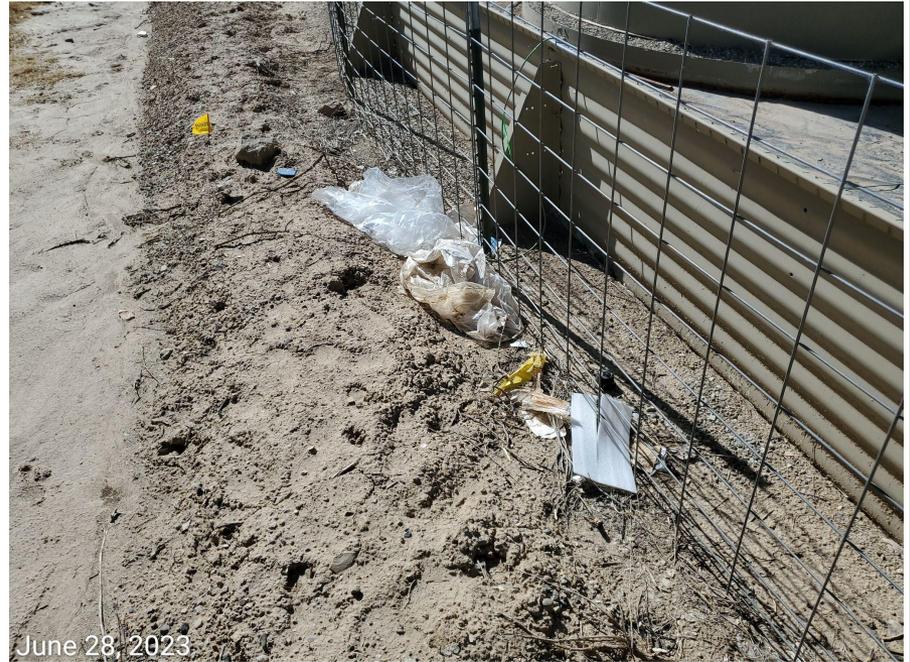
**Photo 15:** See comments under photo 14.

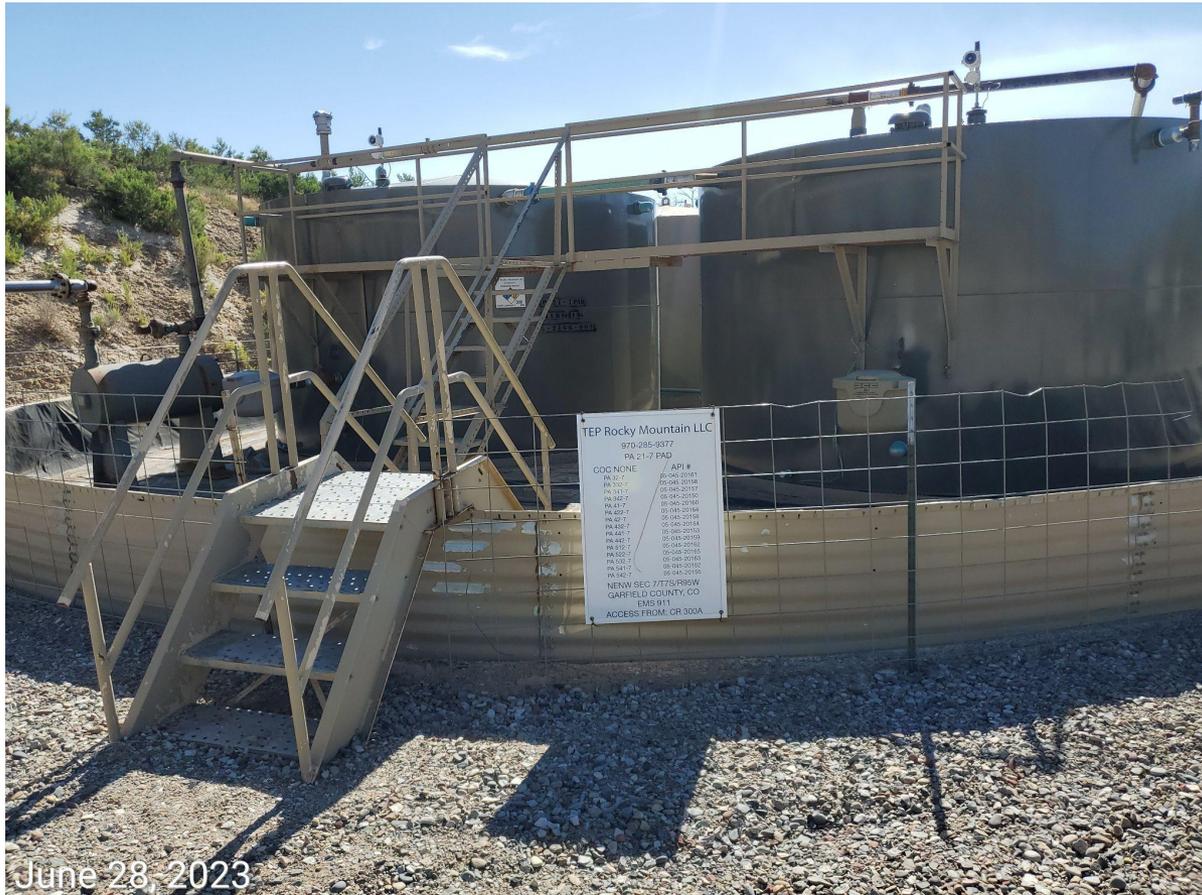
**Photo 15:** Photo shows tank battery with required signage on the east end of the Location.

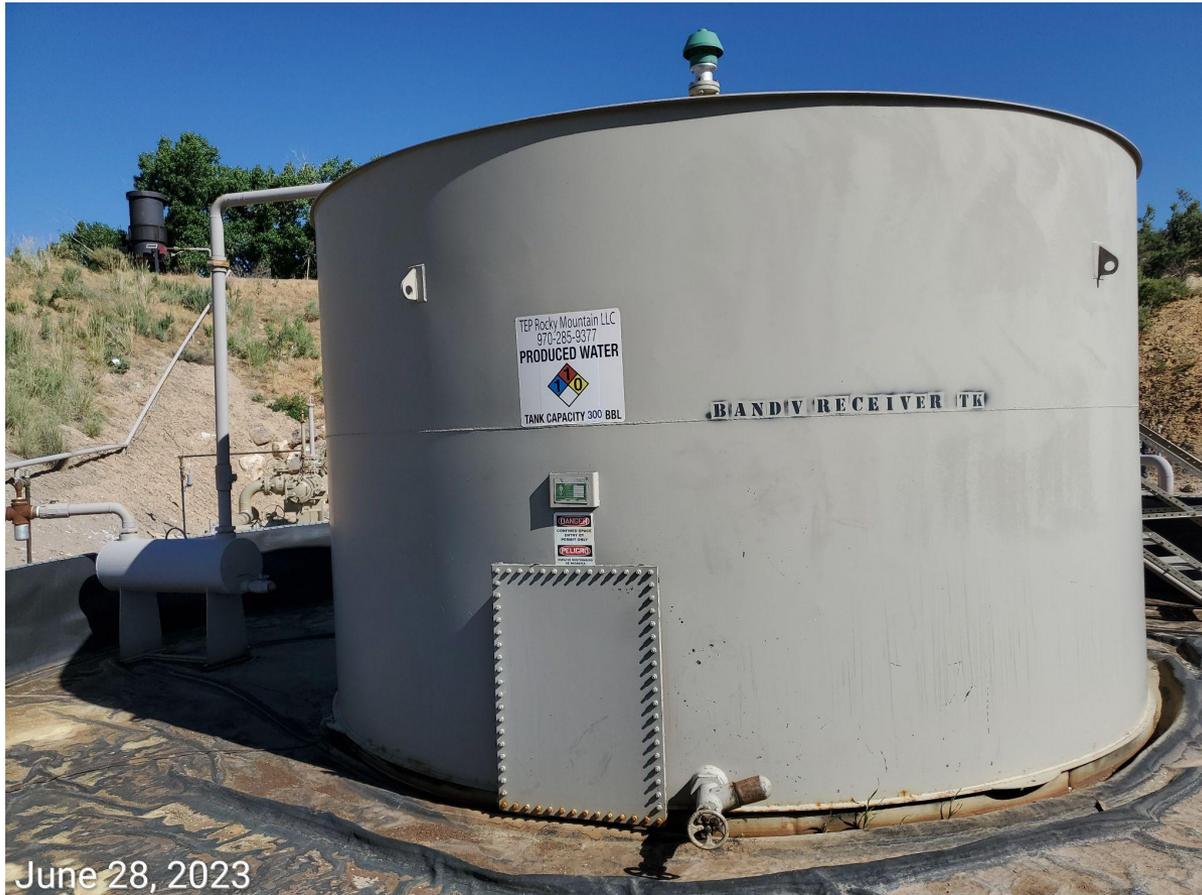
**Photo 16:** Photo shows tank battery on the west end of the Location. Signage required per Rule 605.e not observed at facility.

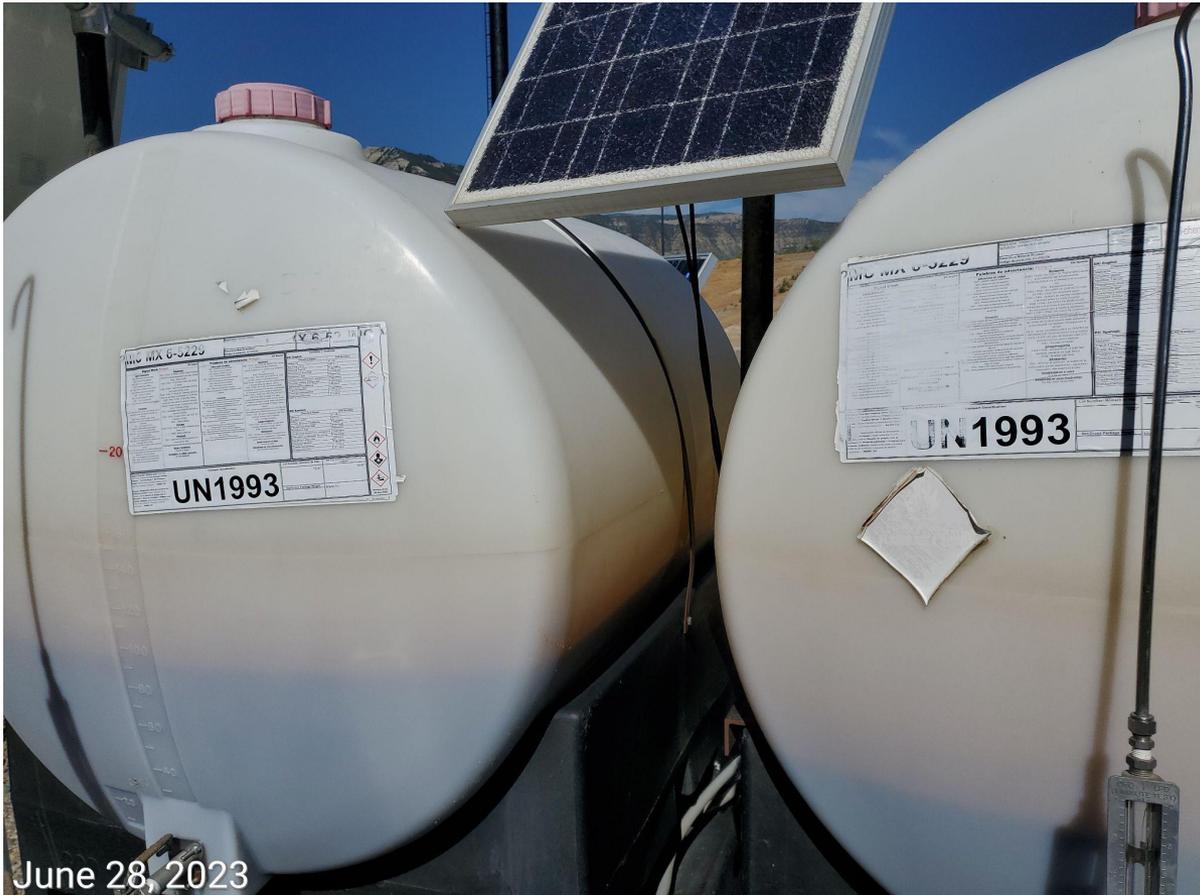
**Photo 17:** Labels at methanol tanks becoming illegible. Maintenance advised.
