# Final Reclamation Inspection

Operator: PDC ENERGY INC - 69175

Location ID: 323171

Inspection Photos  
Location Name: Nadine 1-24  
Location ID: 323171

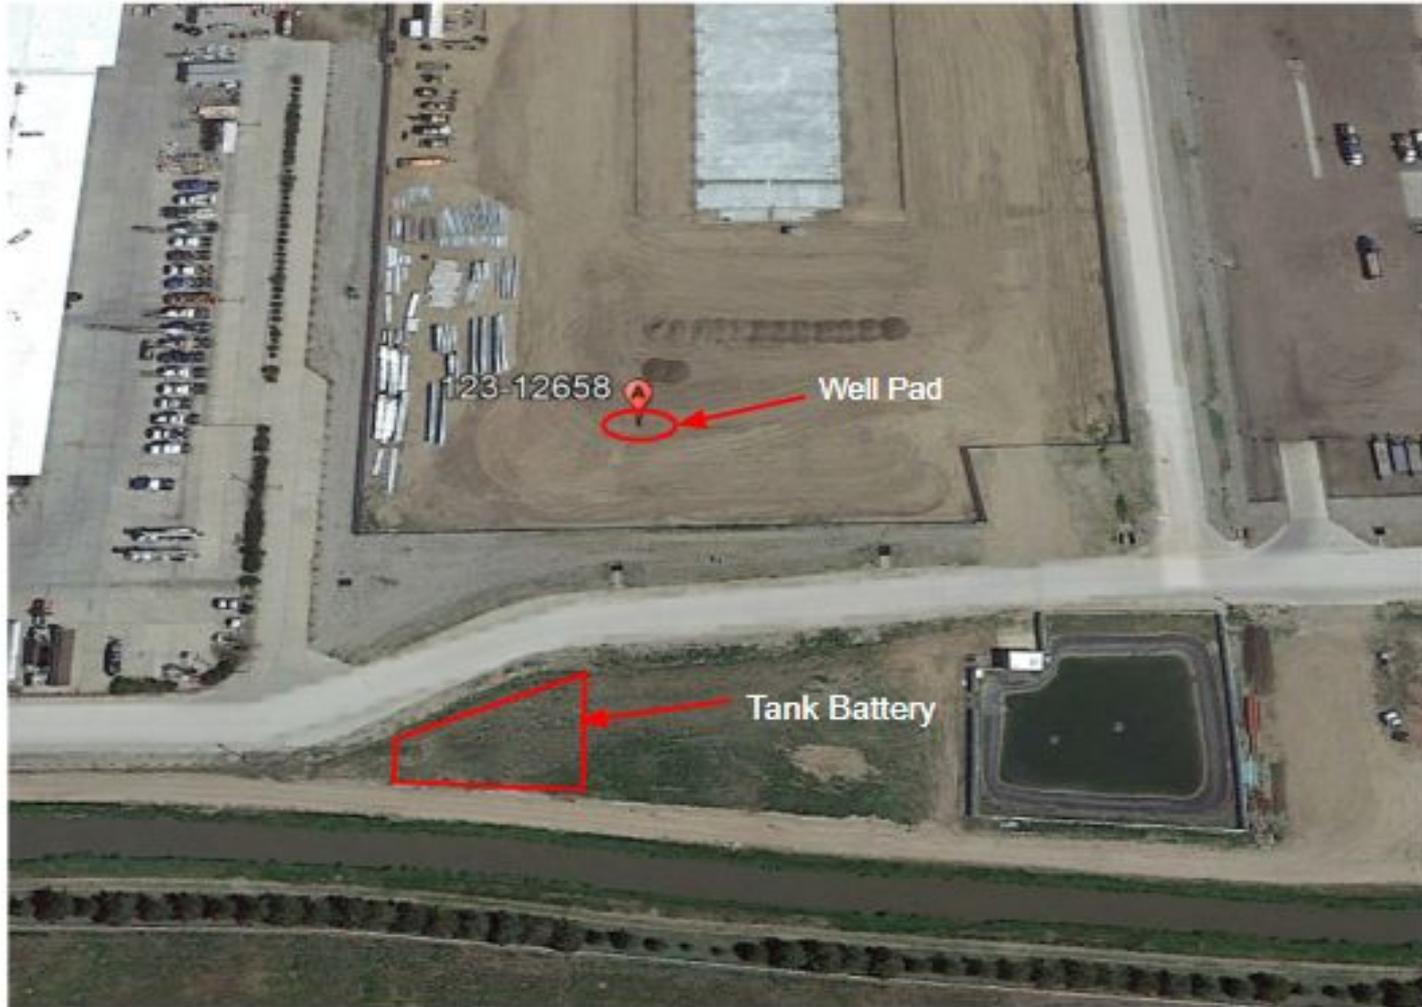
**Photo 1.** 2021 aerial imagery of the well pad and tank battery. Note: well pad falls within a commercial lot owned by Western Equipment Truck Inc.

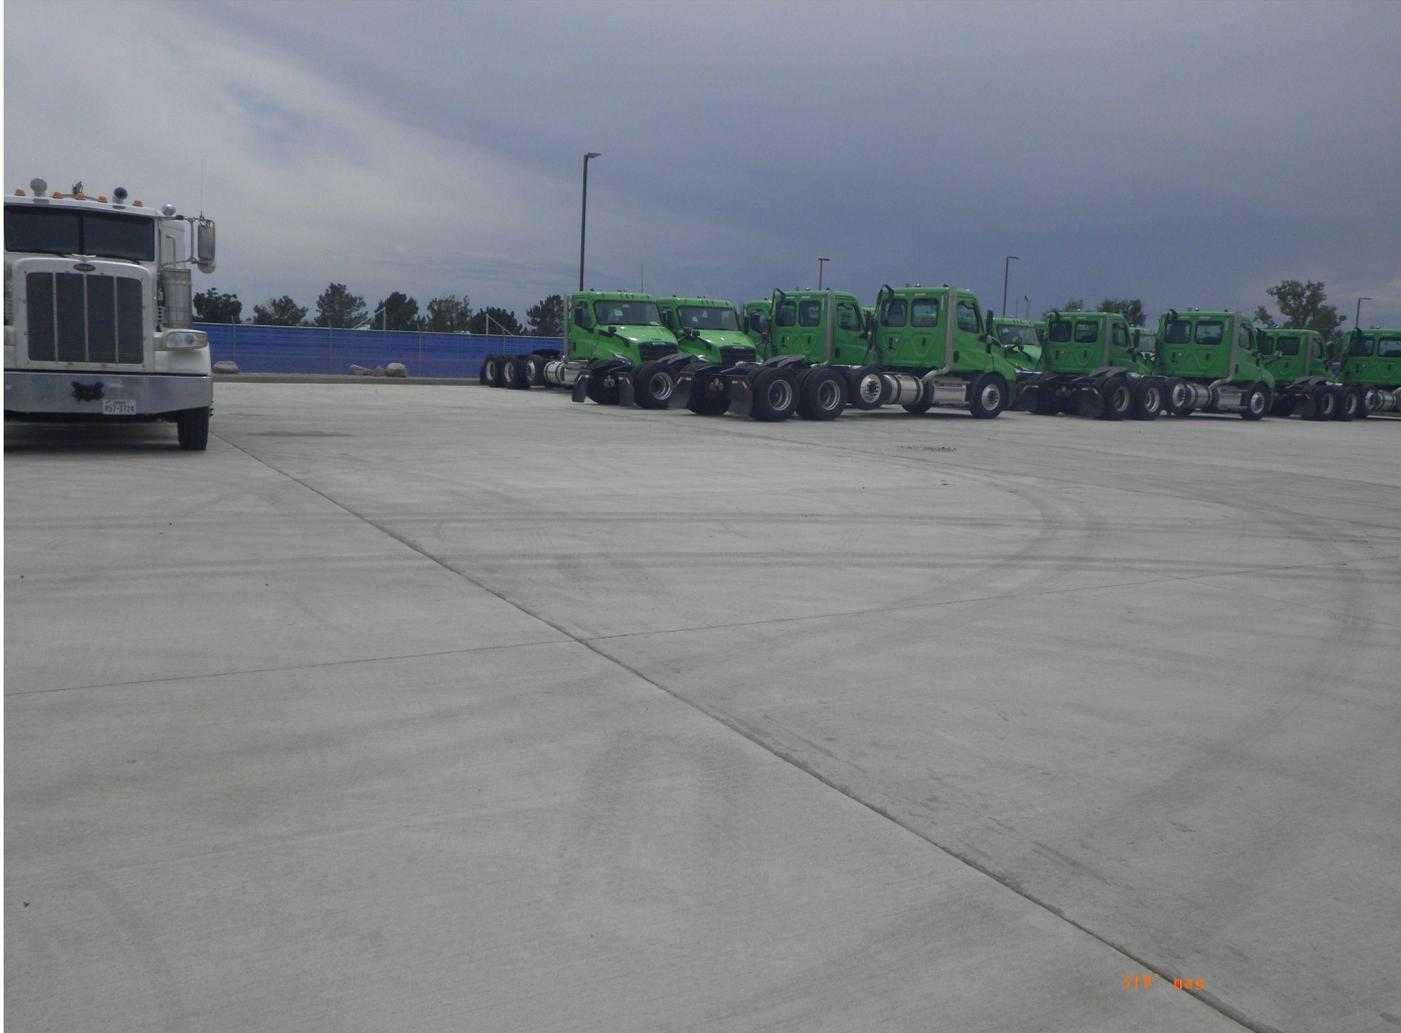
**Photo 2.** Overview photo of the well pad taken at ground level from the northern edge facing south. Note: well pad falls within a commercial area.

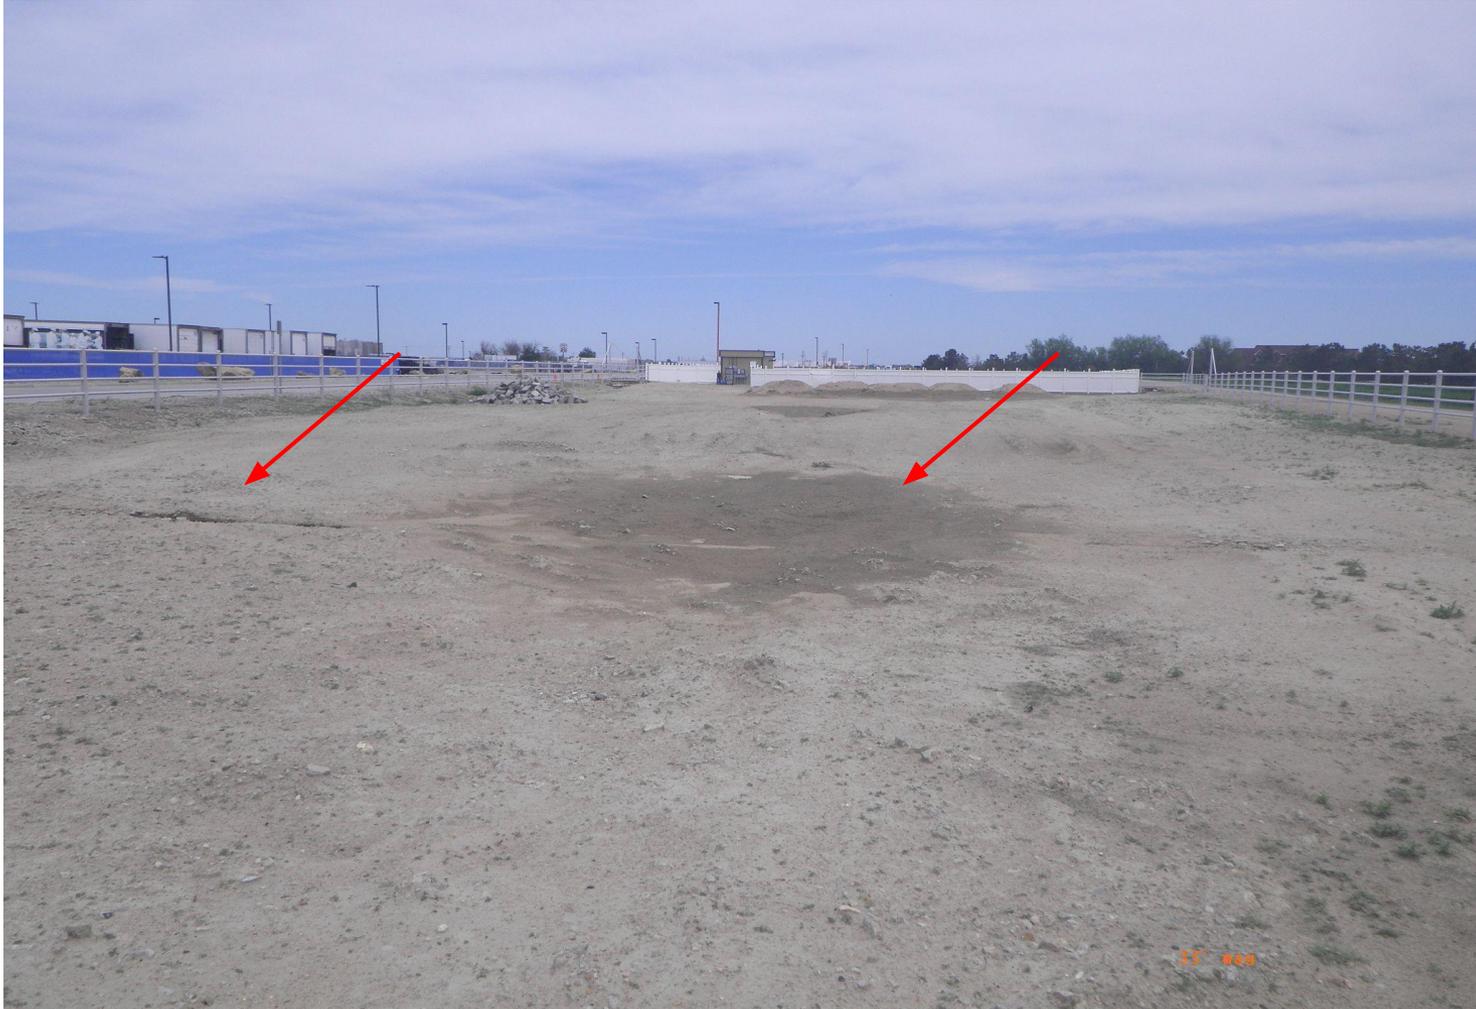
**Photo 3.** Overview photo of the tank battery taken at ground level from the western edge facing east. Note: tank battery has been disturbed but has stormwater issues (rill erosion/pooling water) indicated by red arrows.
