# Inspection Photos

6/28/2023

Operator: CAERUS PICEANCE LLC #10456

Location Number: 479149

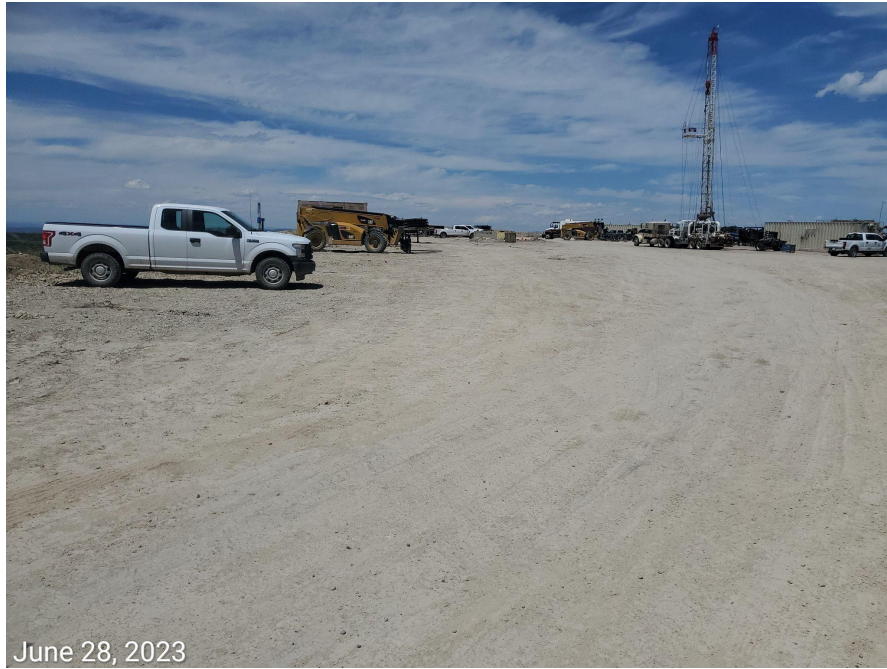
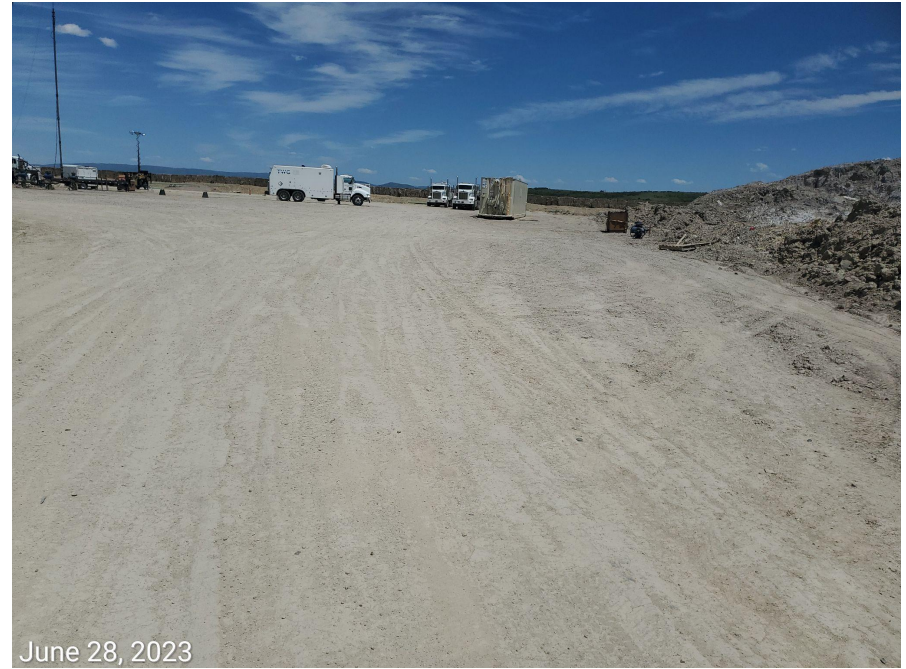
**Photo 1:** Photos taken from the Location entrance on the southwest end of the Location. Photos provide an overview of the Location from north to east.

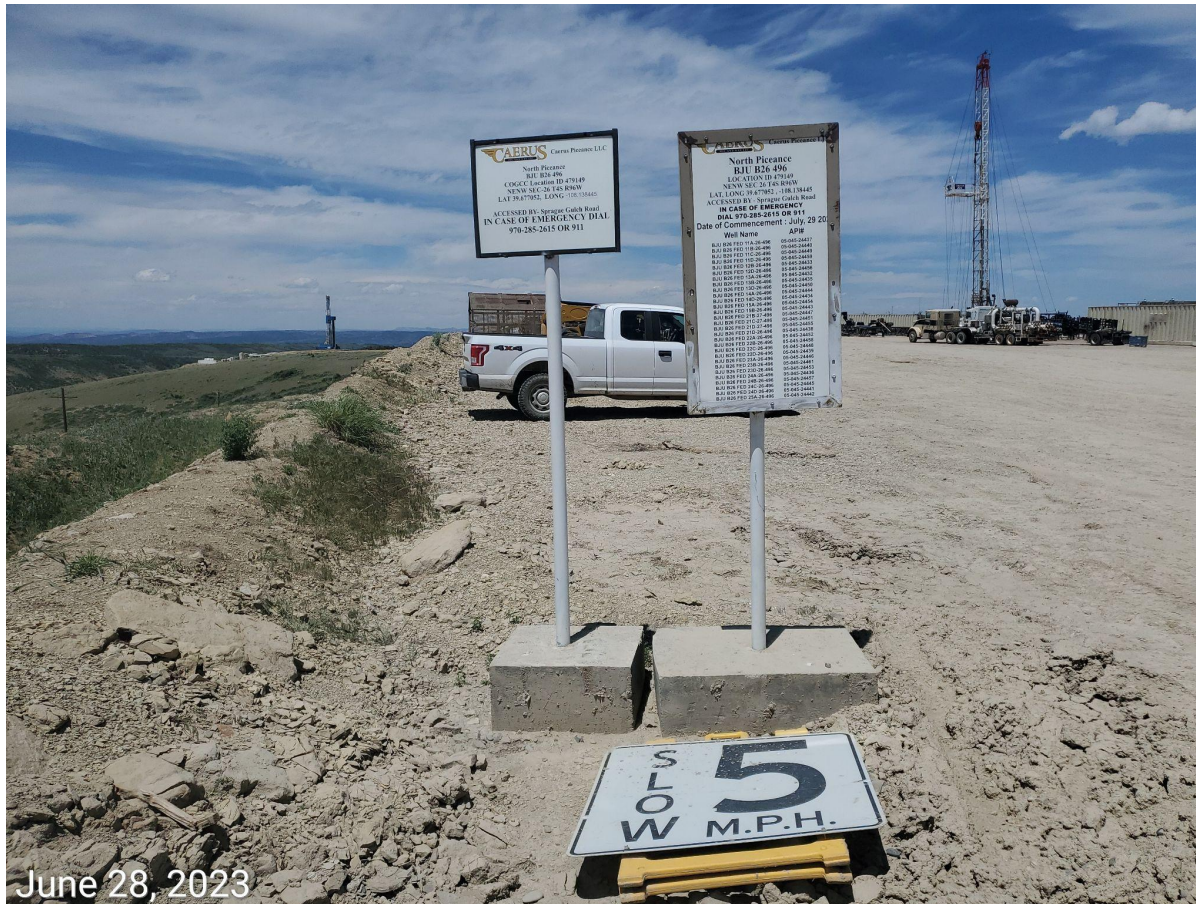
**Photo 2:** Signage at Location entrance. 2A permit information not observed on Location.

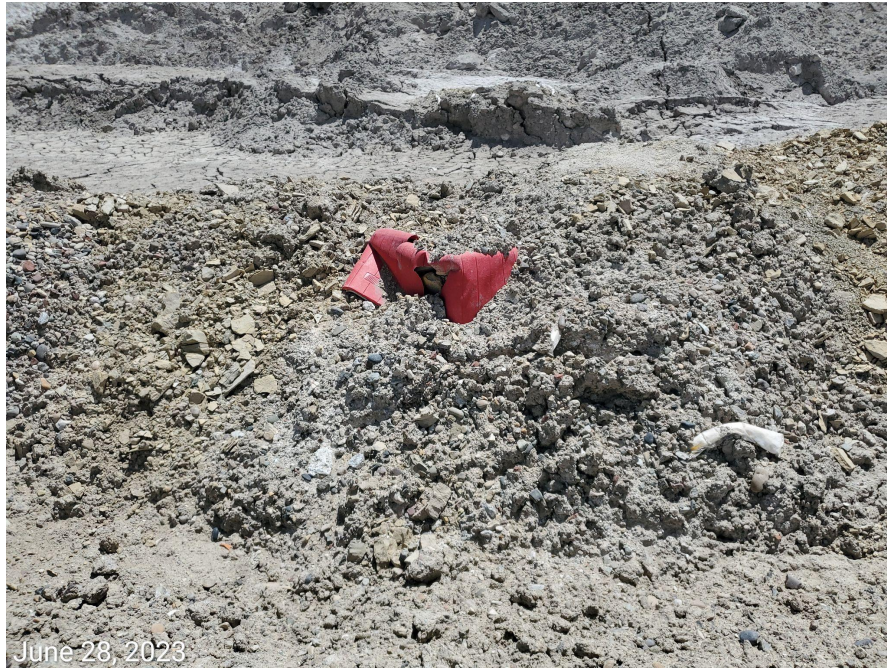
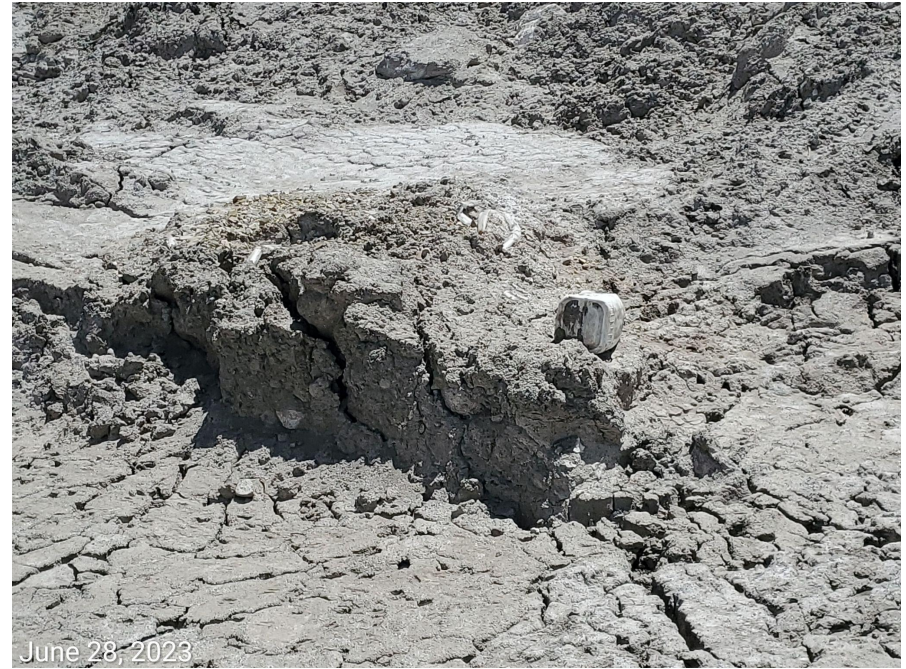
**Photo 3:** Photos 3-6 taken from the Cuttings Trench on the south end of the Location. Photos examples showing Operator has improperly placed and buried trash/rubbish/etc... within the cuttings trench.

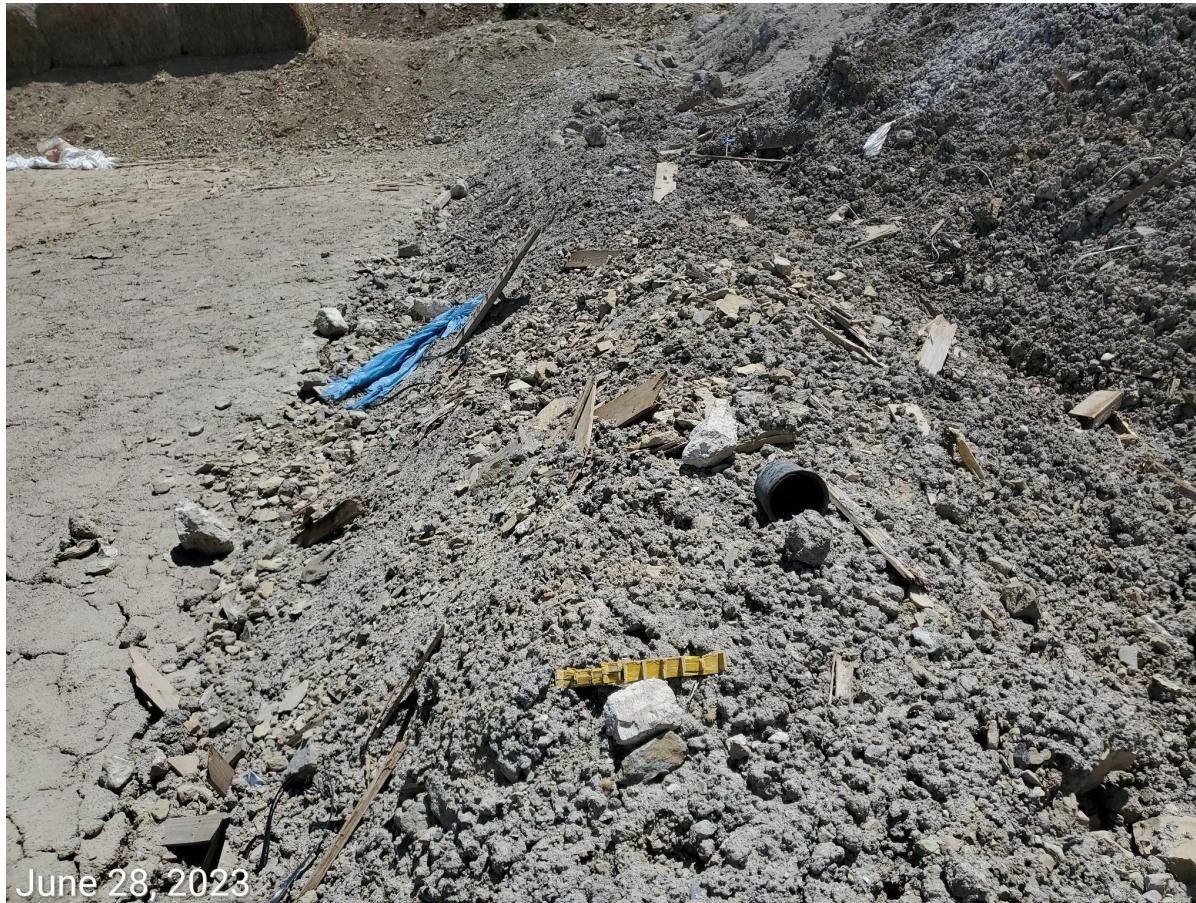
**Photo 6:** See comments under photo 3. Photo also show areas where cuttings material appears to have spilt over the containment berm. Photo also shows trash debris.

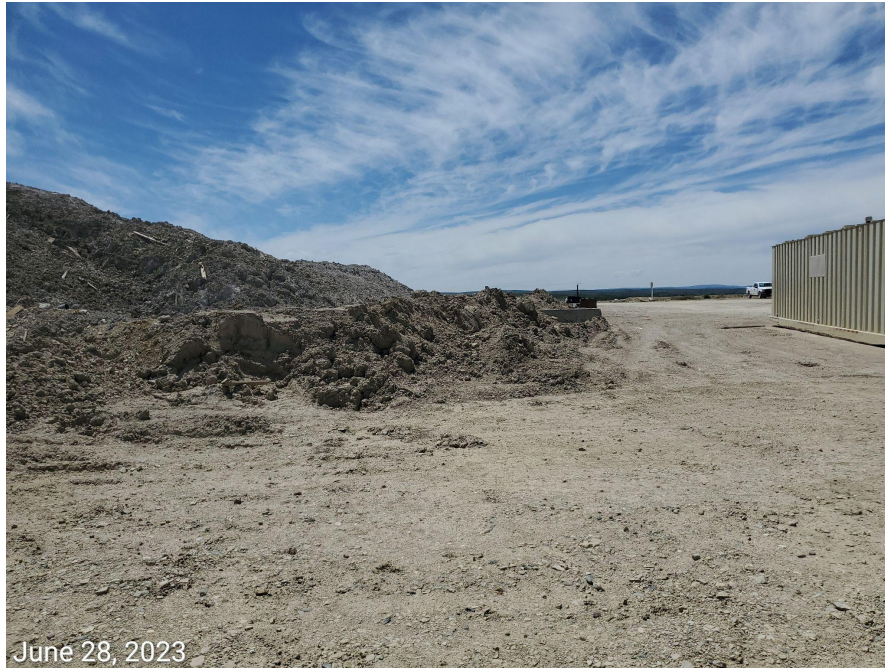
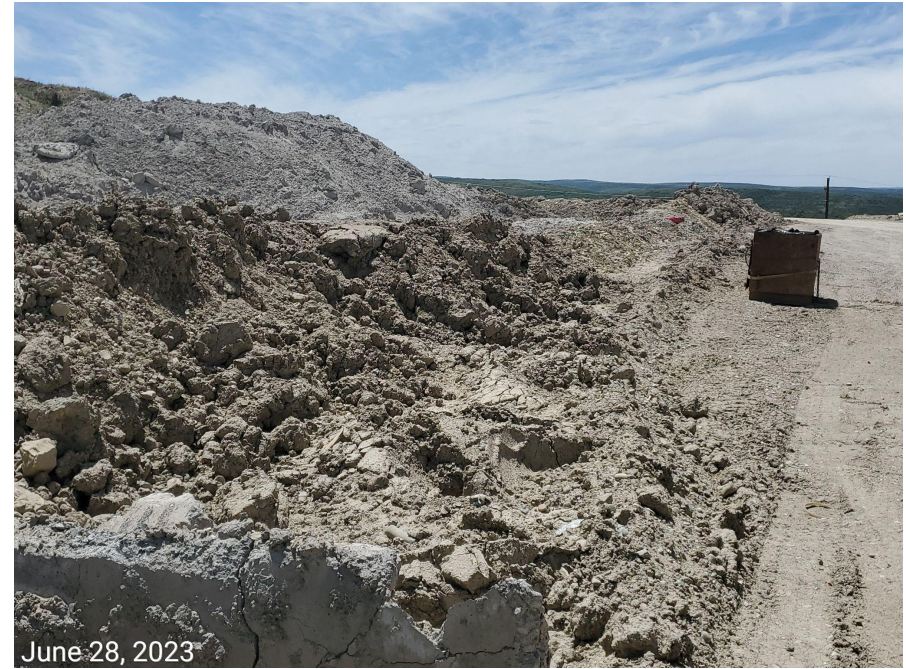
**Photo 7:** Photos taken from the Cuttings Trench on the south end of the Location. Photos show the containment berm is largely unconsolidated material; BMP has not been installed or maintained in accordance with good engineering practices. Areas of the BMP also appear to have been mixed with cuttings material.

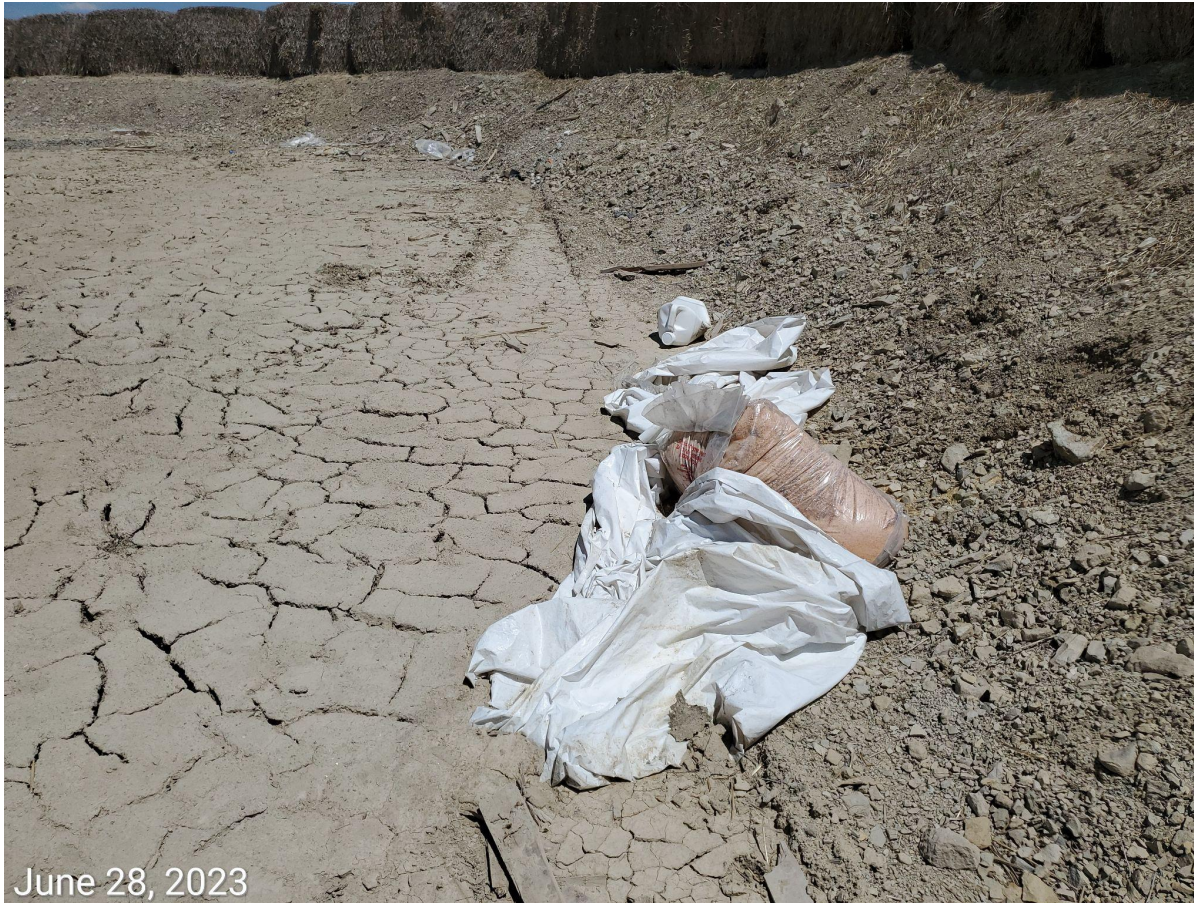
**Photo 8:** Photo taken from the southeast end of the Location. Photo shows trash debris, and what appears to be unused materials improperly stored on the surface of the Location.

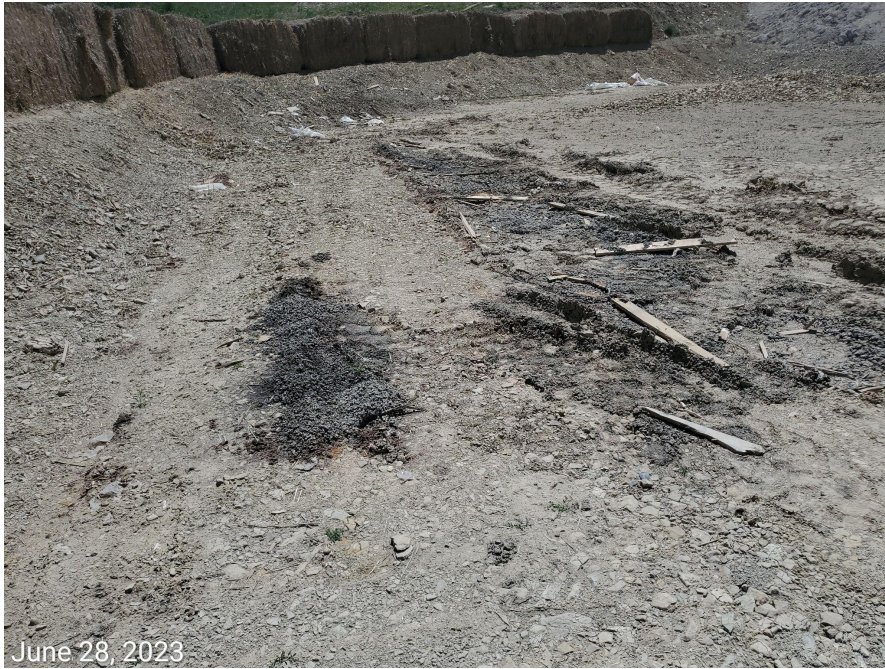
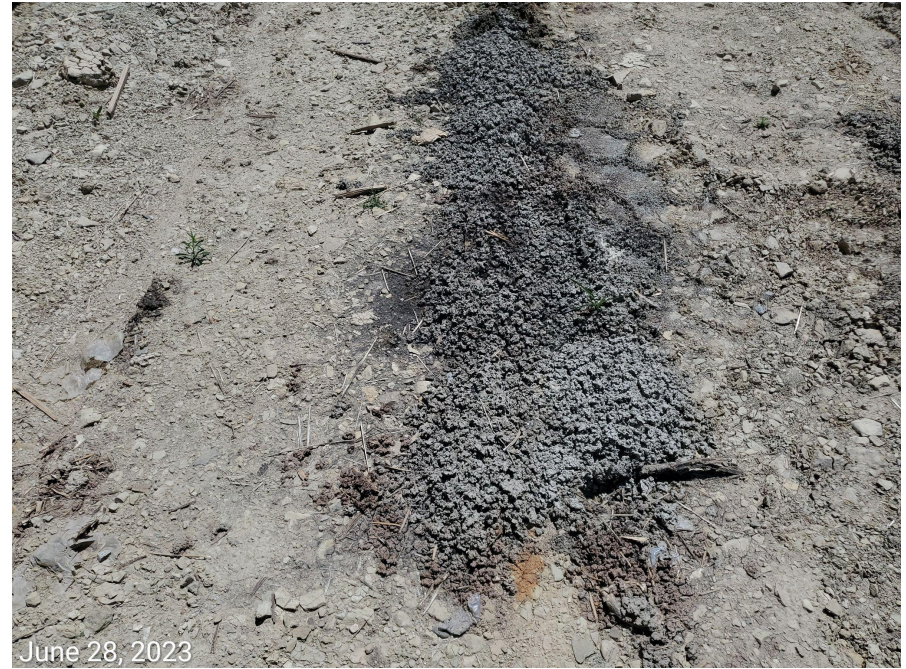
**Photo 9:** Photos taken from the southeast end of the Location. Previous inspection observed various spills due to improper materials handling within the southeast areas. Photo shows spills within the material storage area of the Location remain apparent. Photo also shows trash debris on surface of Location.

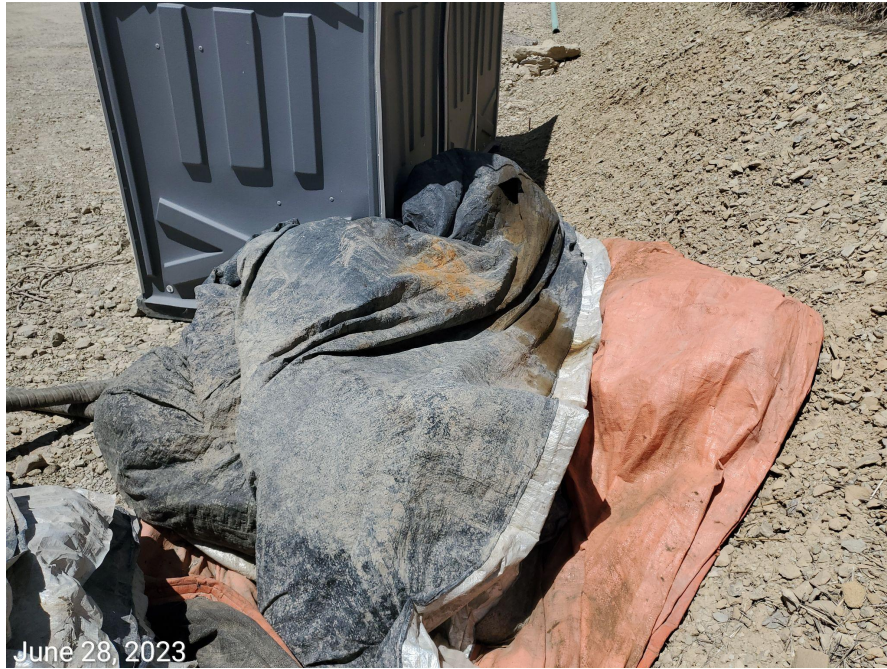
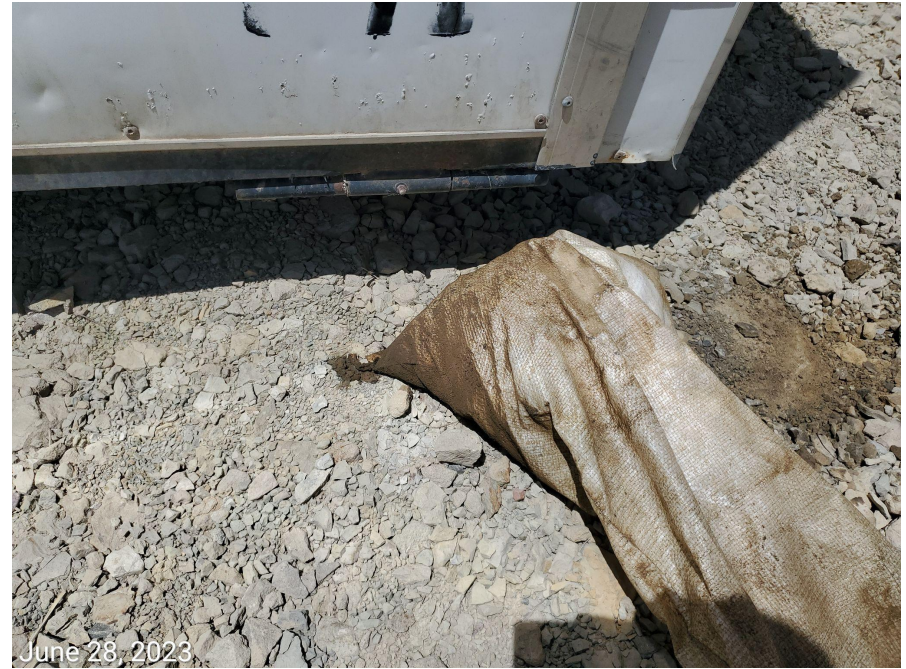
**Photo 10:** Photo taken from the east end of the Location. Photo shows unused tarp material, and a bag with apparent staining; stained soils observed beneath bag in photo right. Unused materials/equipment/supplies require removal. Stained soils require cleaning/remediation to Table 915-1 standards.

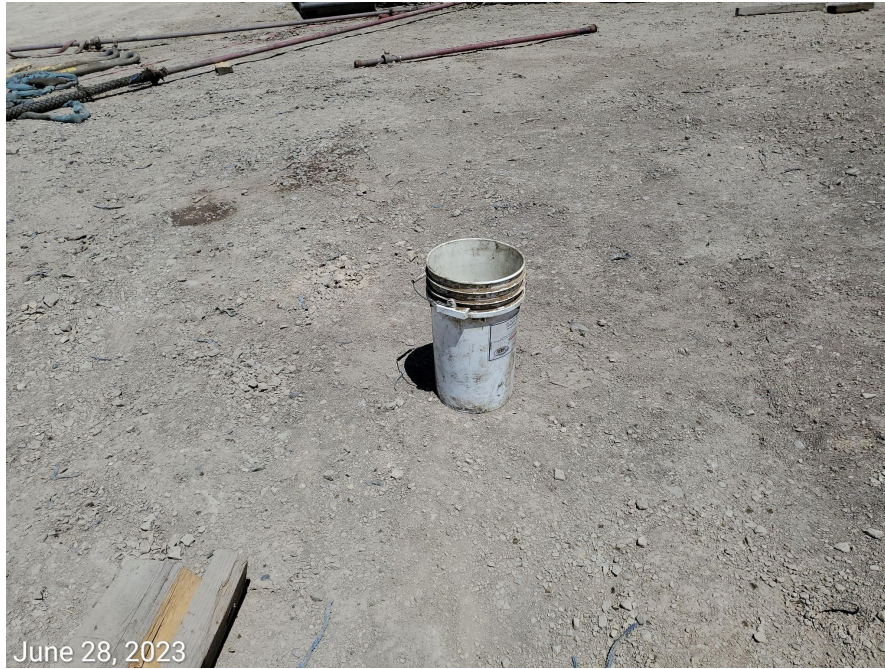
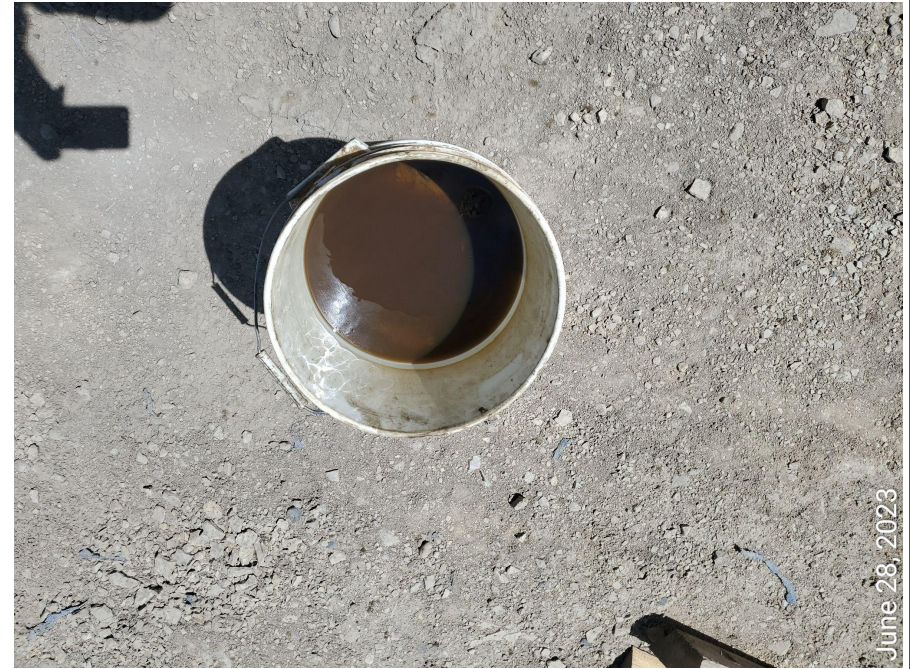
**Photo 11:** Photo shows unlabeled container with unknown fluids observed on the Location. No wildlife protection BMPs in place; no spill prevention or containment BMPs observed. Fluids require removal and proper disposal.

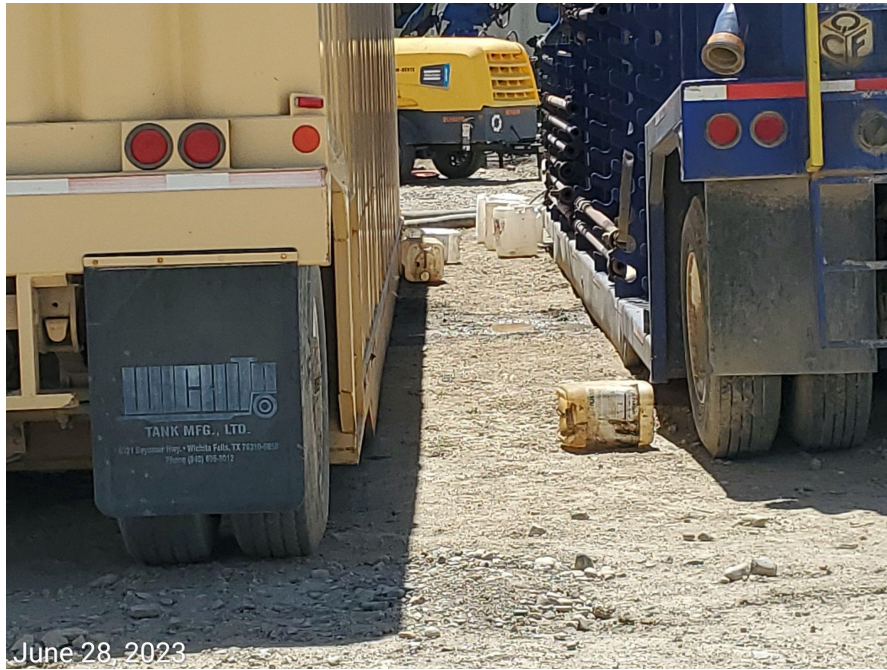
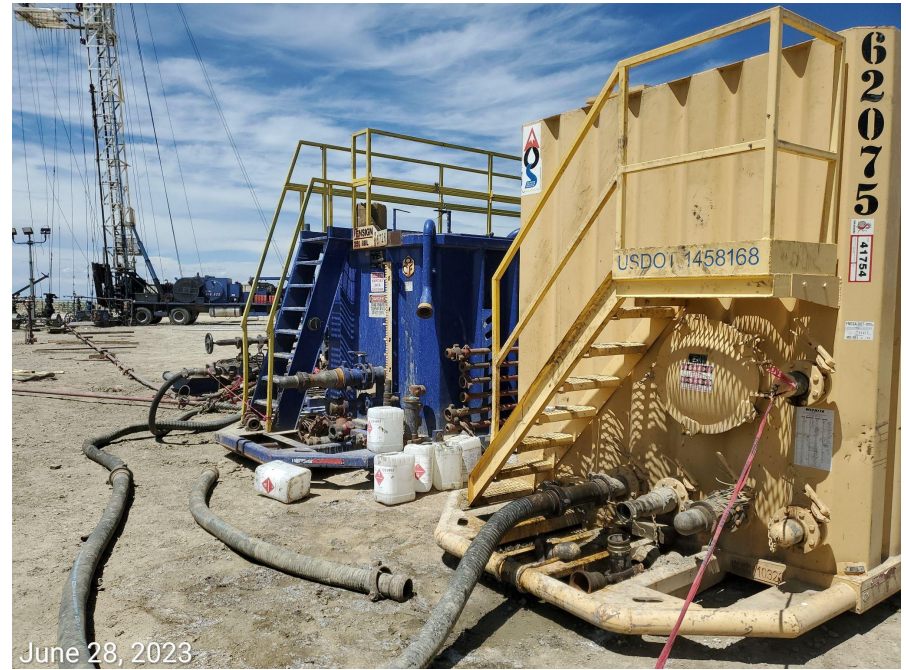
**Photo 12:** Photos taken from the east end of the Location. Photo shows what appears to be empty chemical jugs (trash/debris/rubbish) improperly stored on the Location. Photo also show two tanks missing required labeling pursuant to Rule 605.h, and spill prevention/containment BMPs.

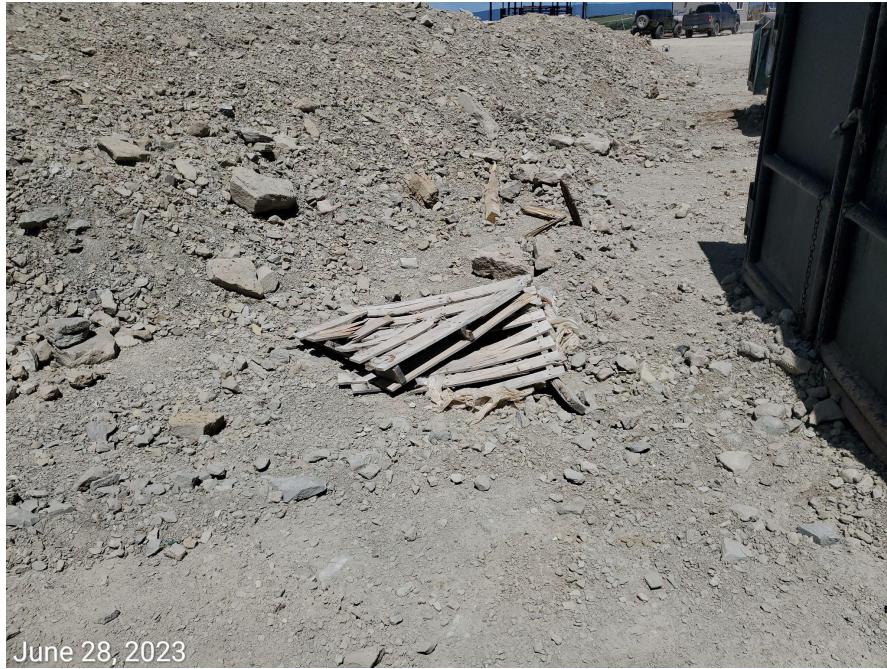
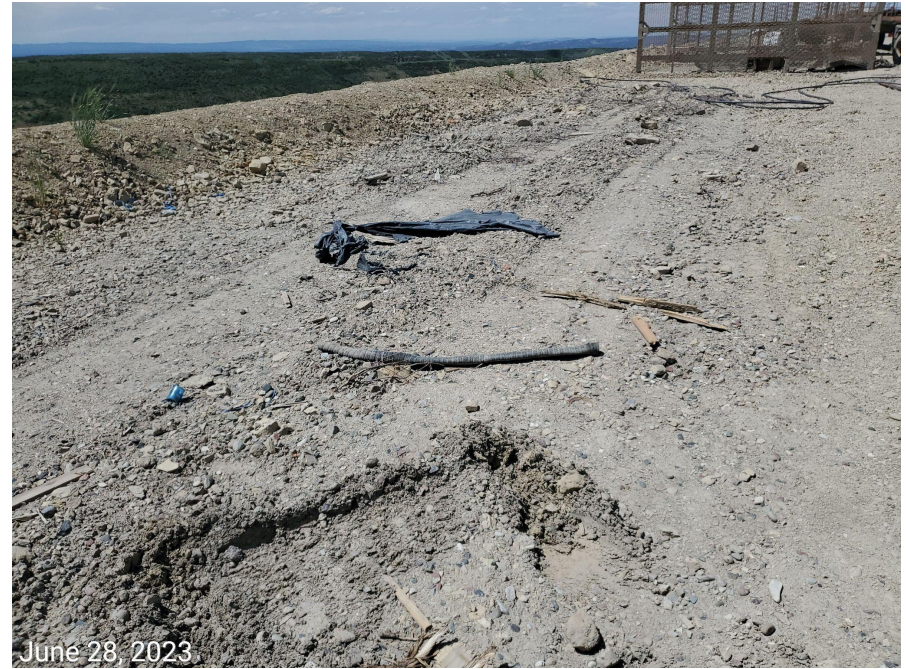
**Photo 13:** Photos examples showing various other trash/debris/rubbish observed throughout the Location.

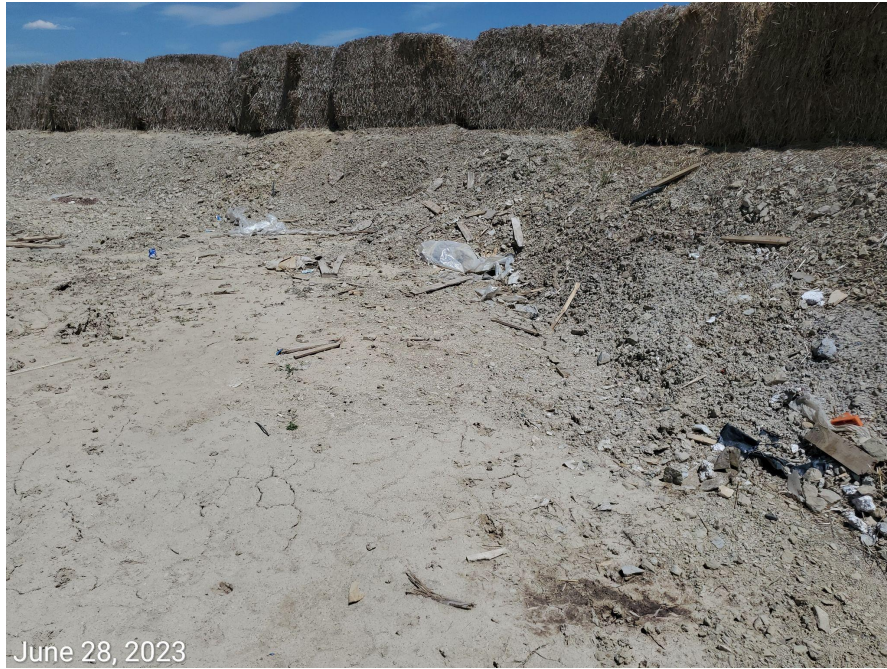
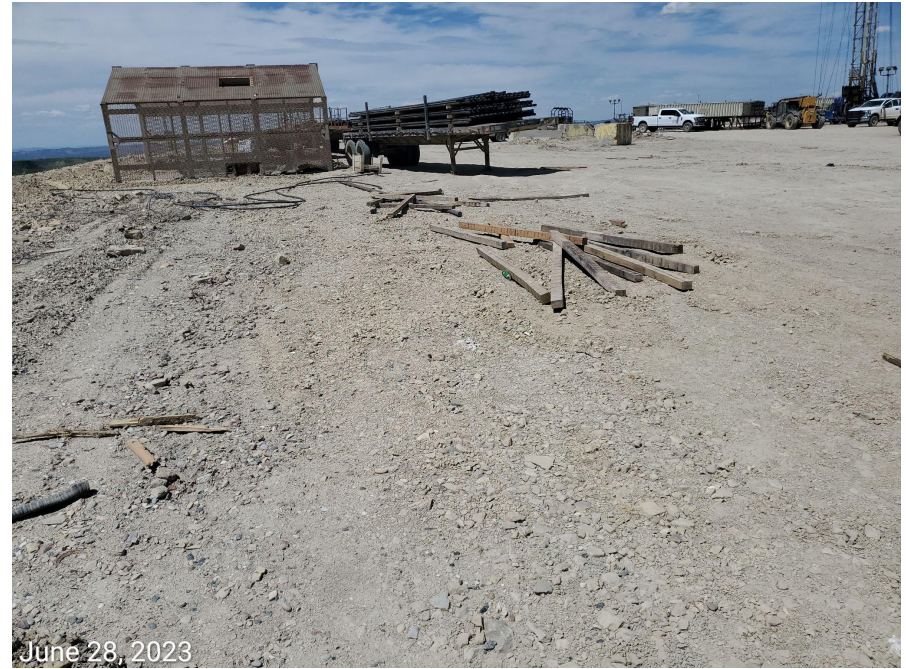
**Photo 14:** Photos examples showing various other trash/debris/rubbish observed throughout the Location.

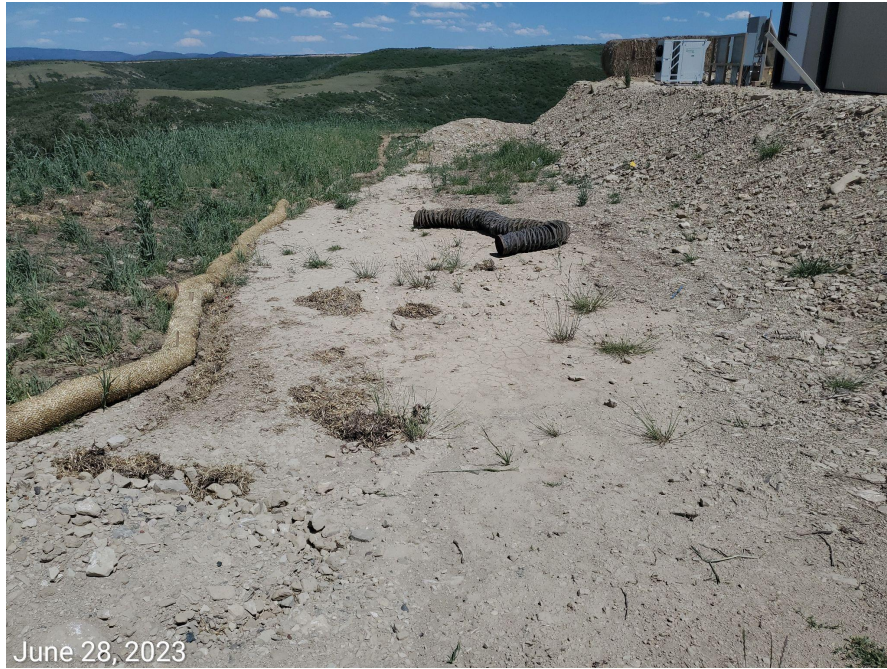
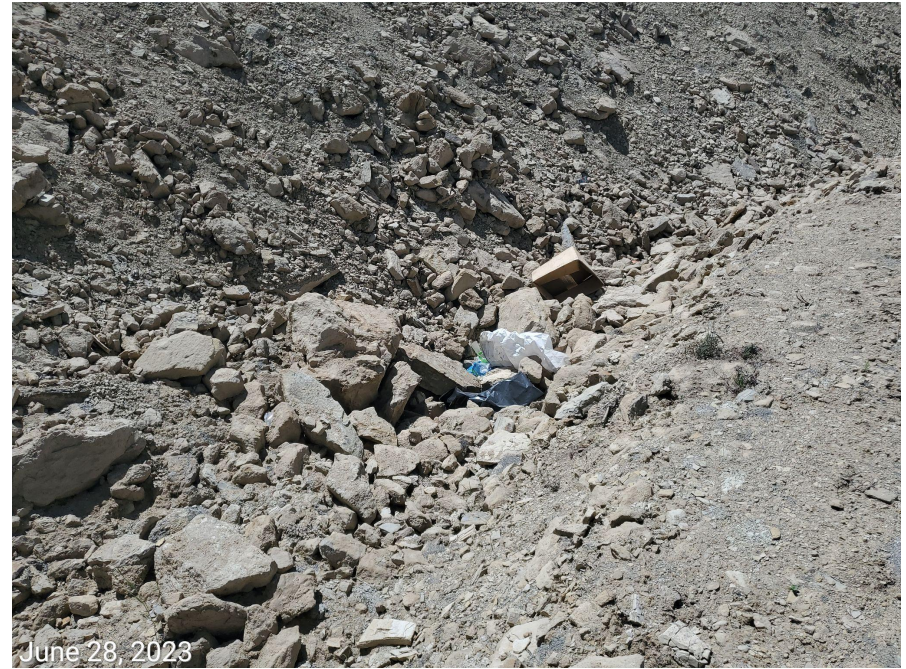
**Photo 15:** Photos examples showing various other trash/debris/rubbish observed along the perimeter of the disturbance area.

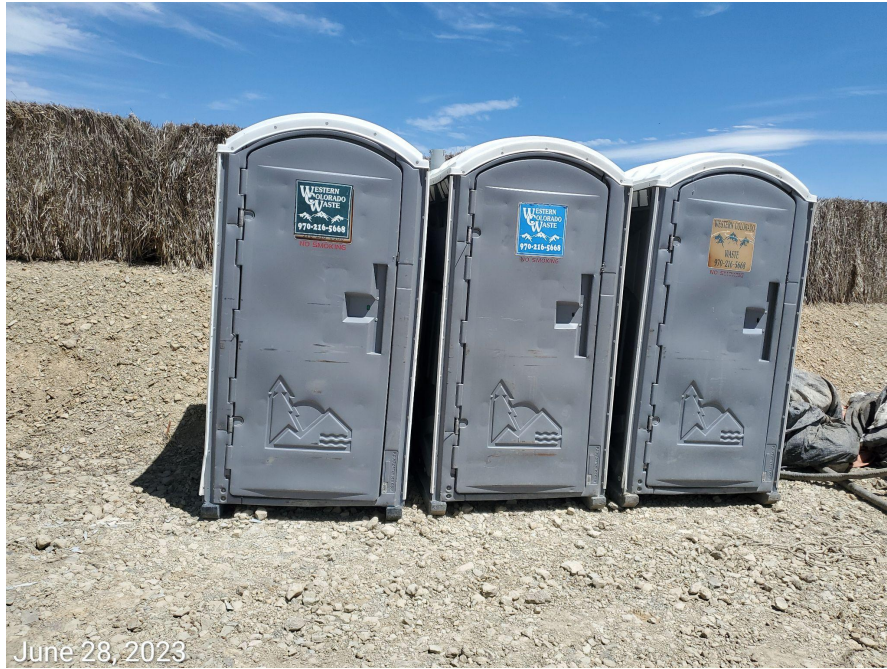
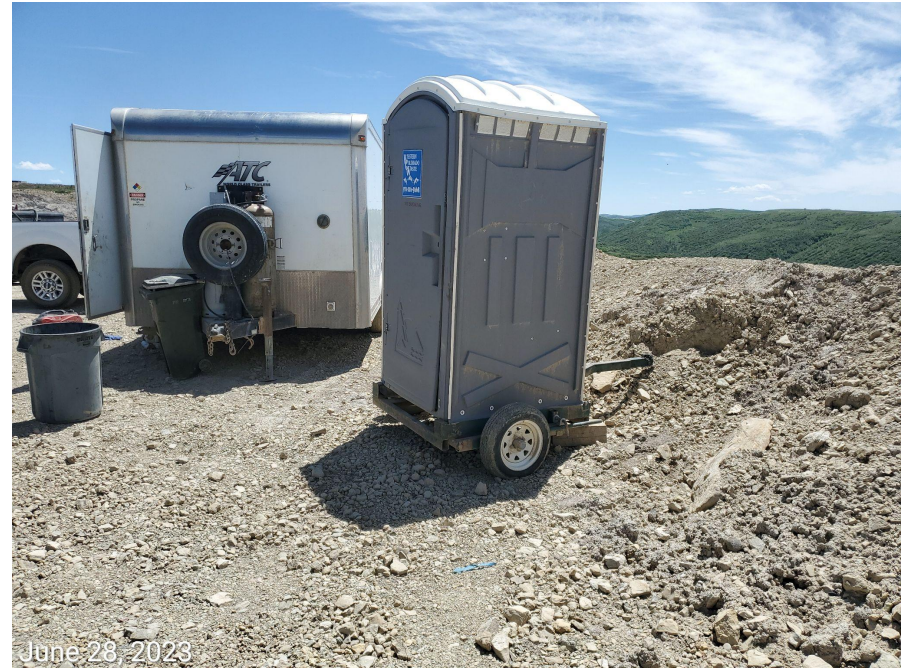
**Photo 16:** Photos show four (4) porta-john units on the Location; Spill prevention/containment BMPs observed to be missing or insufficient at porta-johns.

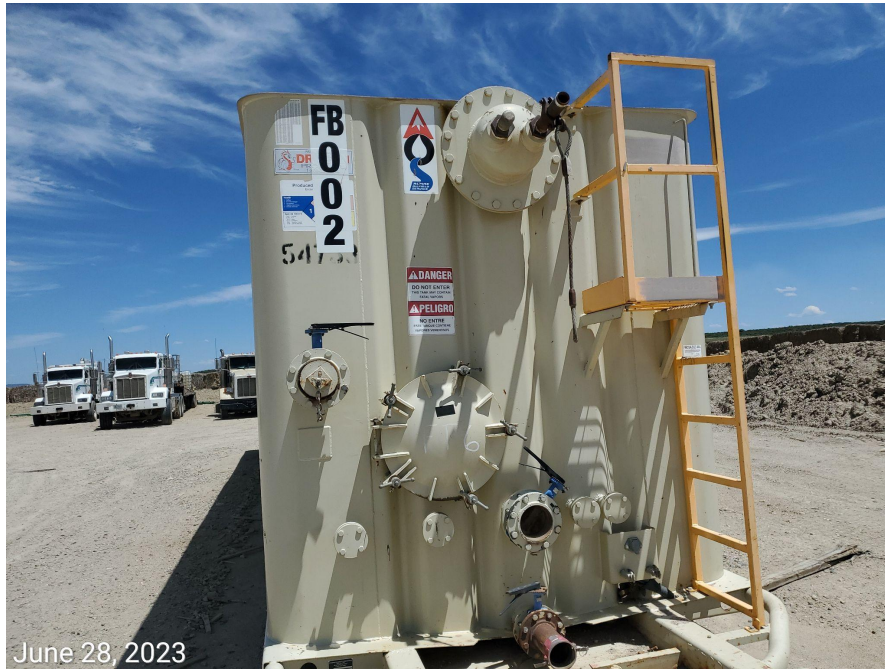
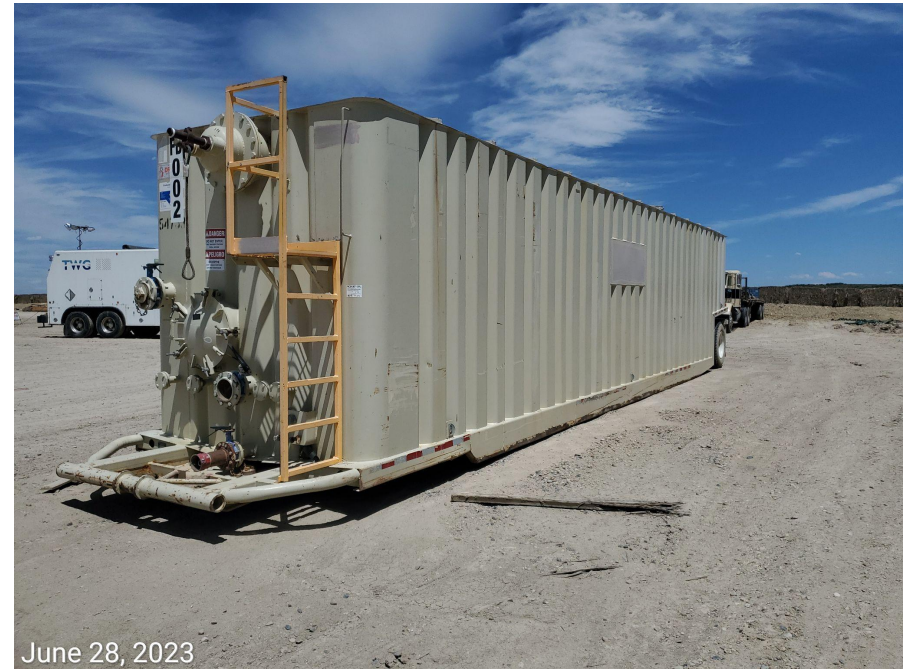
**Photo 17:** Photos 17-19 example showing tanks on the Location missing required labeling information pursuant to Rule 605.h. Photos also show tanks are missing spill prevention/containment BMPs.

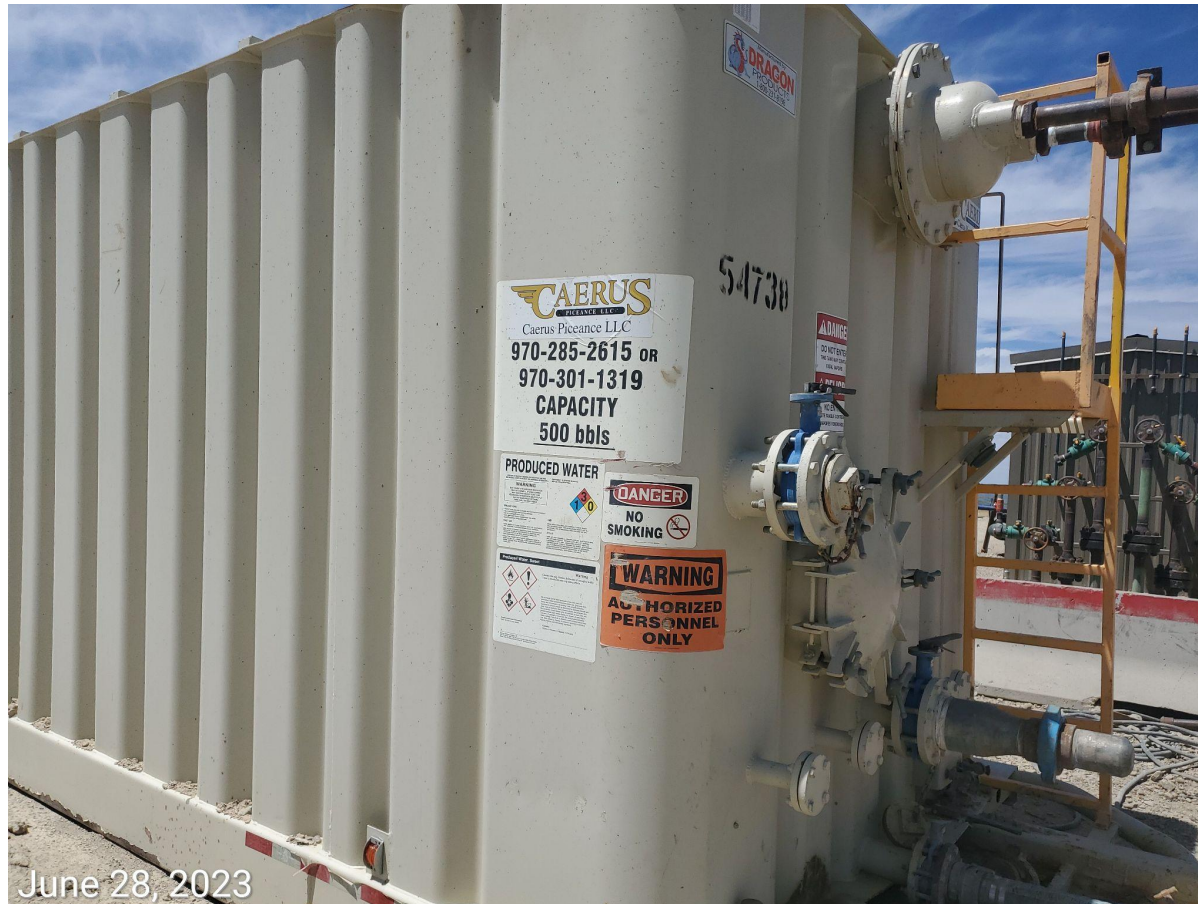
**Photo 20:** Photo example of tank on the Location with required label information including, but not limited to, Operator name, emergency contact number, tank capacity, tank contents, NFPA label, etc... Photos also shows tank is missing spill prevention/containment BMPs.

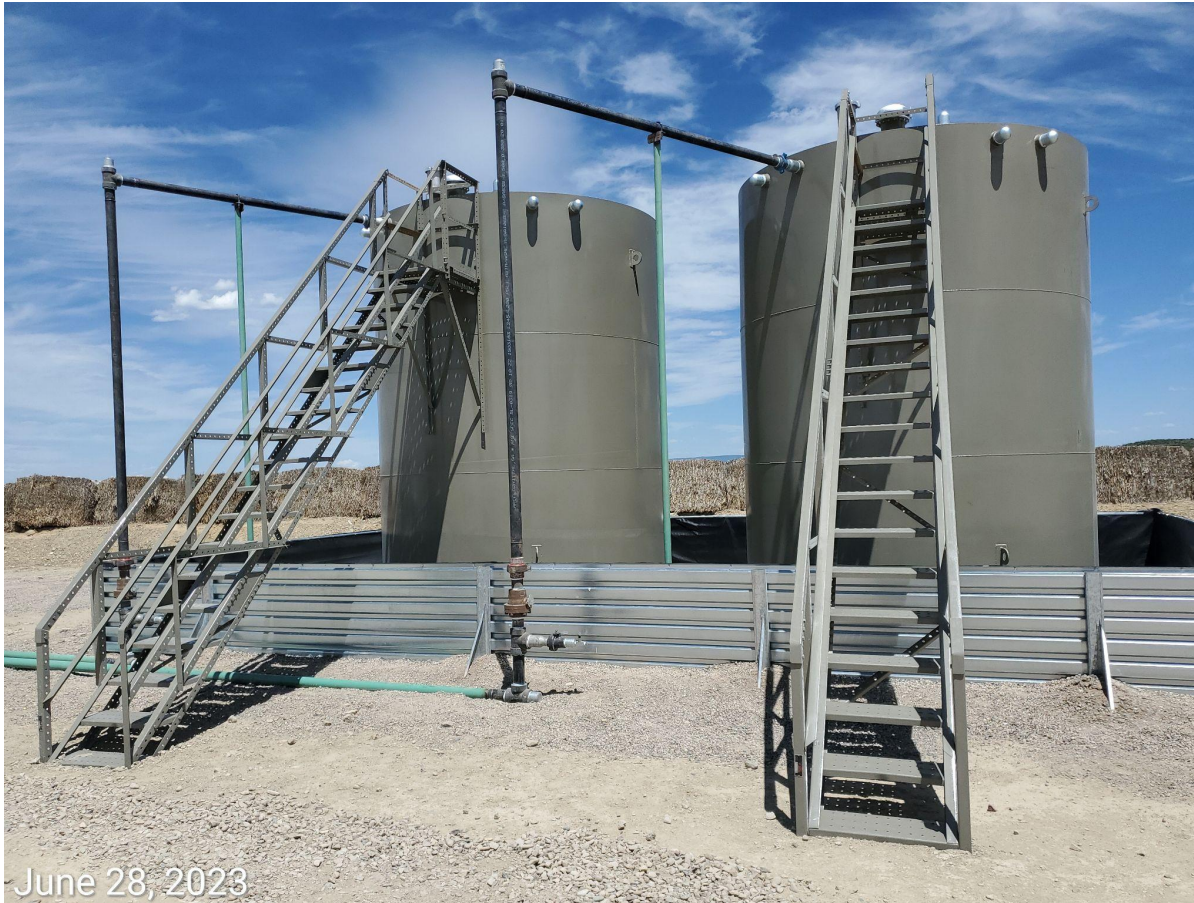
**Photo 21:** Photo taken from the tank battery on the northeast end of the Location. Photo shows signage information has not been posted at the facility, and label information has not been posted on the two tanks.

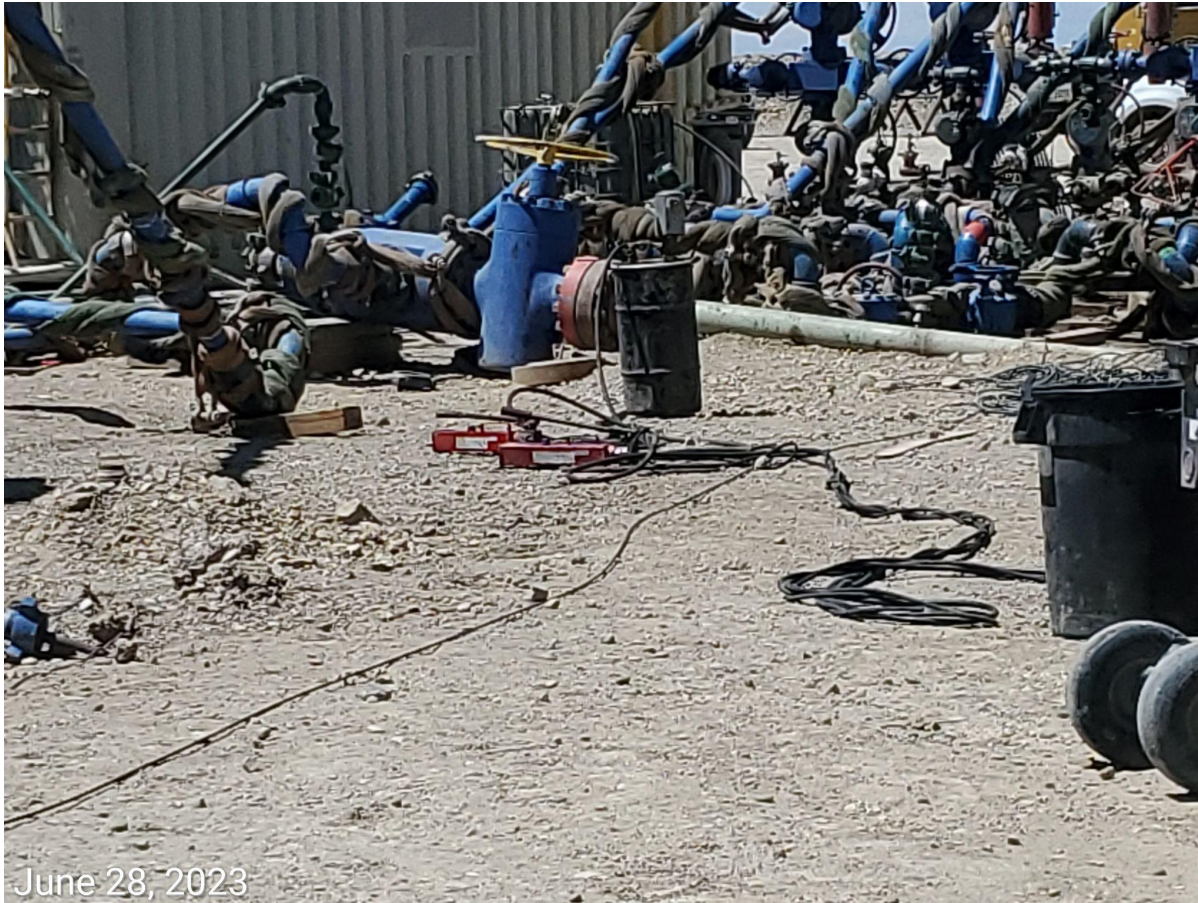
**Photo 22:** Photo example showing barrel observed missing spill prevention/containment BMPs.

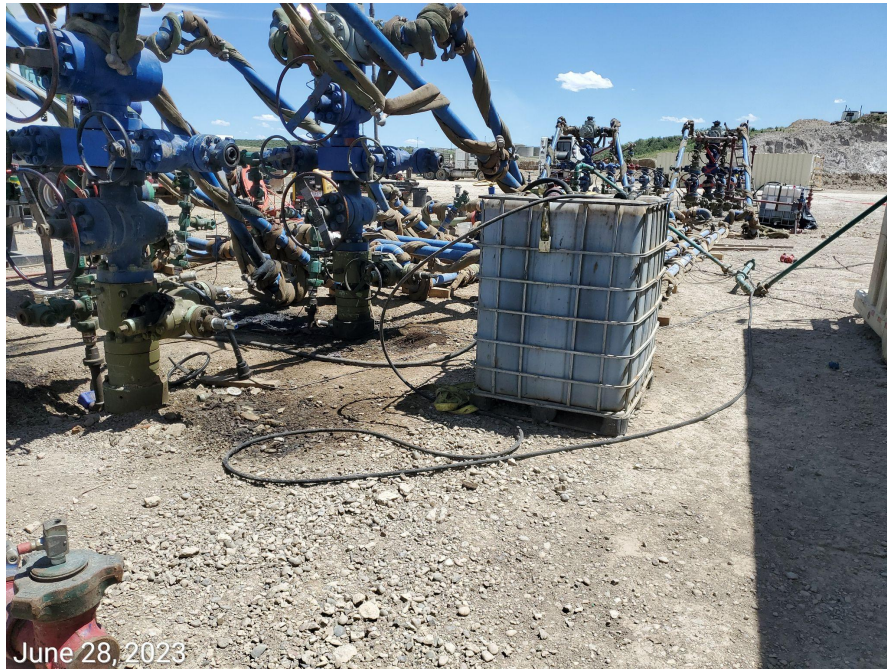
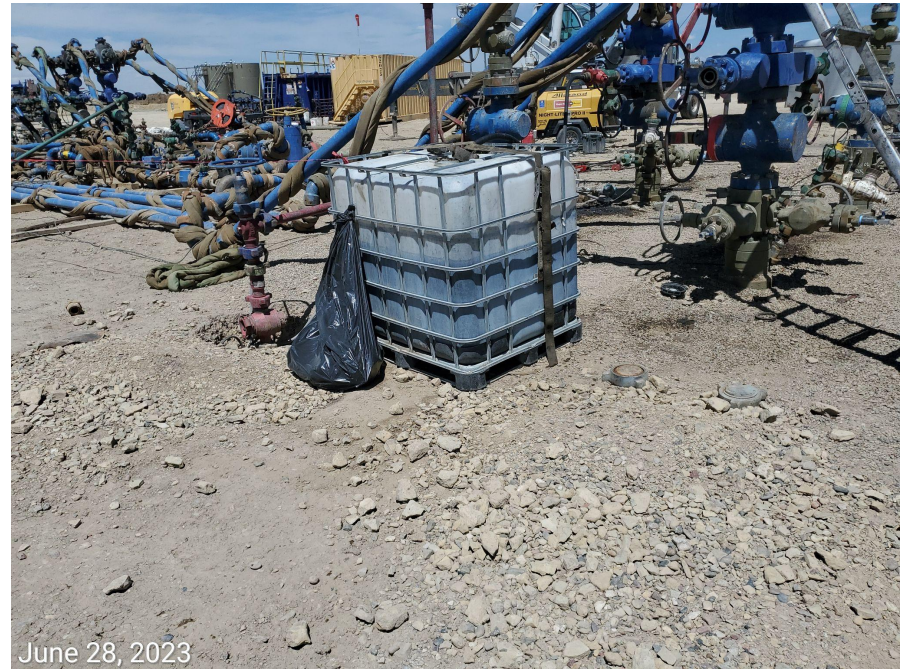
**Photo 23:** Photos examples showing containers on Location missing spill prevention/containment BMPs.
