# Inspection Photos

6/28/2023

Operator: CAERUS PICEANCE LLC #10456

Location Number: 479149

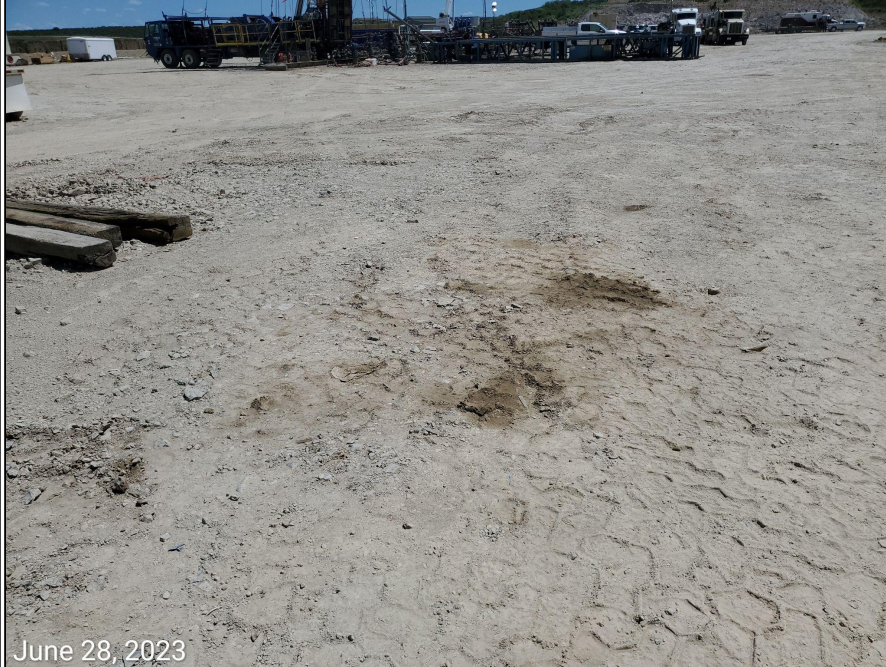
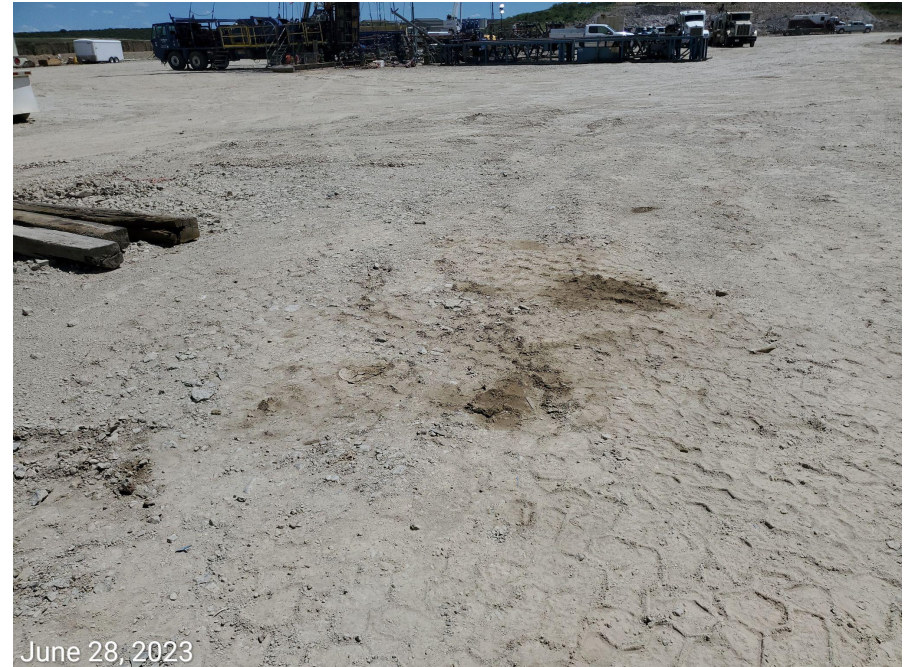
**Photo 24:** Photos 24-26 examples showing additional spills/stained soils observed throughout the Location. See photos

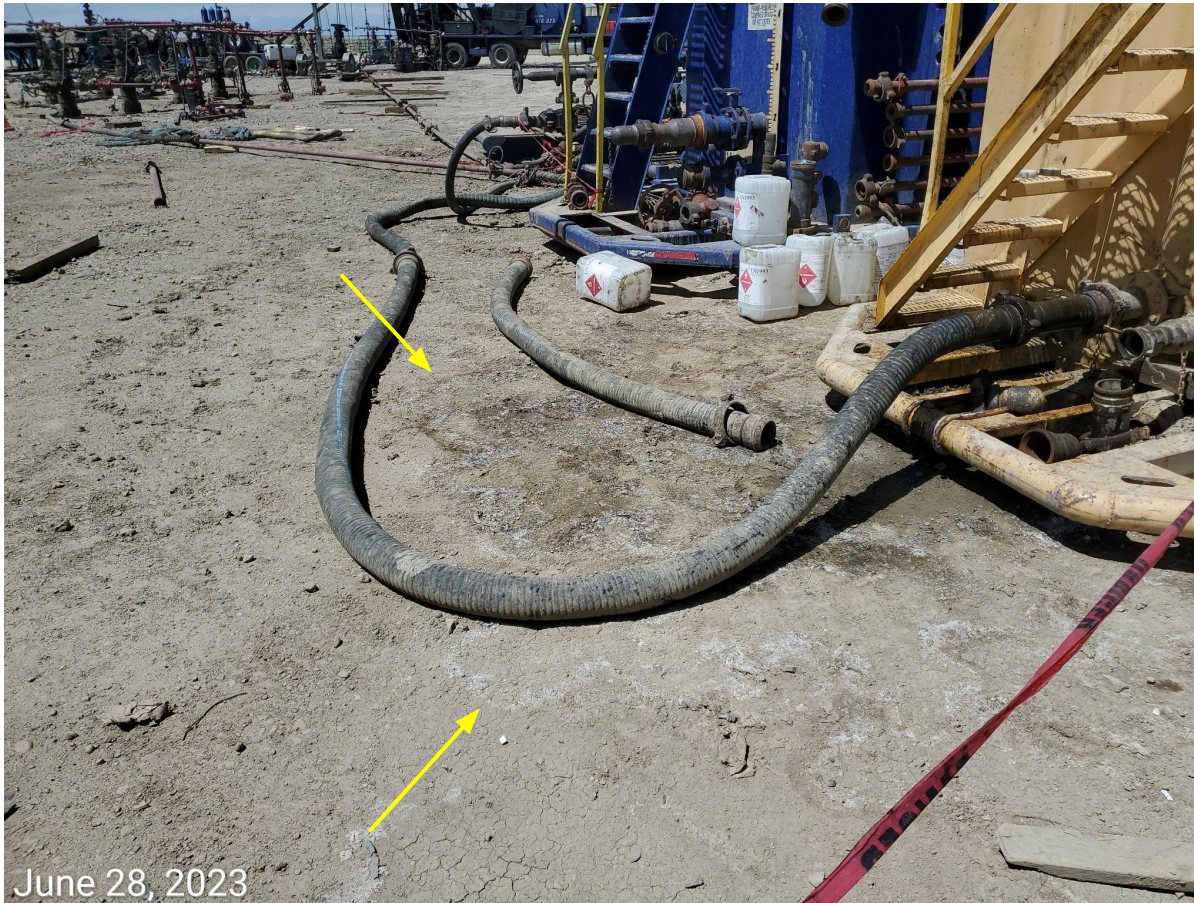
**Photo 12:** Photos taken from the east end of the Location. Photo shows what appears to be empty chemical jugs (trash/debris/rubbish) improperly stored on the Location. Photo also show two tanks missing required labeling pursuant to Rule 605.h, and spill prevention/containment BMPs.

**Photo 26:** Photo shows stained soils from what appears to be a spill at the tank. See comments under photo 12 regarding tank labeling, trash, and spill prevention/containment BMPs.

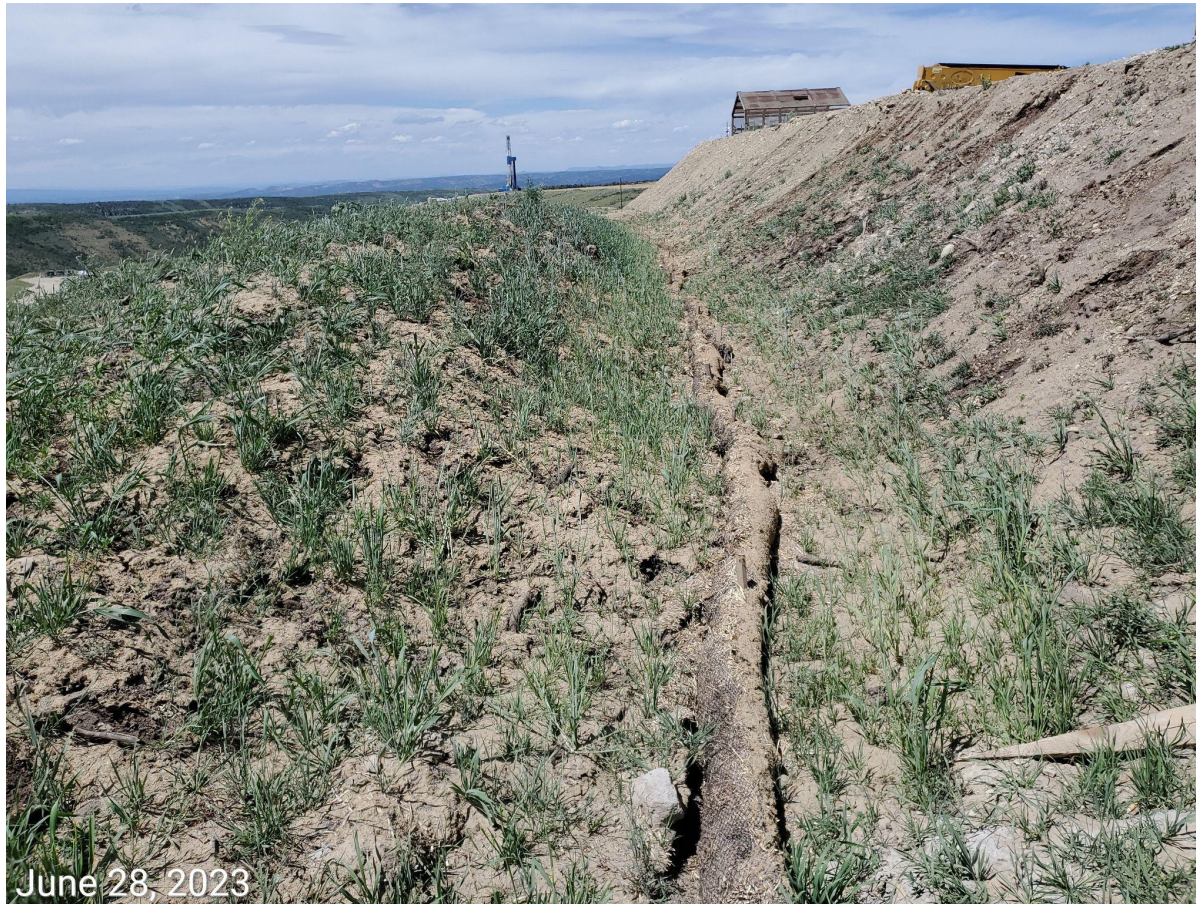
**Photo 27:** Photos 27-28 taken from the topsoil stockpiles on the perimeter of the Location. Photos show Operator has implemented additional BMPs to protect the topsoil stockpiles, and to ensure soils remain properly segregated, and not incorporated as part of stormwater management BMPs for the Location.
