# Final Reclamation Inspection

Operator: NOBLE ENERGY INC - #100322

Location ID: 322698

Inspection Photos  
Location Name: RYDGREN #8-1  
Location ID: 322698

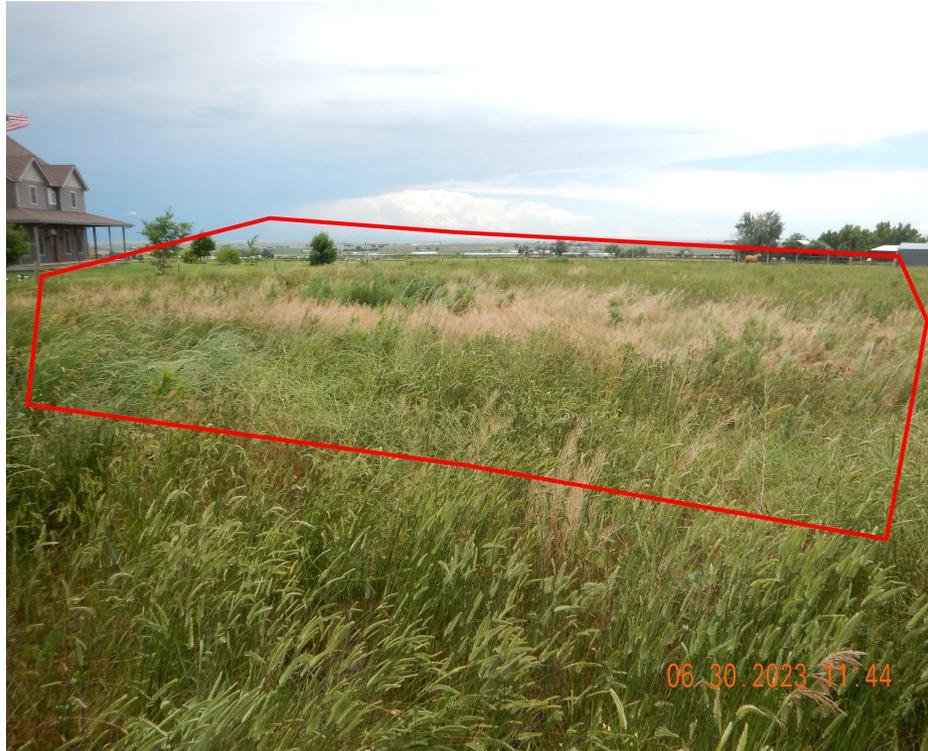
**Photo 1.** Photo taken from the well location, facing Southeast. Photo illustrates the well location is not reflective of reference areas. Well location consists mostly of annual weeds, while the reference area consists mostly of a perennial grass, Crested wheatgrass.

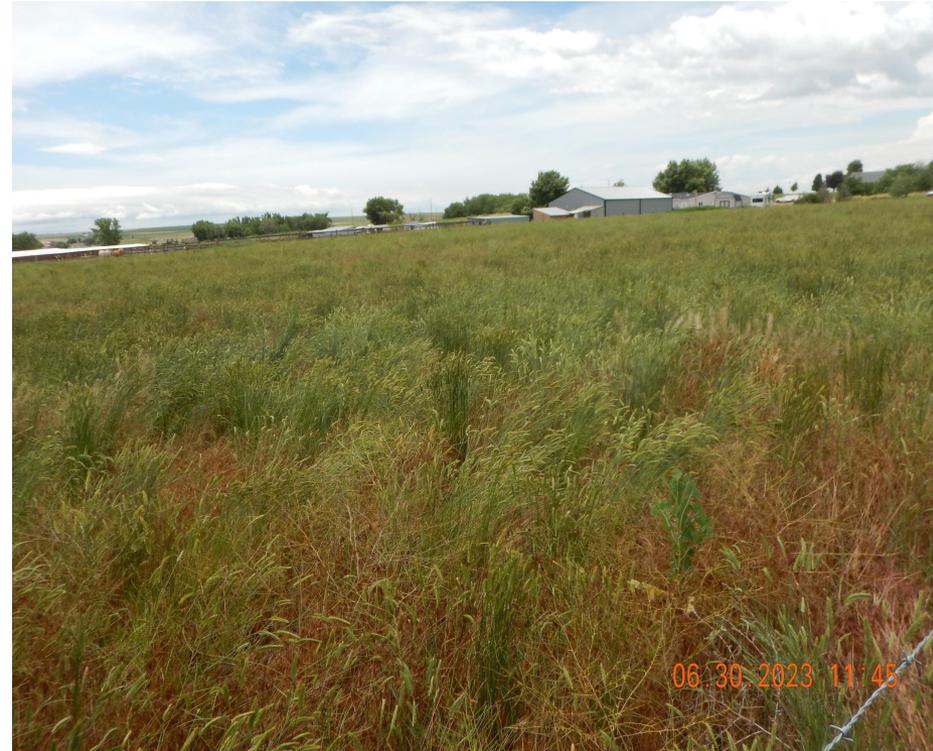
**Photo 2.** Reference photo taken from the well location, facing Southwest. Photo illustrates a field of Crested wheatgrass.

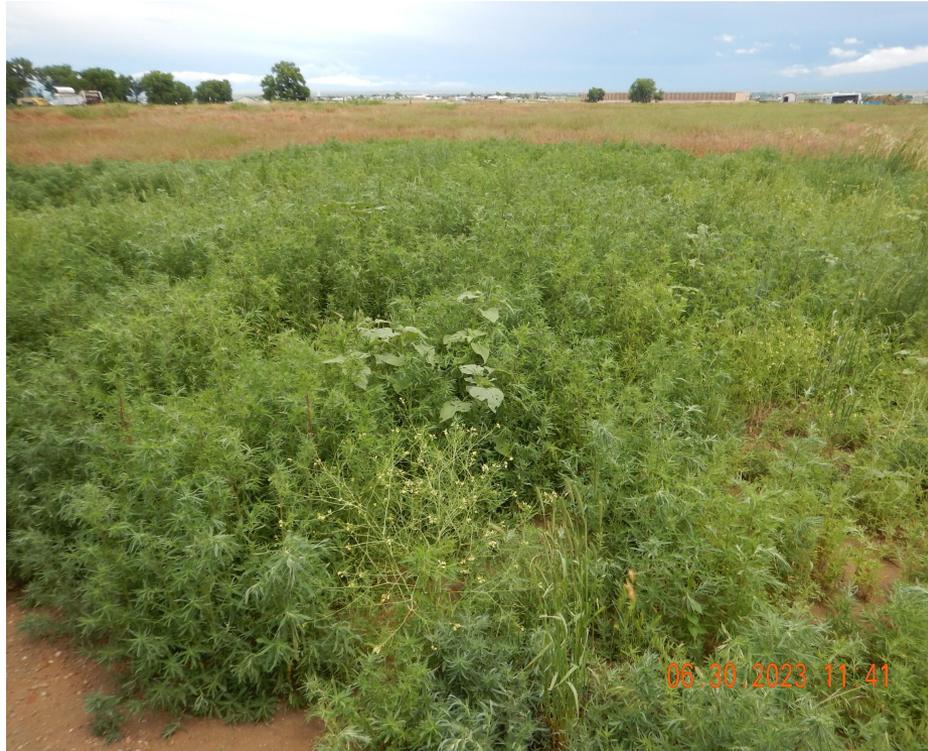
**Photo 3.** Photo taken from the northern portion of the associated tank battery location, facing East. Photo illustrates the northern portion of the tank battery consists mostly of annual weeds.

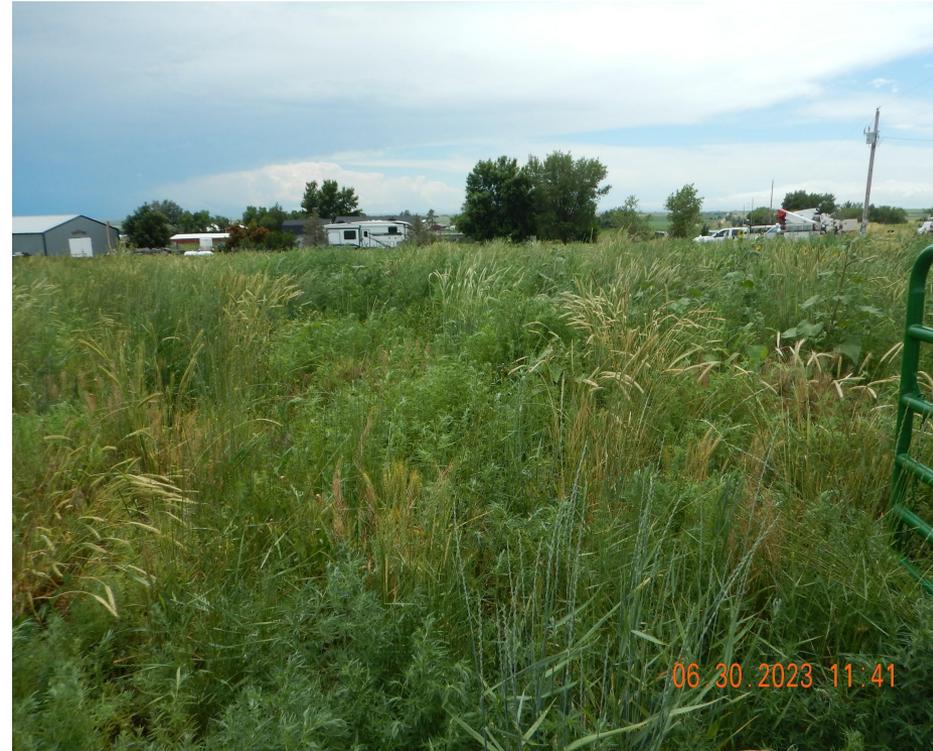
**Photo 4.** Photo taken from the southern portion of the associated tank battery location, facing South. Photo illustrates a mix of perennial grasses and some annual weeds. The perennial grasses are not reflective of the reference perennial grass, Crested wheatgrass.

Note- utility services traveled into the southern portion of the tank battery for maintenance work.
