Interim Reclamation and Stormwater Inspection

Operator: PDC ENERGY INC - 69175

Location ID: 423325

Inspection Document #: 697504751

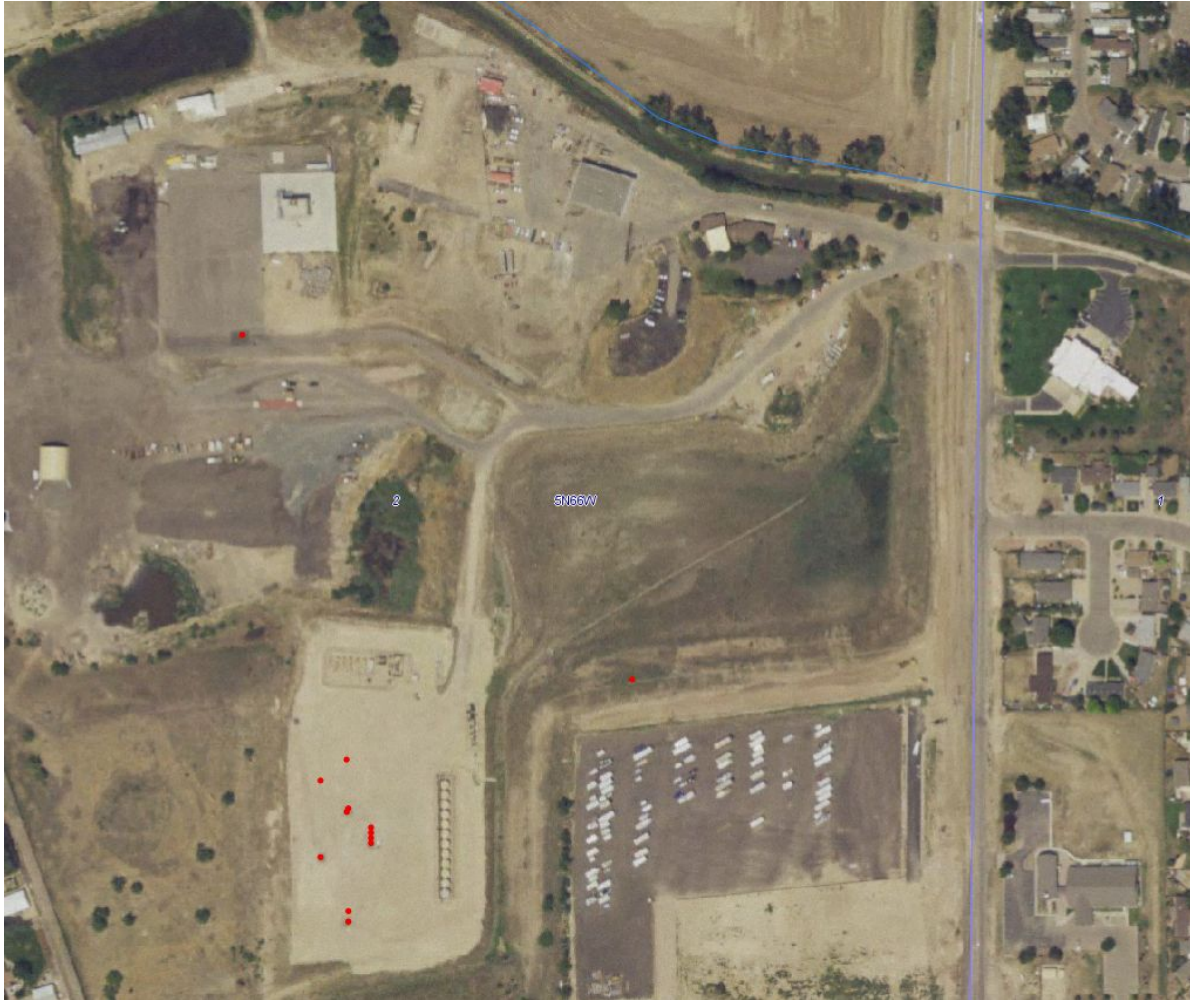
Photo 1. COGCC GISOnline aerial imagery from 2021 illustrates the location overview in relation to surface features, including Waters of the State to the north-northeast.

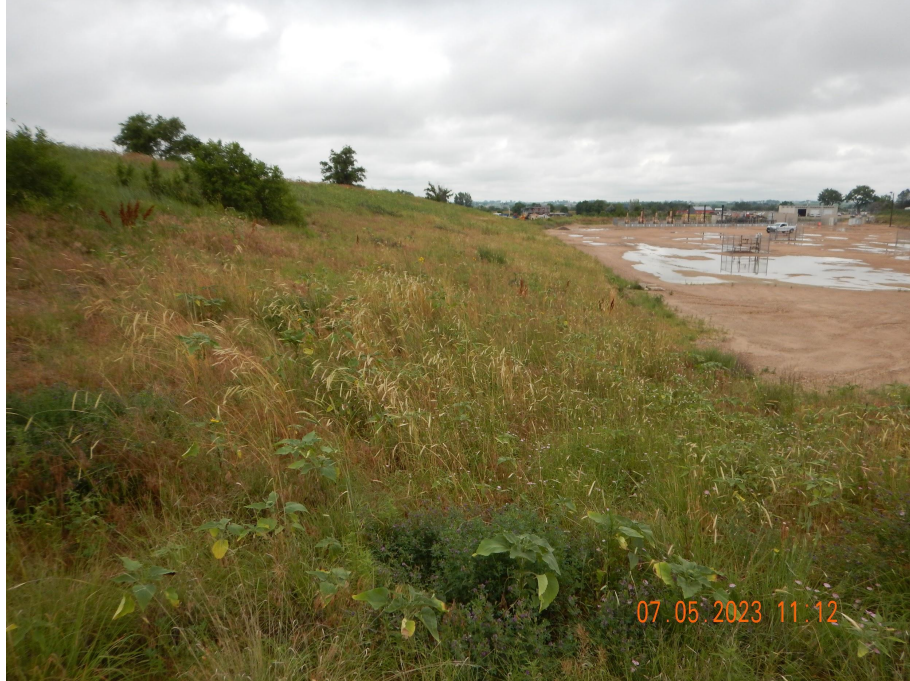
Photo 2. Photo taken from the southwestern location, facing North. Cut slopes have been seeded and are in-process of perennial vegetative establishment.

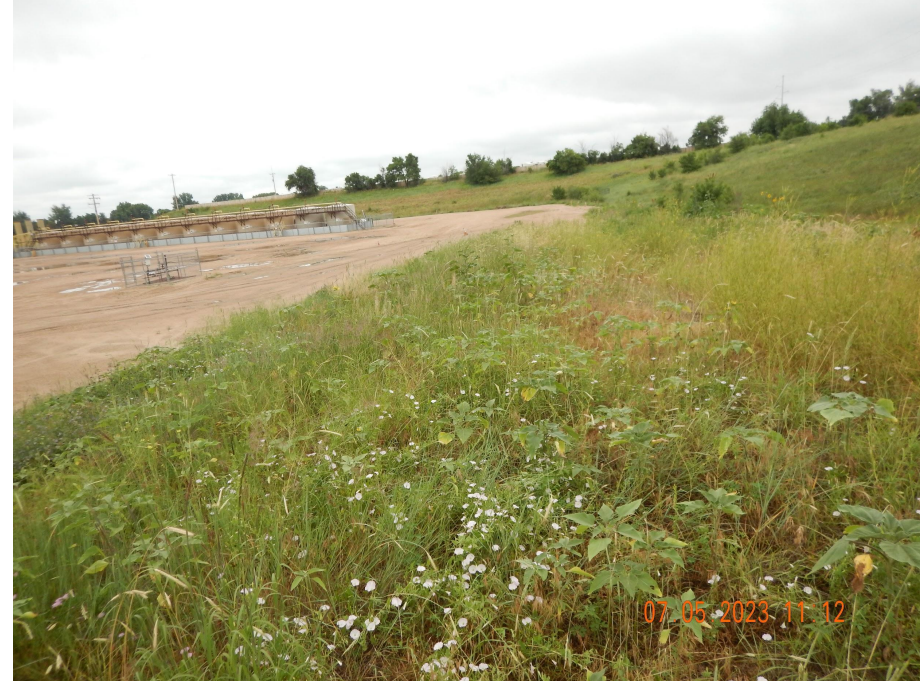
Photo 3. Photo taken from the southwestern location, facing East. See comments under Photo 2.

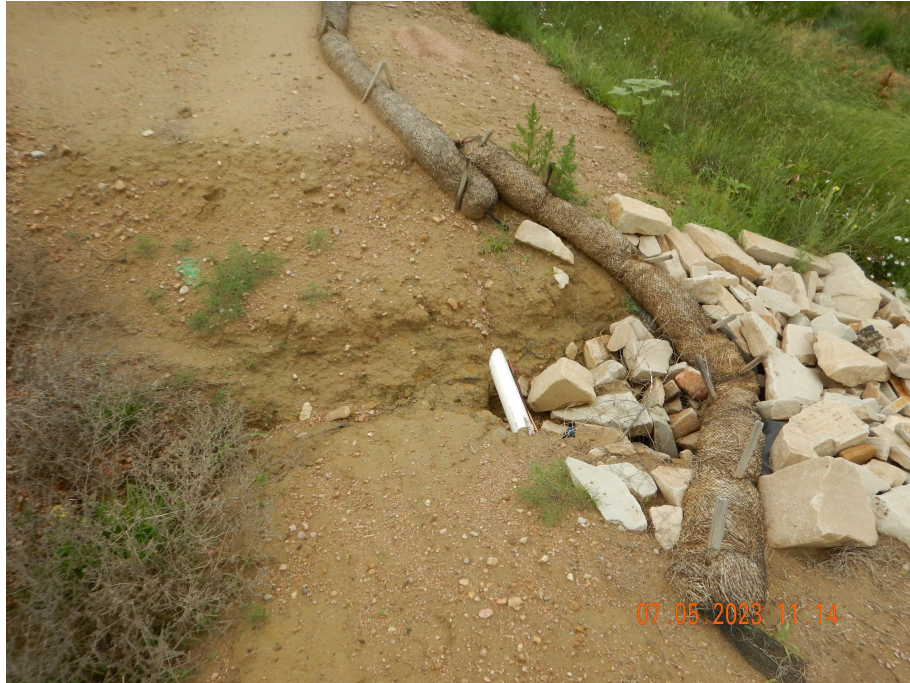
Photo 4. Photo taken from the eastern location. Photo illustrates stormwater BMPs have been installed but are in need of repair. Gully erosion is exposing an unknown line.

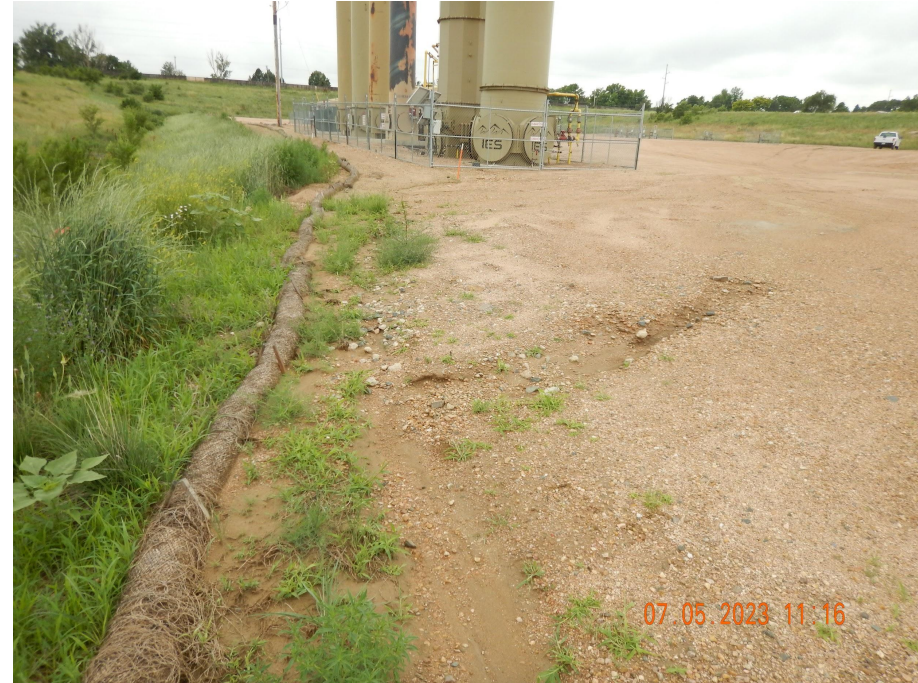
Photo 5. Photo taken from the northeastern location, facing South. Photo illustrates a stormwater BMP in need of repair, as sediment has discharged off location and beyond the BMP. Refer to Photo 6.

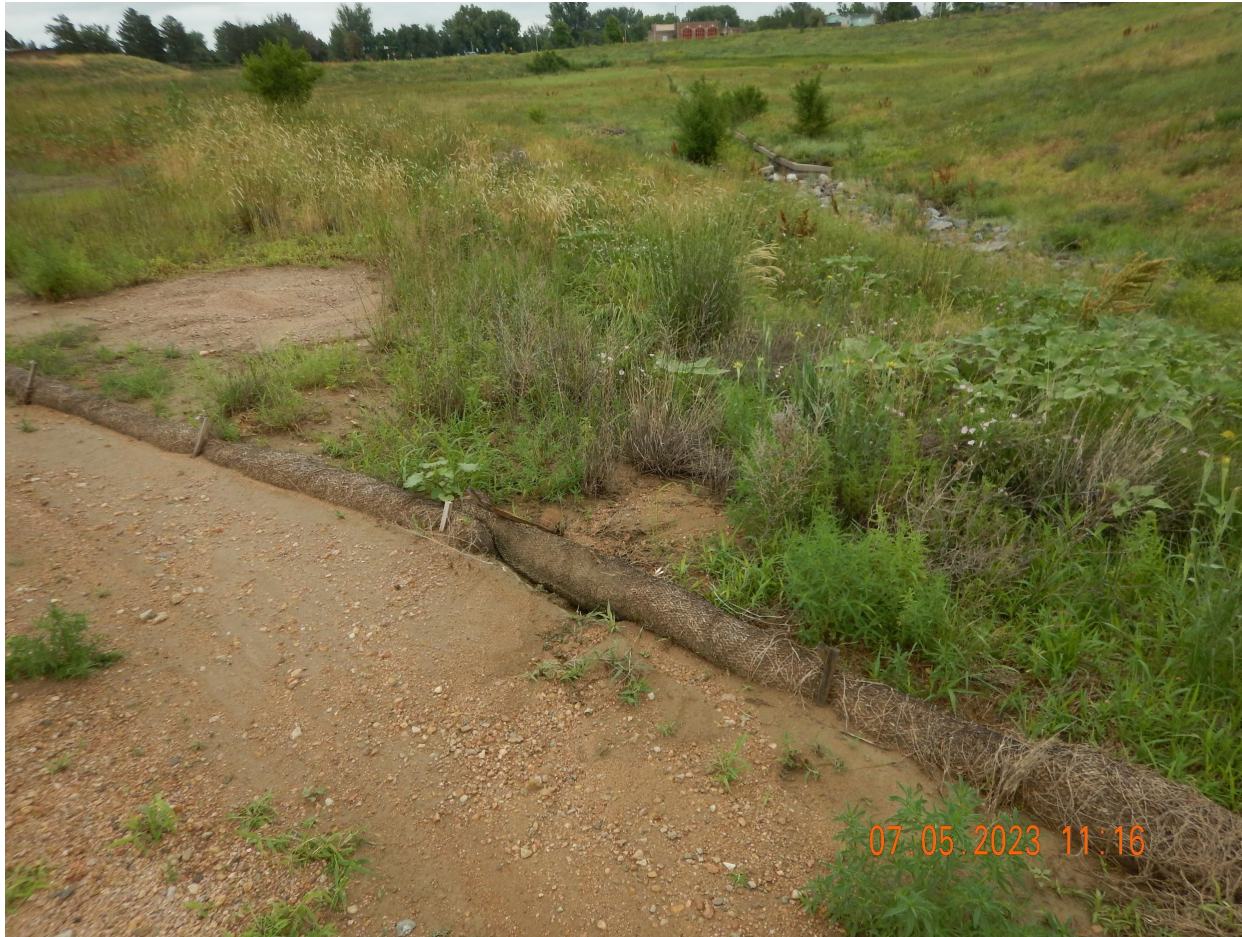
Photo 6. Photo taken from the northeastern location, facing Northeast. Photo illustrates sediment discharge from location.
