Inspection Photos

7/10/2023

Operator: GUNNISON ENERGY LLC - 10515

Location Number: 427218

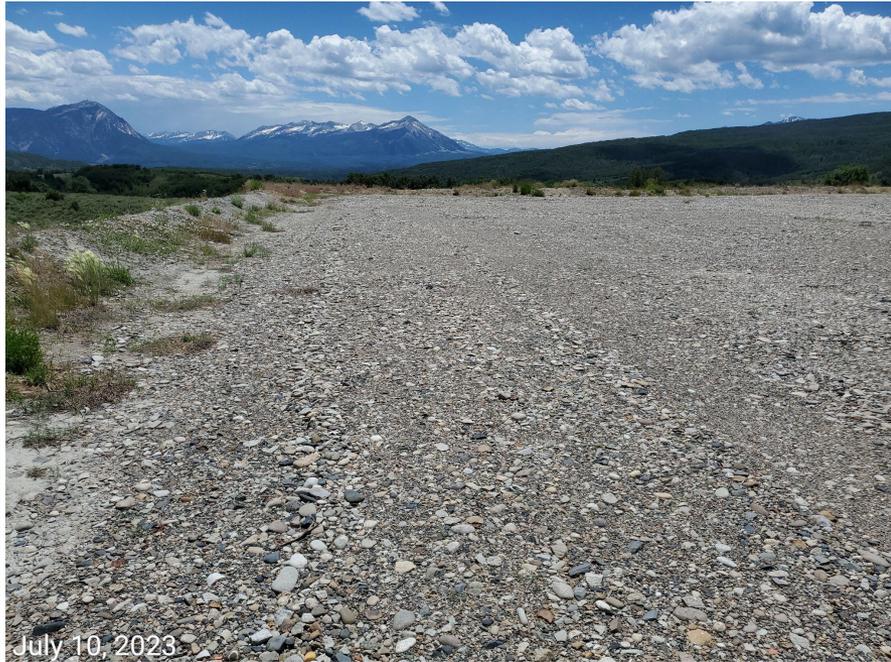
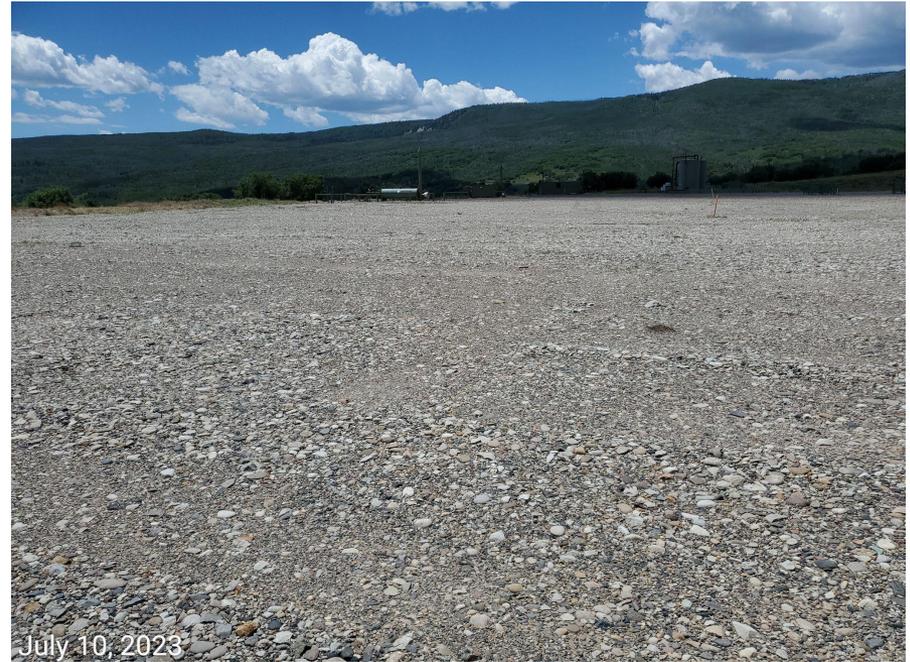
Photo 1: Photos 1-2 taken from the east end of the Location. Photos provide an overview of the Location from southeast, south, southwest to west. Photos show interim reclamation of areas not needed for production have not been conducted in accordance with Rule 1003.b.

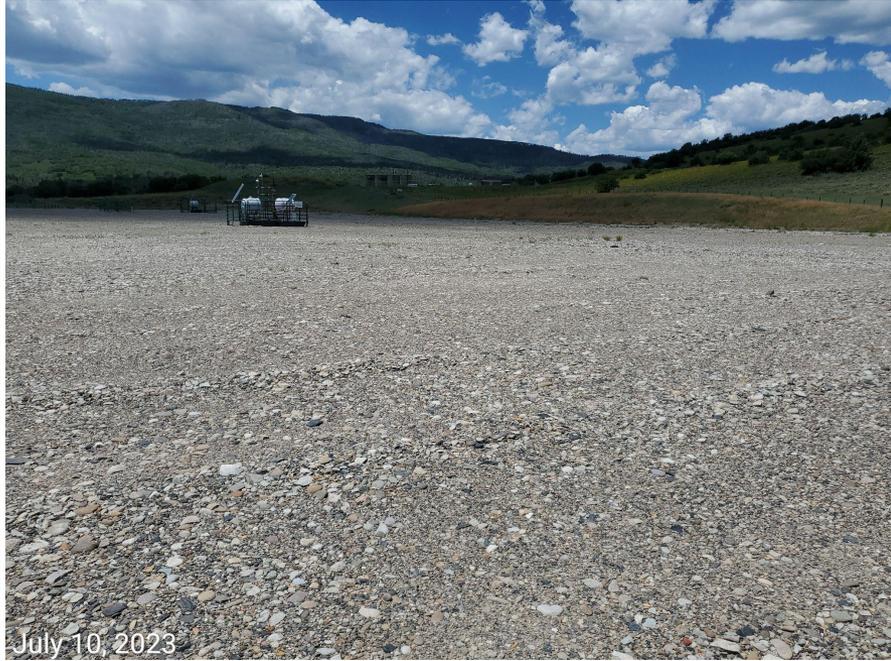
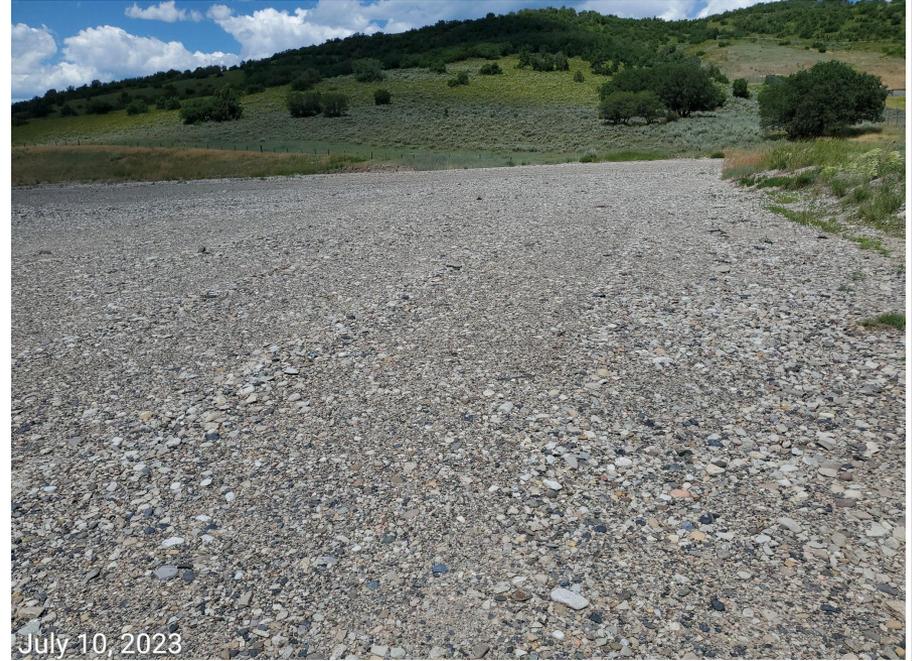
Photo 2: See comments under photo 1.

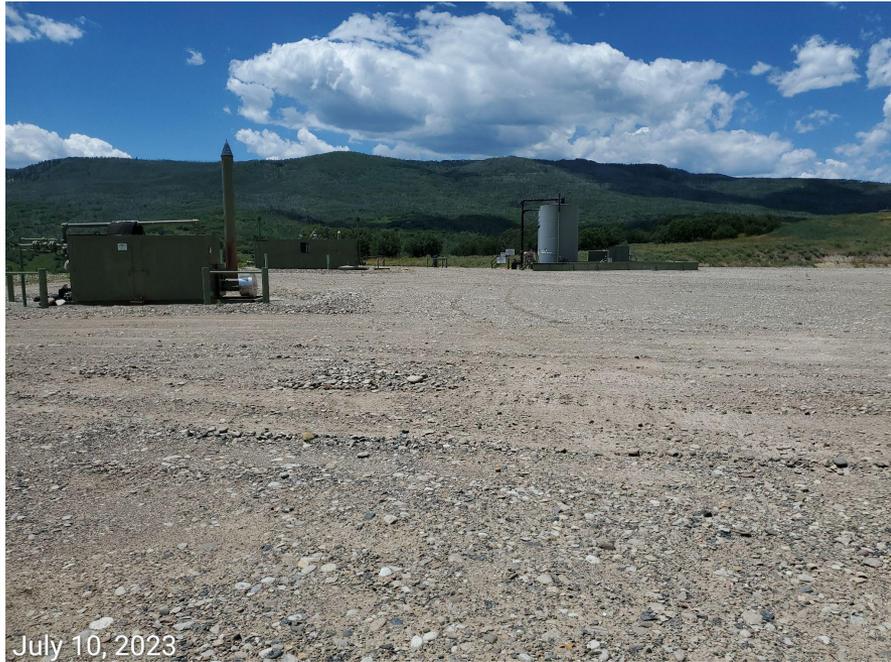
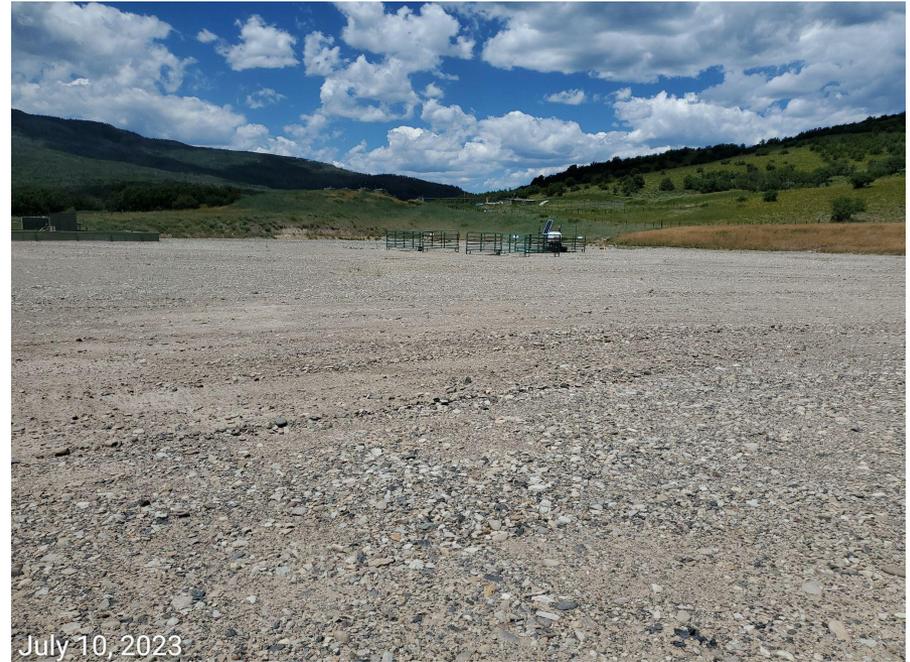
Photo 3: Photos 3-4 taken from the southeast end of the Location. Photos provide an overview of the Location from southwest, west north to northeast. Photos show interim reclamation of areas not needed for production have not been conducted in accordance with Rule 1003.b.

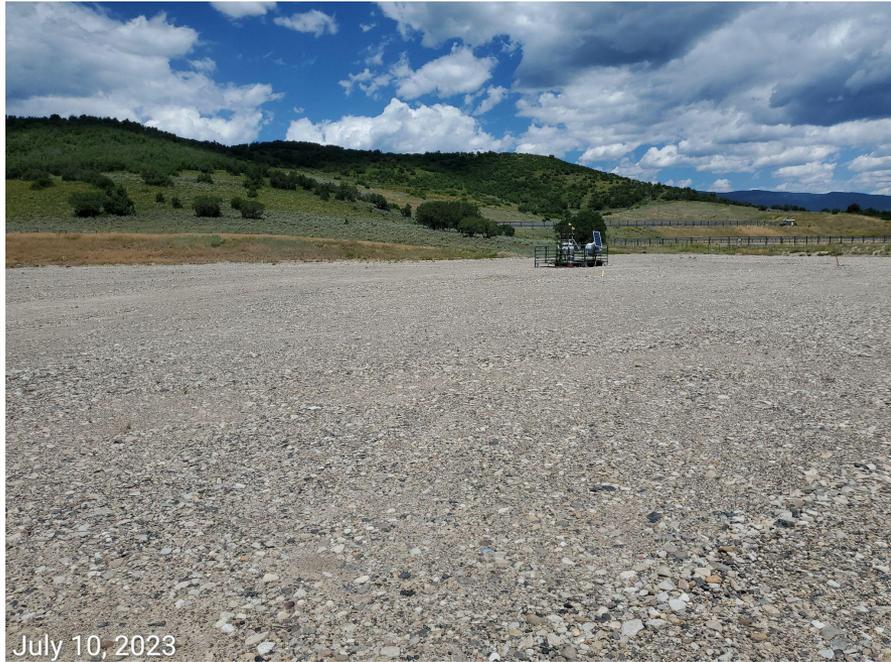
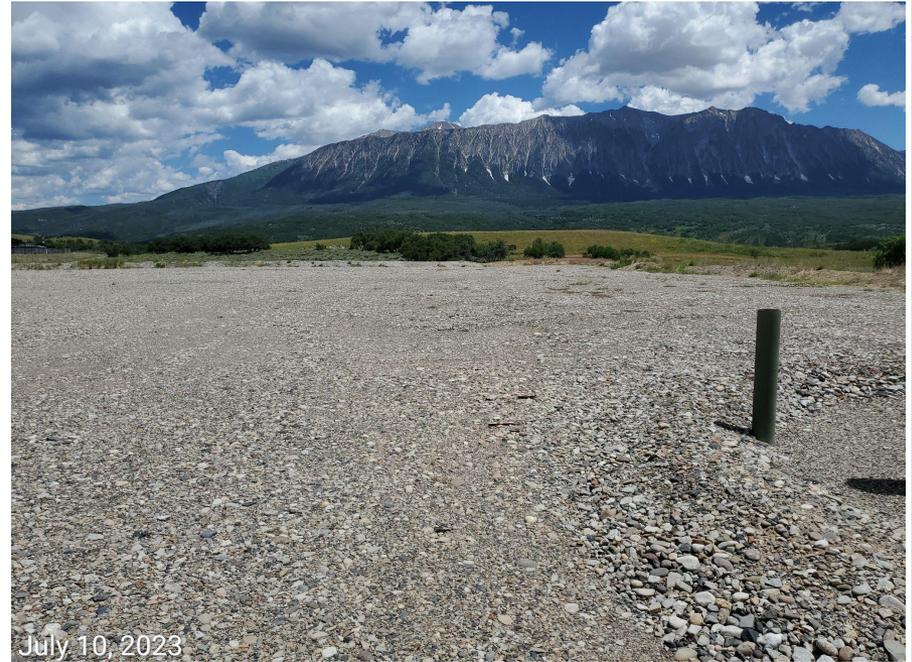
Photo 4: See comments under photo 3.

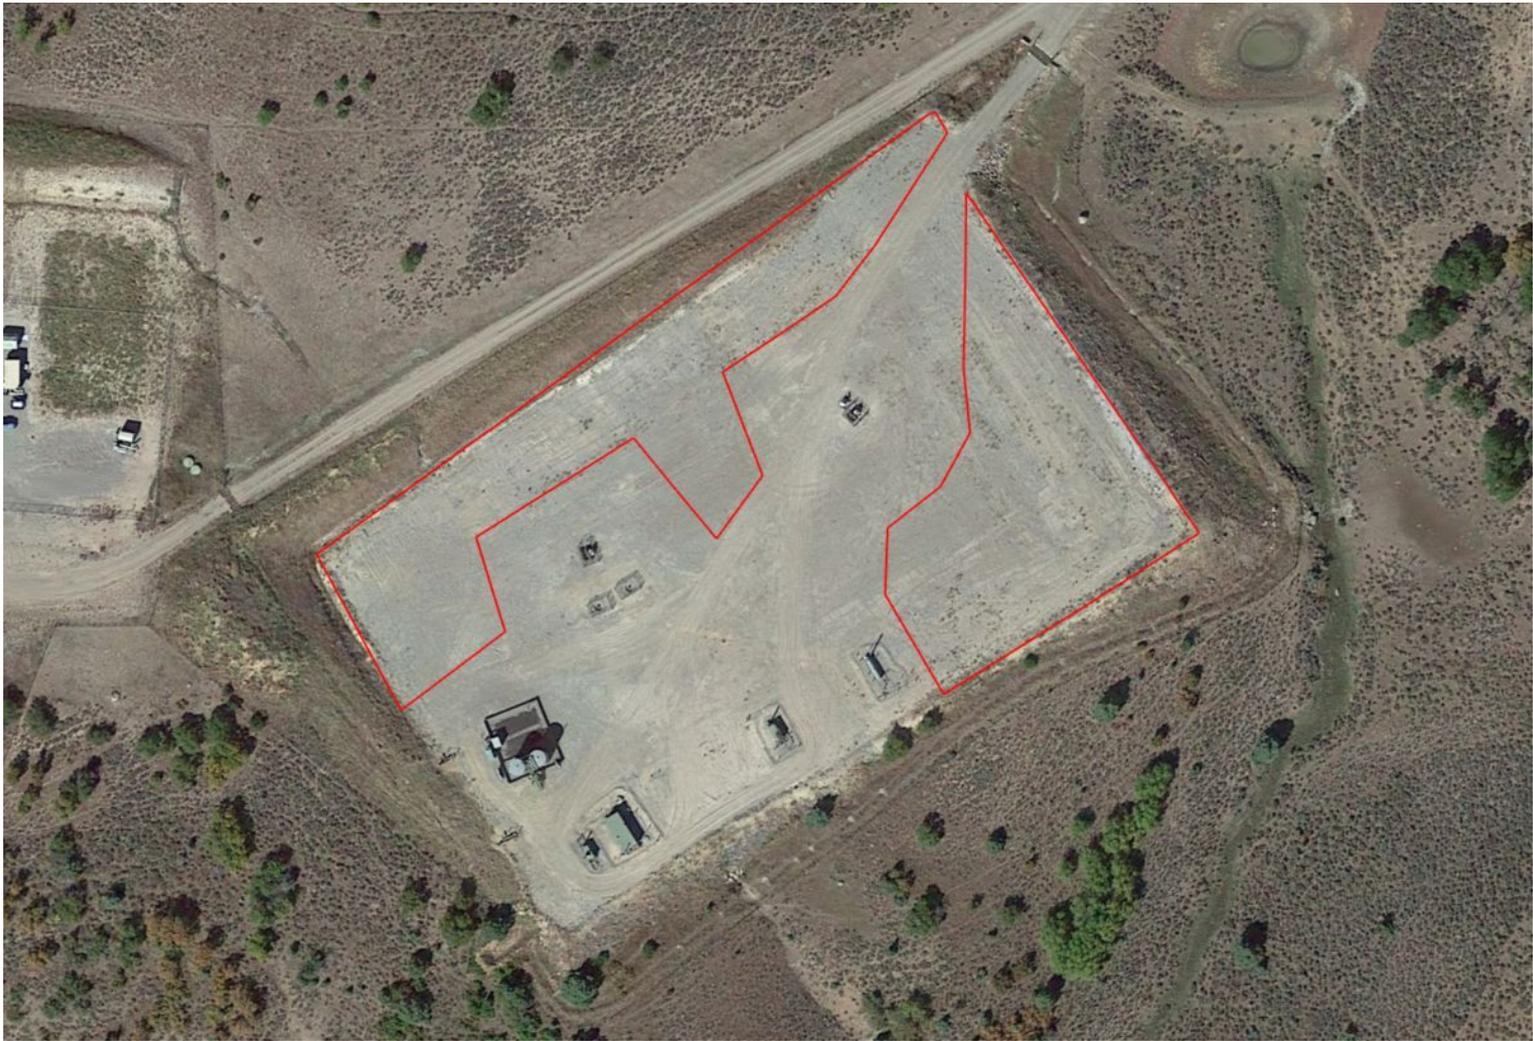
Photo 5: 2019 Google Earth aerial image of the Location. Polygon represents approximate working pad areas of the Location not reasonably needed for production requiring work including, but not limited to, compaction alleviation, recontouring/regrading and reclamation.

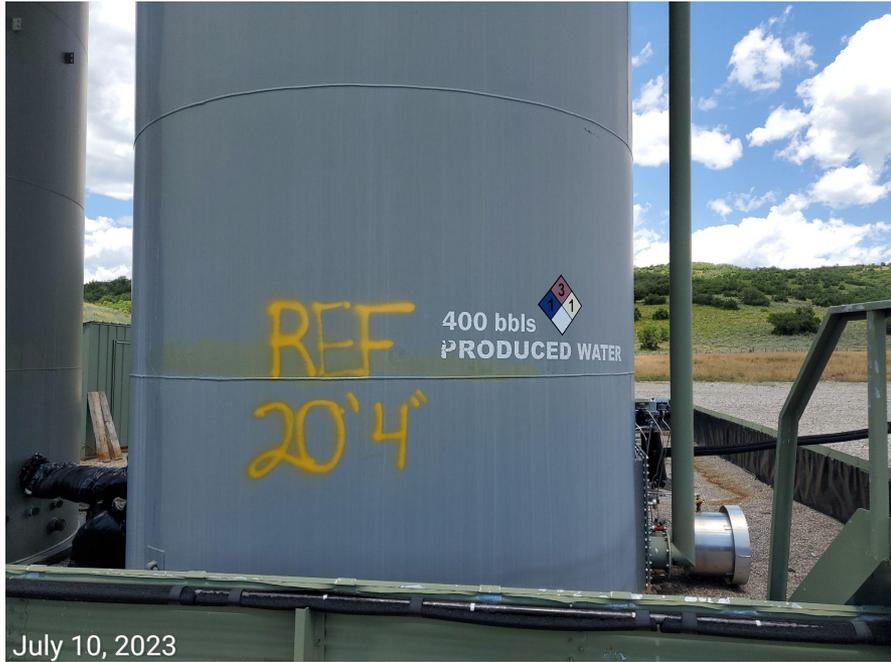
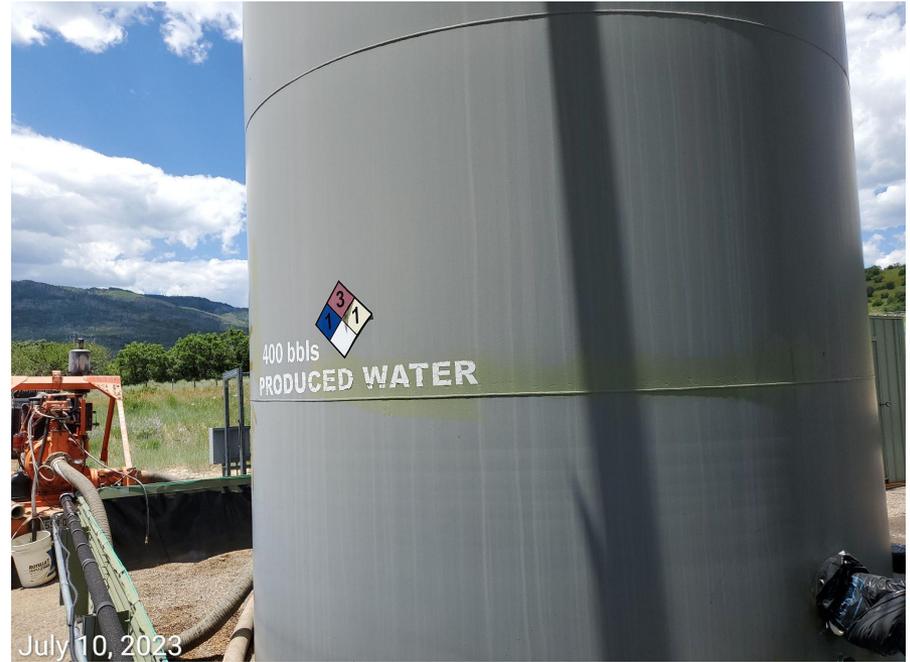
Photo 6: Photos show tanks at the battery facility missing required information, such as Operator name and emergency contact number.

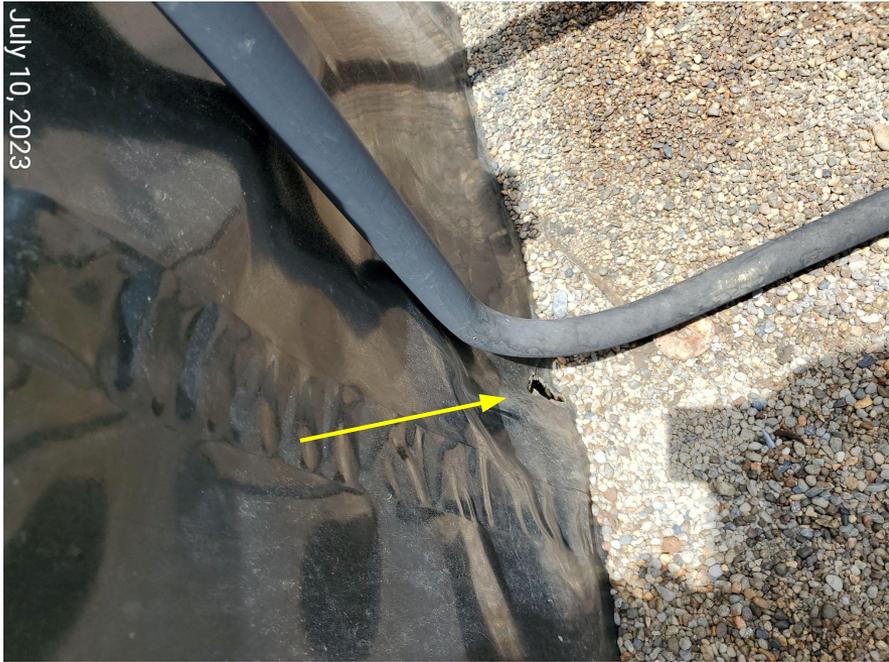
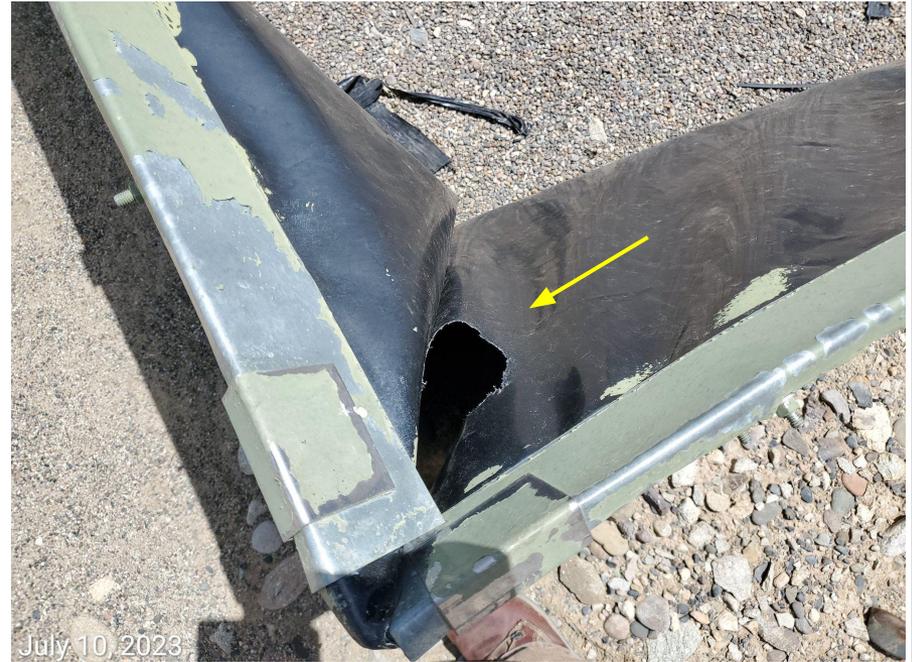
Photo 7: Photos examples showing holes/tears observed within the liner of the tank battery facility's secondary containment BMPs.

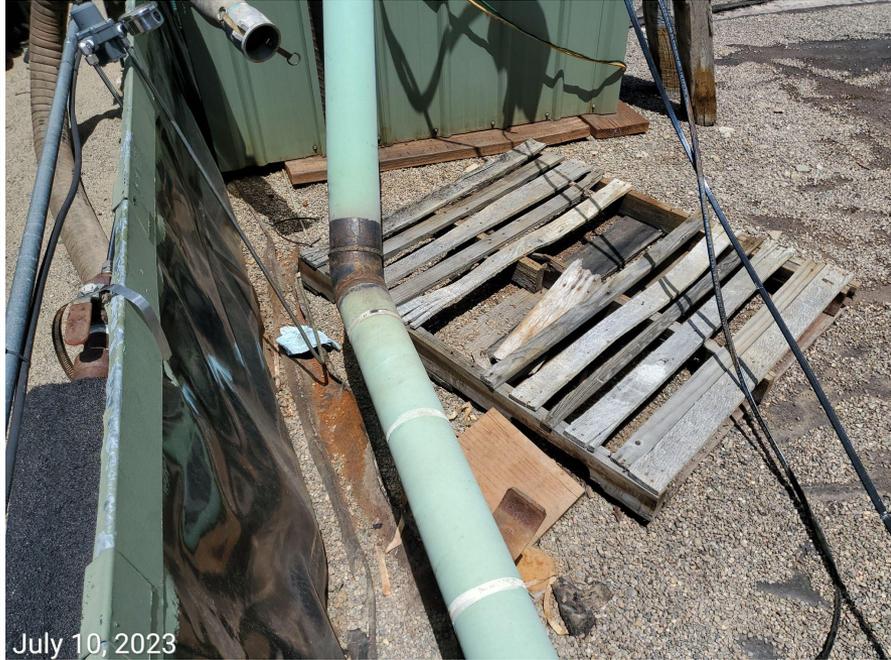
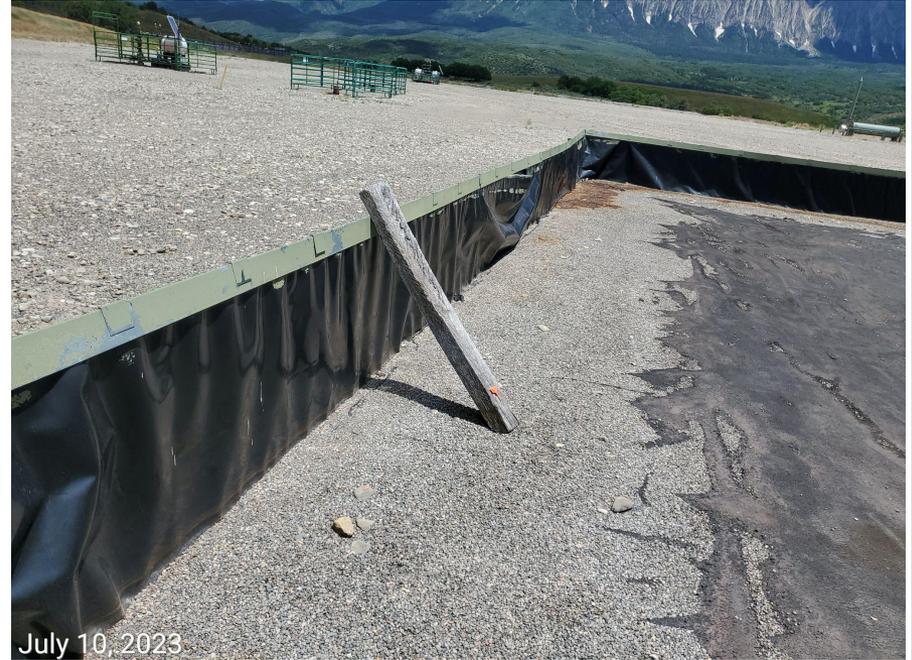
Photo 4: Photos show trash debris improperly stored within the secondary containment of the tank battery facility.

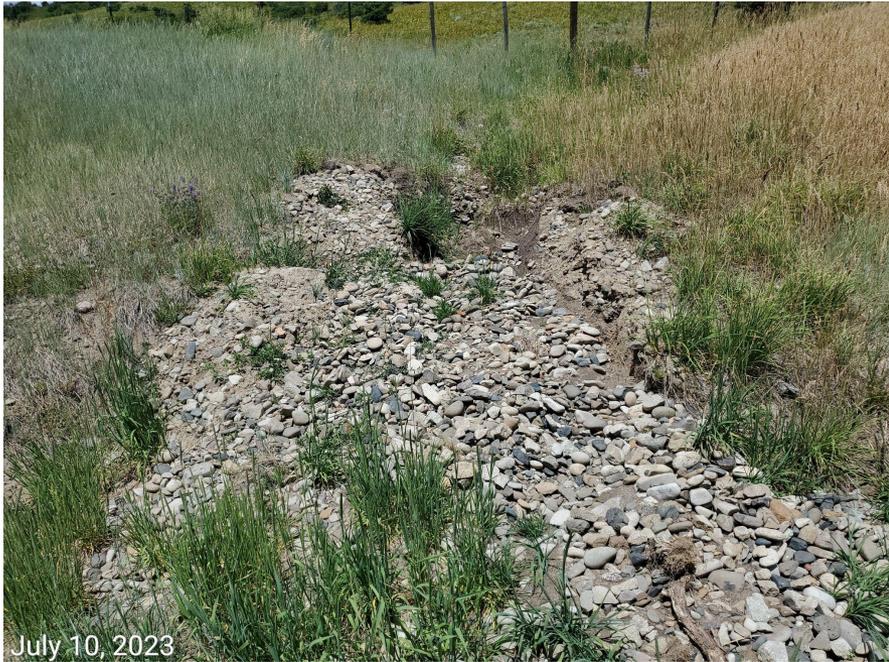
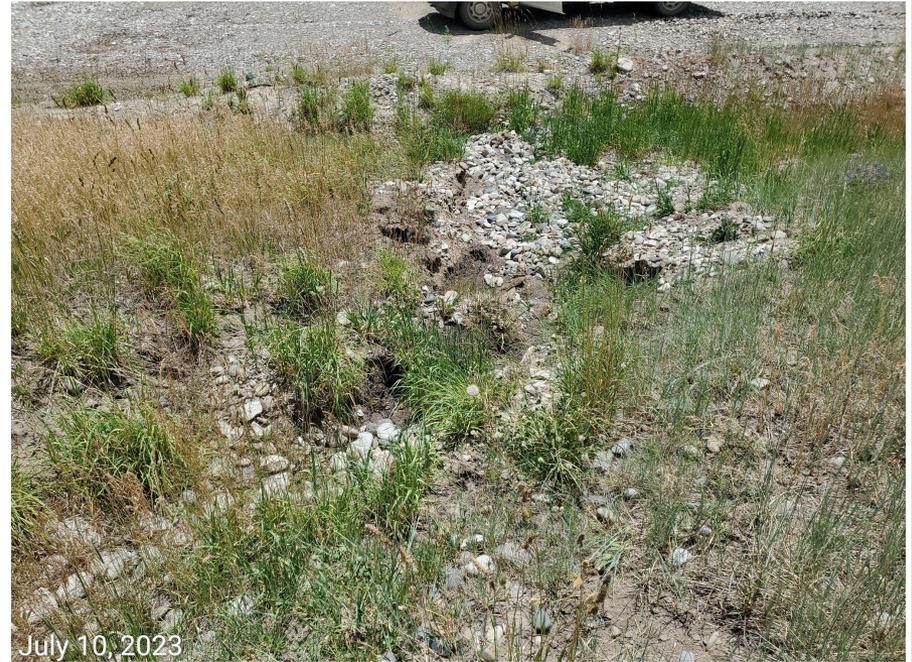
Photo 9: Photo taken from the culvert outlet on the north end of the Location. Photo shows BMPs remain missing or insufficient per good engineering practices at the outlet. Erosion degradation remains apparent. Operator appears to have only dumped river-rock mixed with sediment into the gully formation.
