Inspection Photos

7/10/2023

Operator: GUNNISON ENERGY LLC #10515

Location Number: 453805

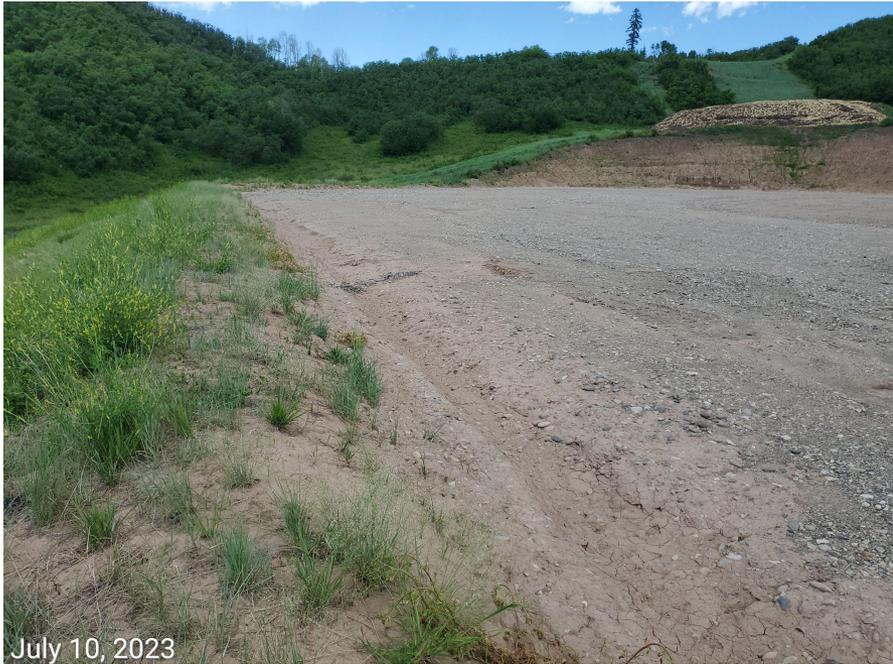
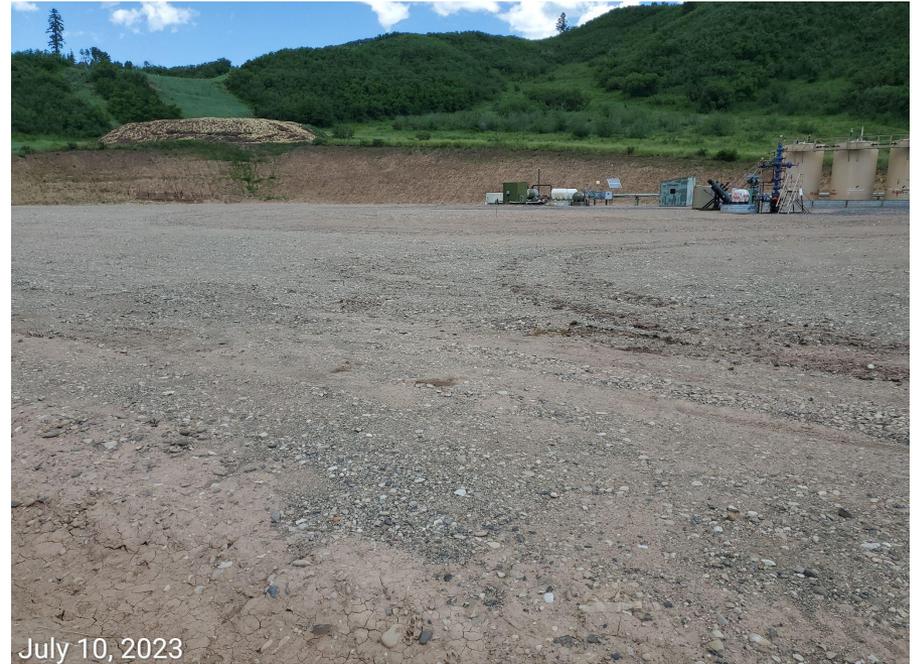
Photo 1: Photos 1-2 taken from the southwest end of the current production areas of the Location. Photos provide an overview of the Location from northwest, north, east to southeast.

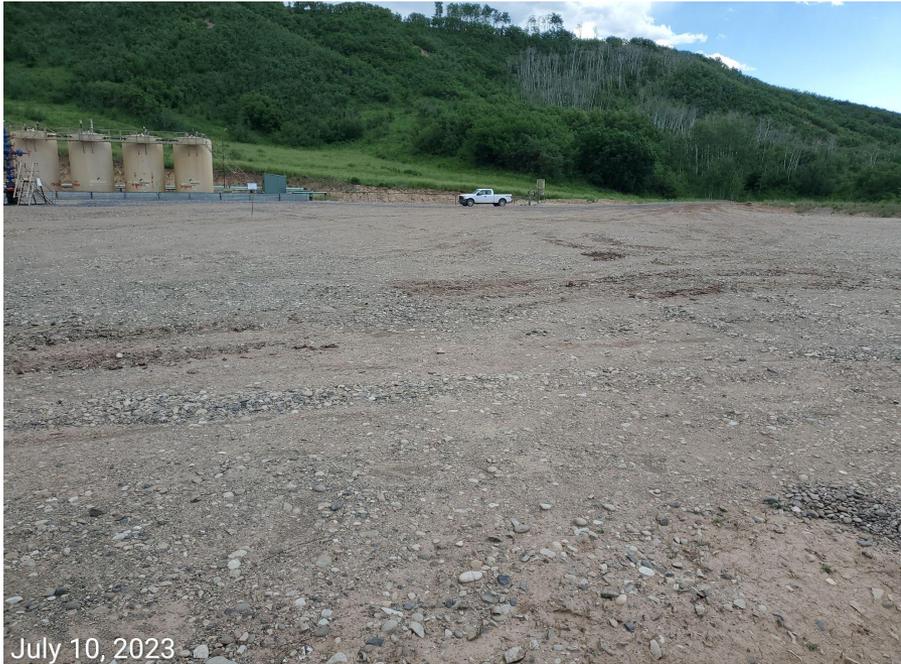
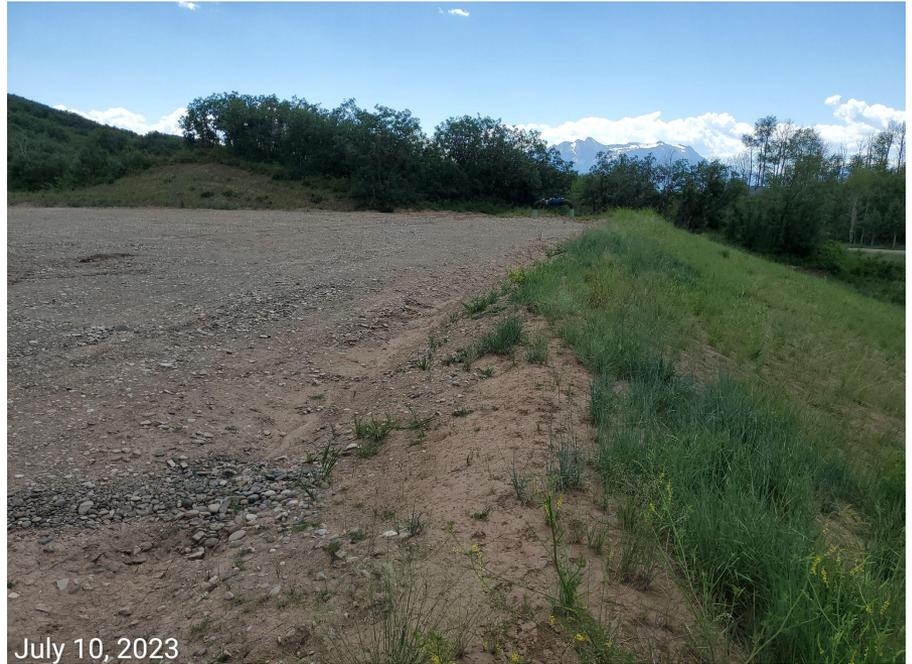
Photo 2: See comments under photo 1.

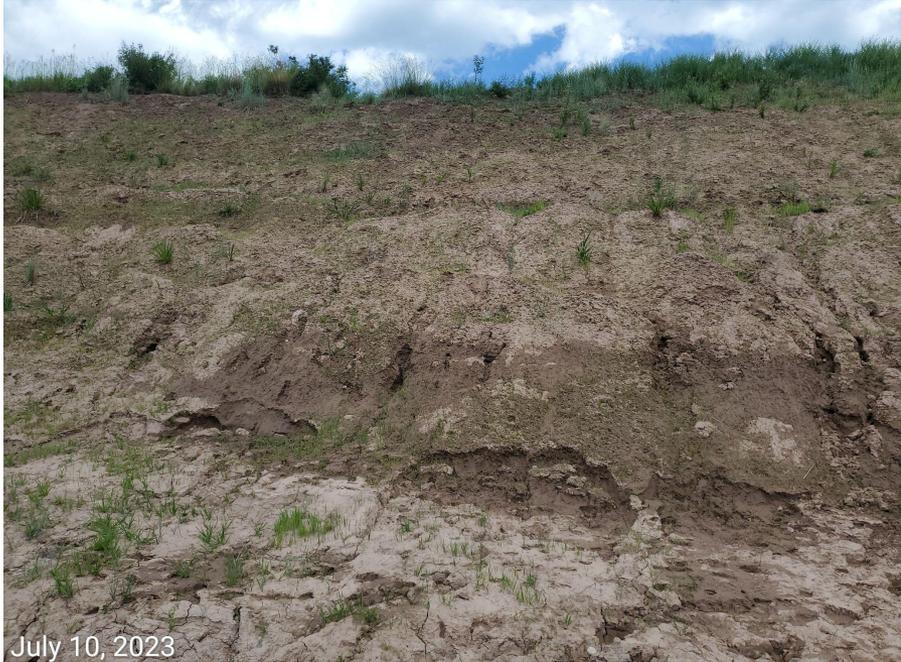
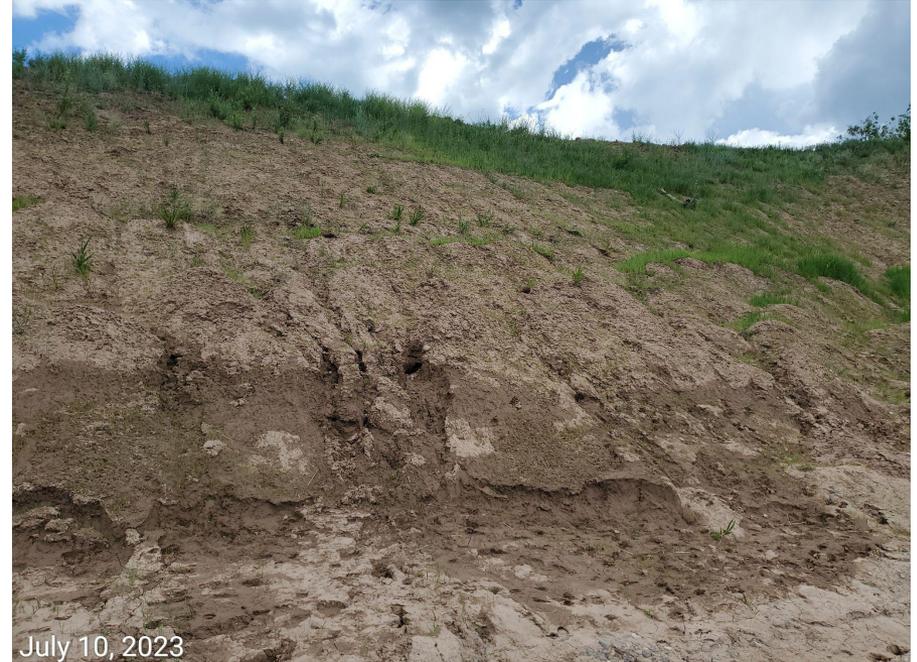
Photo 3: Photos taken from the cut slopes on the north end of the Location. BMPs to stabilize slopes, as well as to minimize erosion/degradation missing or insufficient. Erosion degradation is persisting.

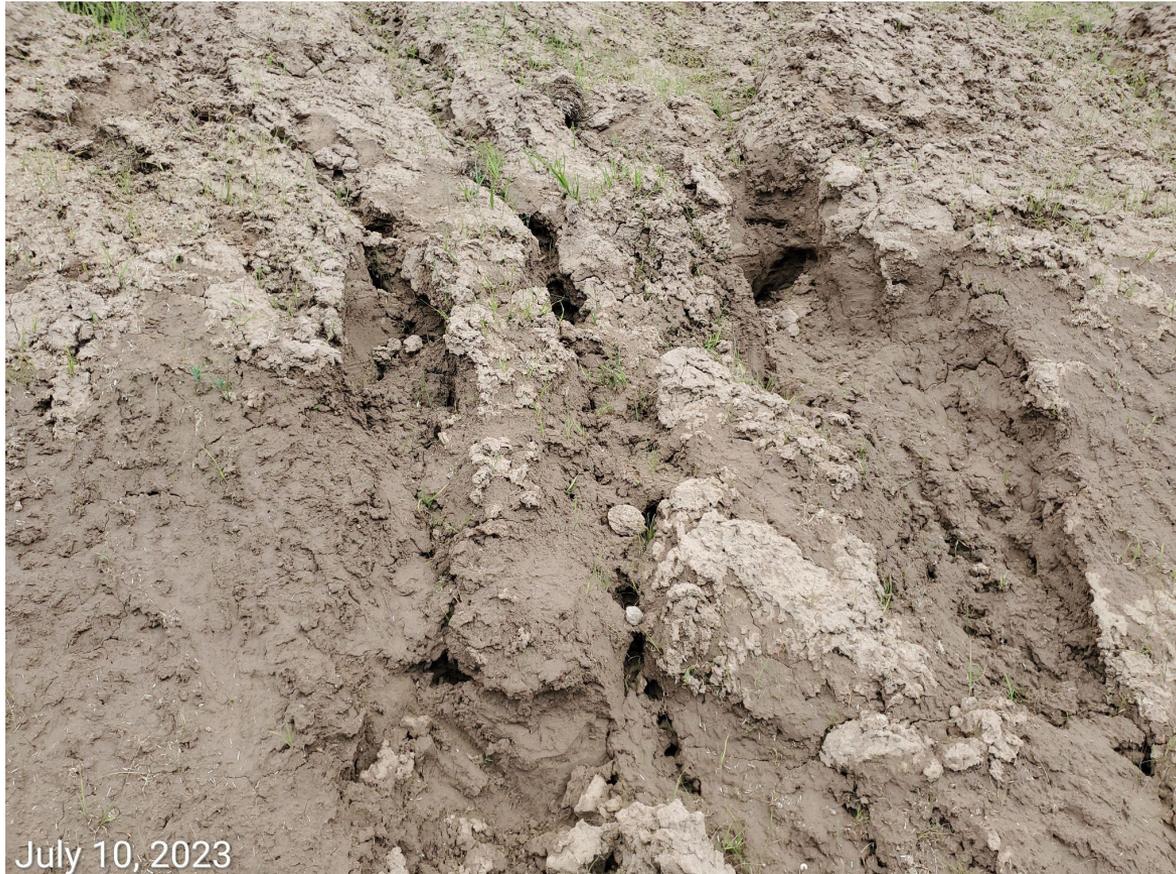
Photo 4: See comments under photo 3.

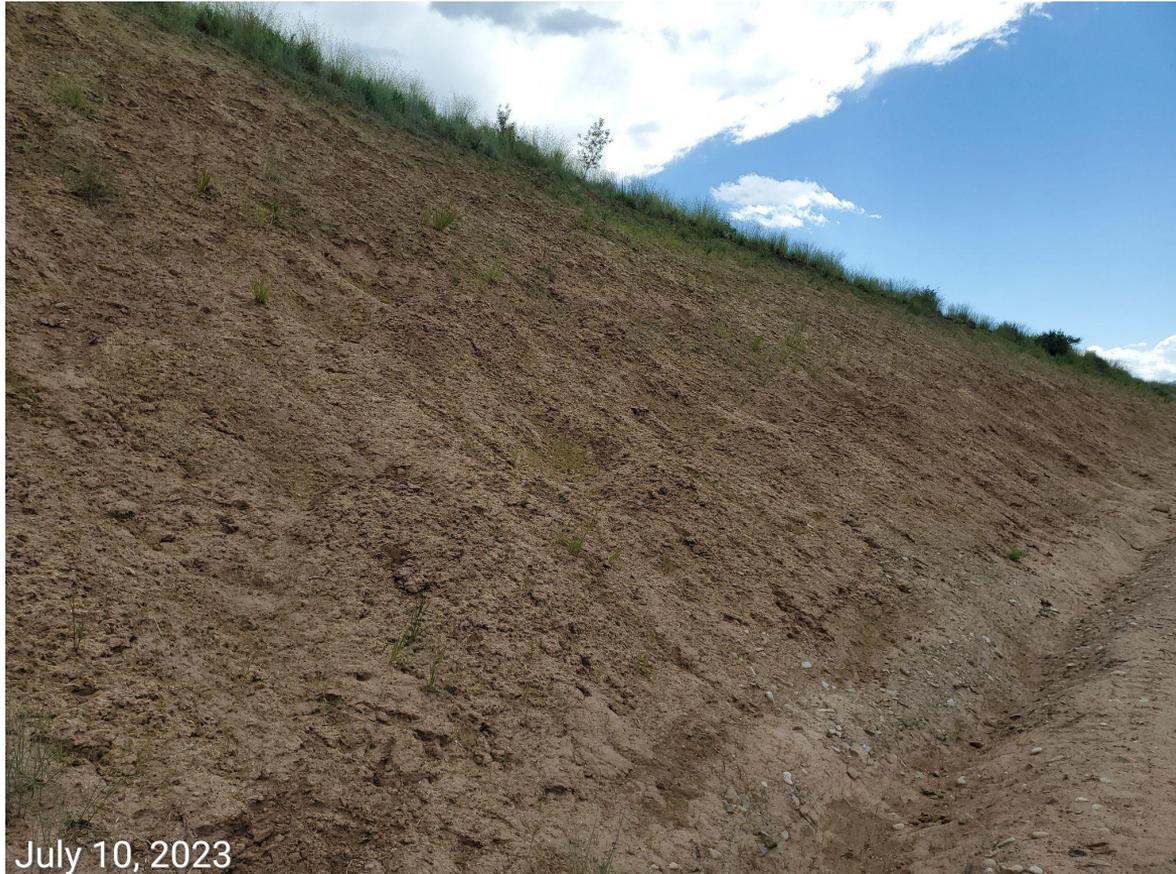
Photo 5: Hydromulch applied to cut slopes. At time of inspection, BMPs appear to be in proper functioning condition within these areas.

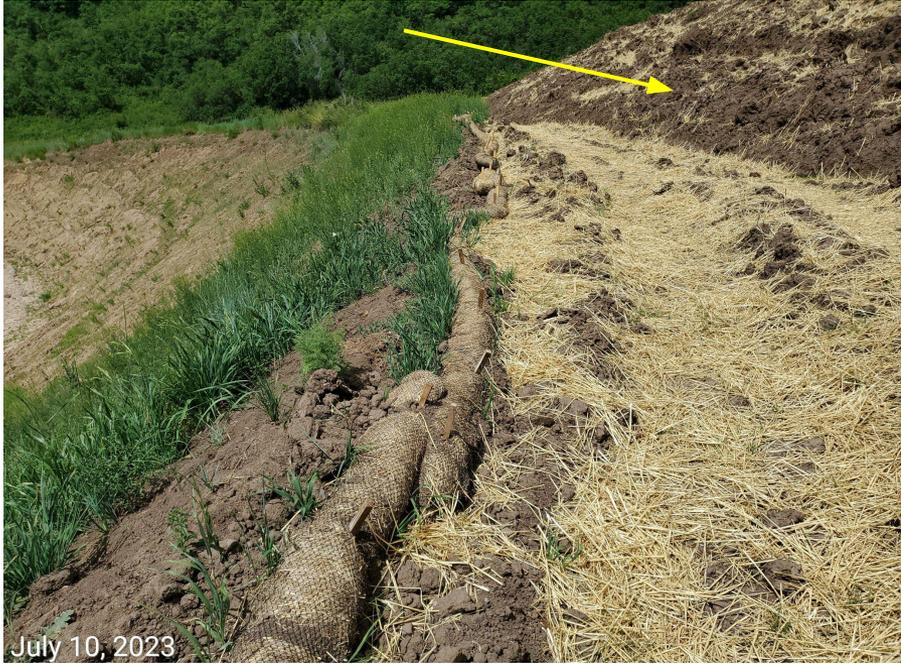
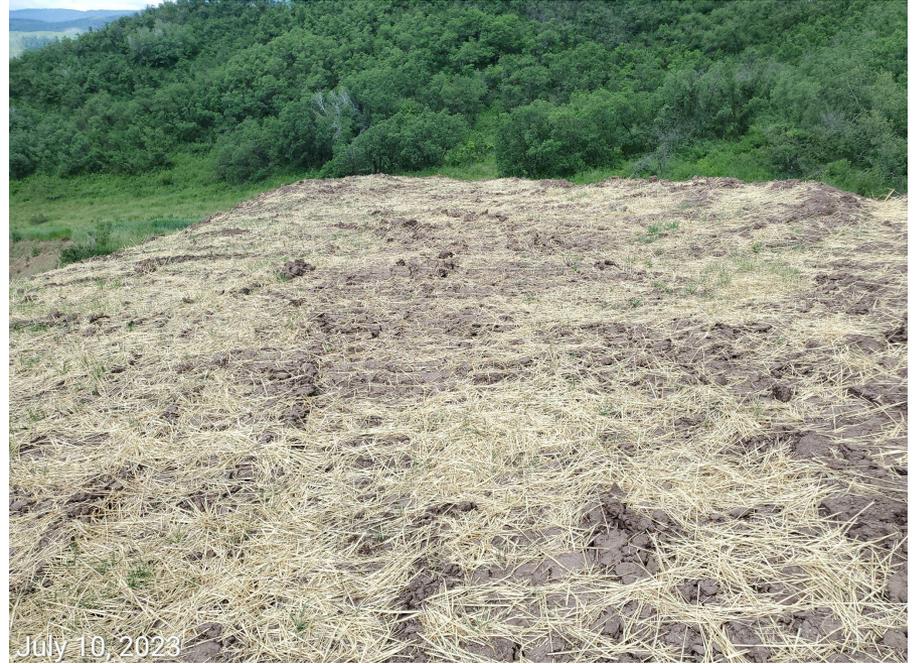
Photo 6: Photos taken from the topsoil stockpile. Photo left example showing straw mulch has sloughed/blown off areas of the slopes. Maintenance advised.

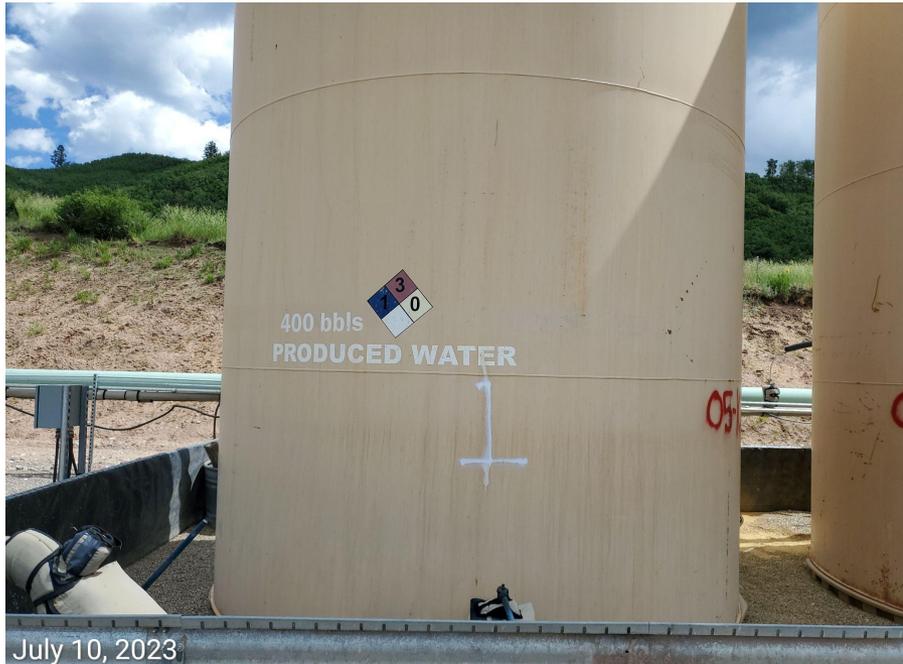
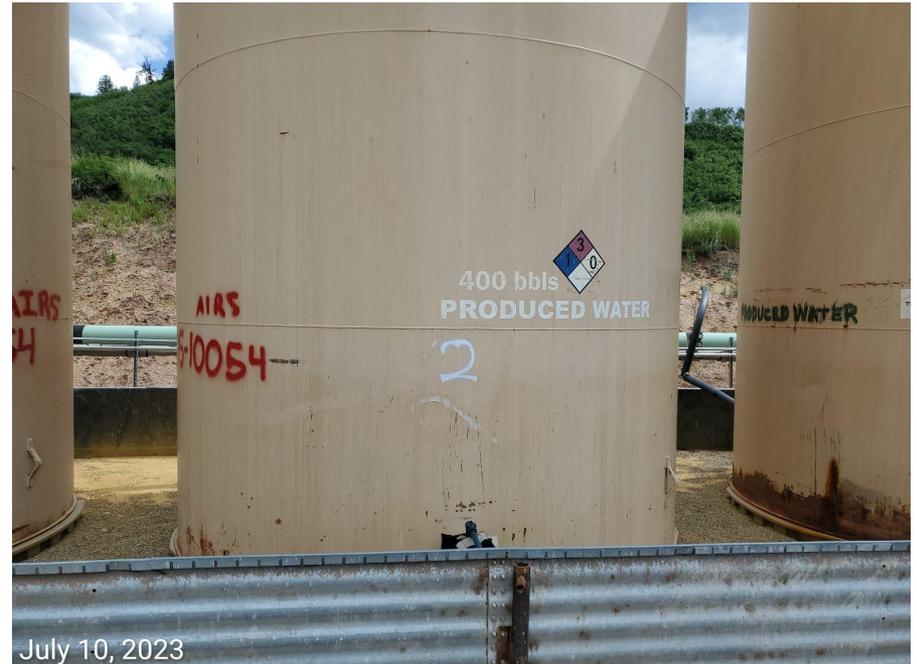
Photo 7: Photos examples showing required information, such as the Operator's name and emergency contact number are missing from the tanks at the battery facility.

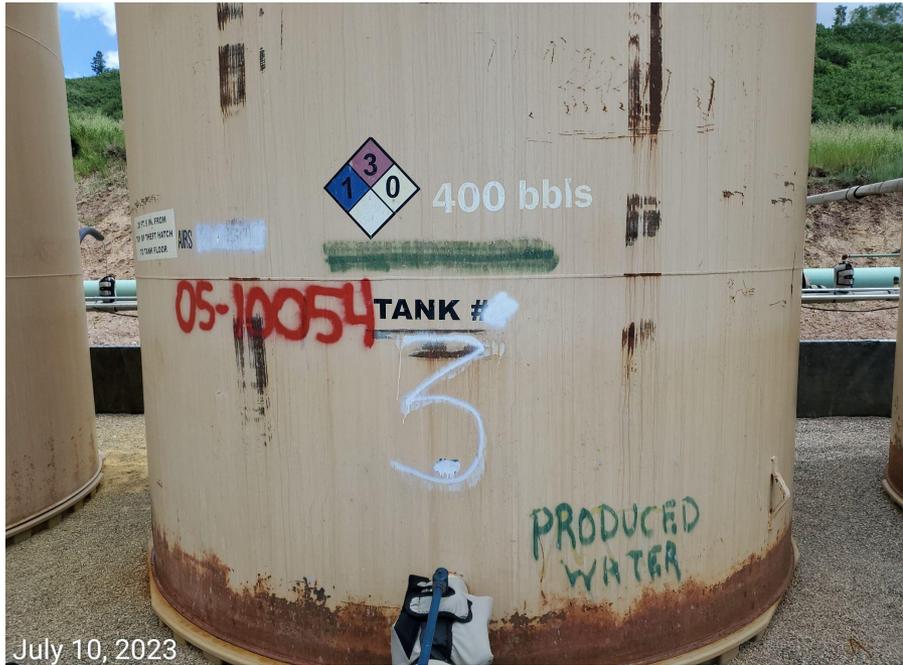
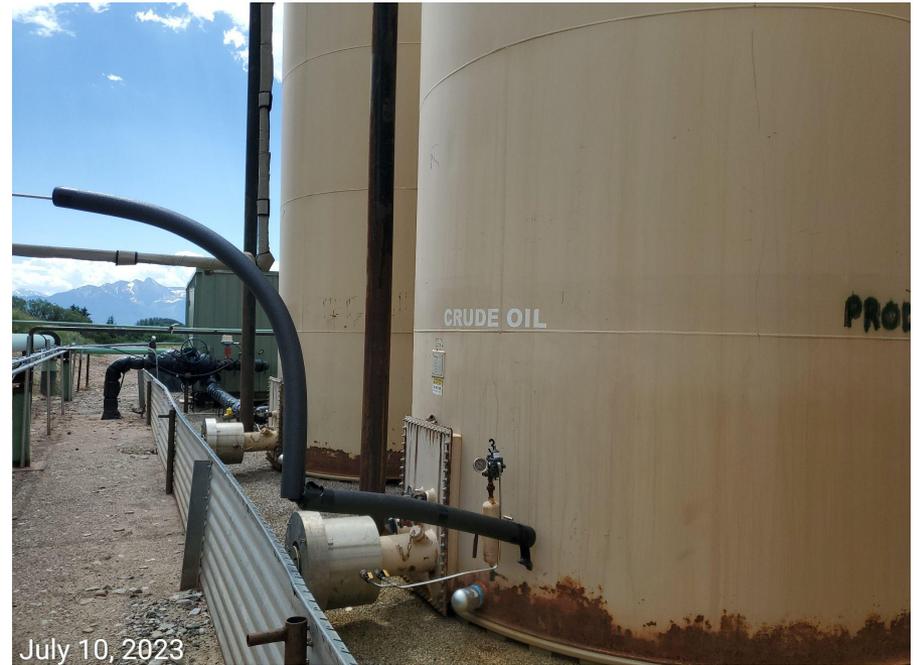
Photo 8: Tank “#3” labeled as both “produced water” and “crude oil”.

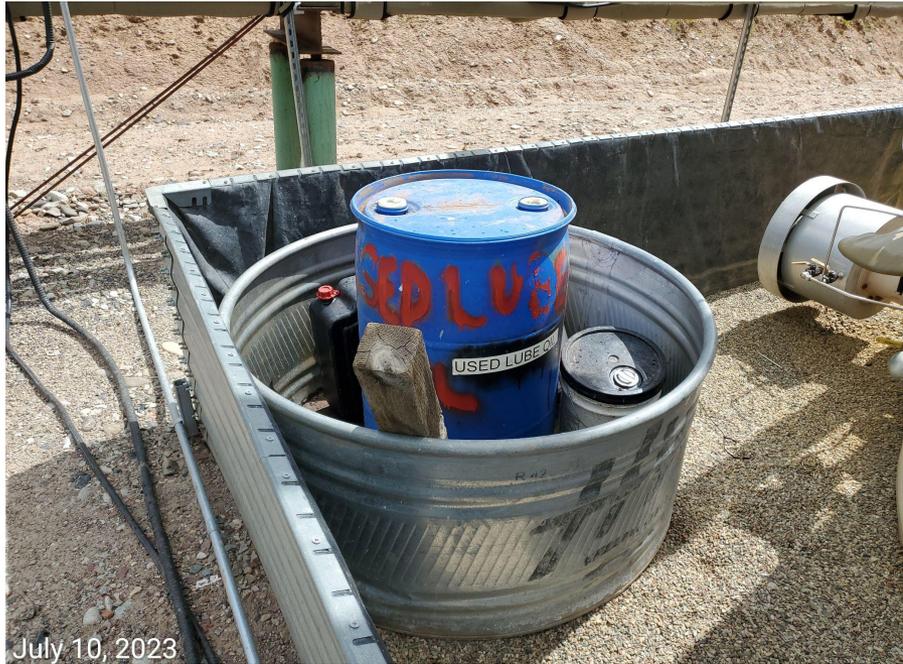
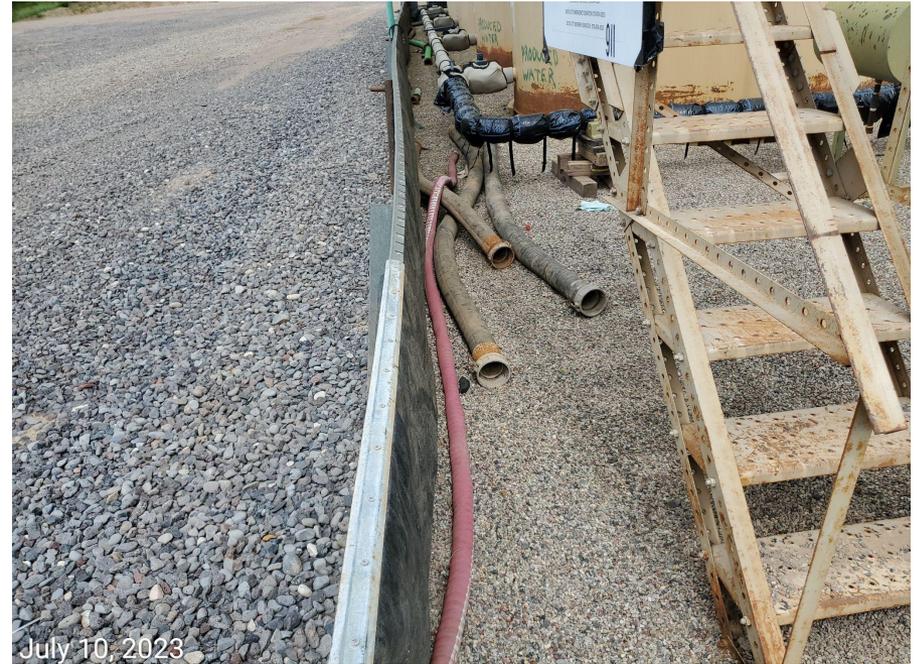
Photo 9: Photos 9-10 examples showing various unused equipment, materials, trash/rubbish, etc... improperly stored within the secondary containment BMP of the Tank Battery Facility.

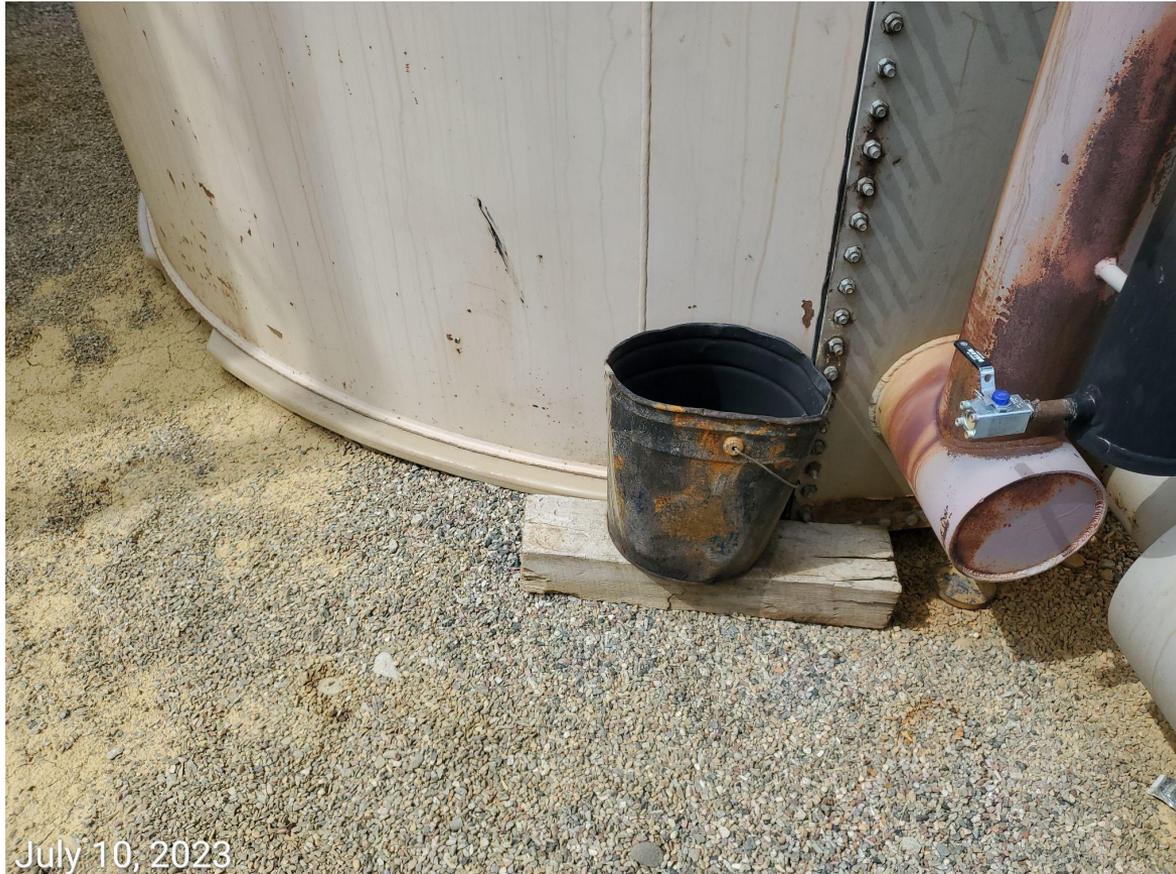
Photo 10: See comments under photo 9.

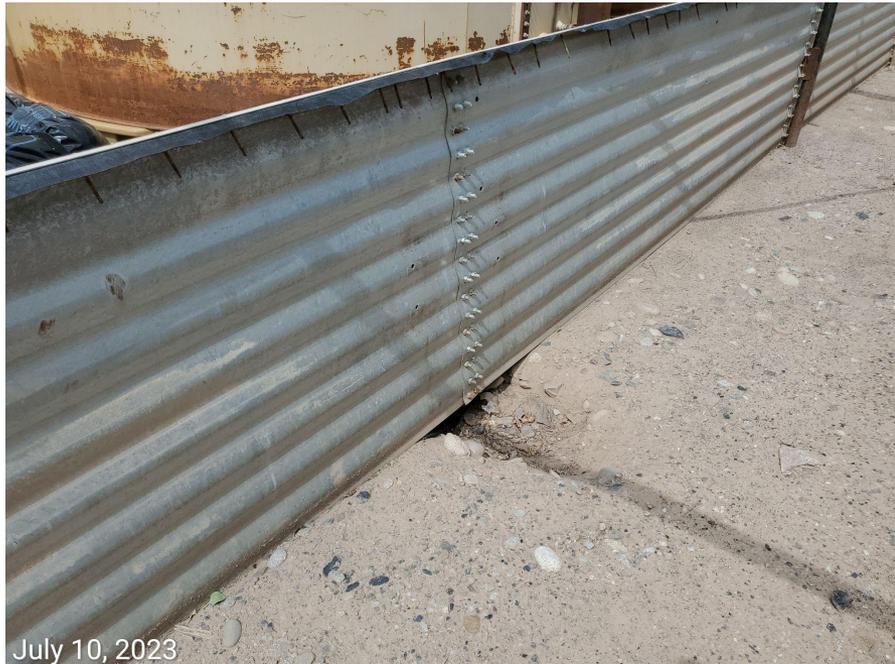
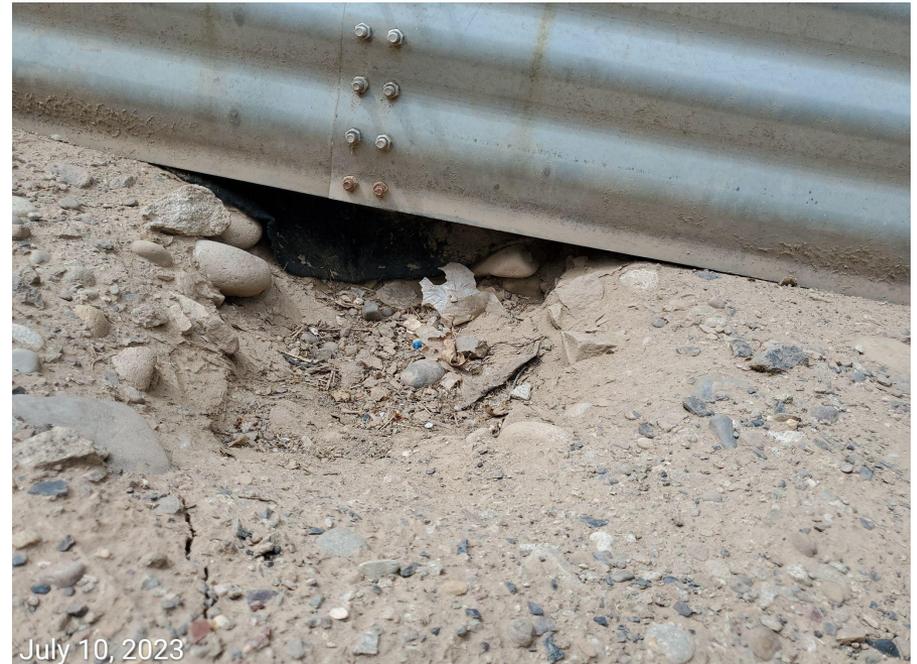
Photo 11: Photos show wildlife appear to have burrowed beneath the secondary containment BMP. Liner potentially compromised. Unclear if BMP is sufficiently impervious to contain a spill or release.

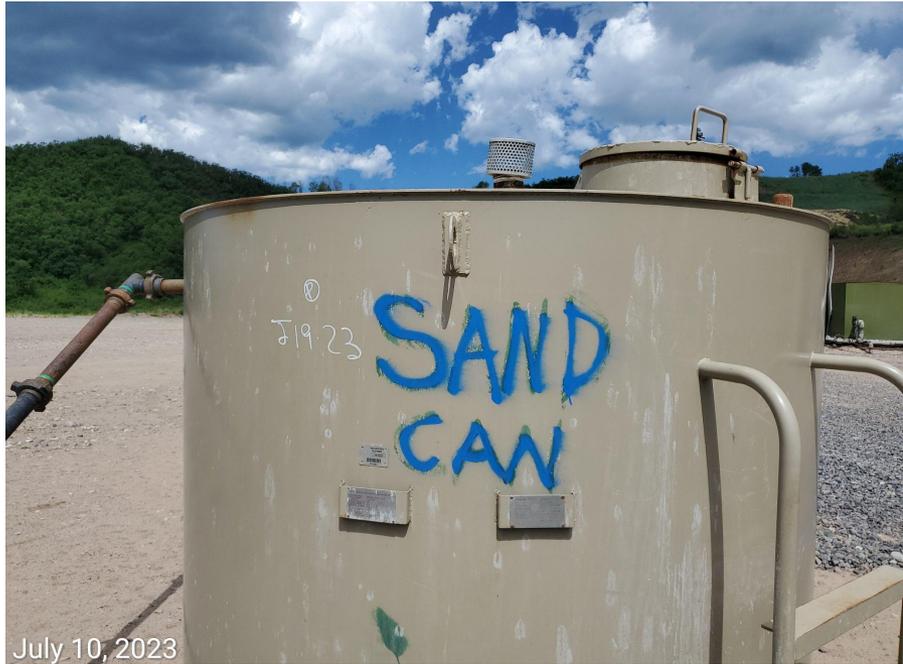
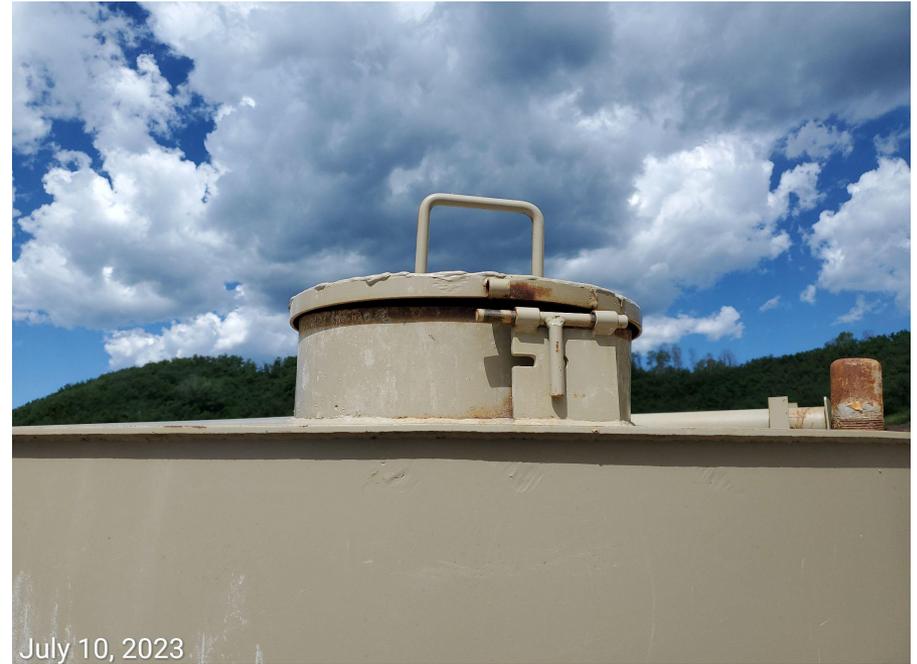
Photo 12: Hatch at the “sand can” not properly secured/closed.

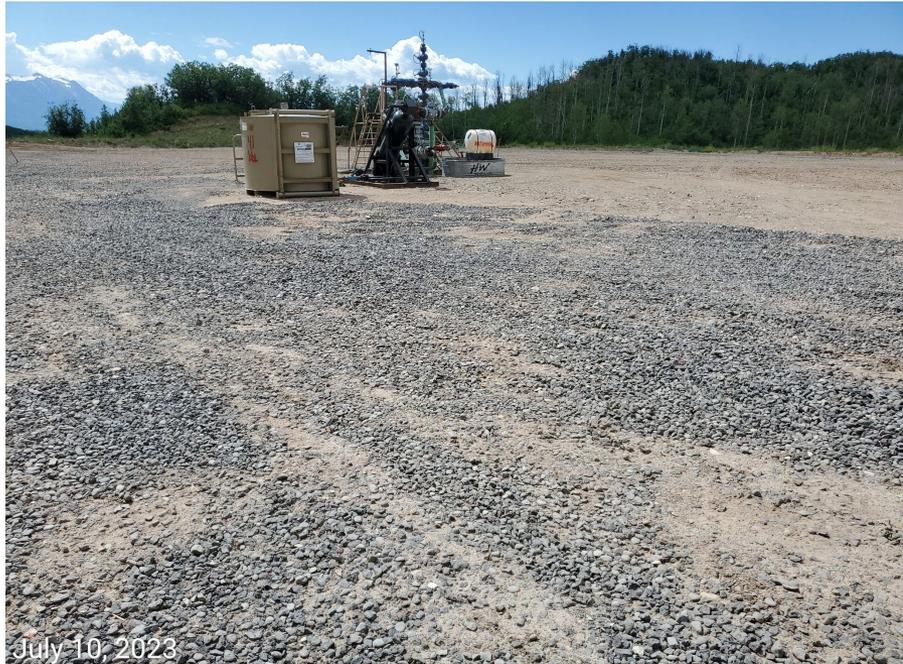
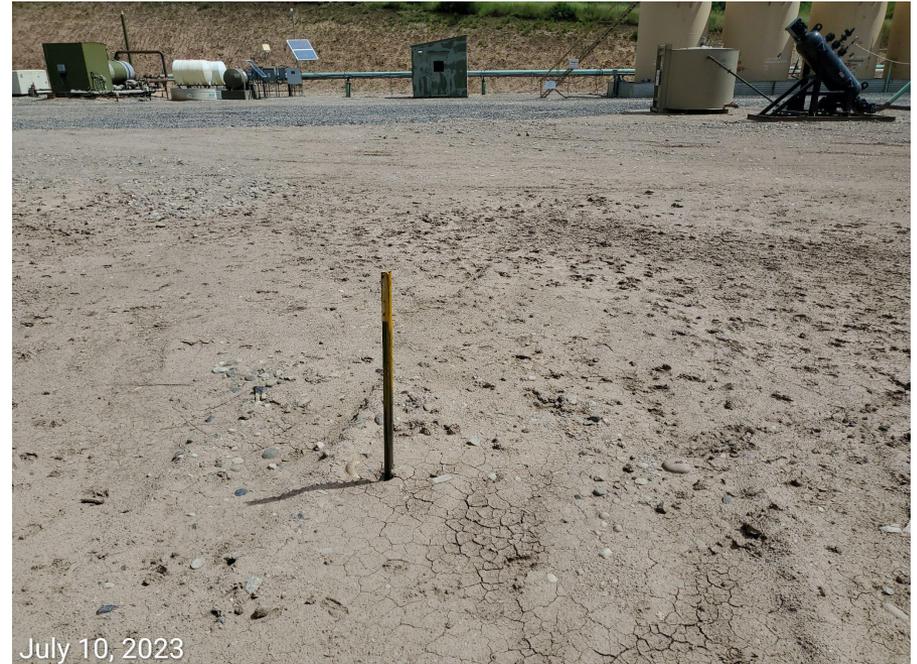
Photo 13: Photo left shows marker for the northern anchor is missing; Photo right taken from the western anchor, facing north towards the northern anchor.

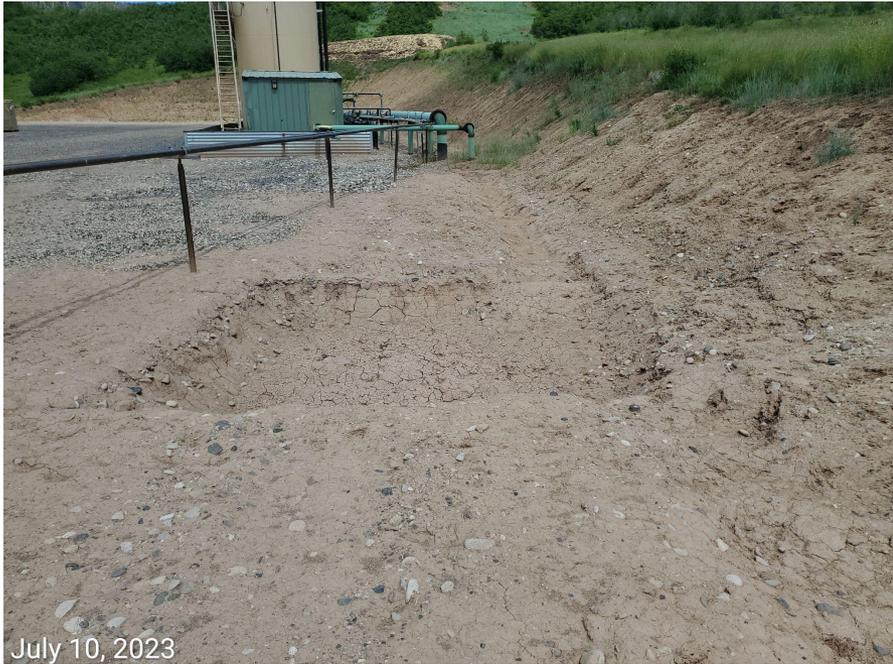
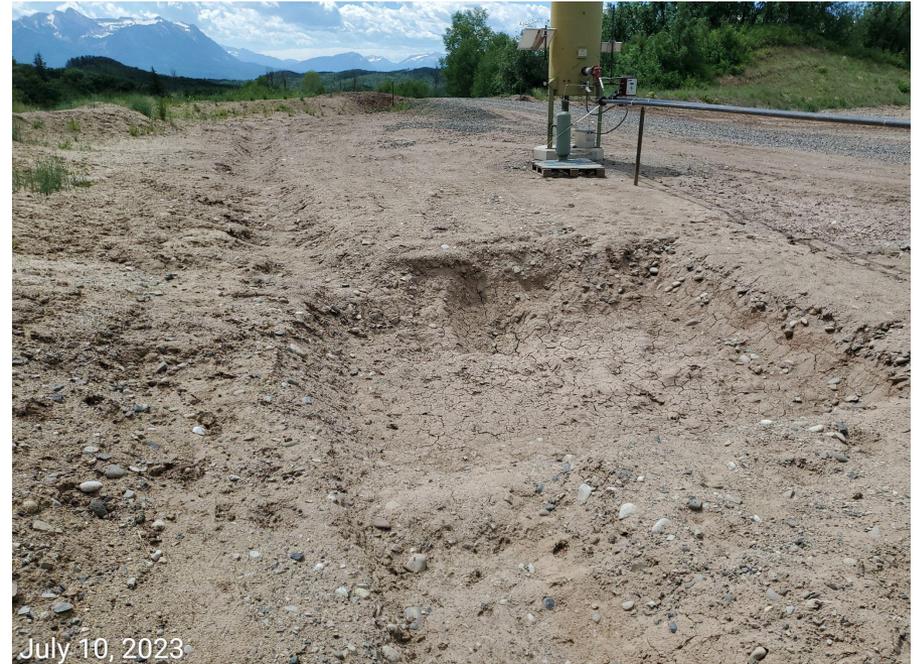
Photo 14: Photo taken from the east end of the Location. Photo shows excavation associated with Remediation Proj. #23148. Potentially impacted materials previously stored within ditch have been removed. Photo also shows BMPs to prevent stormwater from entering, or discharging from the sample pits remain missing or insufficient per corrective actions.
