Inspection Photos

API: 099-06909

Operator: RENEGADE OIL & GAS COMPANY LLC

Inspection Date: 7/11/2023

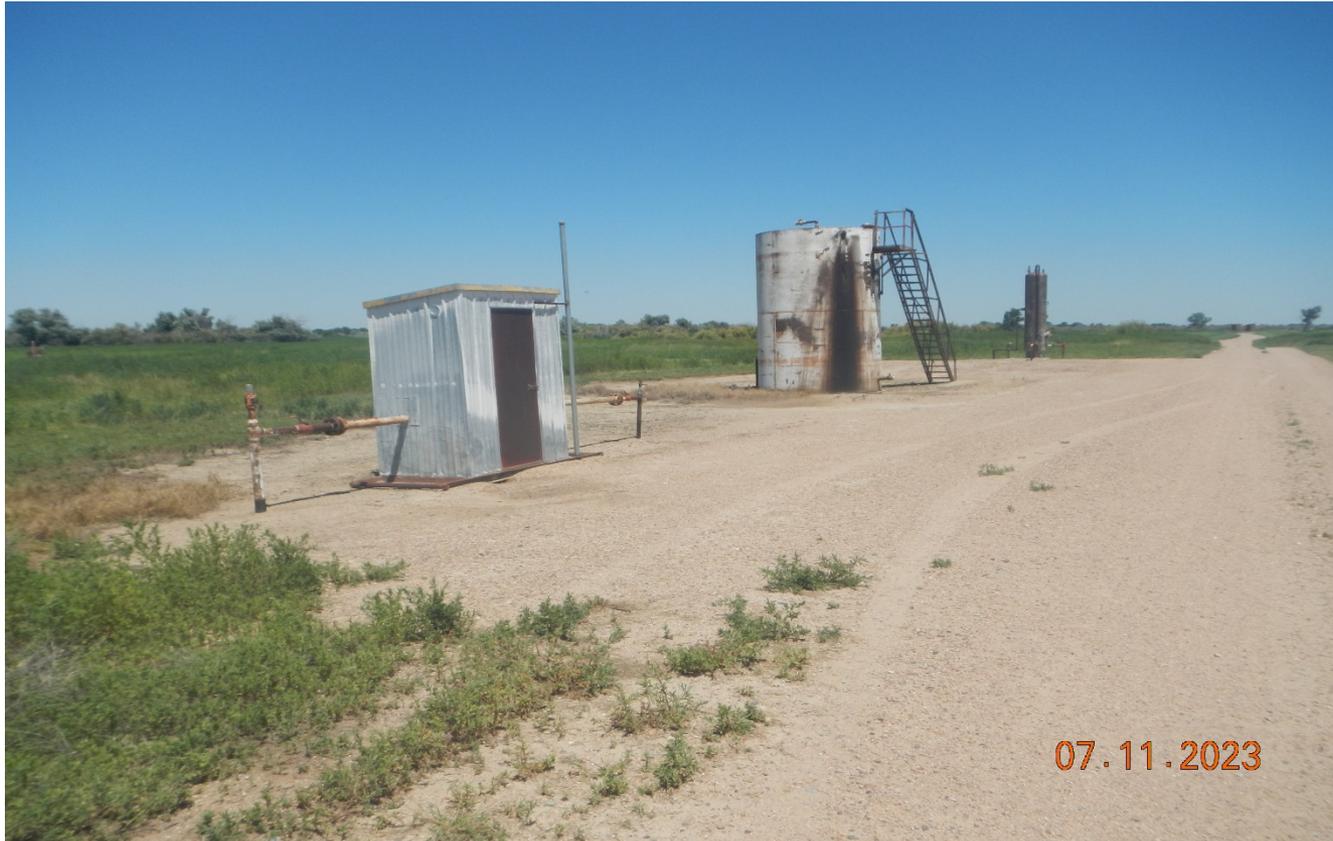
Photo 1. Facing northeast toward the offsite tank battery there is no sign posted at the tank battery which is off site from the well.

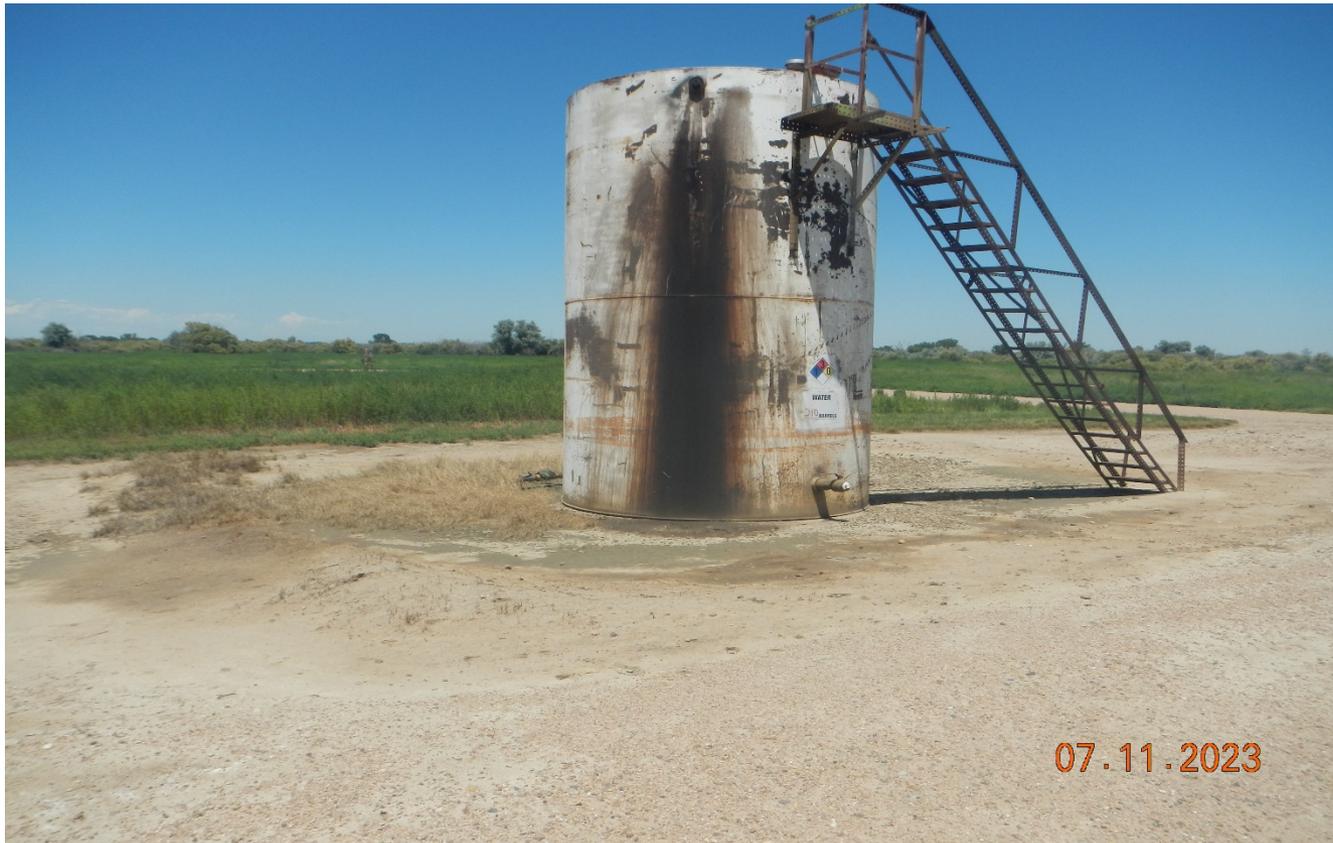
Photo 2. Facing toward the tank which is labeled as water. It appears crude oil has leaked out from the top. Additionally there is no secondary containment around the tank.

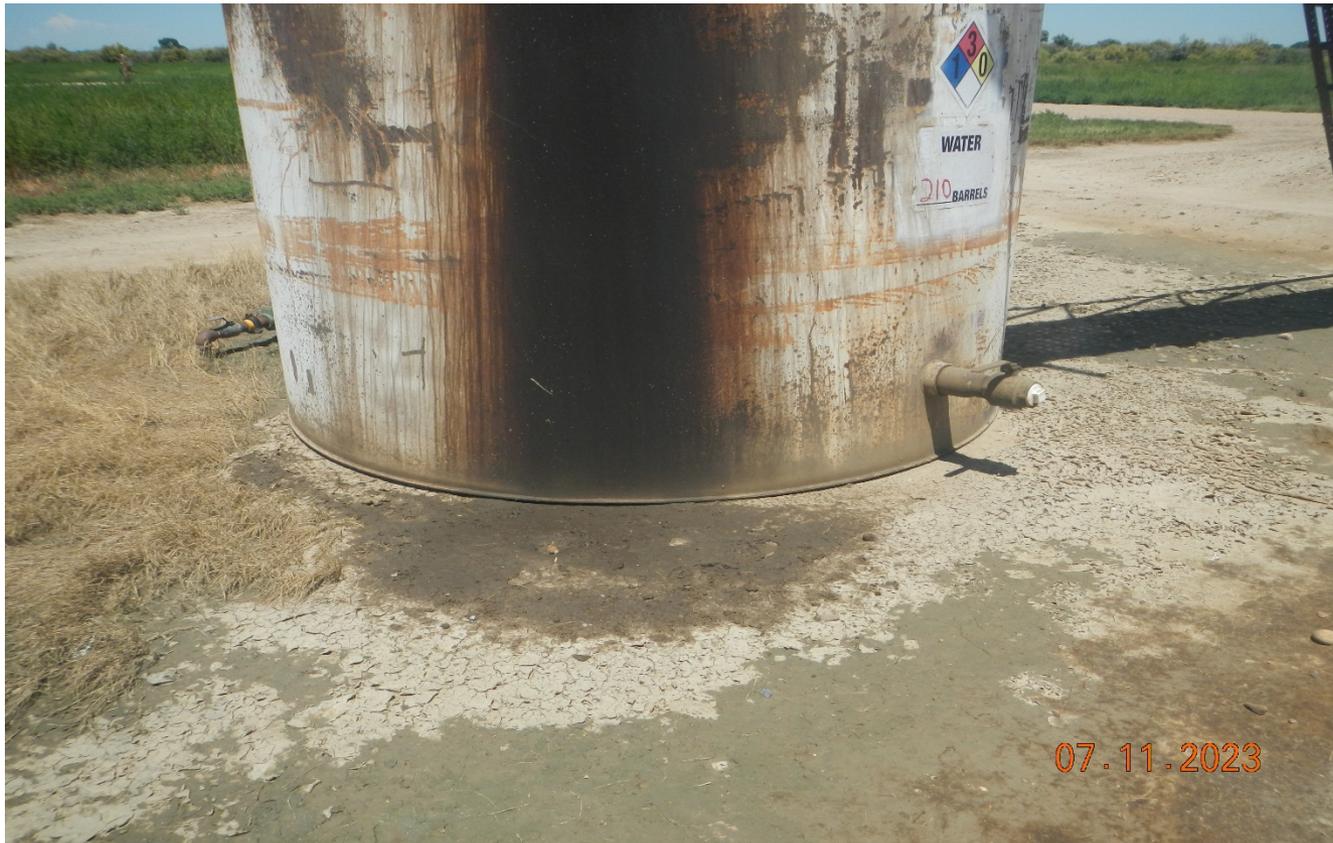
Photo 3. There is oil stained soils at the tank that need to be cleaned up.

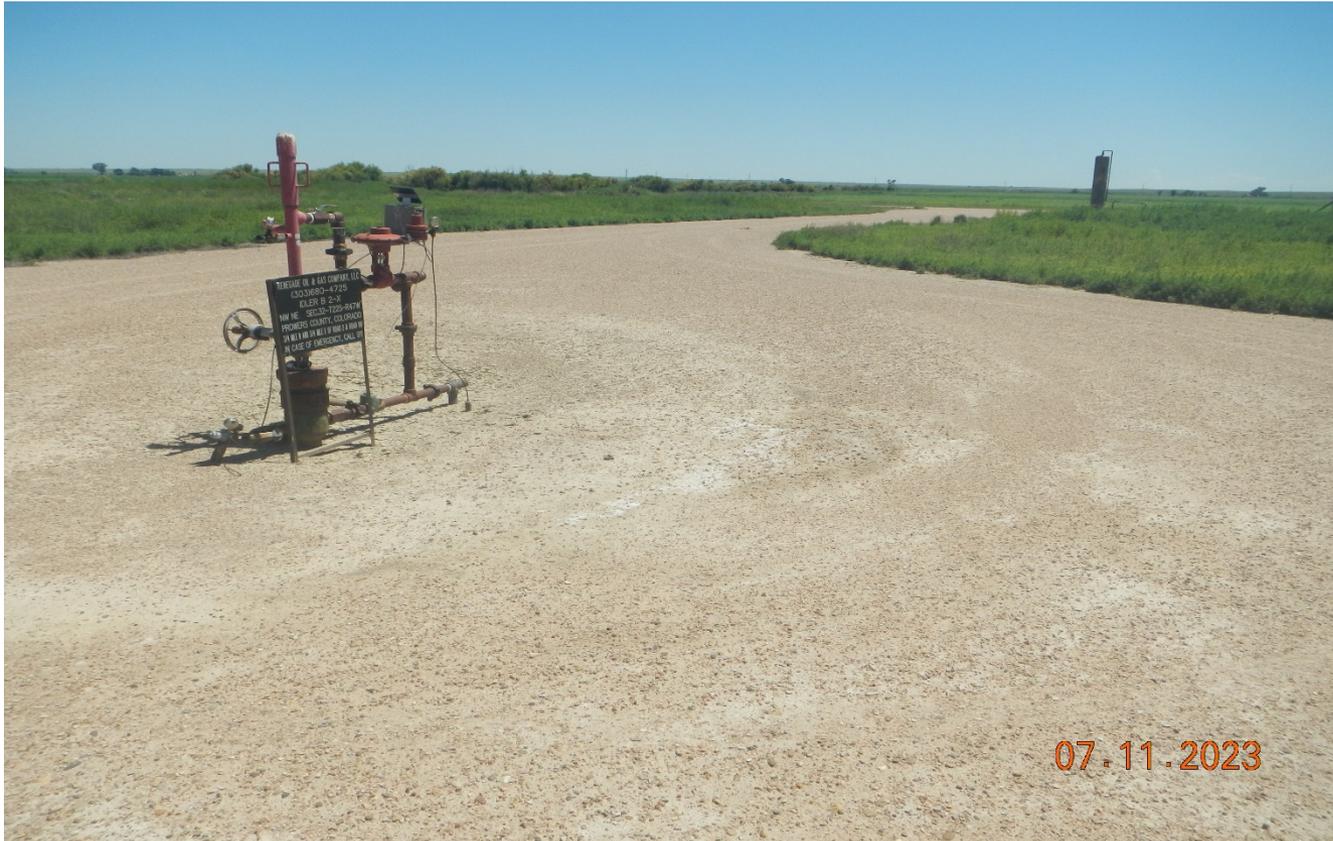
Photo 4. There is well sign posted at the wellhead. The well is a distance away from the tank battery and an addition sign should be posted at the tank battery.
