Inspection Photos

Operator: TEP ROCKY MOUNTAIN LLC #96850

Location Number: 324421

Garfield County, CO

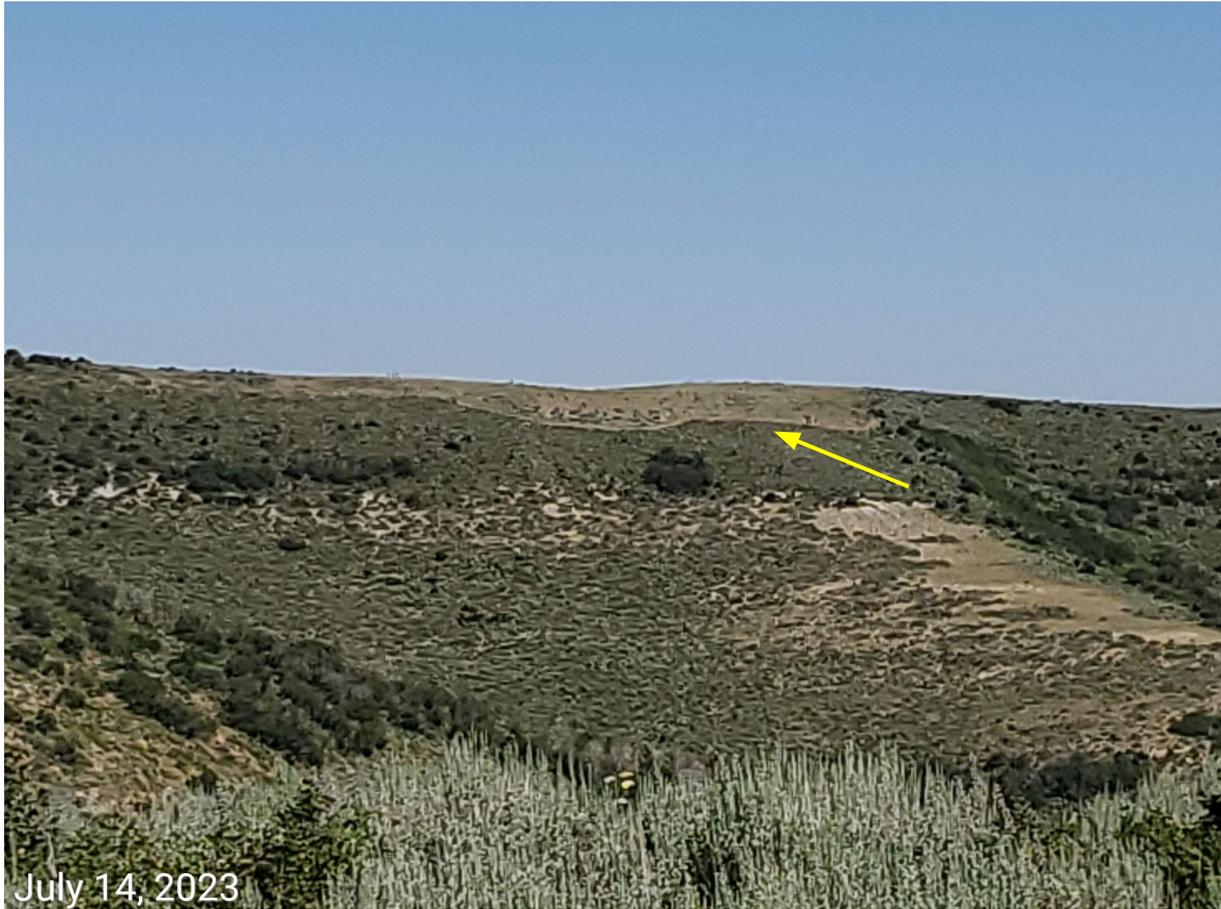
Photo 1: Photo taken from the access road ~ ½ mile south of the Location. Photo shows berms remain along the southern perimeter of the Location. Location has not been reclaimed in accordance with 1004 Rules.

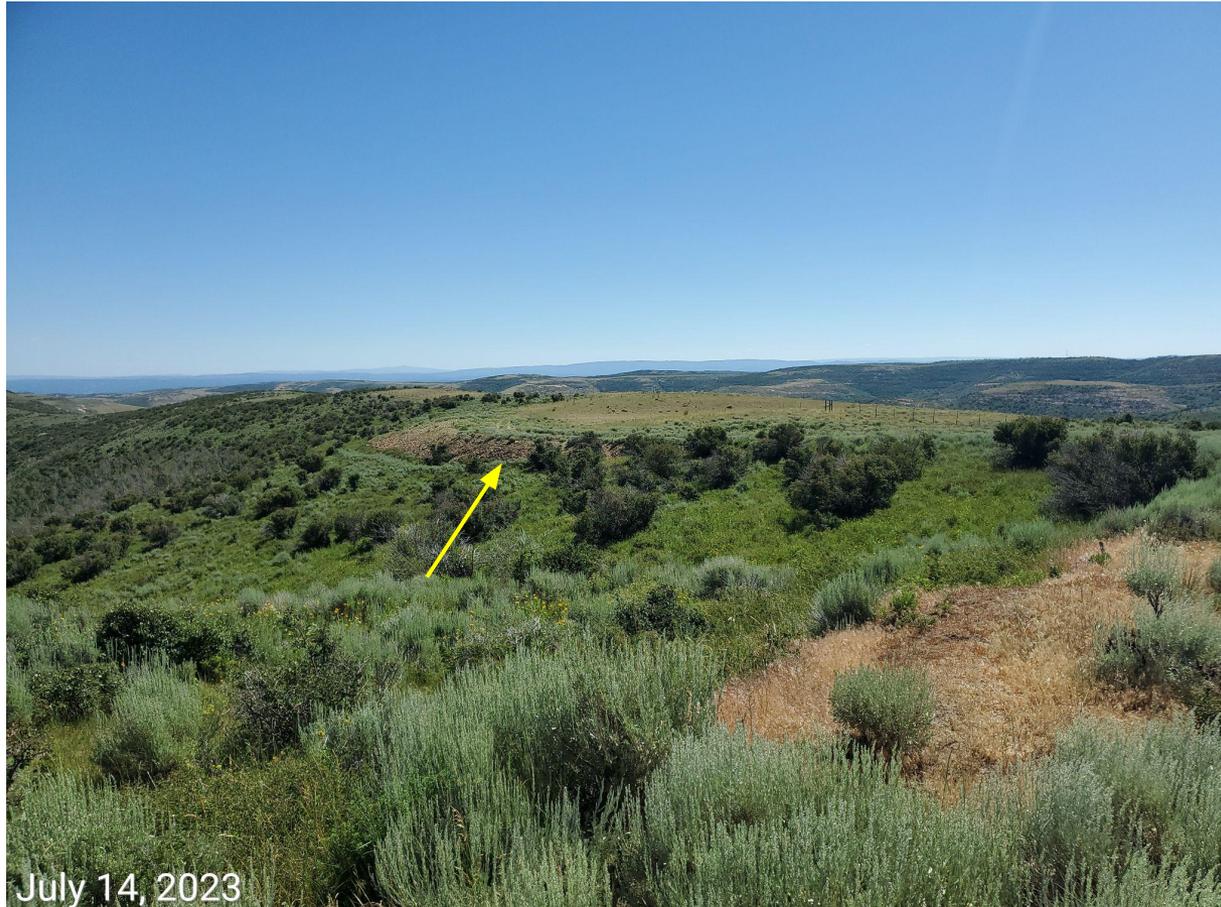
Photo 2: Photo taken from the west of the Location. Photo shows fill slopes remain. Location has not been recontoured/regraded and reclaimed.

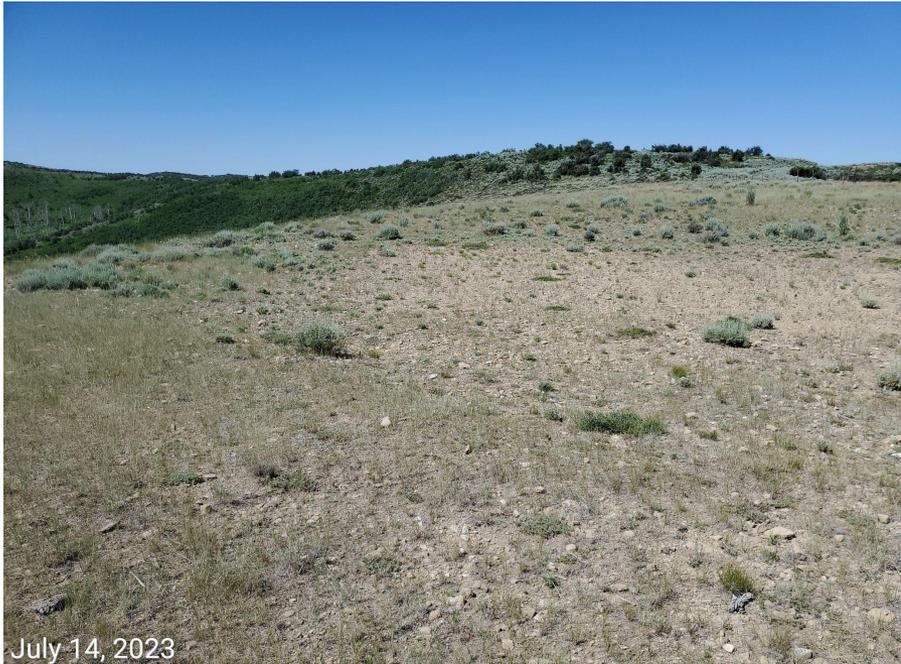
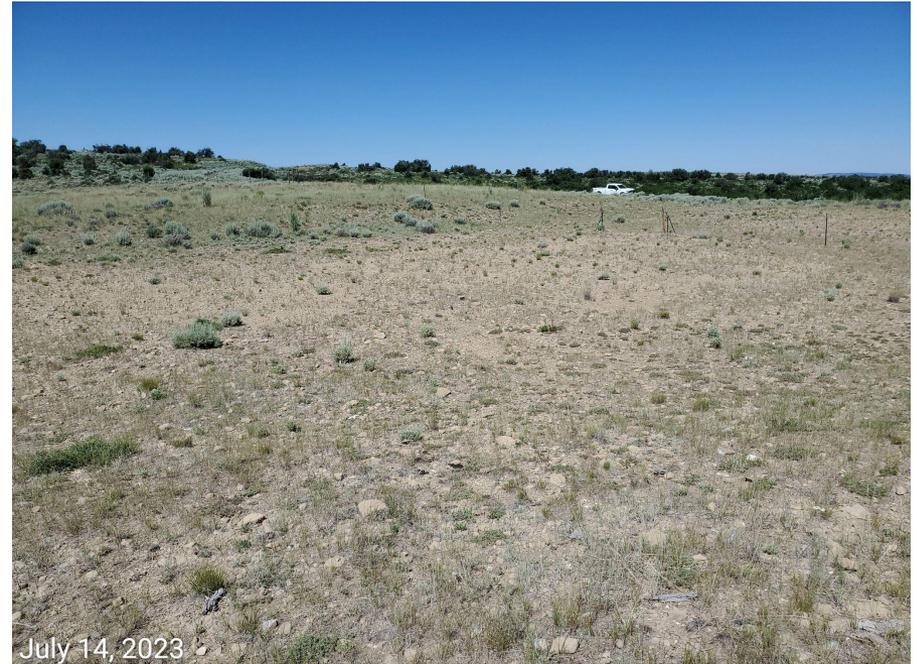
Photo 3: Photos 3-4 taken from the east end of the Location. Photos provide an overview from south, southwest, northwest to north. Location has not been recontoured/regraded and reclaimed; topsoil has not been replaced; compaction alleviation not performed.

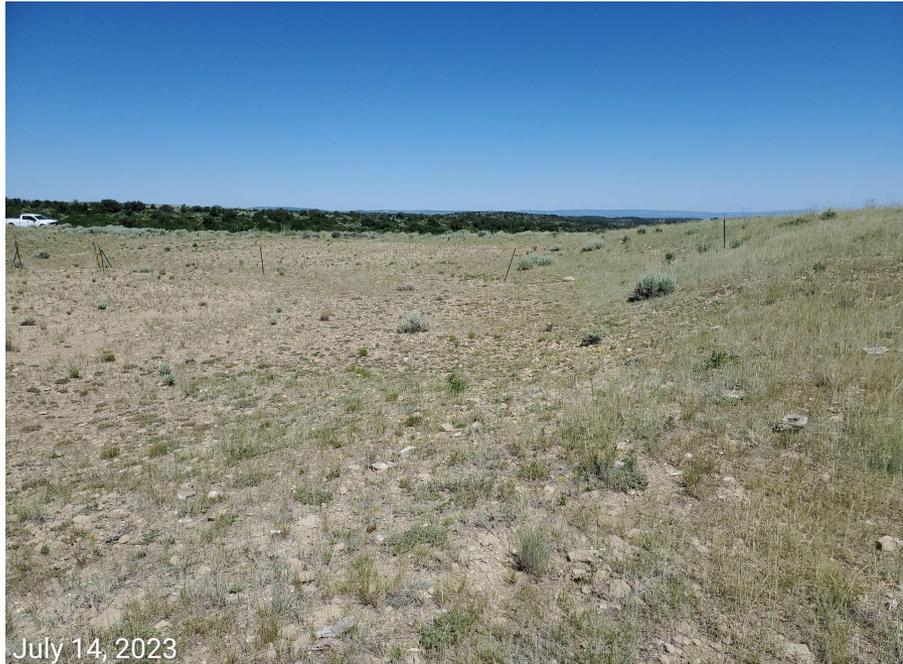
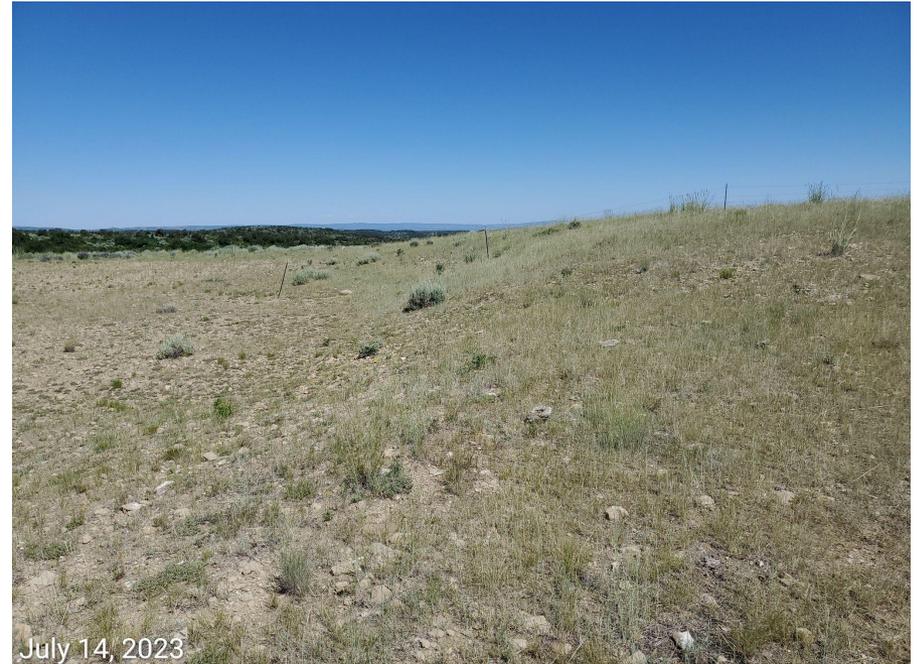
Photo 4: See comments under photo 3.

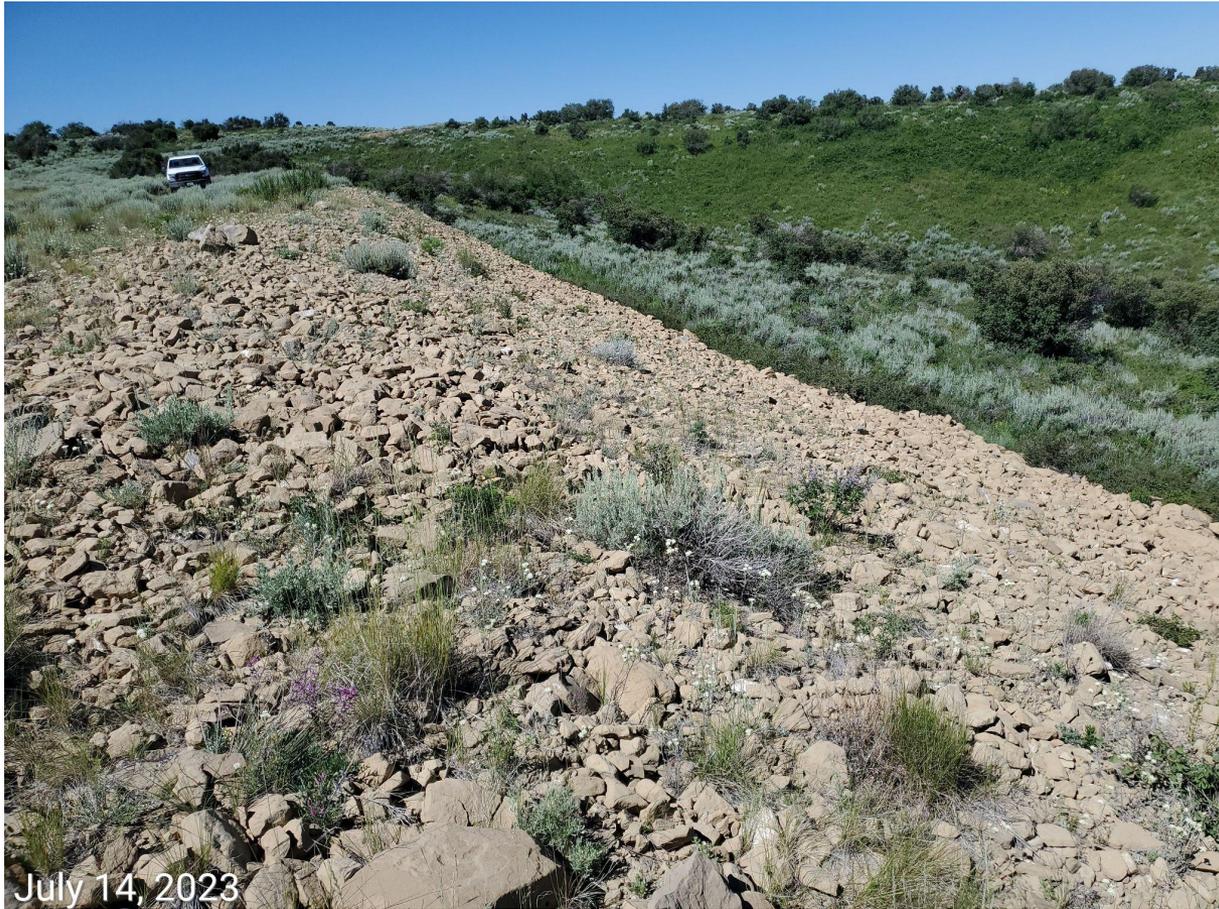
Photo 5: Fill slopes on the Location; Location has not been recontoured/regraded and reclaimed.

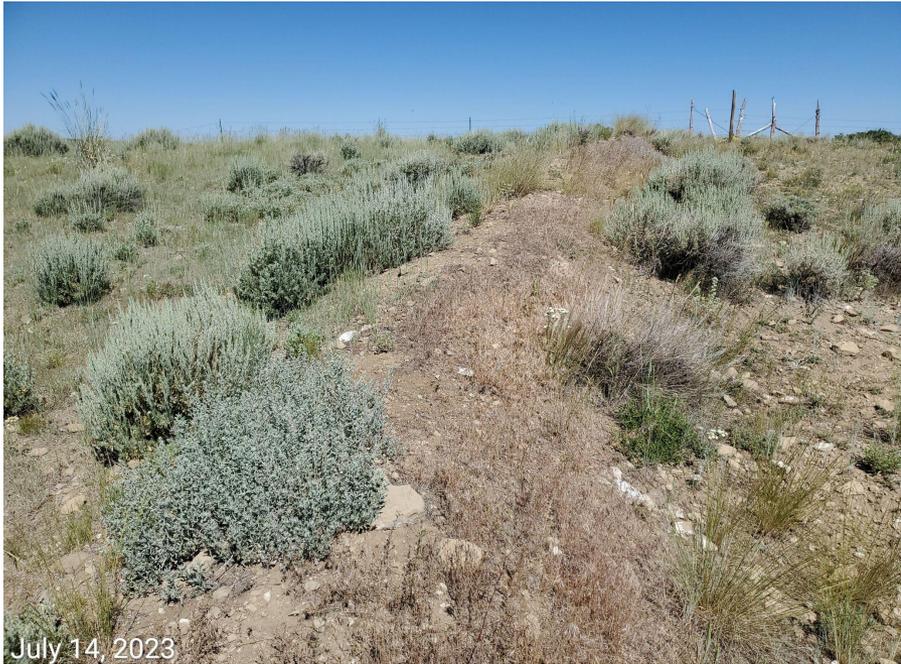
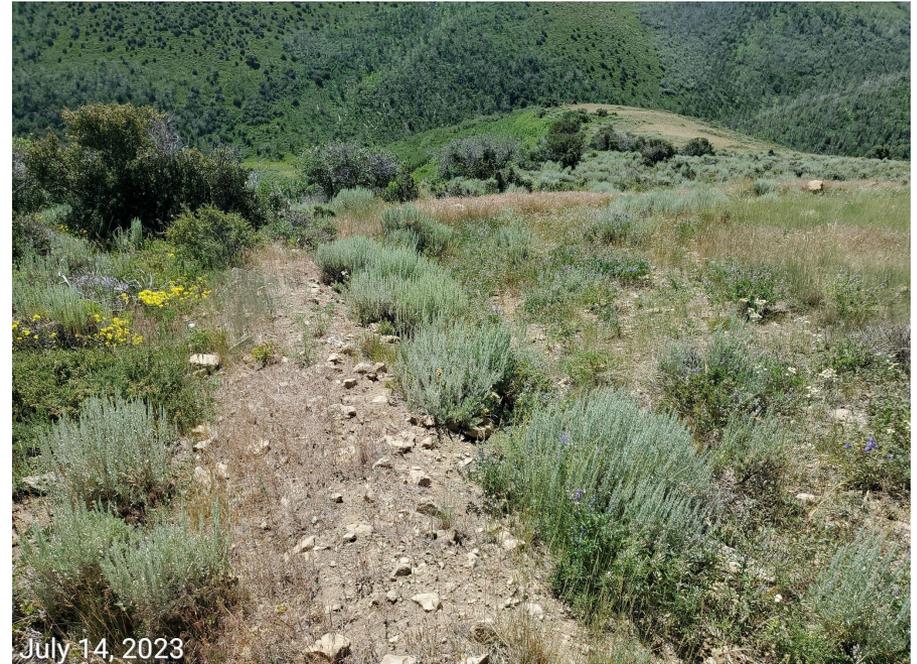
Photo 6: Soils stockpiled on the southern perimeter of the Location has not been replaced.

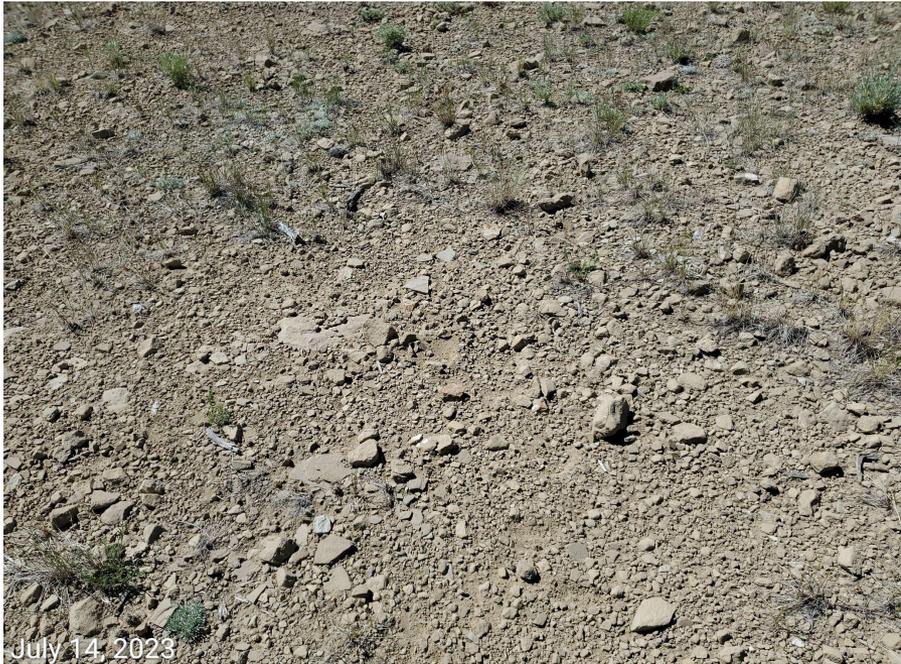
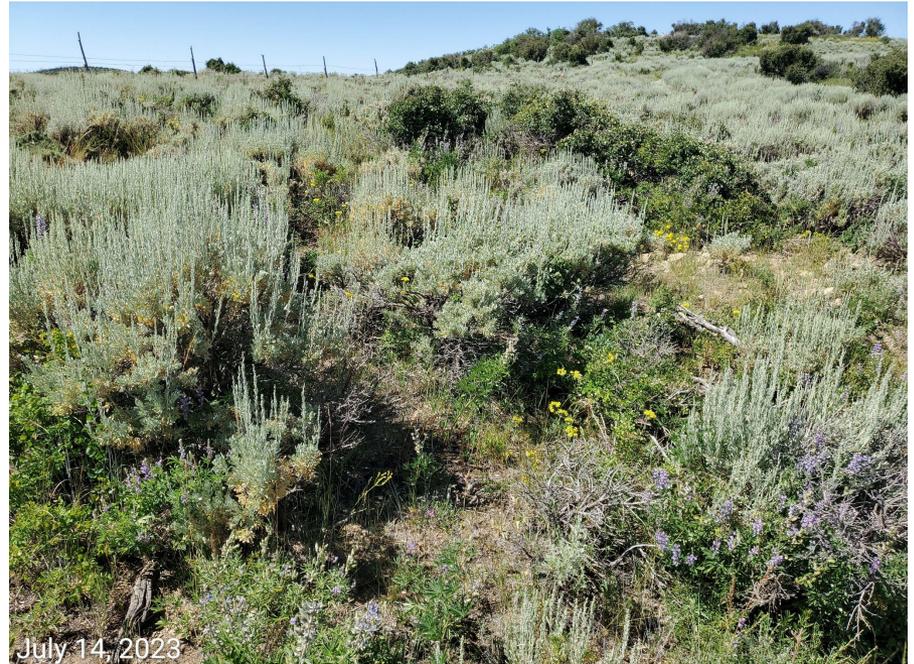
Photo 3: Photo left taken from the central areas of the disturbed Location. Photo shows topsoil has not been replaced. Photo right is an example of the vegetation within the adjacent reference area for comparison.
