Final Reclamation and Stormwater Inspection

Operator: MARKUS PRODUCTION INC - 53790

Location ID: 313907

Inspection Photos
Location Name: Welker 43-30
Location ID: 313907

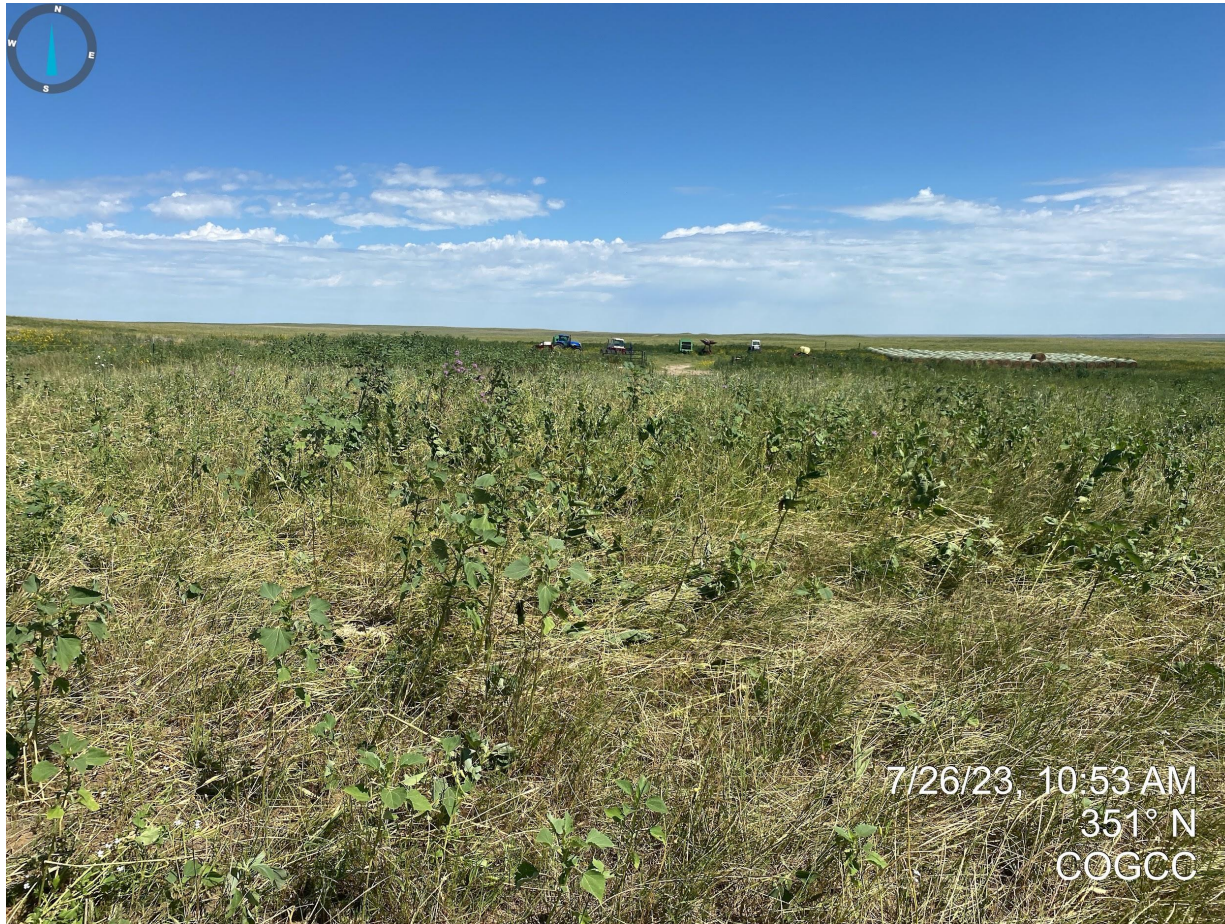
Photo 1. The former well location appears to be progressing towards Rule 1004 standards with evidence of the reclaimed areas reflective of the adjacent areas.

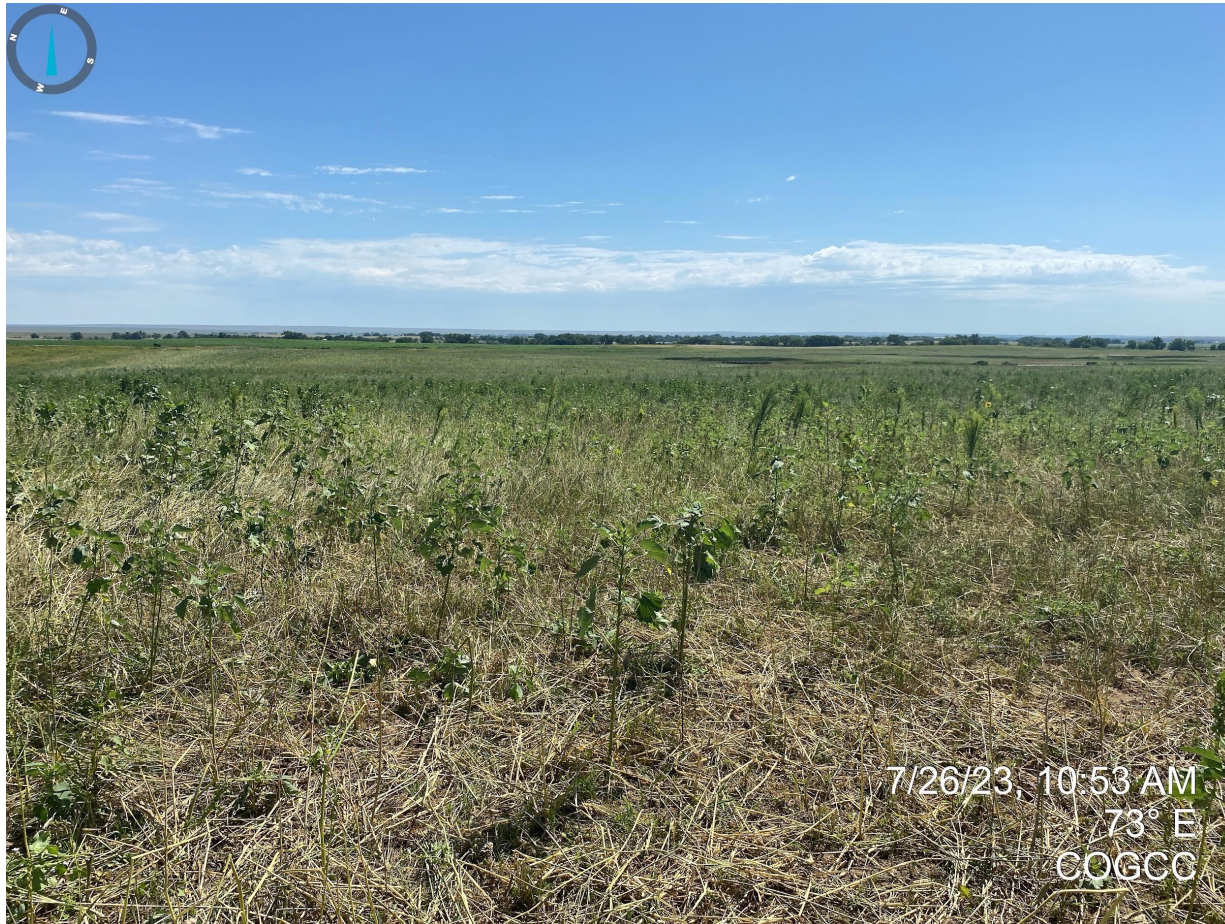
Photo 2. See comments in Photo 1.

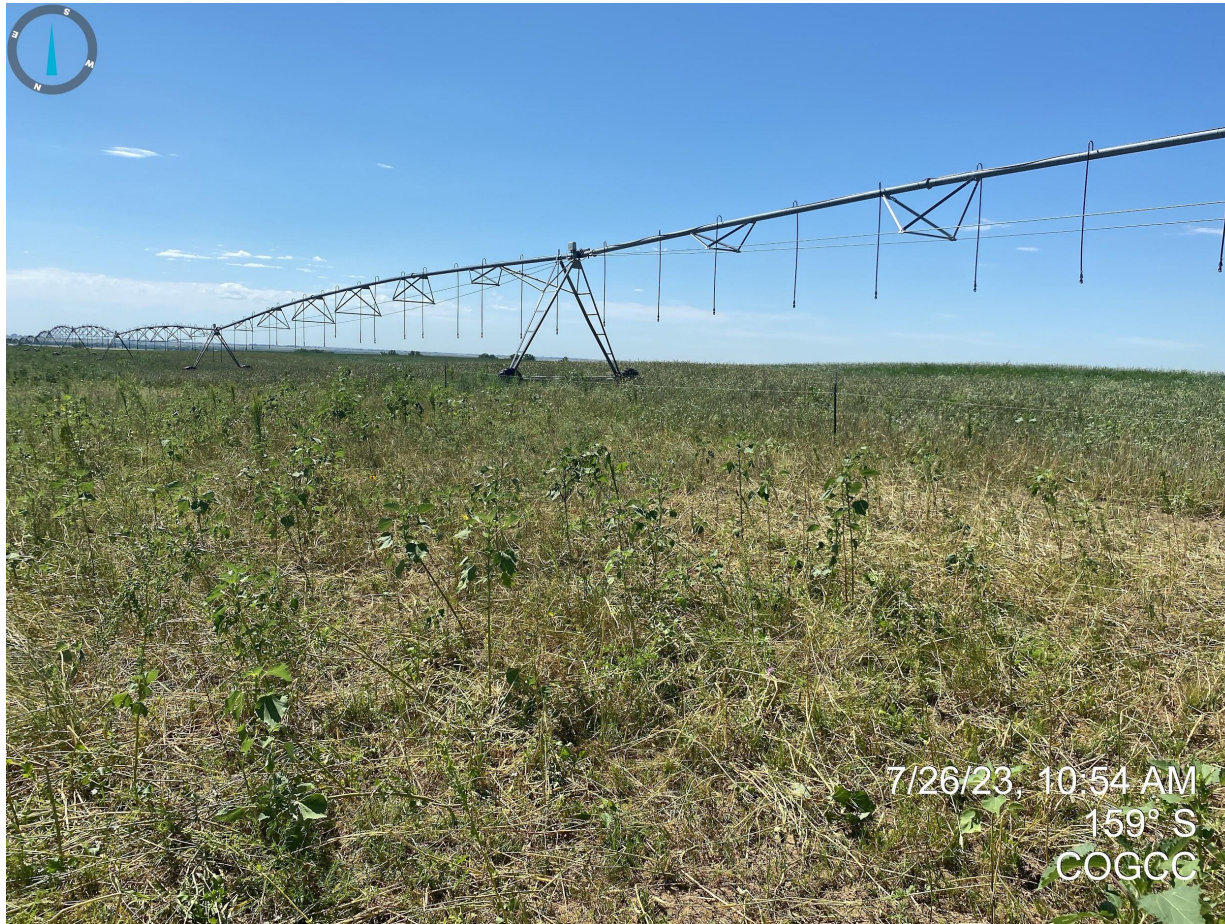
Photo 3. See comments in Photo 1.

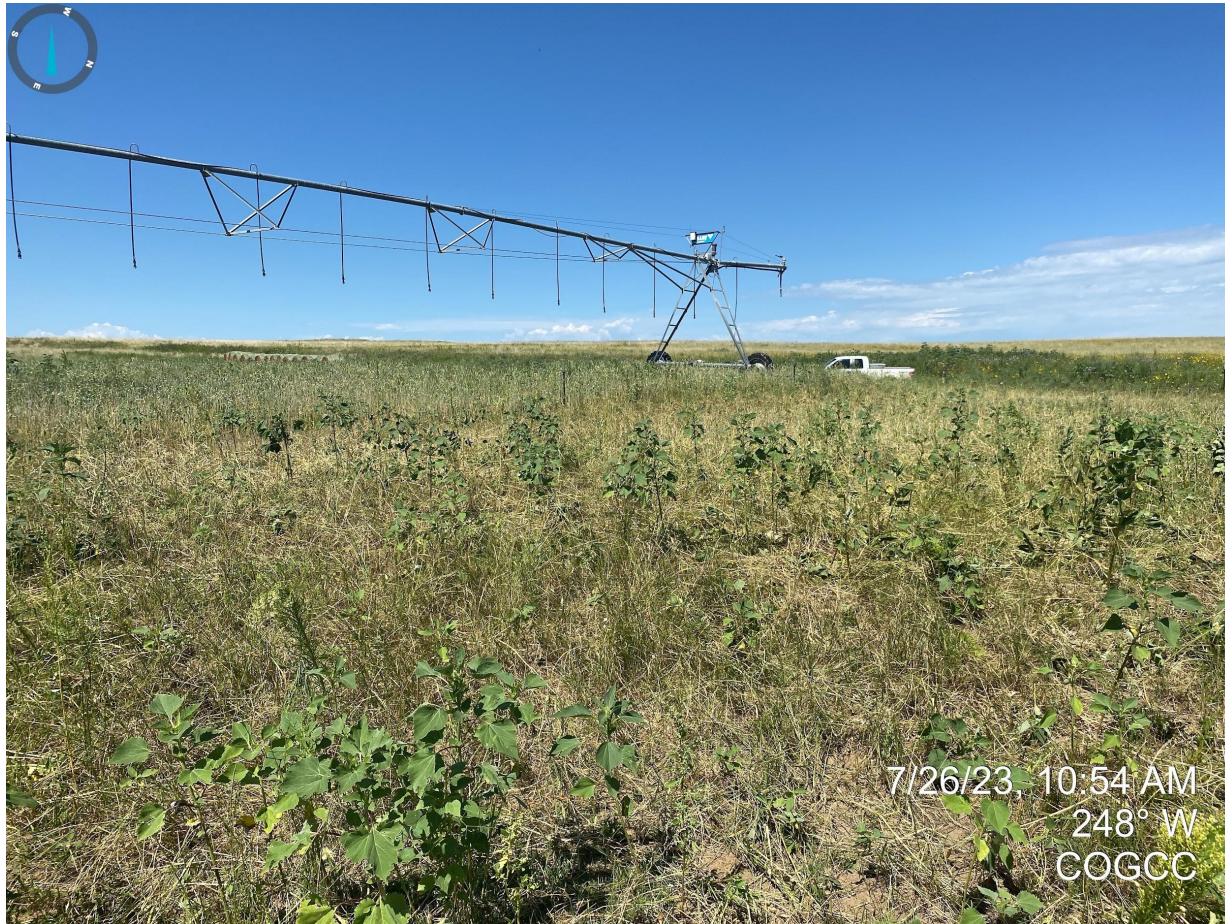
Photo 4. See comments in Photo 1.

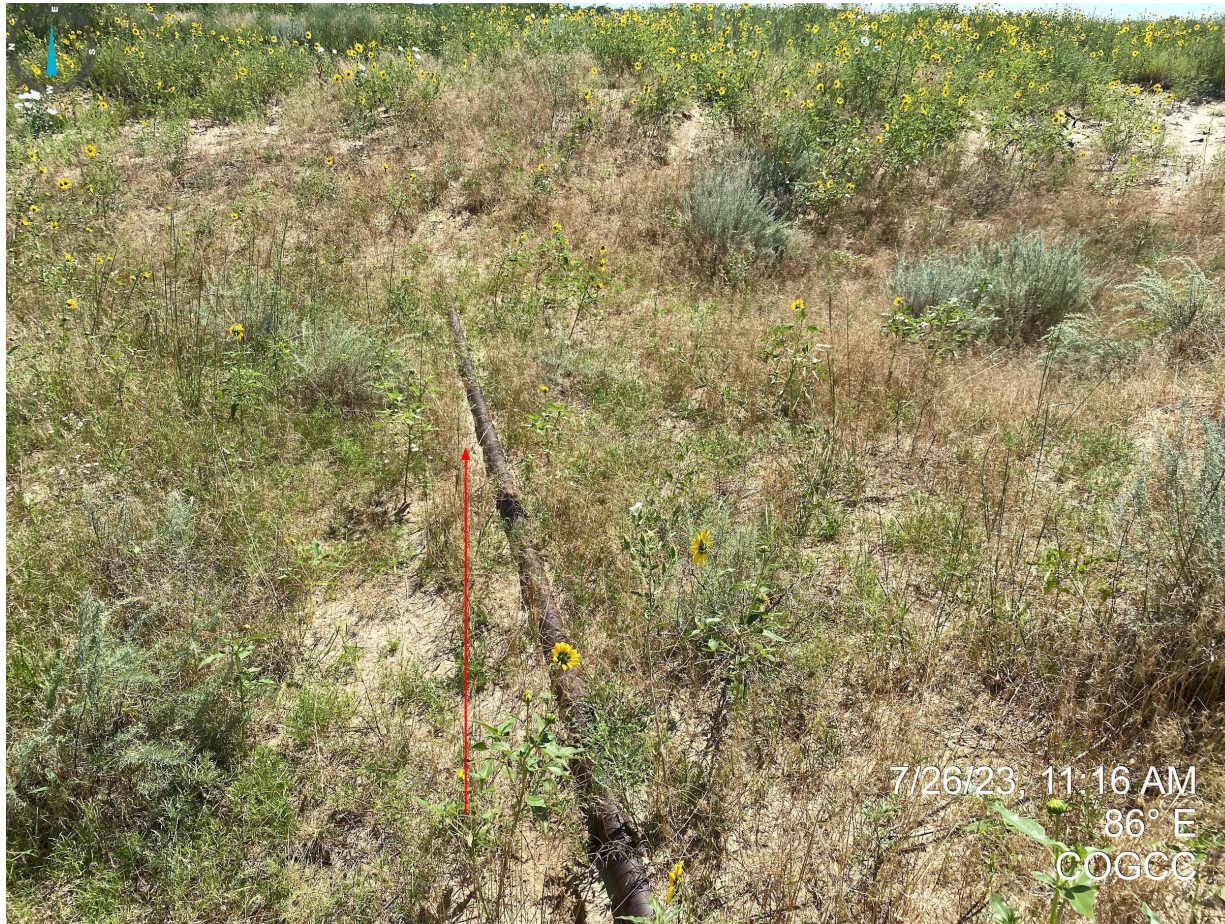
Photo 5. Partially buried flowline observed adjacent to an access road, running from the well location to the former tank battery location. This equipment will need to be properly removed. Refer to subsequent photos for aerial imagery.

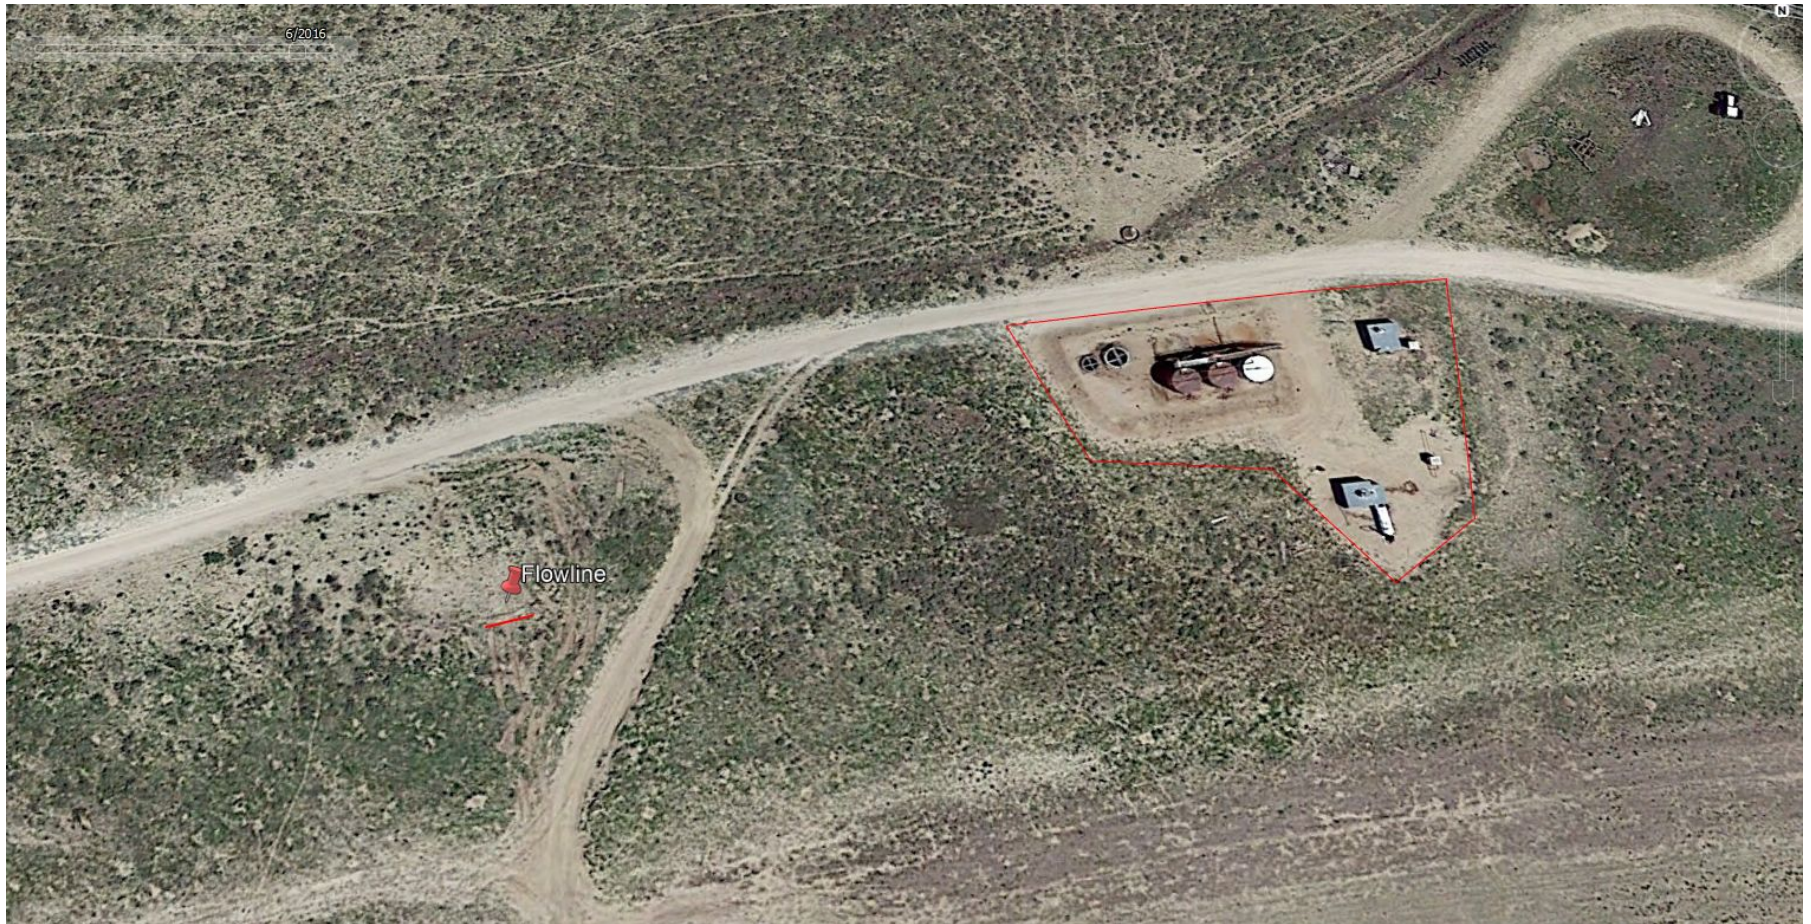
Photo 5. Google Earth aerial imagery taken circa 06/2016 illustrates the flowline position and the former tank battery location.

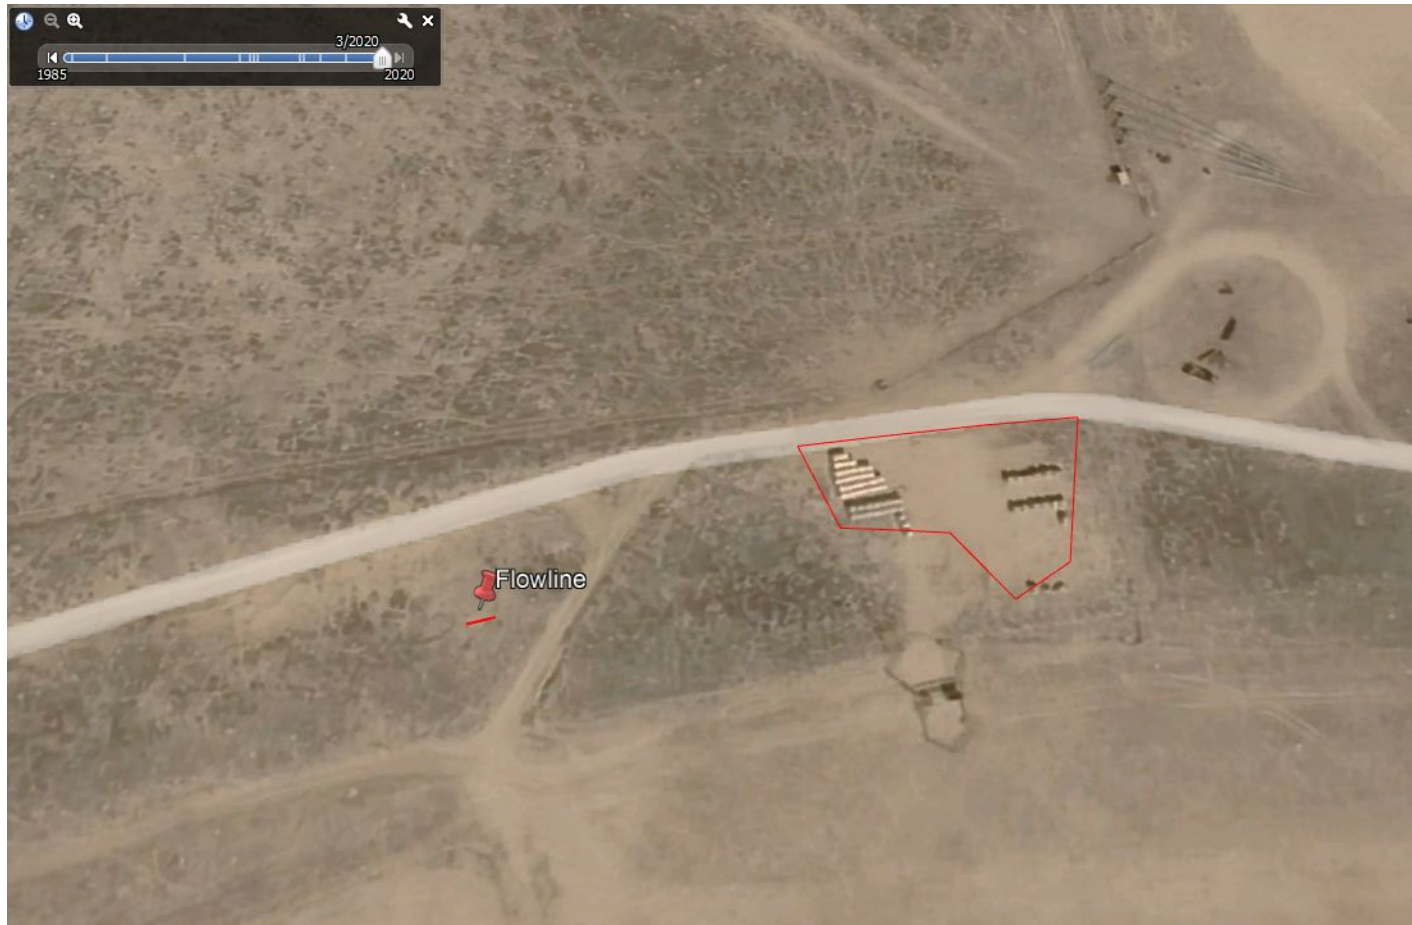
Photo 6. Google Earth aerial imagery taken circa 03/2020, illustrating that the former tank battery location does not appear reflective of adjacent reference areas as it is being used as storage. The tank battery location will need to be reclaimed per Rule 1004 standards.
