Final Reclamation Inspection

Operator: KERR MCGEE OIL & GAS ONSHORE LP #47120

Location ID: 305875

Inspection Photos
Location Name: BETZ #30-15
Location ID: 305875

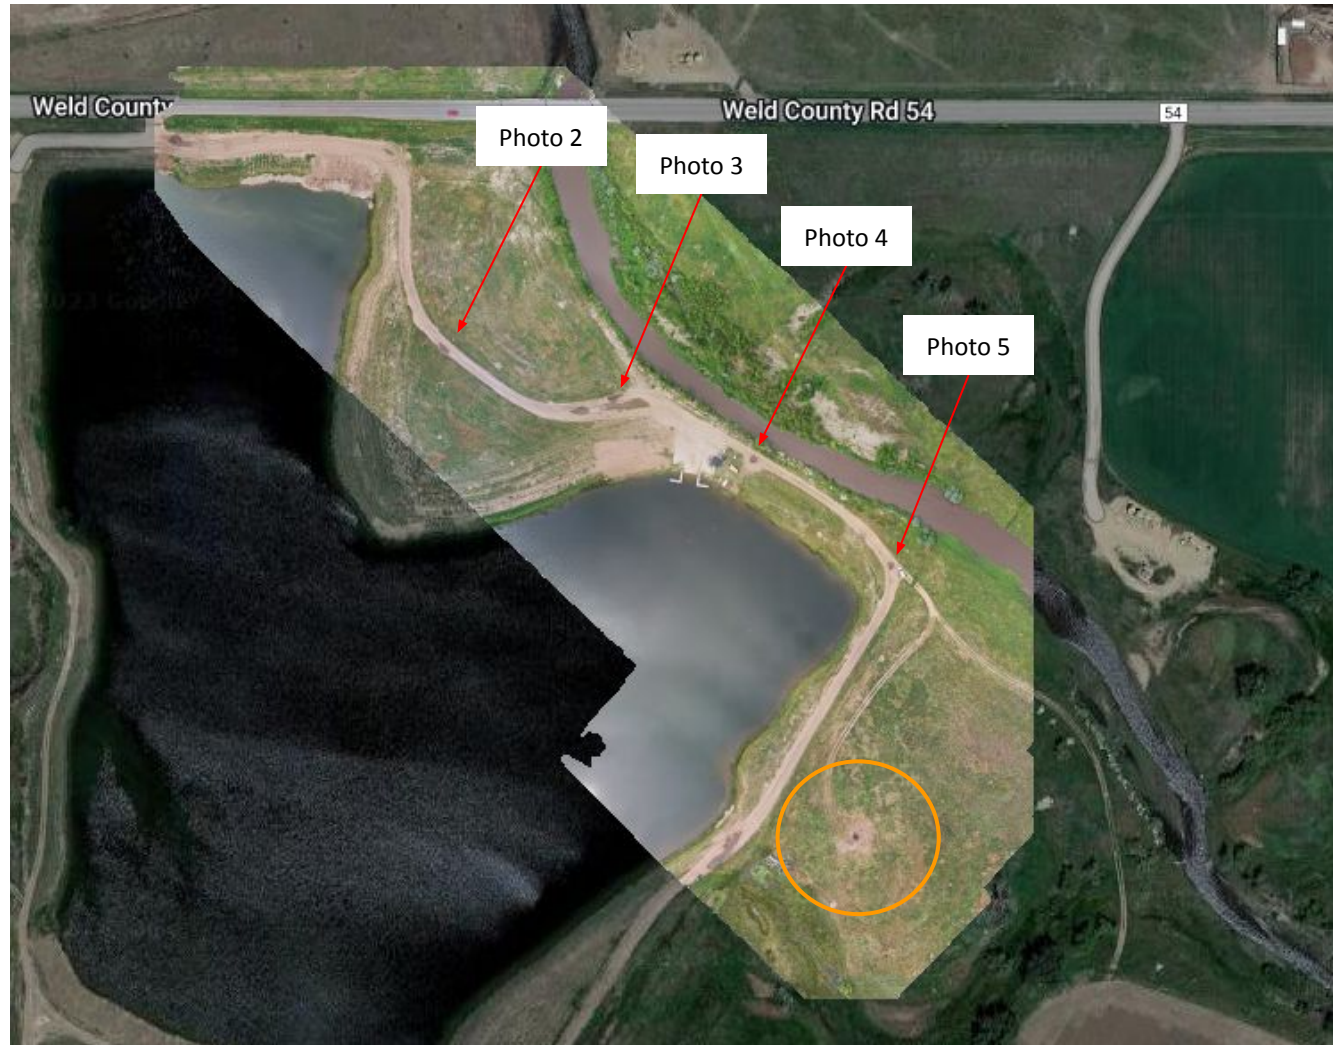
Photo 1. Drone aerial imagery illustrates the access road which has been used for the Croissant 30-12, 30-13 and Betz 30-15 well locations. Red arrows indicate road damages from plugging operations on Betz 30-15 (orange circle).

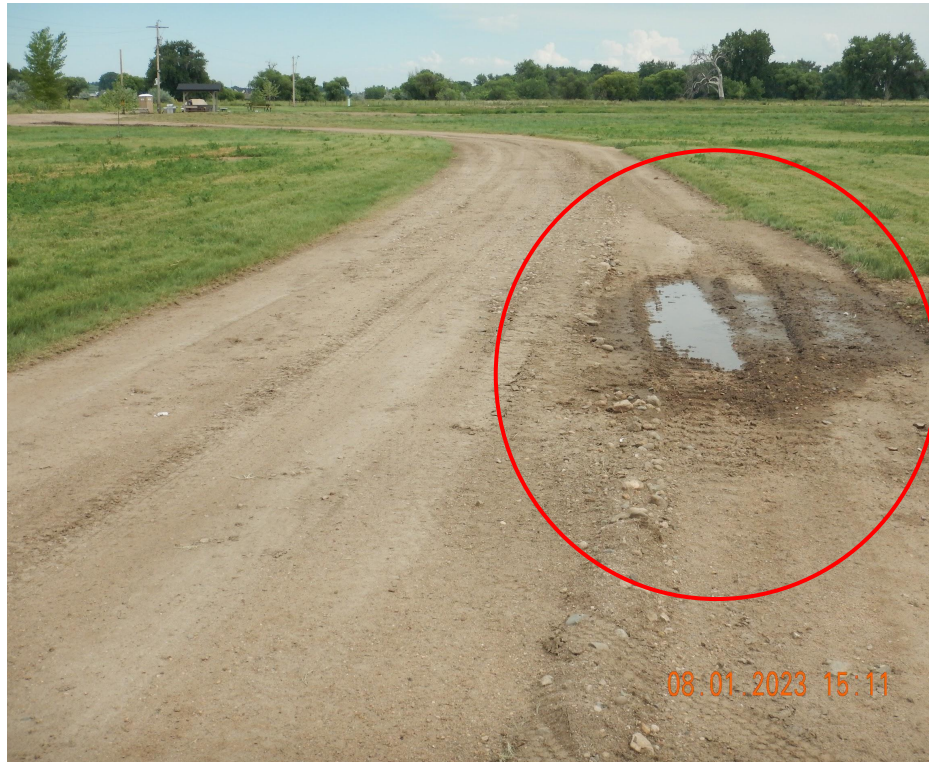
Photo 2. Photo taken from a portion of the access road, facing Southeast. Photo illustrates road damages from plugging operations.

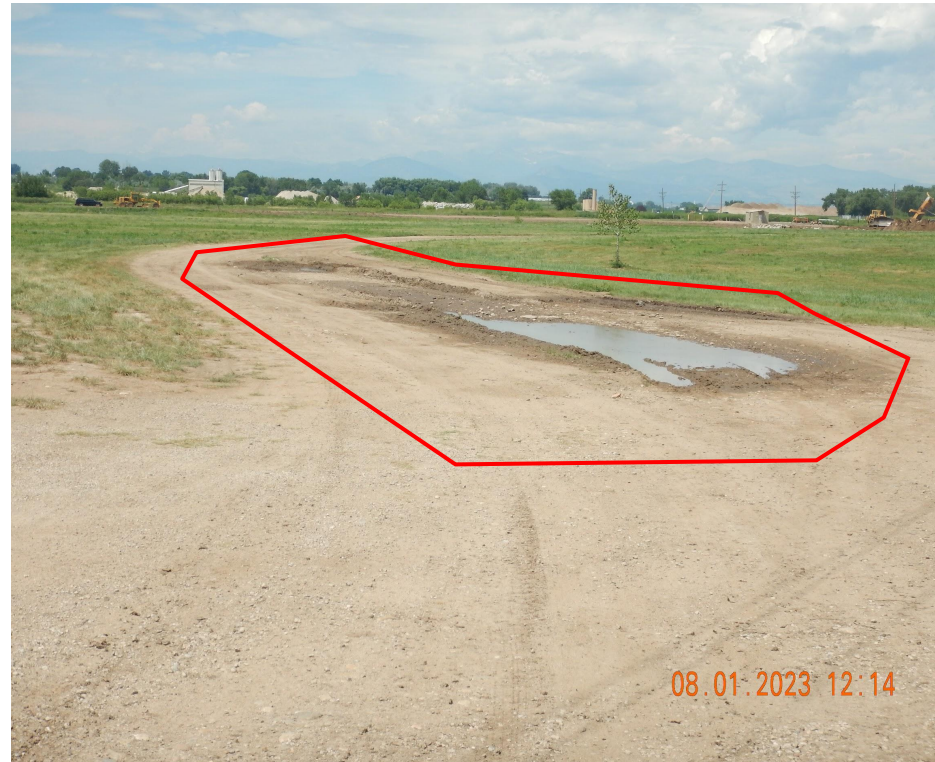
Photo 3. Photo taken from a portion of the access road, facing Northwest. Photo illustrates road damages from plugging operations.

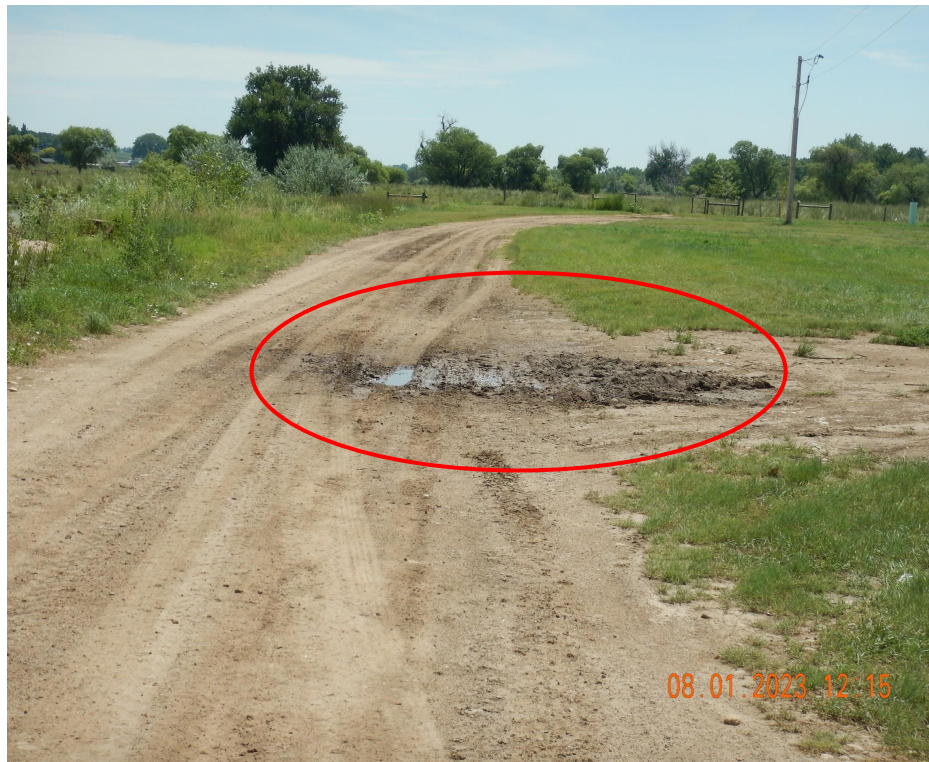
Photo 4. Photo taken from a portion of the access road, facing East. Photo illustrates road damages from plugging operations.

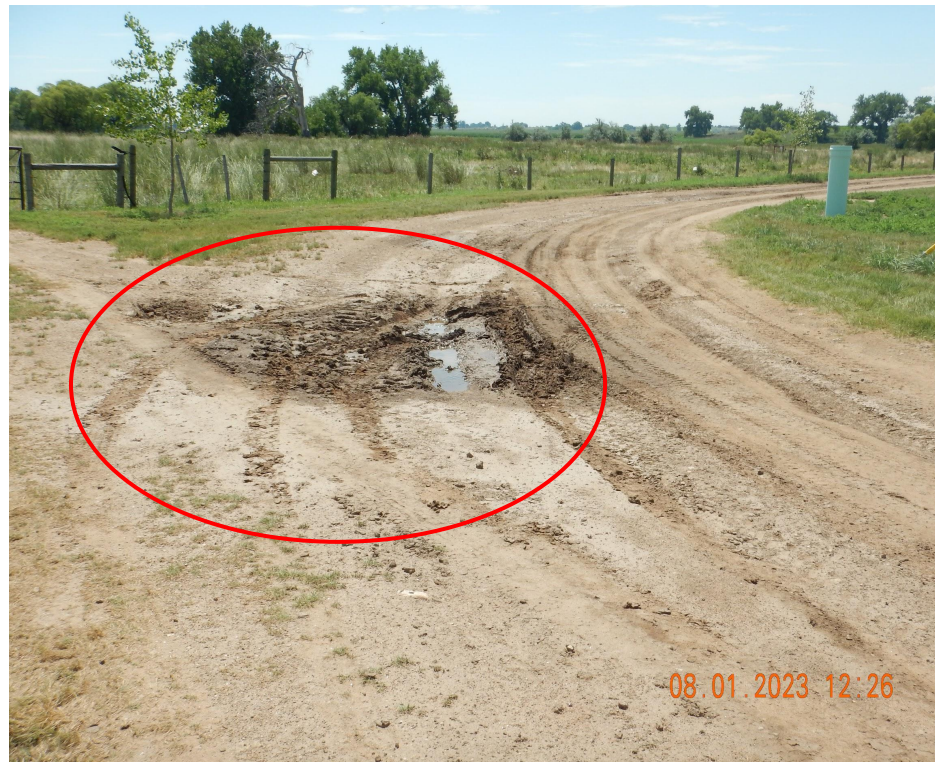
Photo 5. Photo taken from a portion of the access road, facing East. Photo illustrates road damages from plugging operations.

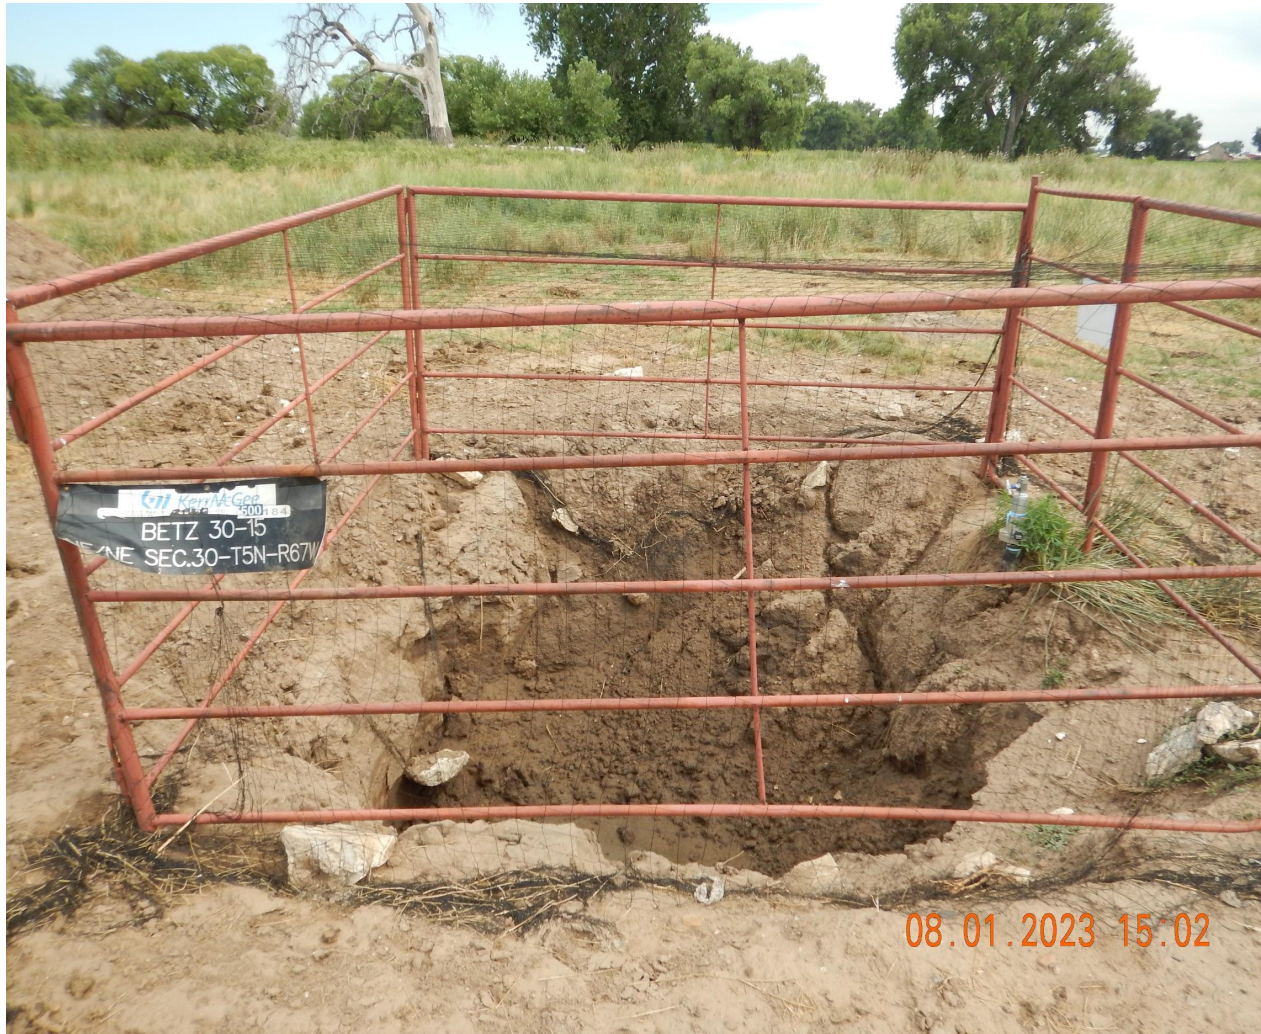
Photo 6. Photo taken from the well location, facing East. Photo illustrates an open excavation due to plugging operations. Cattle fencing and netting have been installed. Netting is in need of repair as approximate 10" holes were observed.
