Final Reclamation and Stormwater Inspection

Operator: MAGPIE OPERATING INC - 52530

Location ID: 312143

Logan County, CO

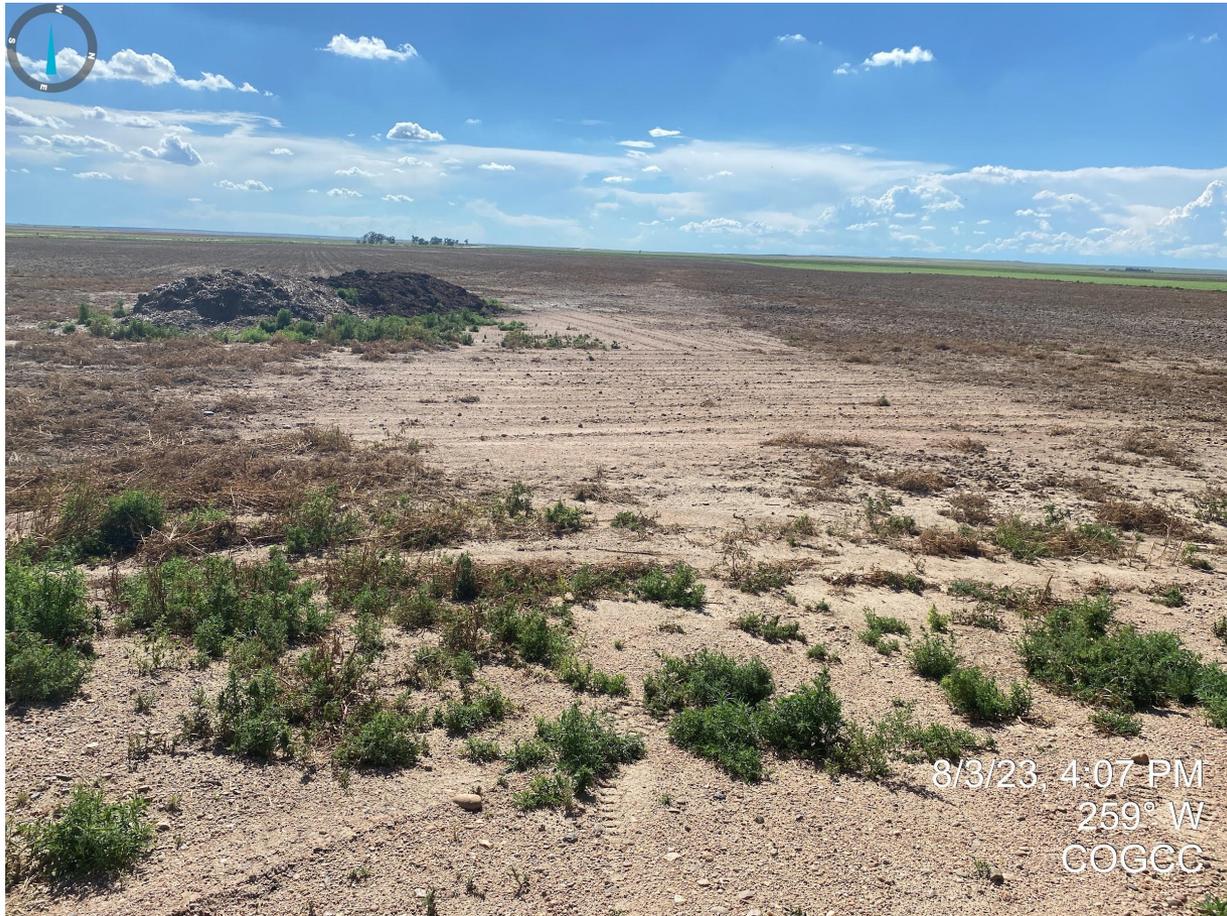
Photo 1. Photo taken from adjacent county road. It does not appear any reclamation activities have occurred since the previous inspection (Doc #708200216) conducted on 05/03/2023. Previous corrective actions required the Operator to conduct reclamation activities including but not limited to- removing road base/gravel from the former productions areas and well location, recontour/grading/leveling, and performing decompaction per Rule 1004 requirements.

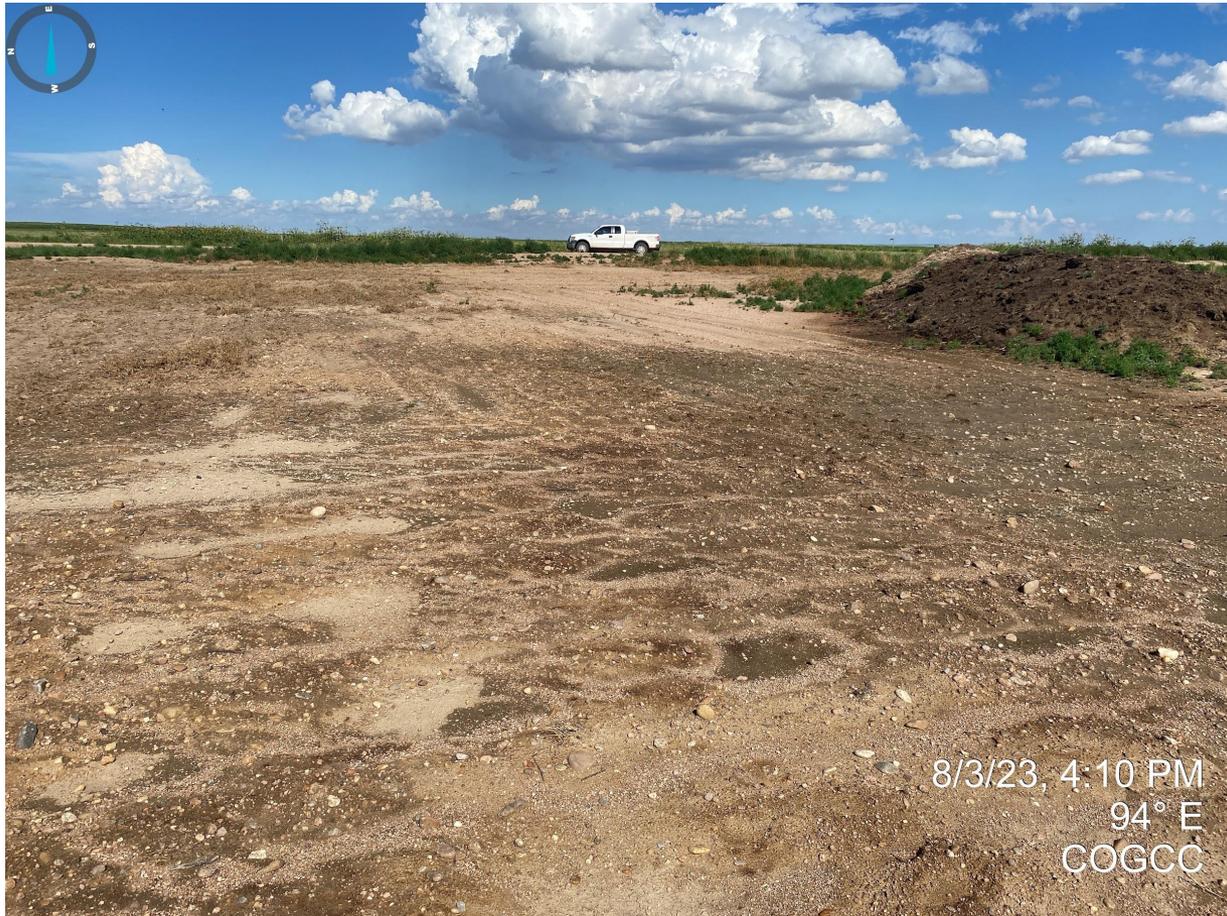
Photo 2. Continued from Photo 1. Road base and gravel remain on the location and requires removal per Rule 1004.

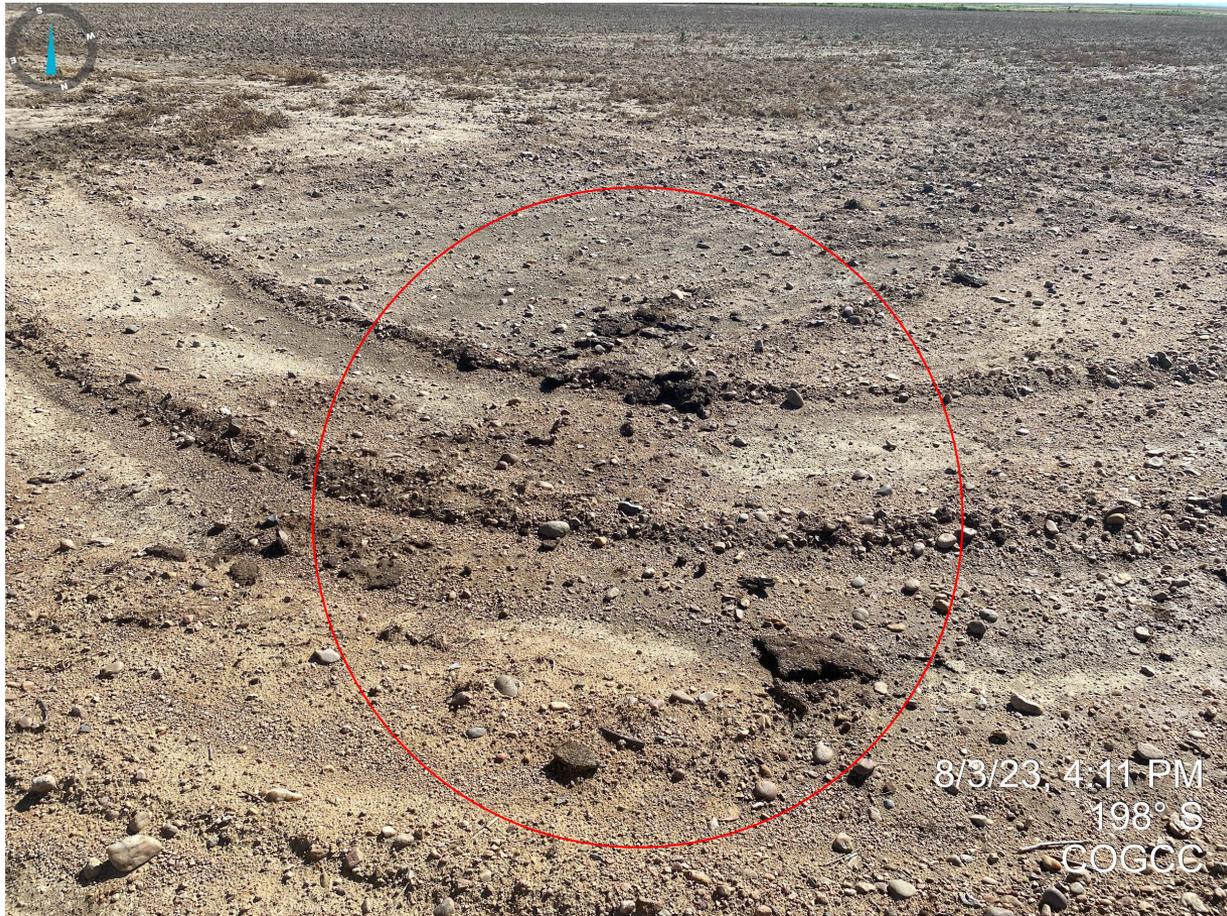
Photo 3. Stained soil observed on the western portion of the former production areas. The Operator shall ensure that all impacted material is properly removed from the location in accordance with Rule 905.e.

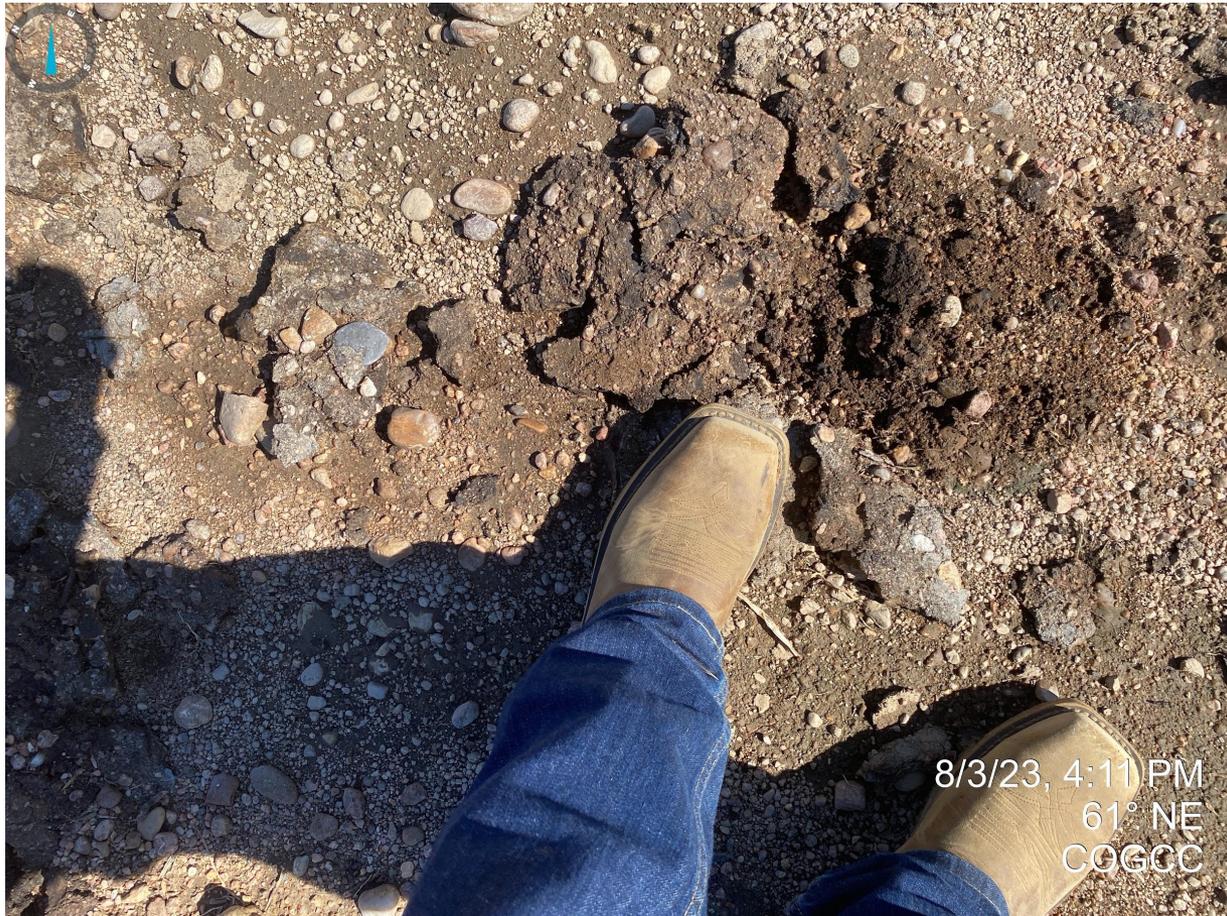
Photo 4. Continued from Photo 3. Close up photo of stained material (a chemical odor from the soil was detected during this inspection).

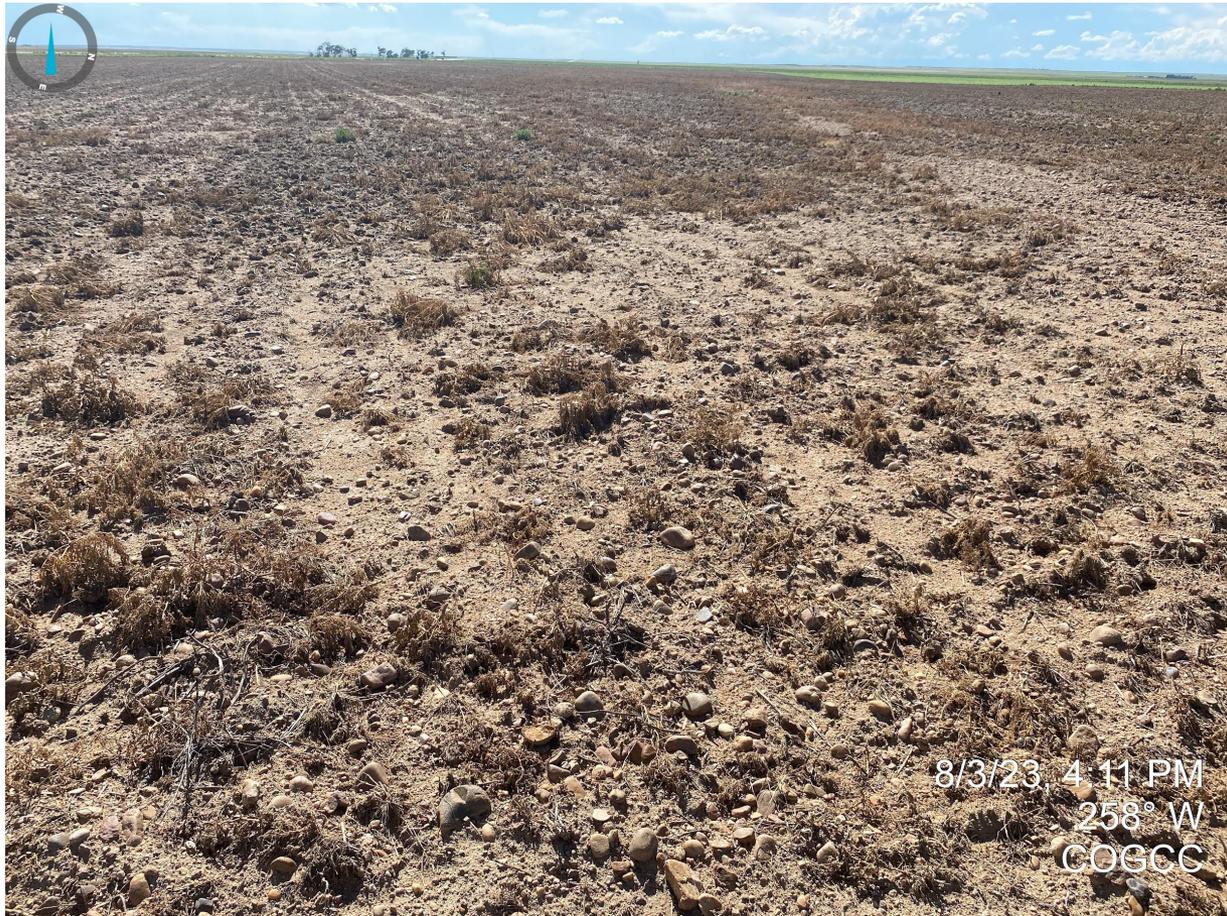
Photo 5. Taken from the northwestern portion of the former production areas. Photo illustrates the presence of gravel/road base still on location.

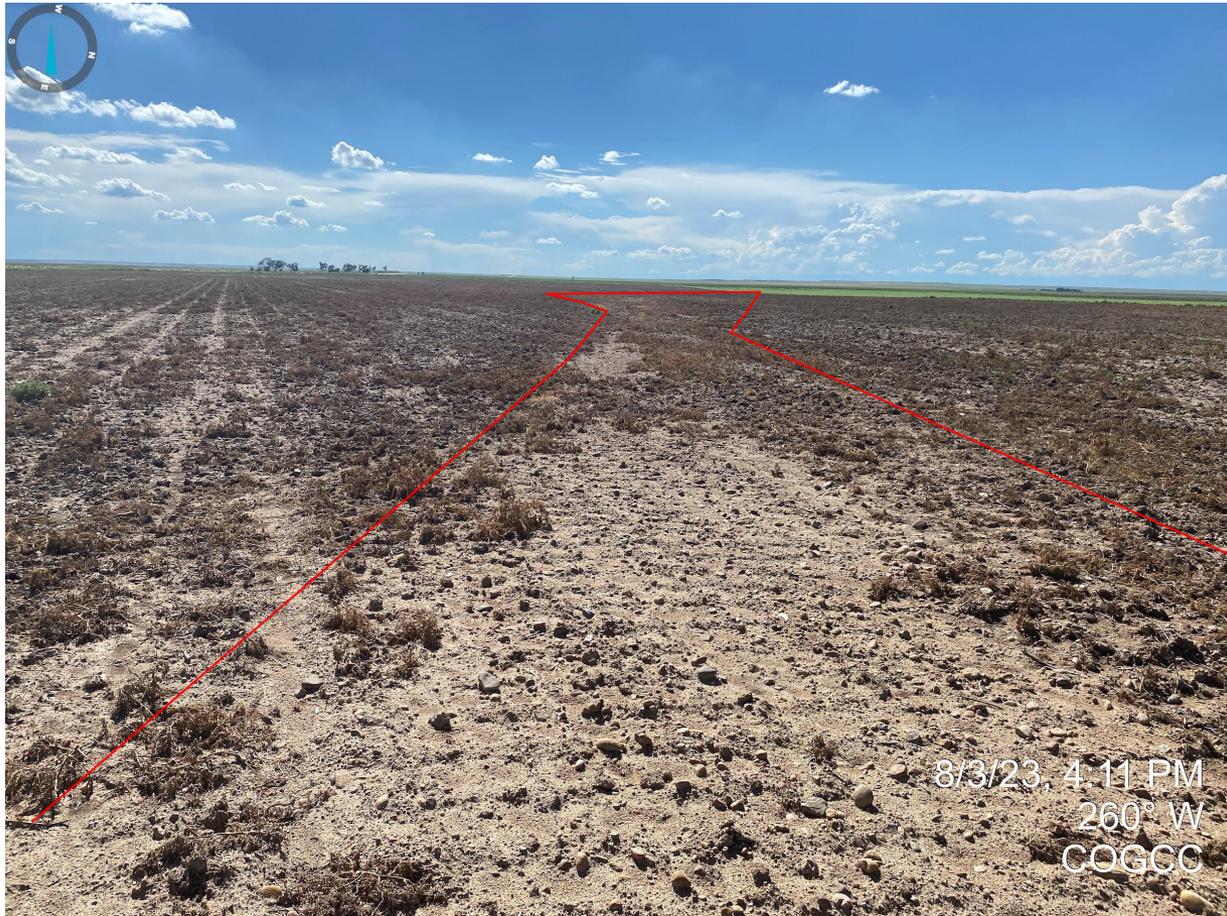
Photo 6. Facing west from the access road. Road base/gravel is evident and requires removal per Rule 1004.

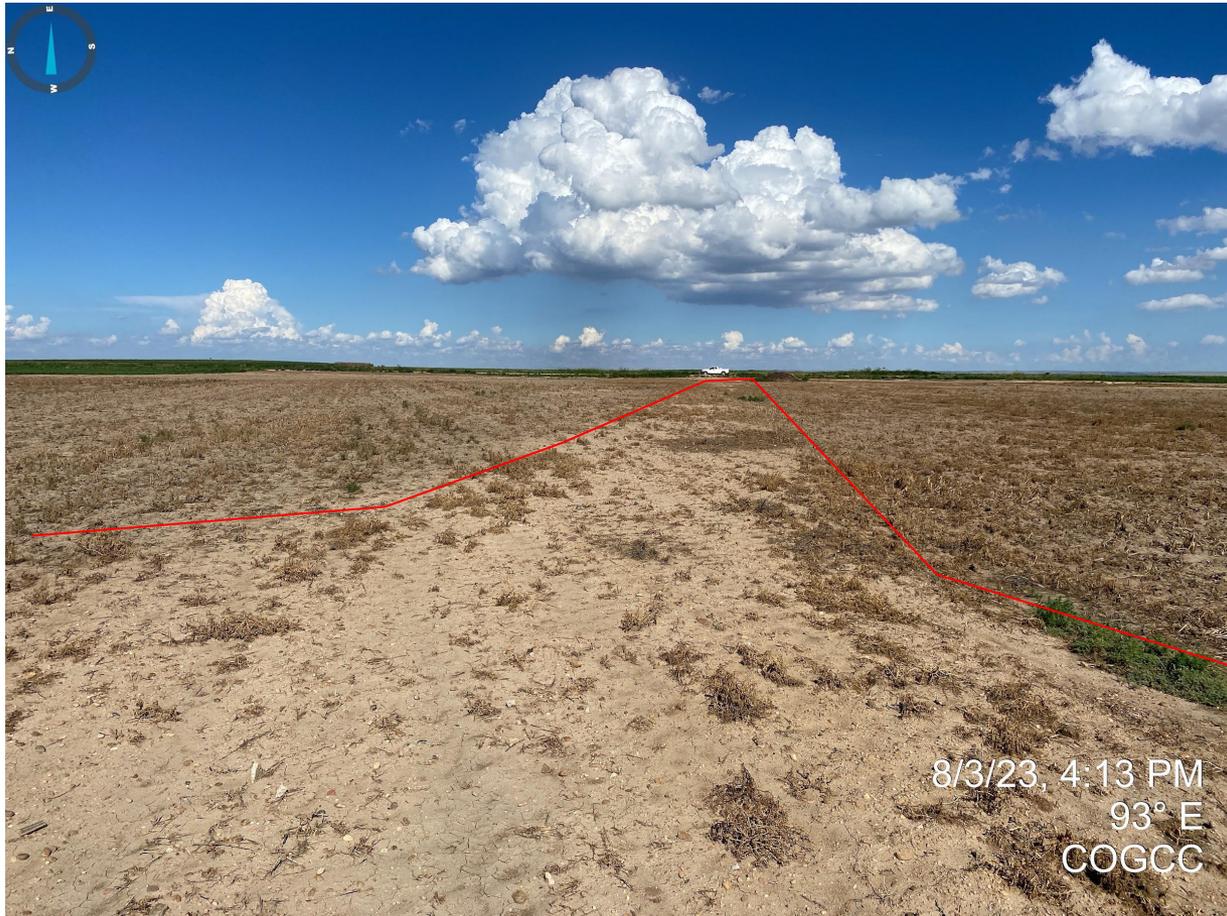
Photo 7. Taken from the former well head. Red outline illustrates the access road that requires additional reclamation activities including but not limited to- recontouring/grading, leveling, removal of road base/gravel, and decompaction.

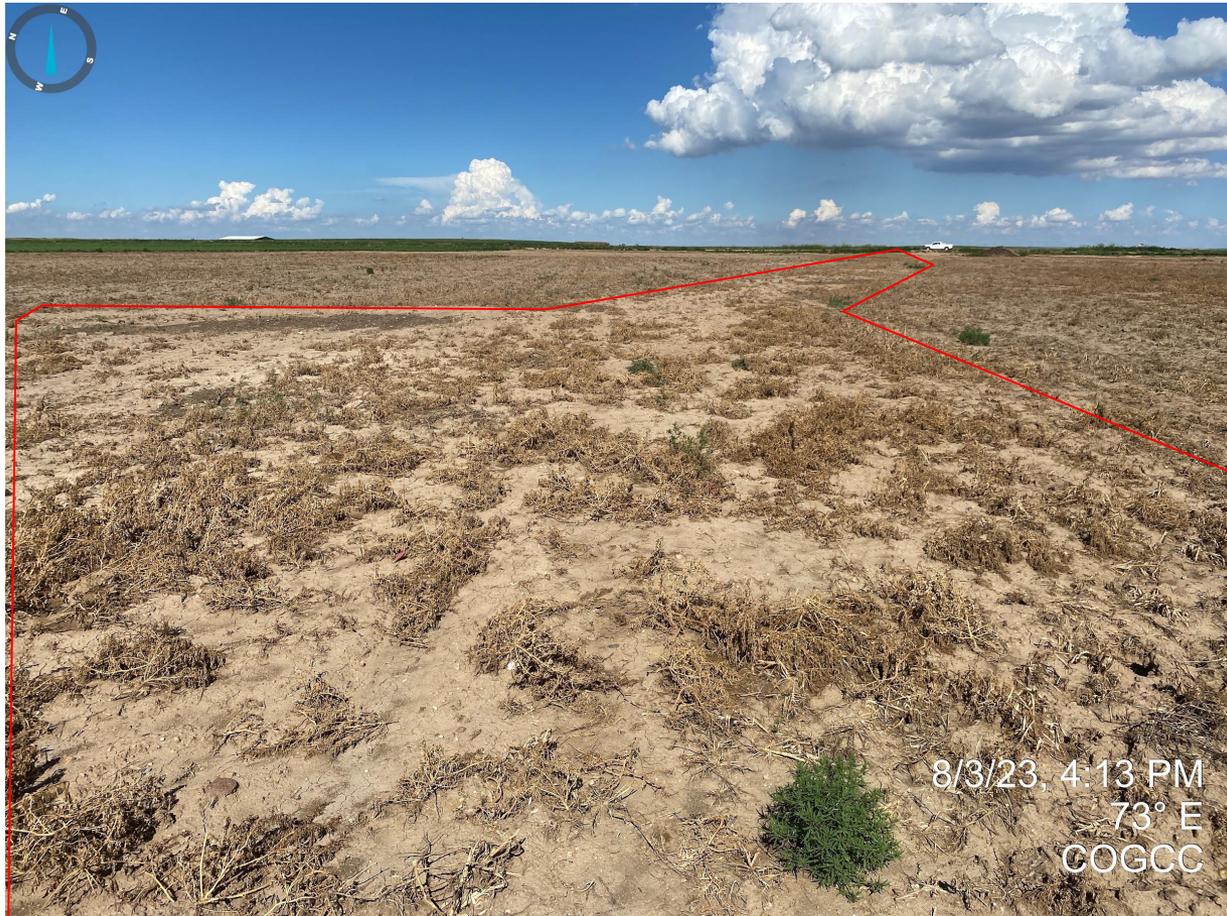
Photo 8. Taken from the former well location. The former well location will require additional reclamation activities including but not limited to- recontouring/grading, leveling, removal of road base/gravel, and decompaction.

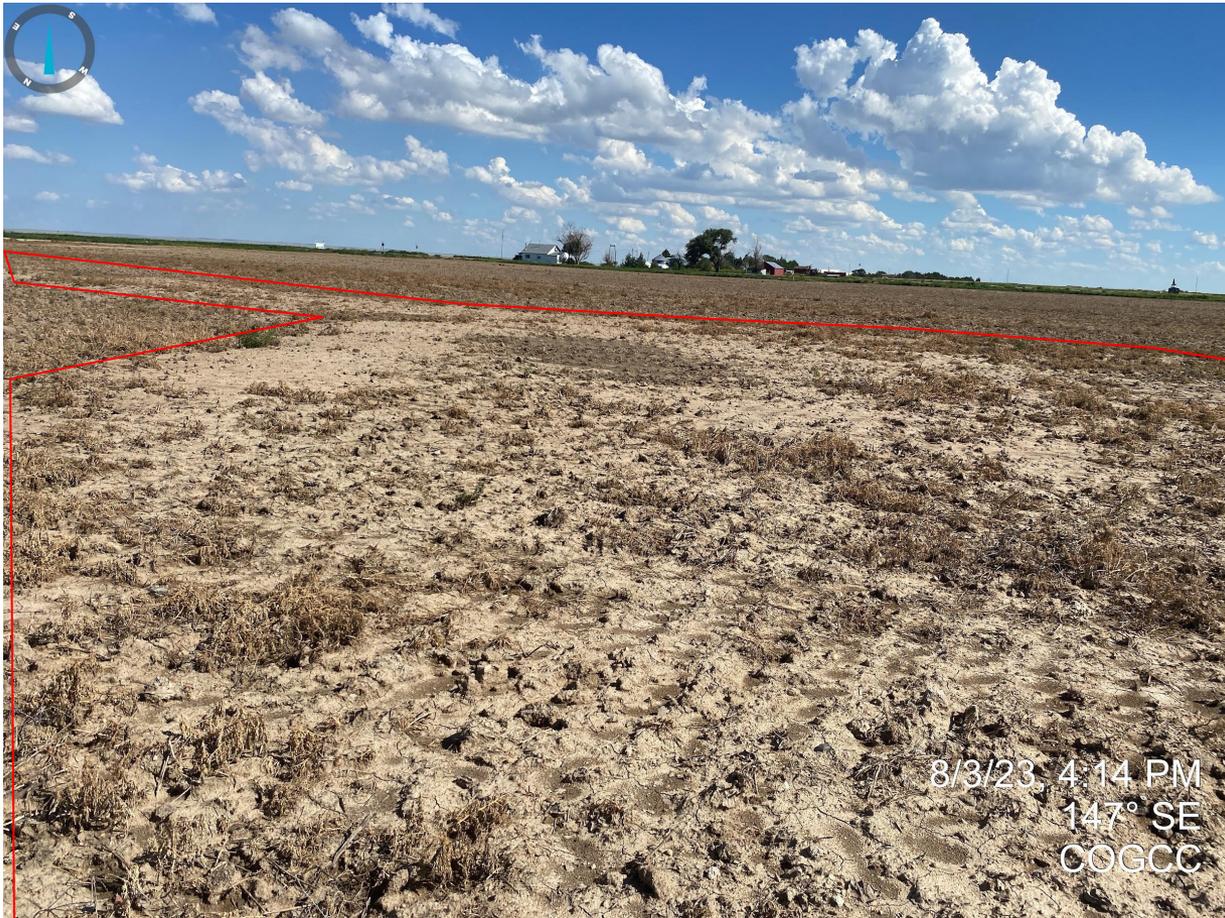
Photo 9. See comments in Photo 8.

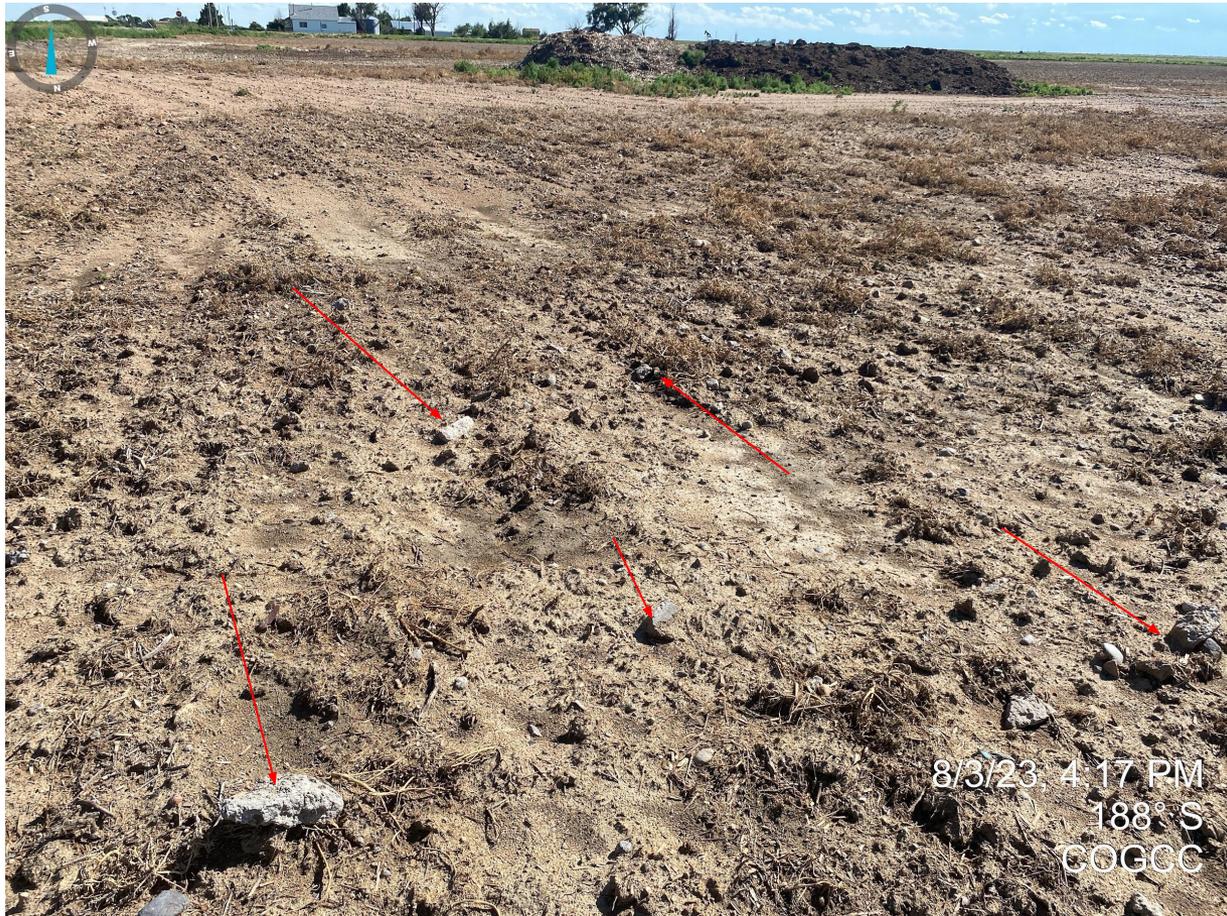
Photo 10. Concrete debris observed north of the former production areas will require proper disposal.

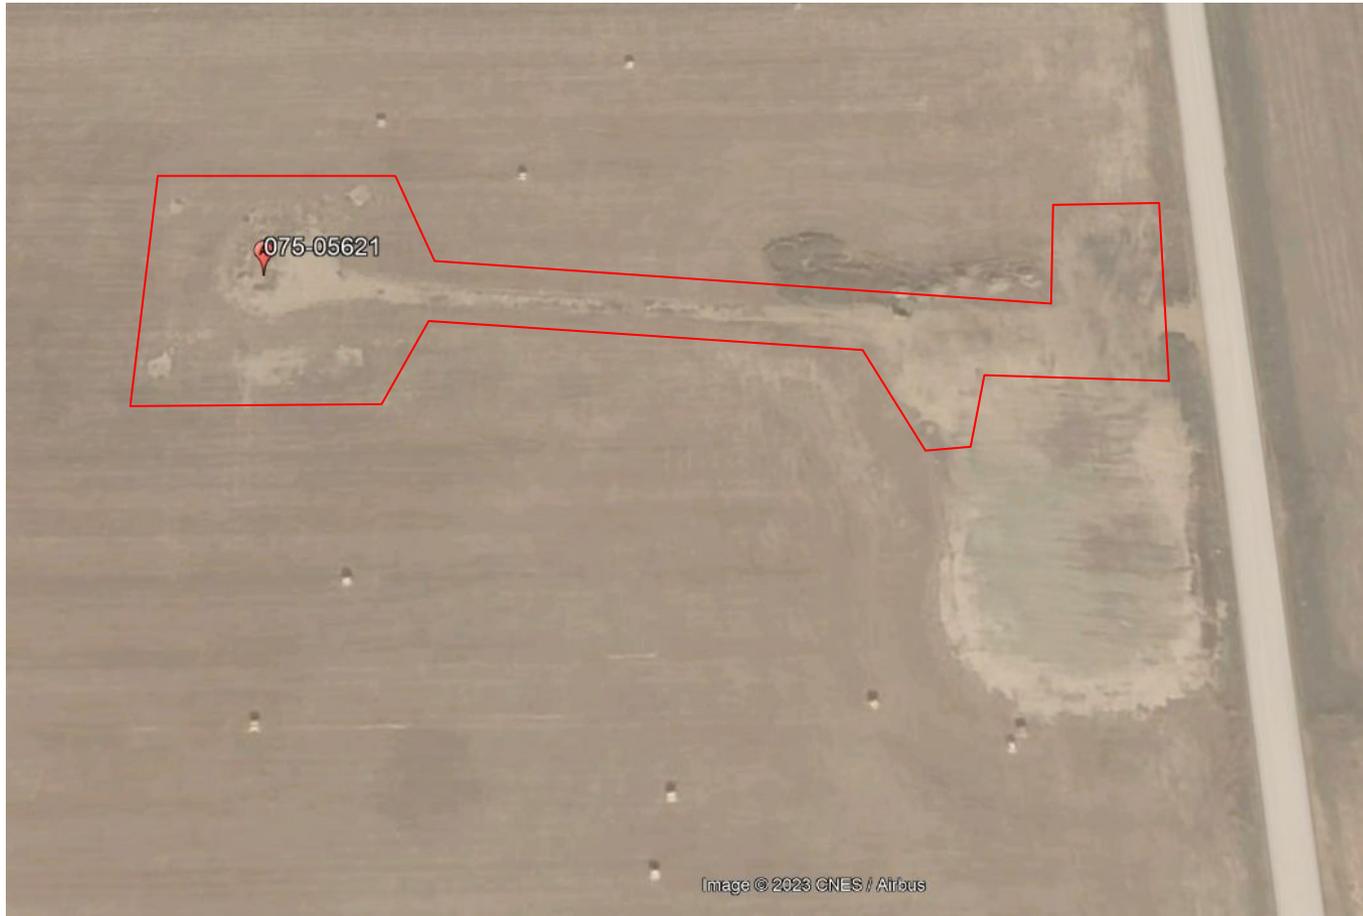
Photo 11. Google Earth aerial imagery (circa 10/2020) illustrating red outline of former access road, well location, and production area disturbances that will require final reclamation activities ASAP. Active remediation should not preclude the commencement of final reclamation activities on the above identified areas. Final reclamation should have been completed by 07/22/2019, per 1004 Rules.
