Interim Reclamation and Stormwater Inspection

Operator: UPLAND EXPLORATION LLC- #10701

Location ID: 462908

Inspection Photos
Location Name: Little Lady 21/North Well Pad
Location ID: 462908

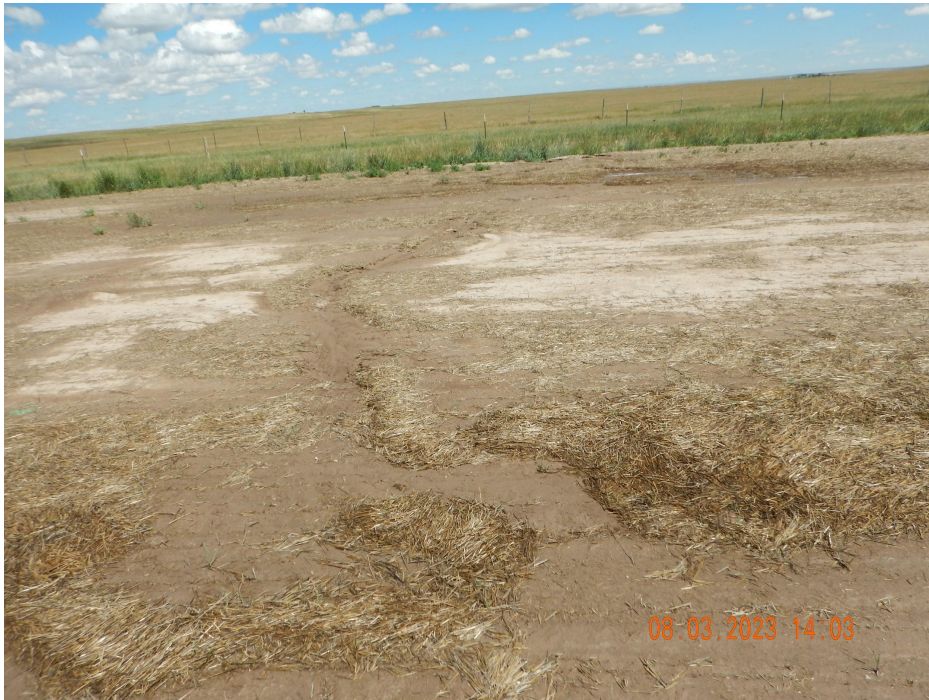
Photo 1. Photo taken from the southeastern location, facing East. Photo illustrates interim reclamation areas have been reseeded; however, erosion that was previously observed is in need of repair.

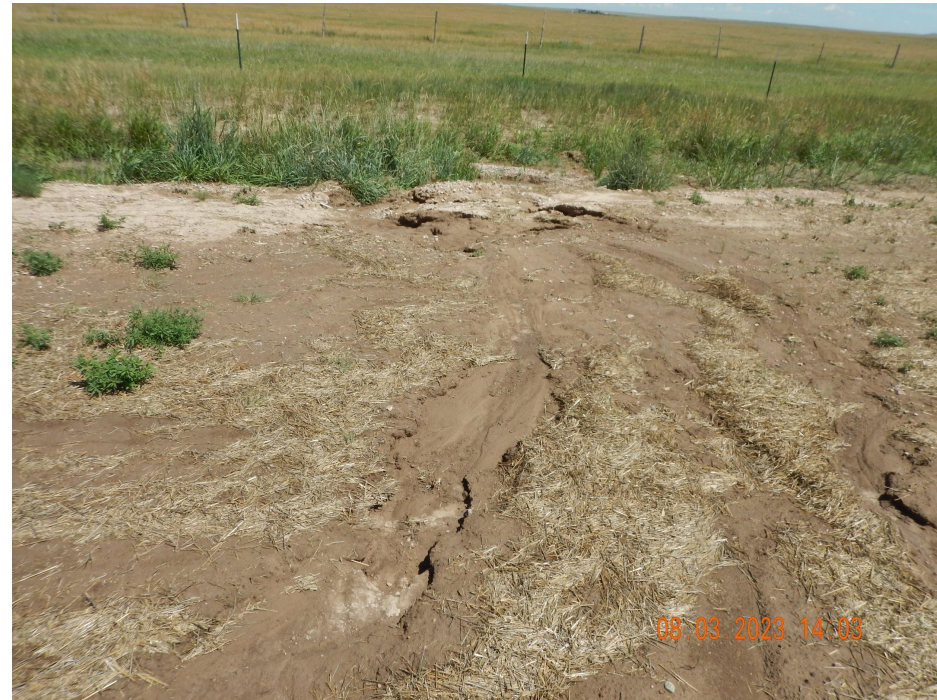
Photo 2. Close up photo taken of the erosion needing repair.

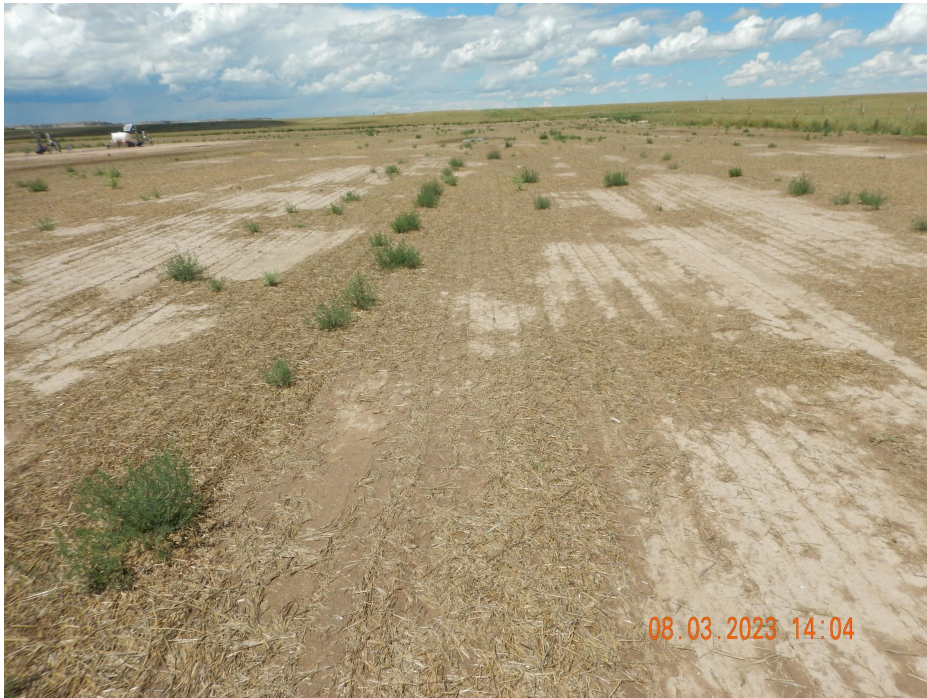
Photo 3. Photo taken from the southeastern location, facing North. Photo illustrates interim reclamation areas have been reseeded. There was some desirable germination observed; however, Staff is not comfortable putting this In-Process until further germination of desirable species is established.

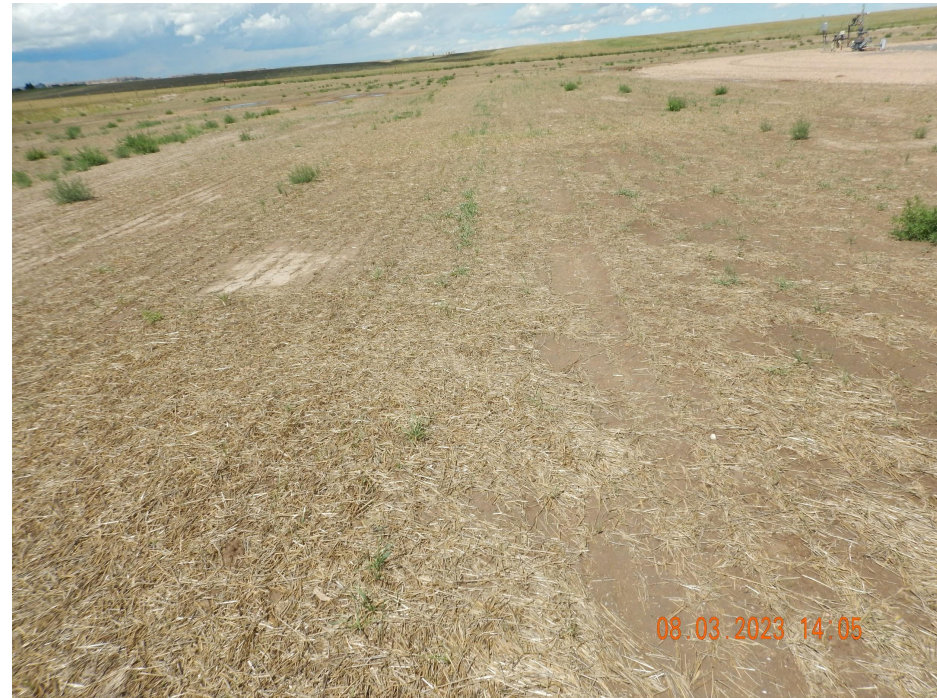
Photo 4. Photo taken from the southwestern location, facing North. See comments under Photo 3.

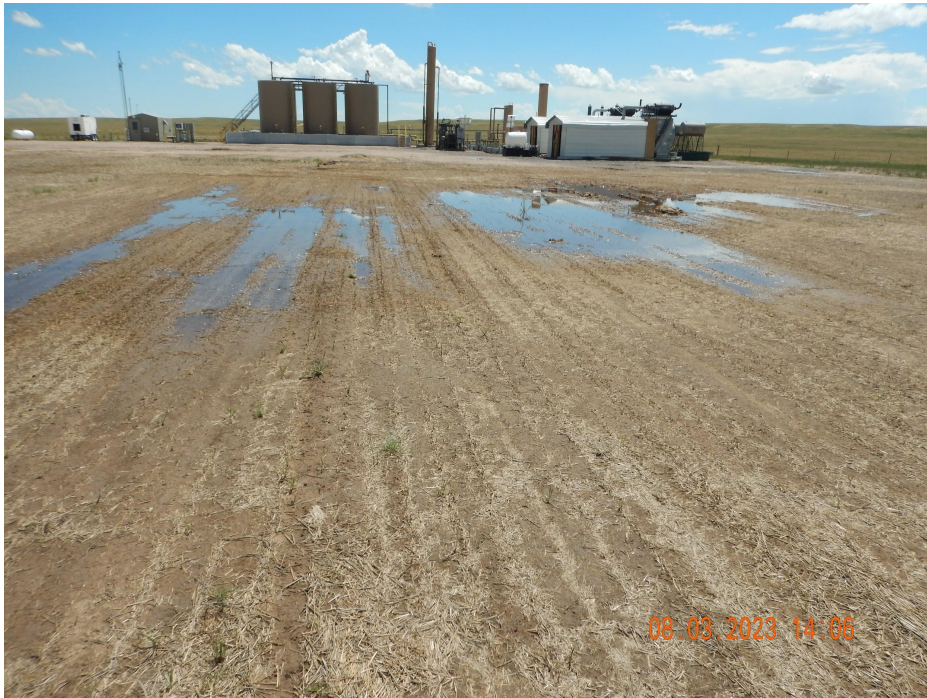
Photo 5. Photo taken from the southwestern location, facing South. See comments under Photo 3.

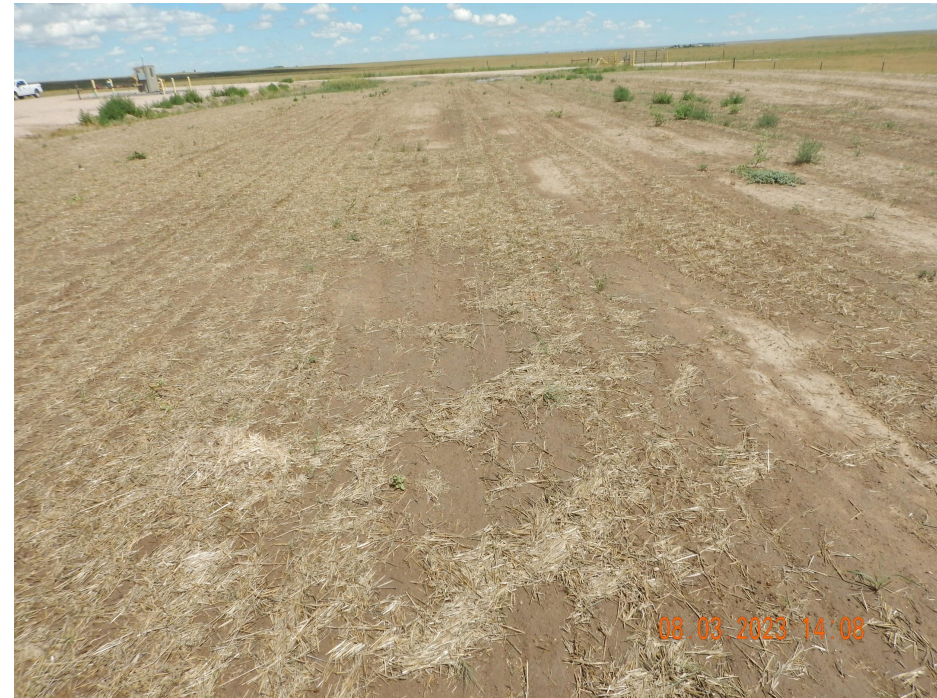
Photo 6. Photo taken from the topsoil stockpile, facing East. Photo illustrates the topsoil stockpile has been reseeded; however, Staff is not comfortable putting this In-Process until further germination of desirable species is established.
