Inspection Photos

8/14/2023

Operator: GENESIS GAS & OIL COLORADO LLC
- 10384

Location Number: 316579
Rio Blanco County, CO

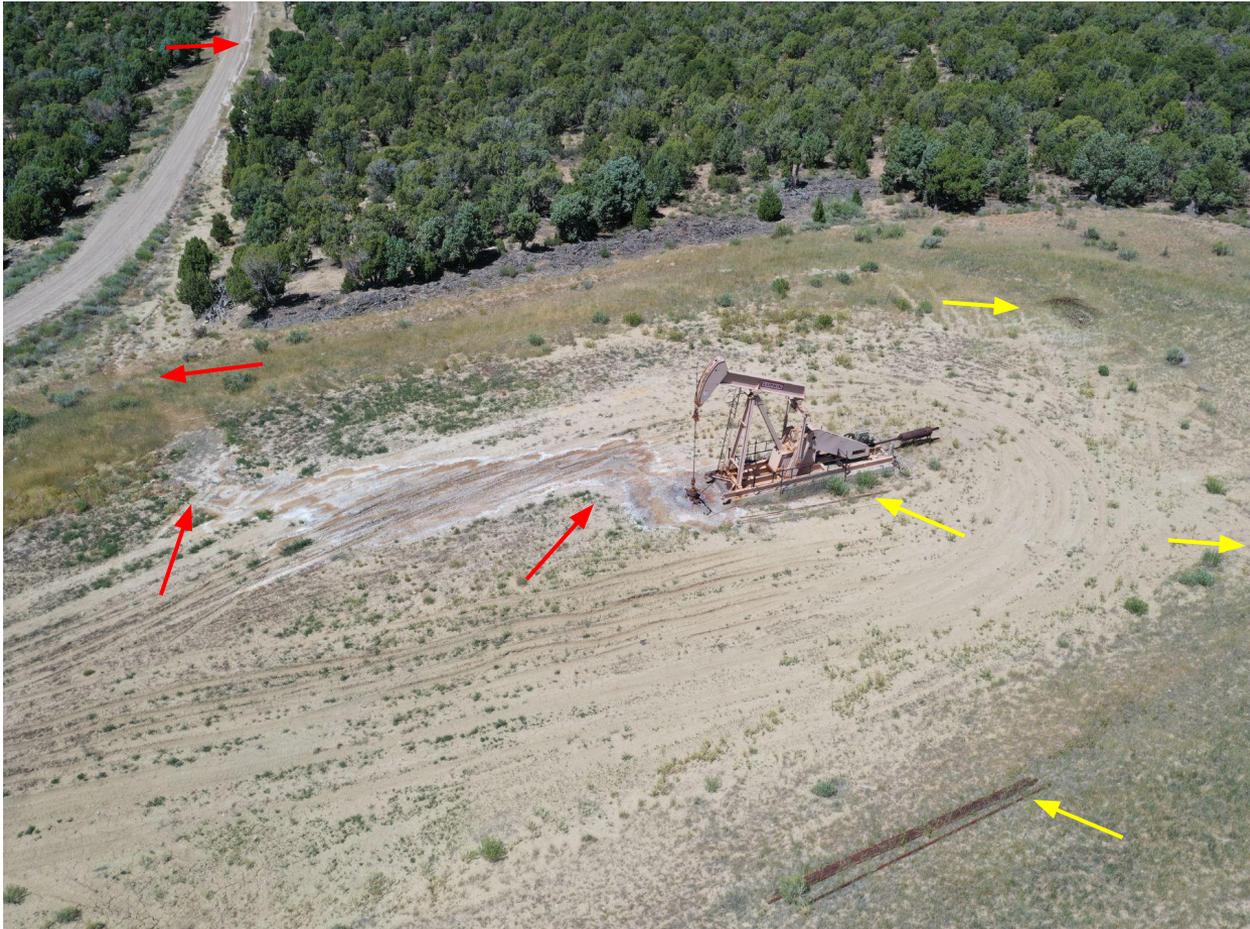
Photo 1: Photo taken with a sUAS. Photo shows that a spill/release of E&P waste fluids originating at the wellhead has impacted large areas of the Location and traveled off-site to the northwest along and on the lease road (red arrows); spill traveled approximately 1,000 feet from point of release to approximate end point. Photo also shows unused equipment/debris improperly stored on the Location (yellow arrows).

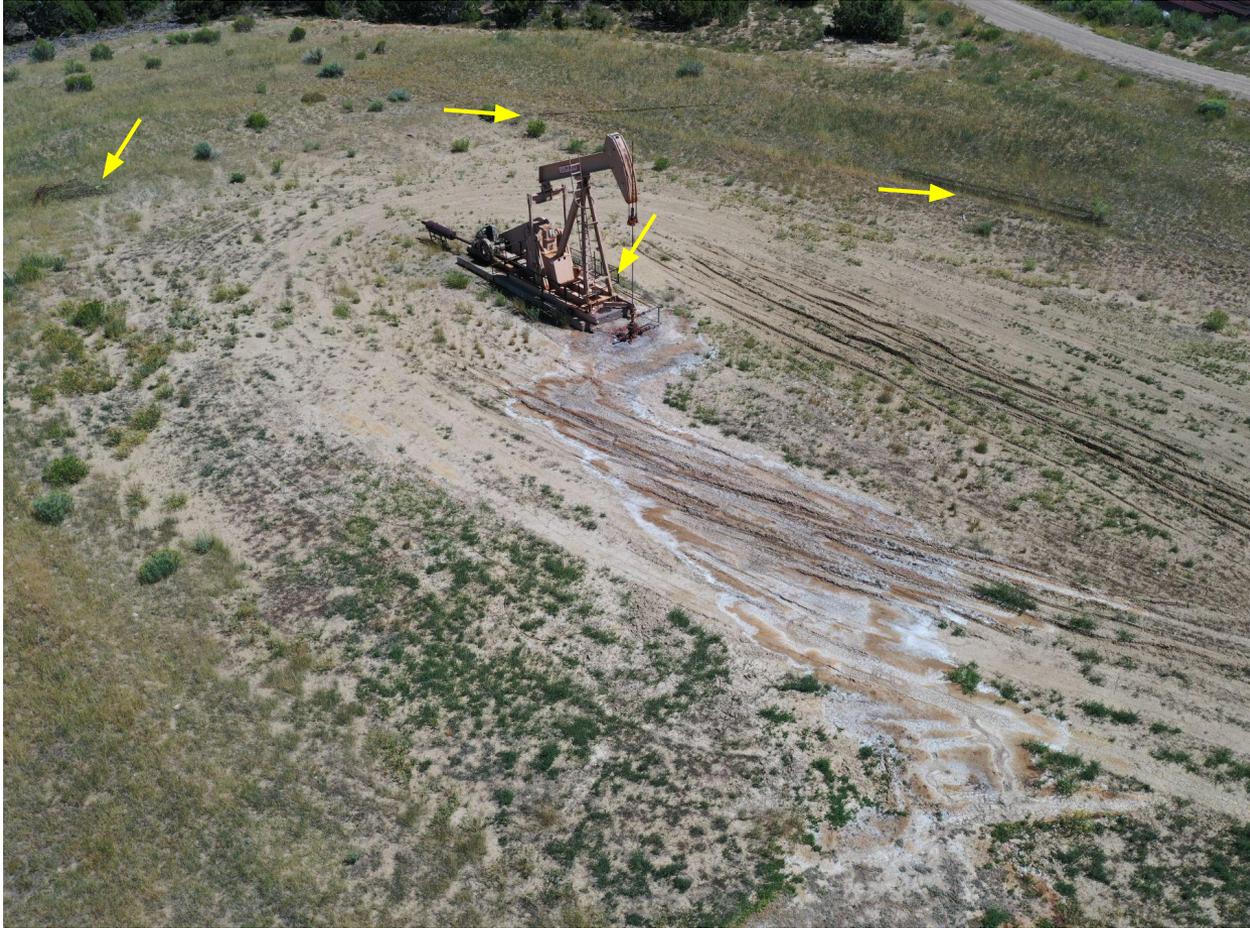
Photo 2: Photo taken with a sUAS. Photo shows that a spill/release of E&P waste fluids originating at the wellhead has impacted large areas of the Location and traveled off-site to the northwest along and on the lease road; spill traveled approximately 1,000 feet from point of release to approximate end point. Photo also shows unused equipment/debris improperly stored on the Location (yellow arrows).

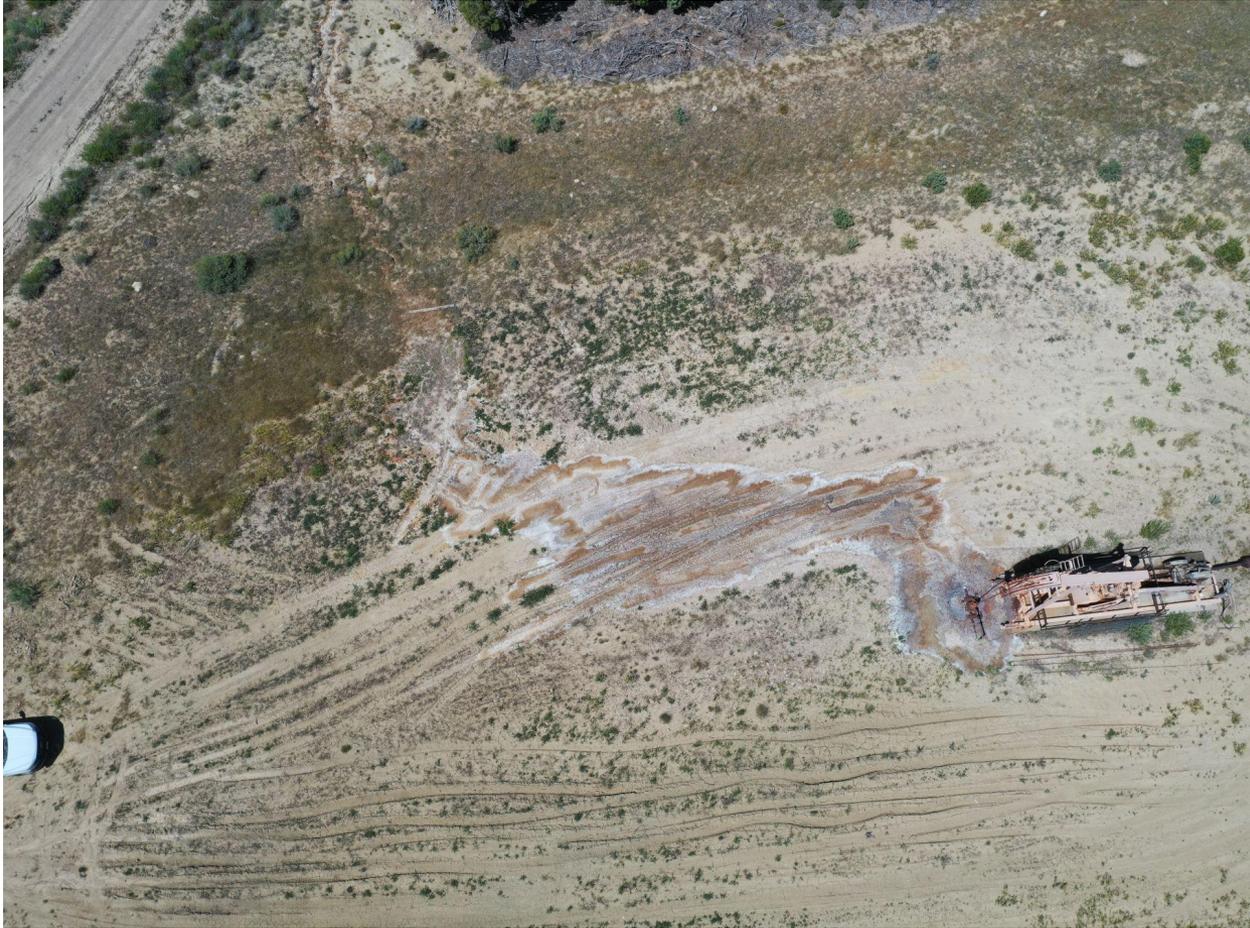
Photo 3: Photo taken with a sUAS. Photo shows that a spill/release of E&P waste fluids originating at the wellhead has impacted large areas of the Location and traveled off-site to the northwest along and on the lease road; spill traveled approximately 1,000 feet from point of release to approximate end point.

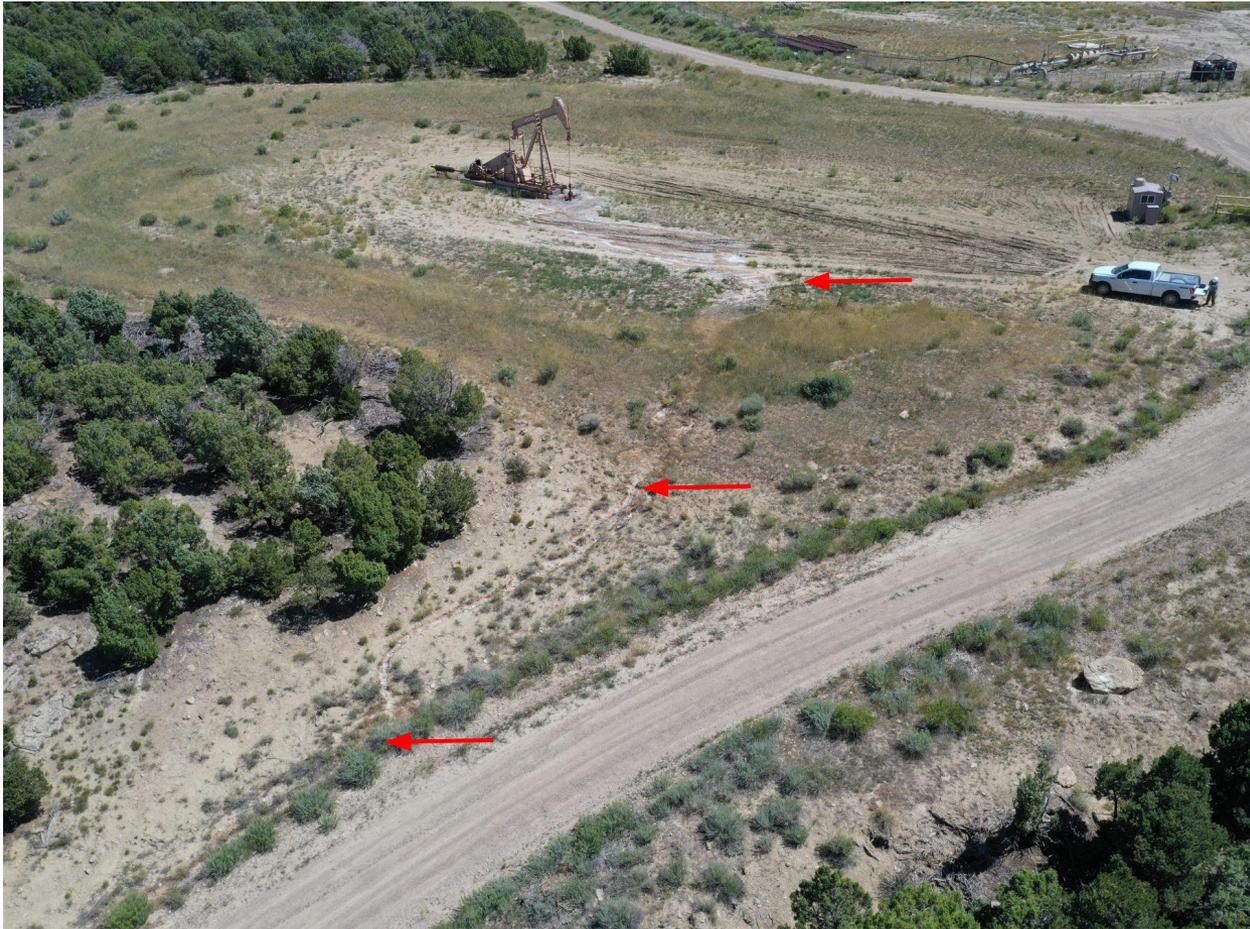
Photo 4: Photo taken with a sUAS. Photo shows that a spill/release of E&P waste fluids originating at the wellhead has impacted large areas of the Location and traveled off-site to the northwest along and on the lease road (red arrows); spill traveled approximately 1,000 feet from point of release to approximate end point.

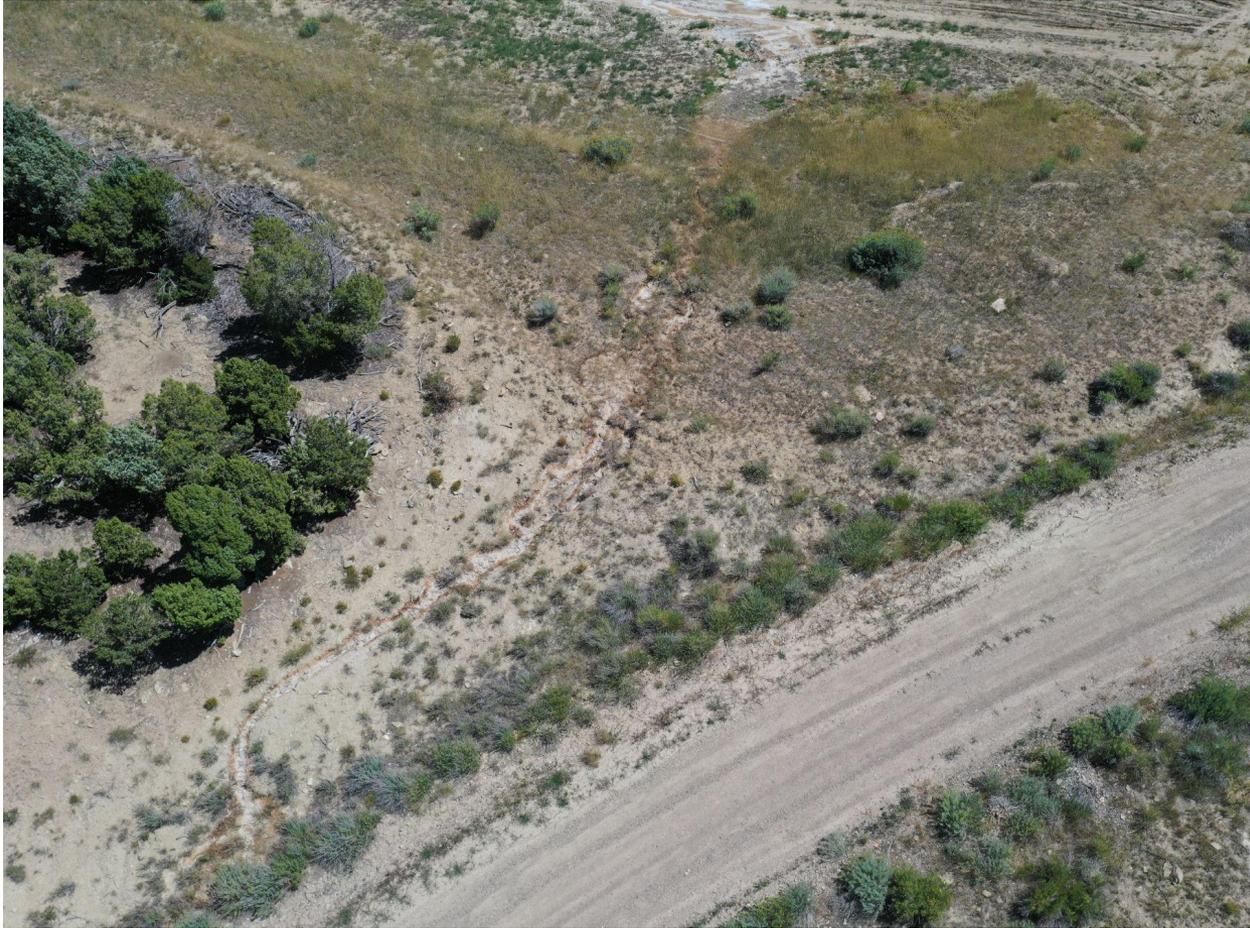
Photo 5: Photo taken with a sUAS. Photo shows that a spill/release of E&P waste fluids originating at the wellhead has impacted large areas of the Location and traveled off-site to the northwest along and on the lease road; spill traveled approximately 1,000 feet from point of release to approximate end point.

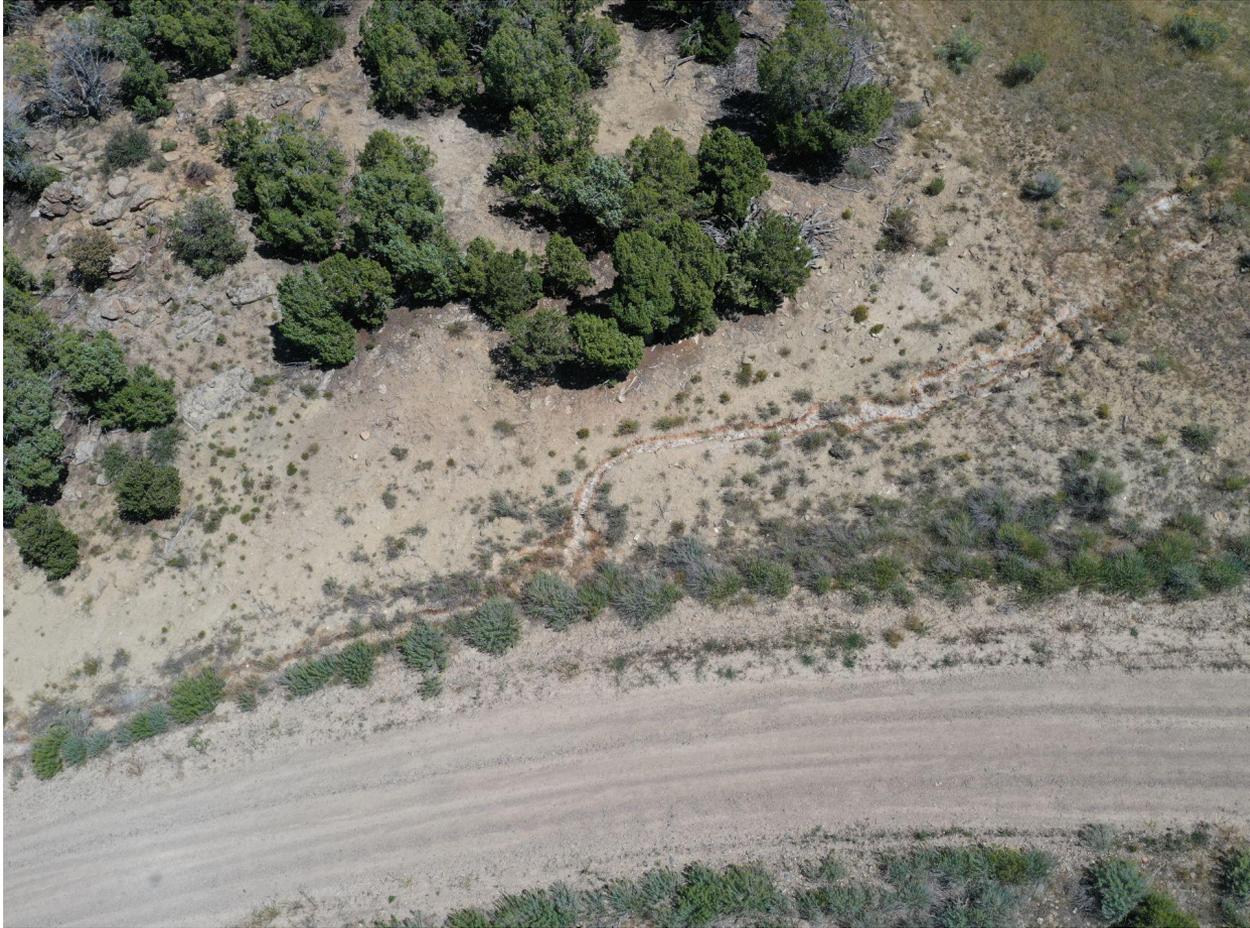
Photo 6: Photo taken with a sUAS. Photo shows that a spill/release of E&P waste fluids originating at the wellhead has impacted large areas of the Location and traveled off-site to the northwest along and on the lease road; spill traveled approximately 1,000 feet from point of release to approximate end point.

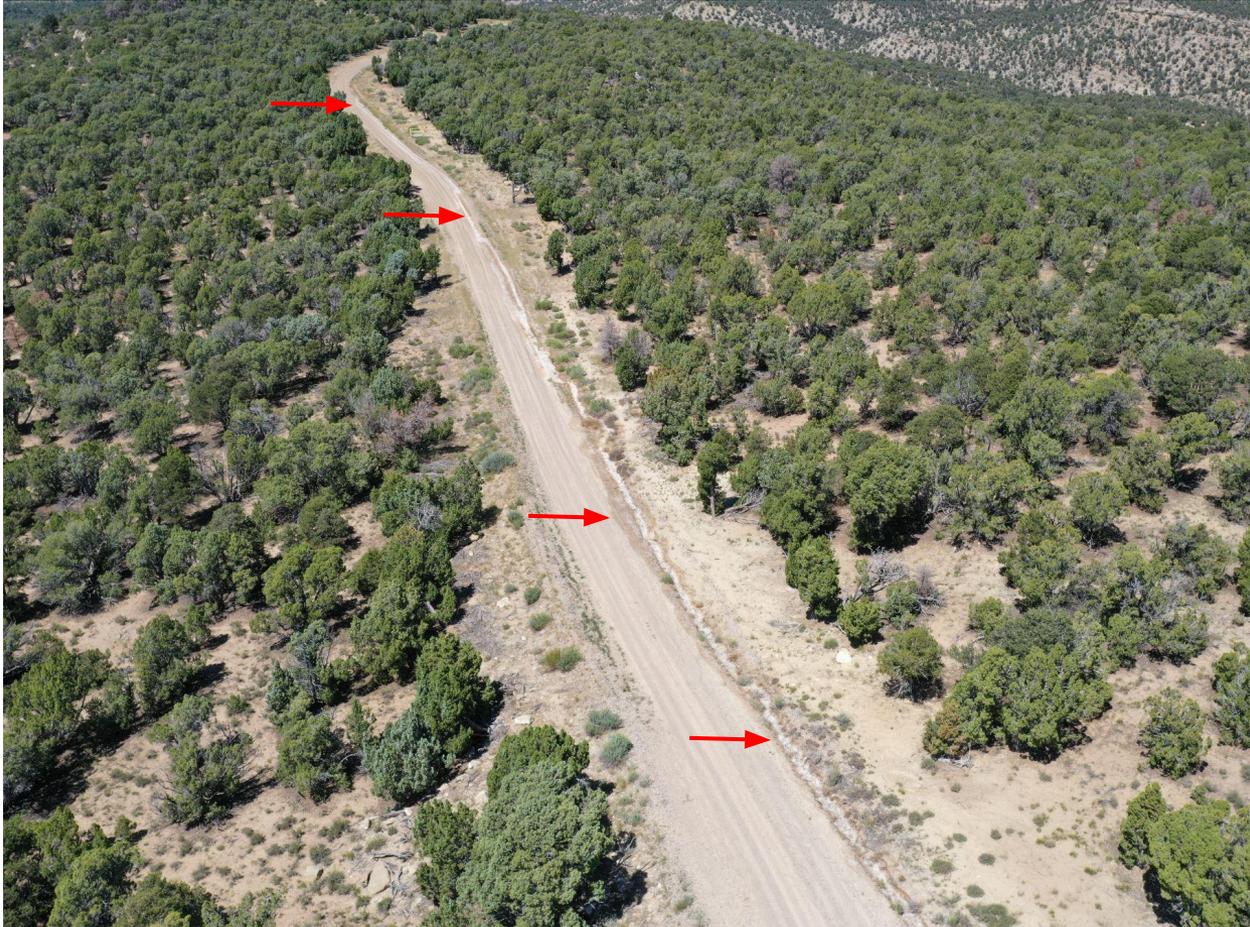
Photo 7: Photo taken with a sUAS. Photo shows that a spill/release of E&P waste fluids originating at the wellhead has impacted large areas of the Location and traveled off-site to the northwest along and on the lease road (red arrows); spill traveled approximately 1,000 feet from point of release to approximate end point.

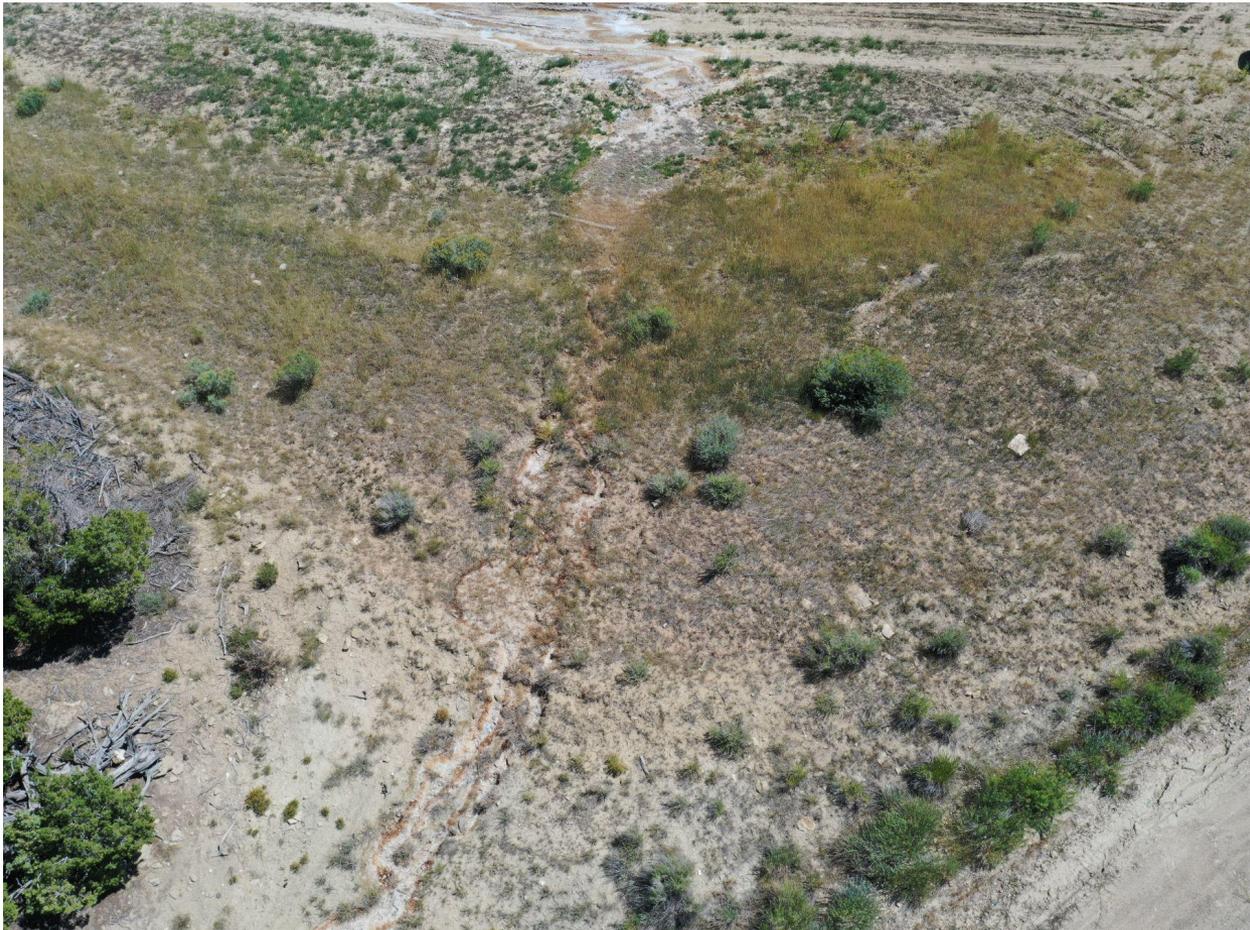
Photo 8: Degradation on slopes/interim areas due to spill/release.

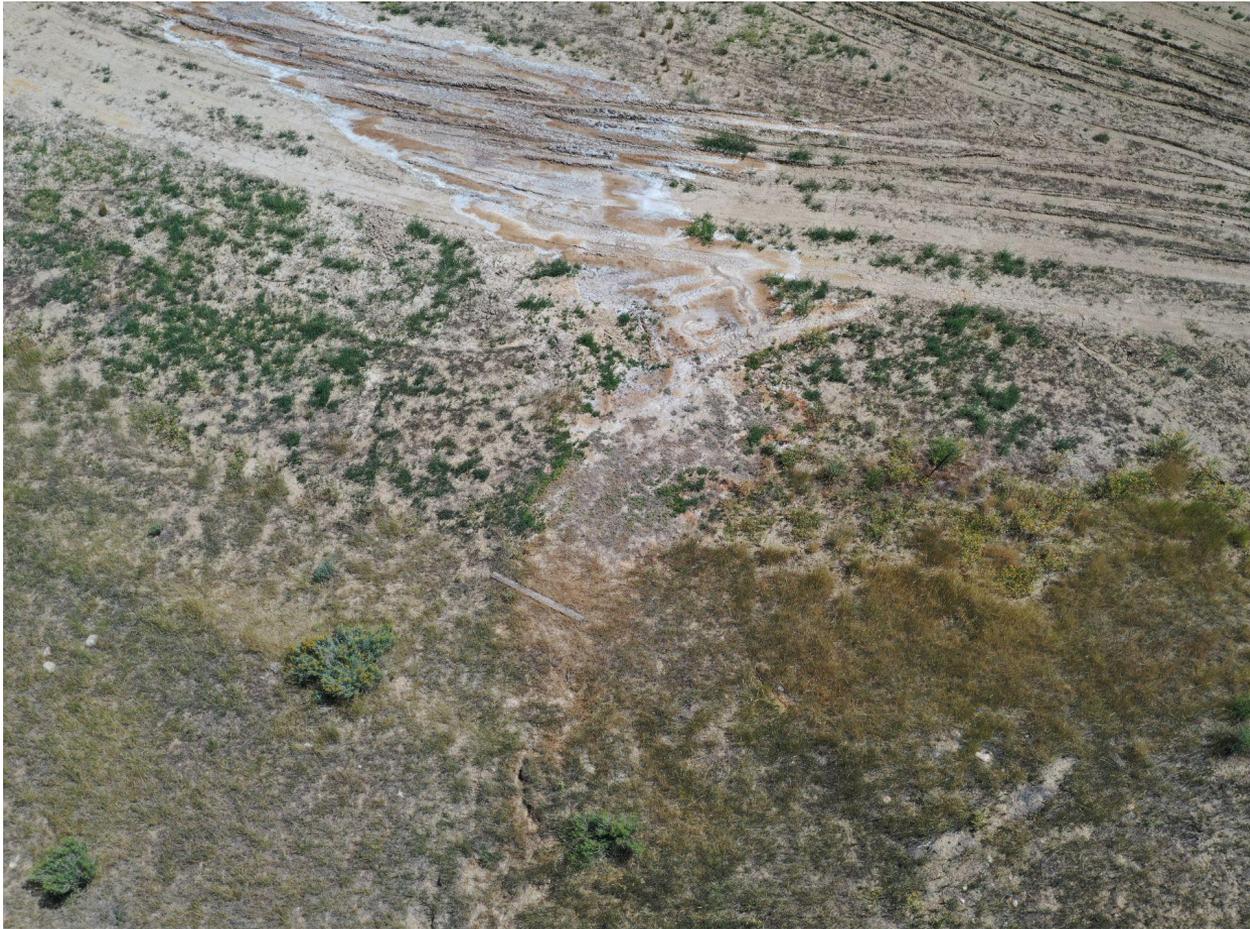
Photo 9: Degradation on slopes/interim areas due to spill/release.

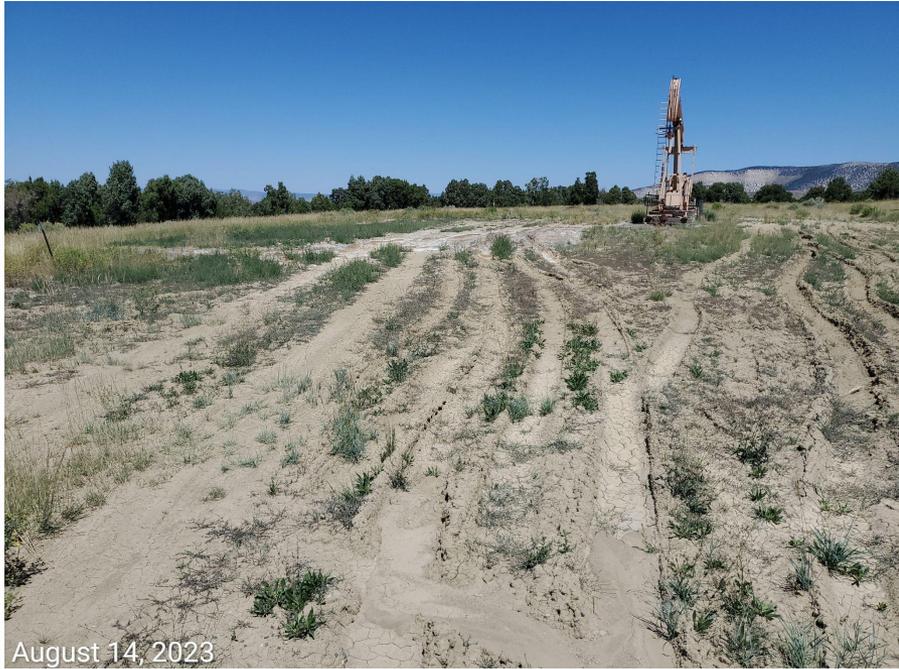
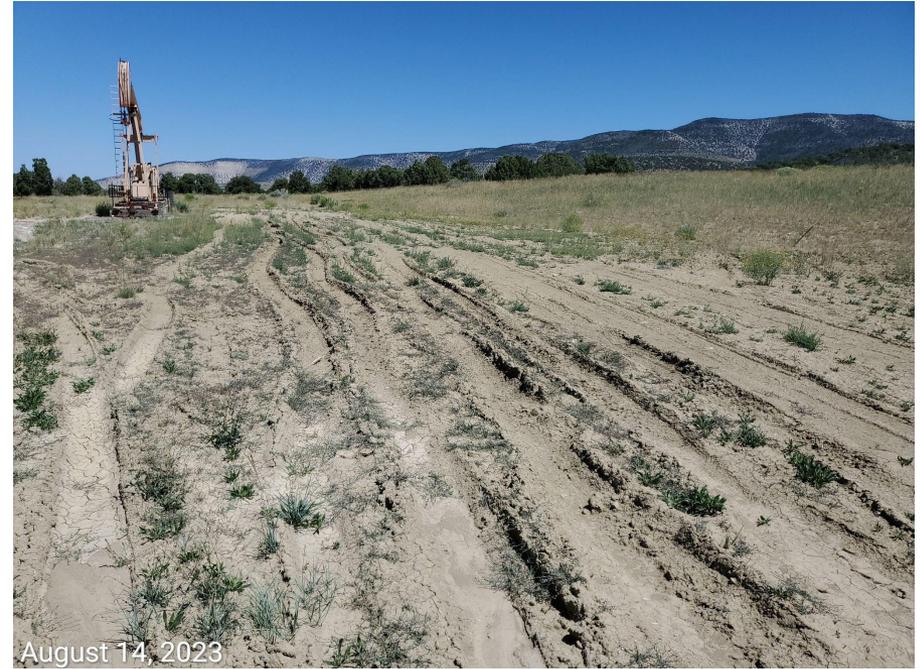
Photo 10: Photos taken from the west end of the Location, facing northeast and east. Photos provide overview of the Location. Photo also shows that stormwater, erosion and vehicle tracking control measures are missing or insufficient; Working pad lacks stabilization- rutting/tracking observed.

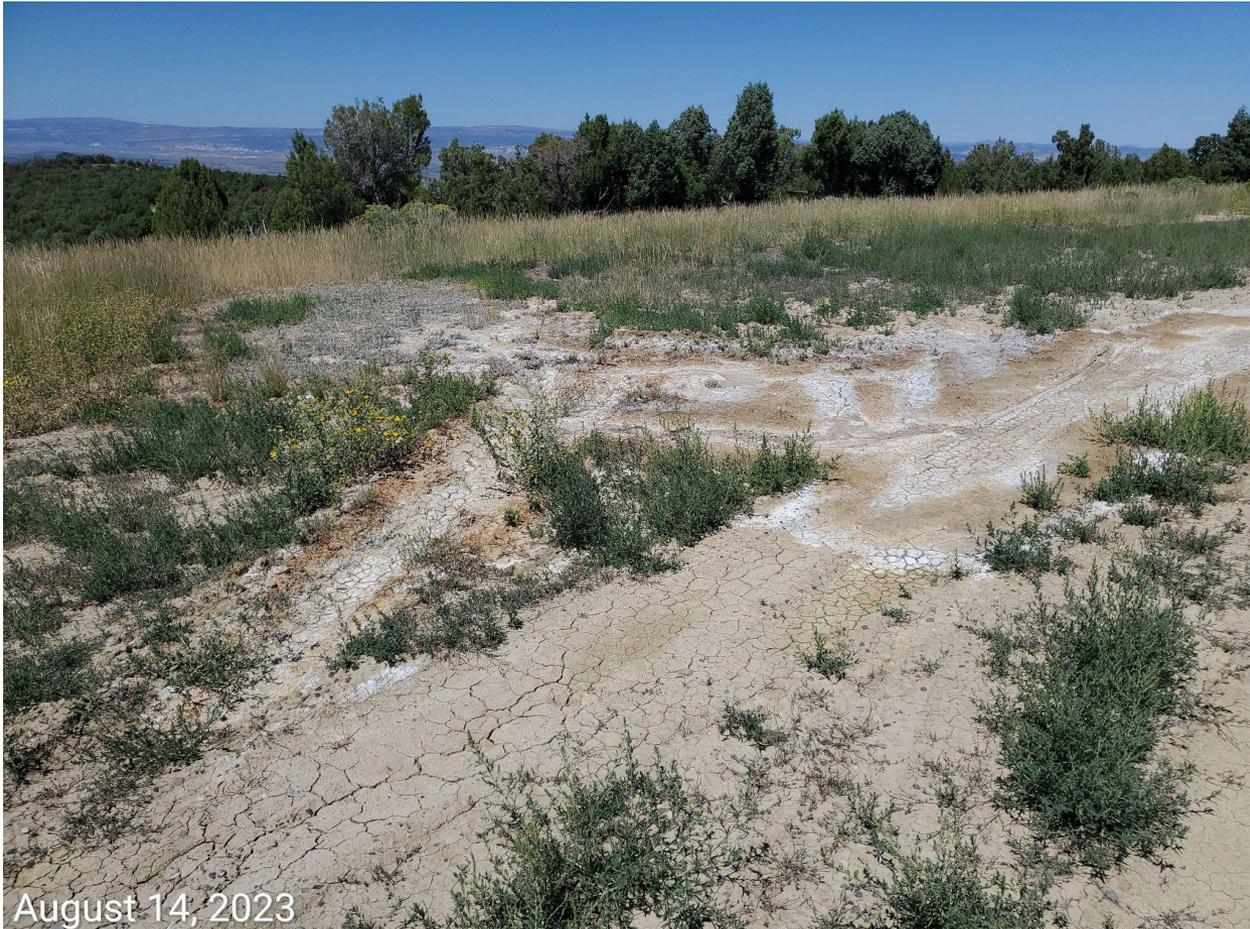
Photo 11: Photo taken from the west end of the working pad surface, facing north. Photo shows spill/release of E&P waste fluids originating at the wellhead has impacted large areas of the Location and traveled off-site.

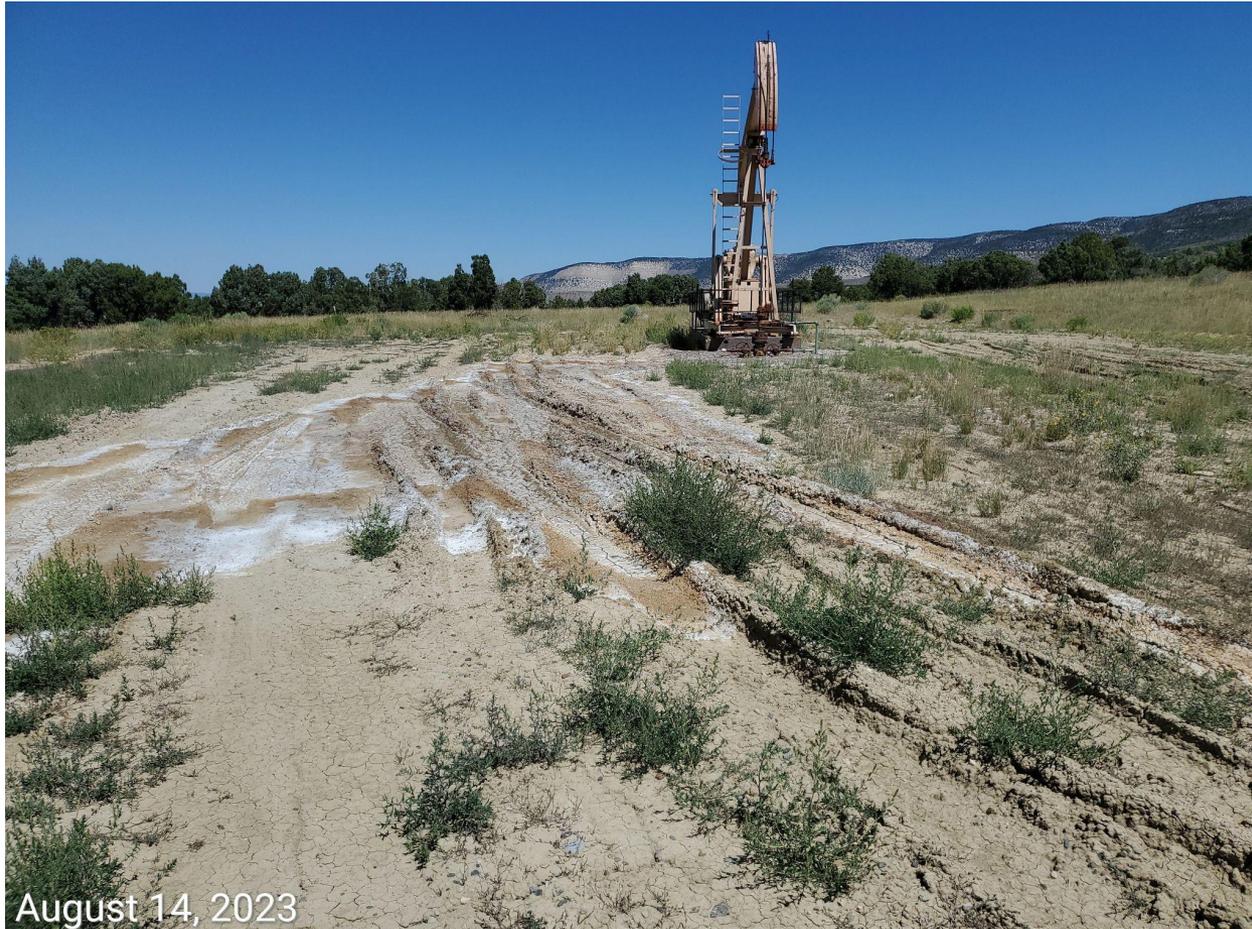
Photo 12: Photo shows spill/release of E&P waste fluids originating at the wellhead has impacted large areas of the Location.

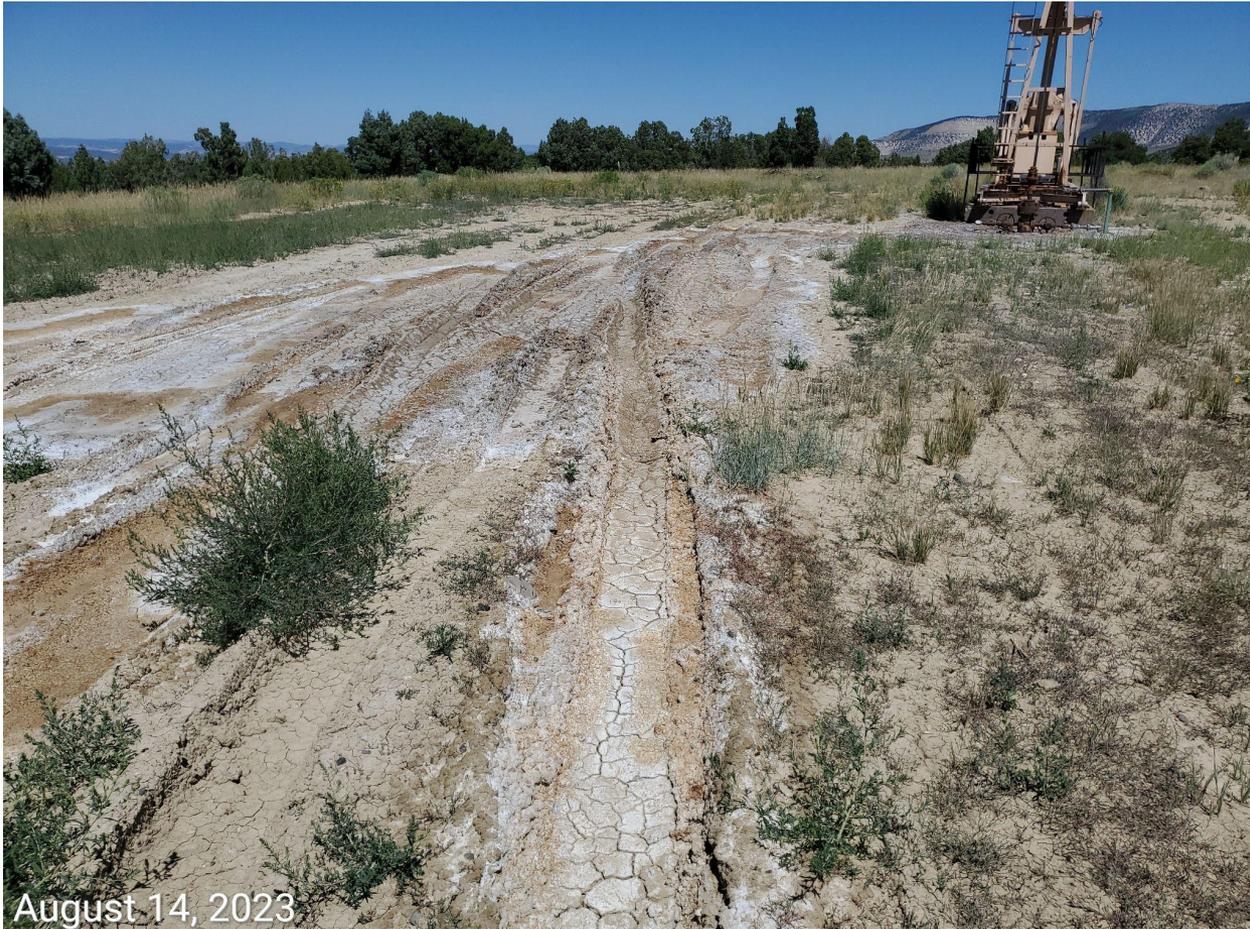
Photo 13: Photo shows spill/release of E&P waste fluids originating at the wellhead has impacted large areas of the Location.

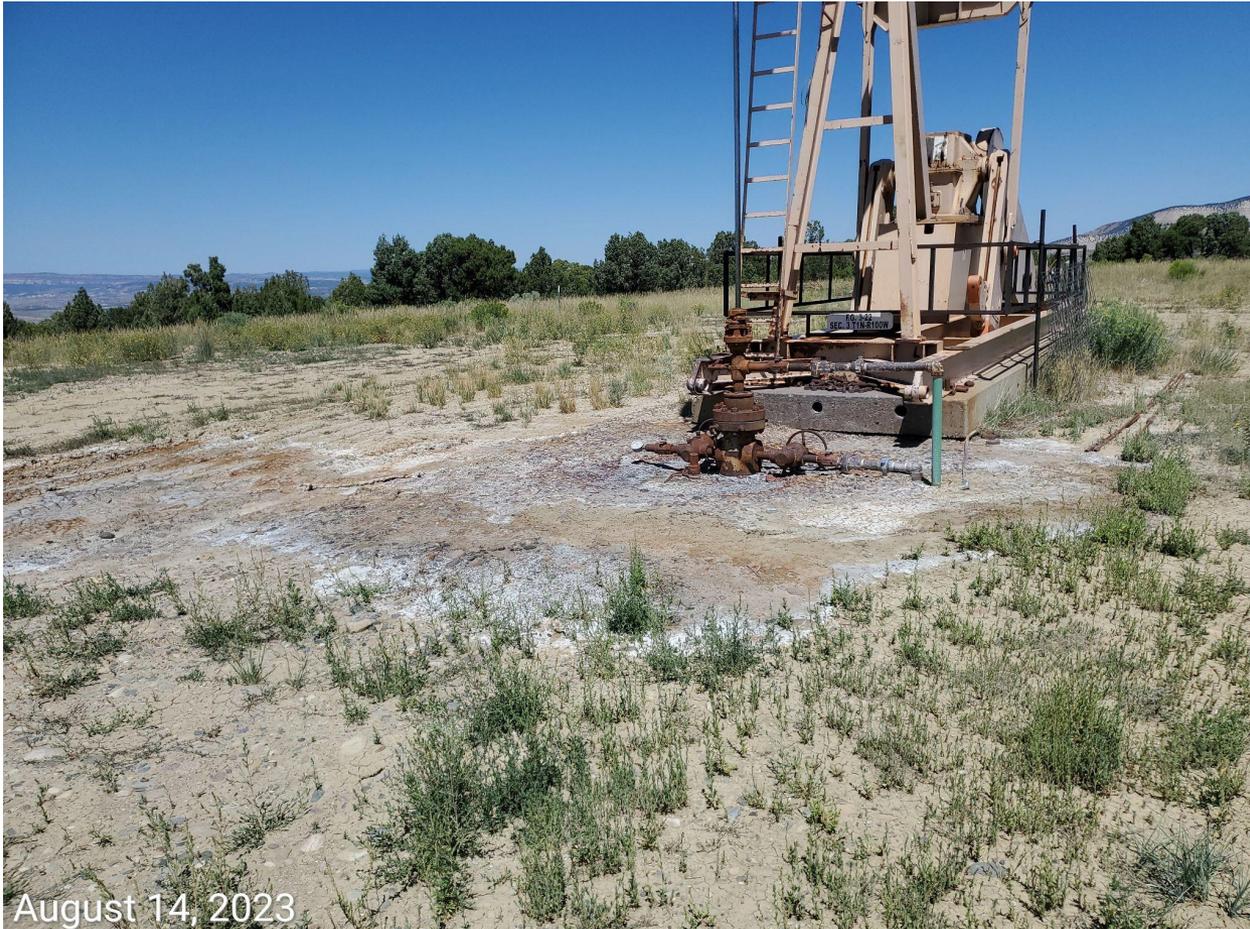
Photo 14: Photo shows spill/release of E&P waste fluids originating at the wellhead has impacted large areas of the Location.

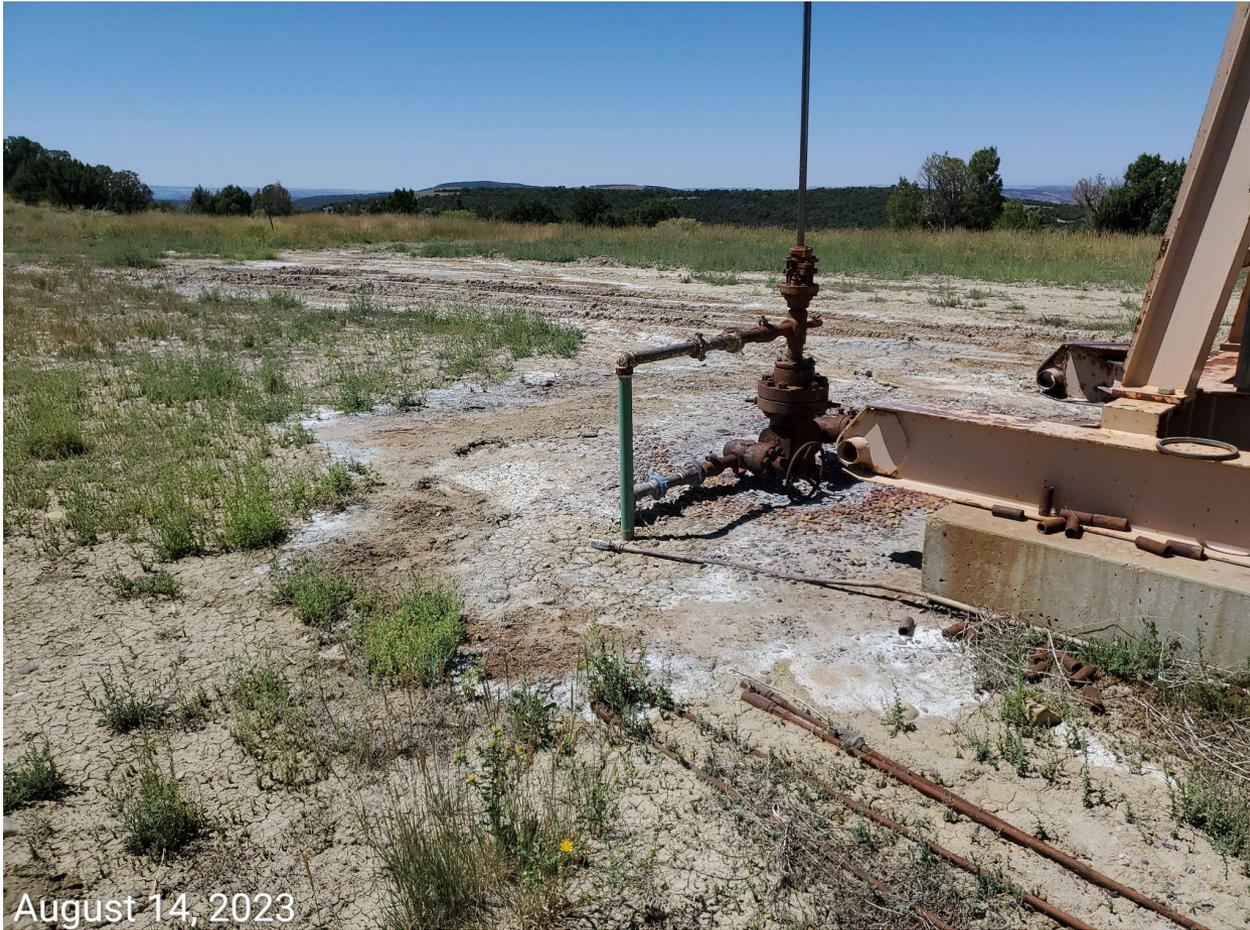
Photo 15: Photo shows spill/release of E&P waste fluids originating at the wellhead has impacted large areas of the Location.

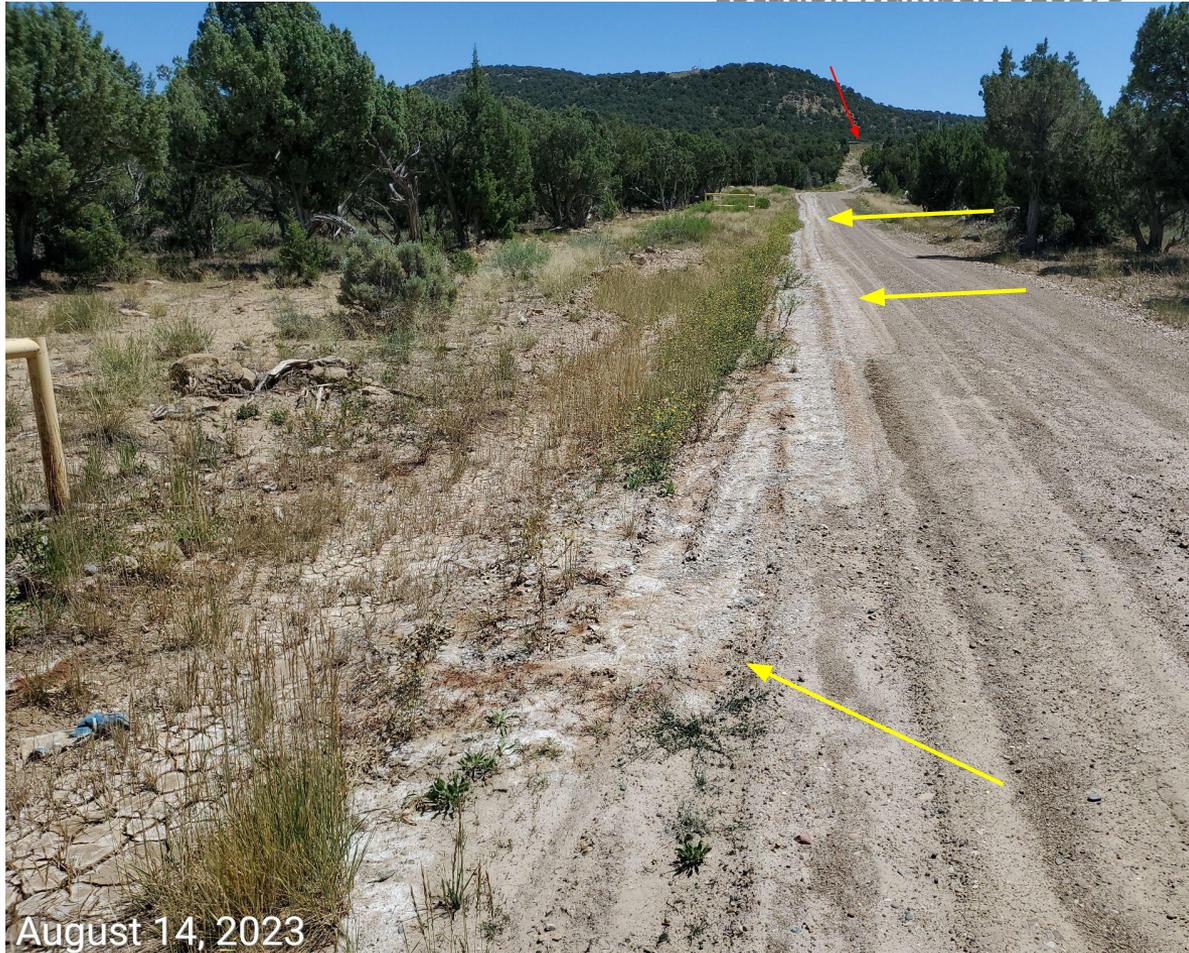
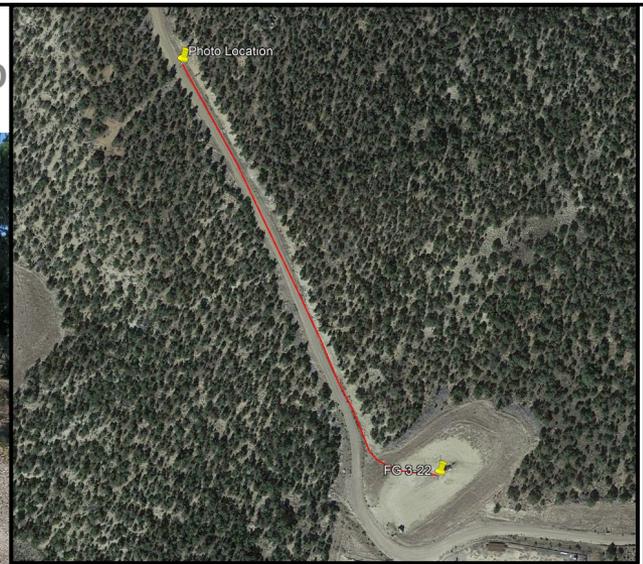
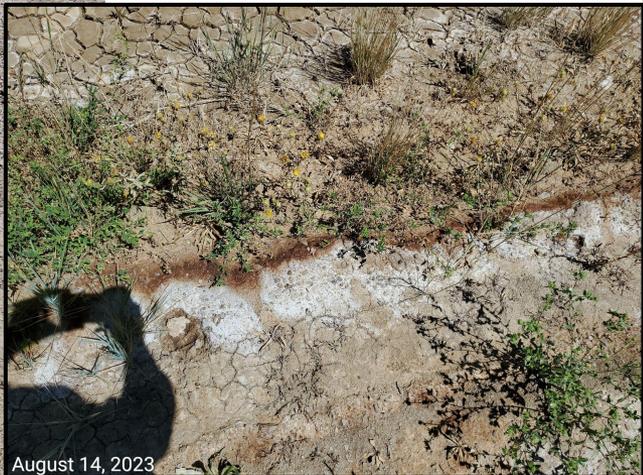
Photo 16: Photo taken from the access road north of the Location, facing south. Photo shows approximate end point of the spill/release, ~1,000 feet from the wellhead (red arrow)

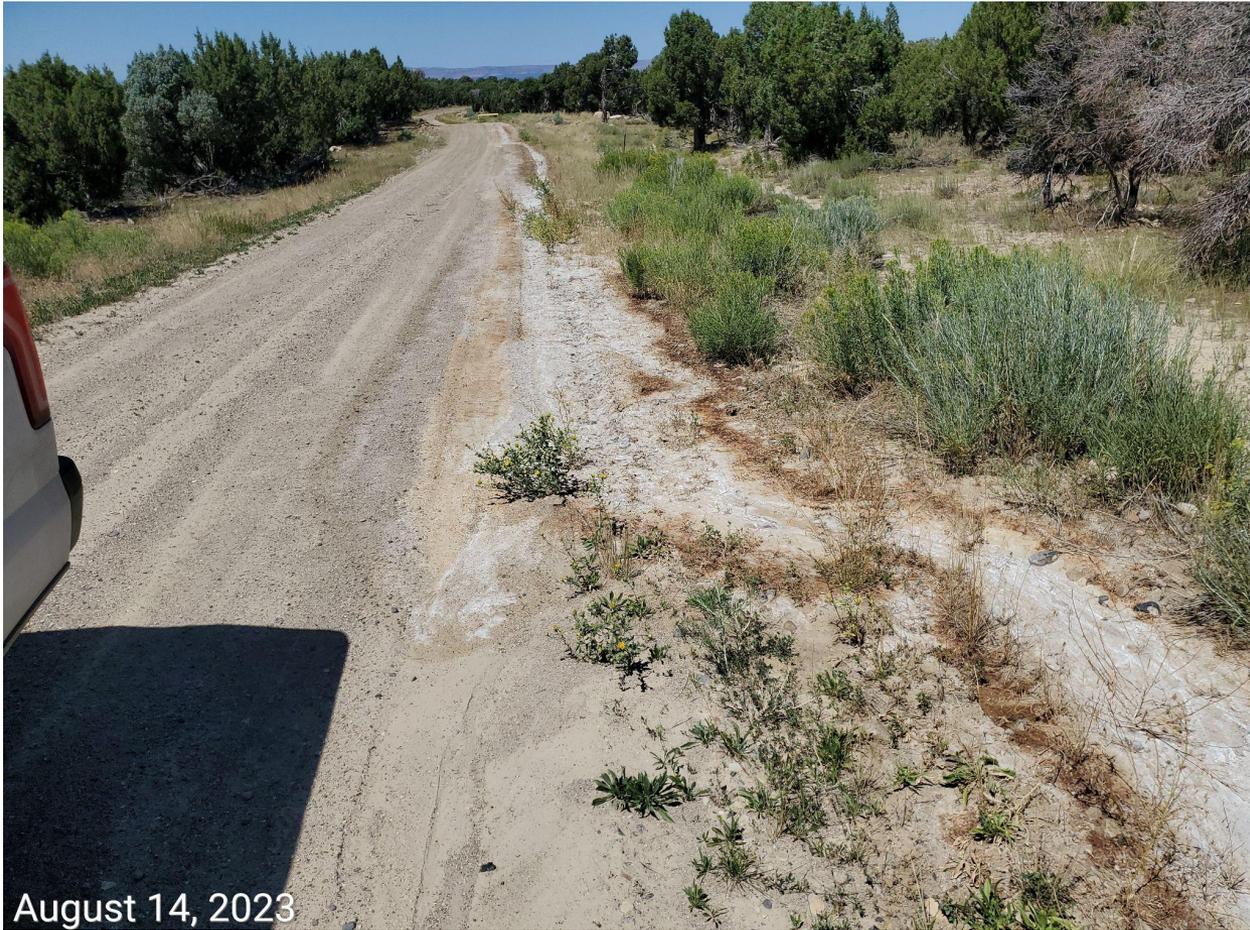
Photo 17: Photo shows spill/release originating from the well head had traveled and impacted areas along the access road.

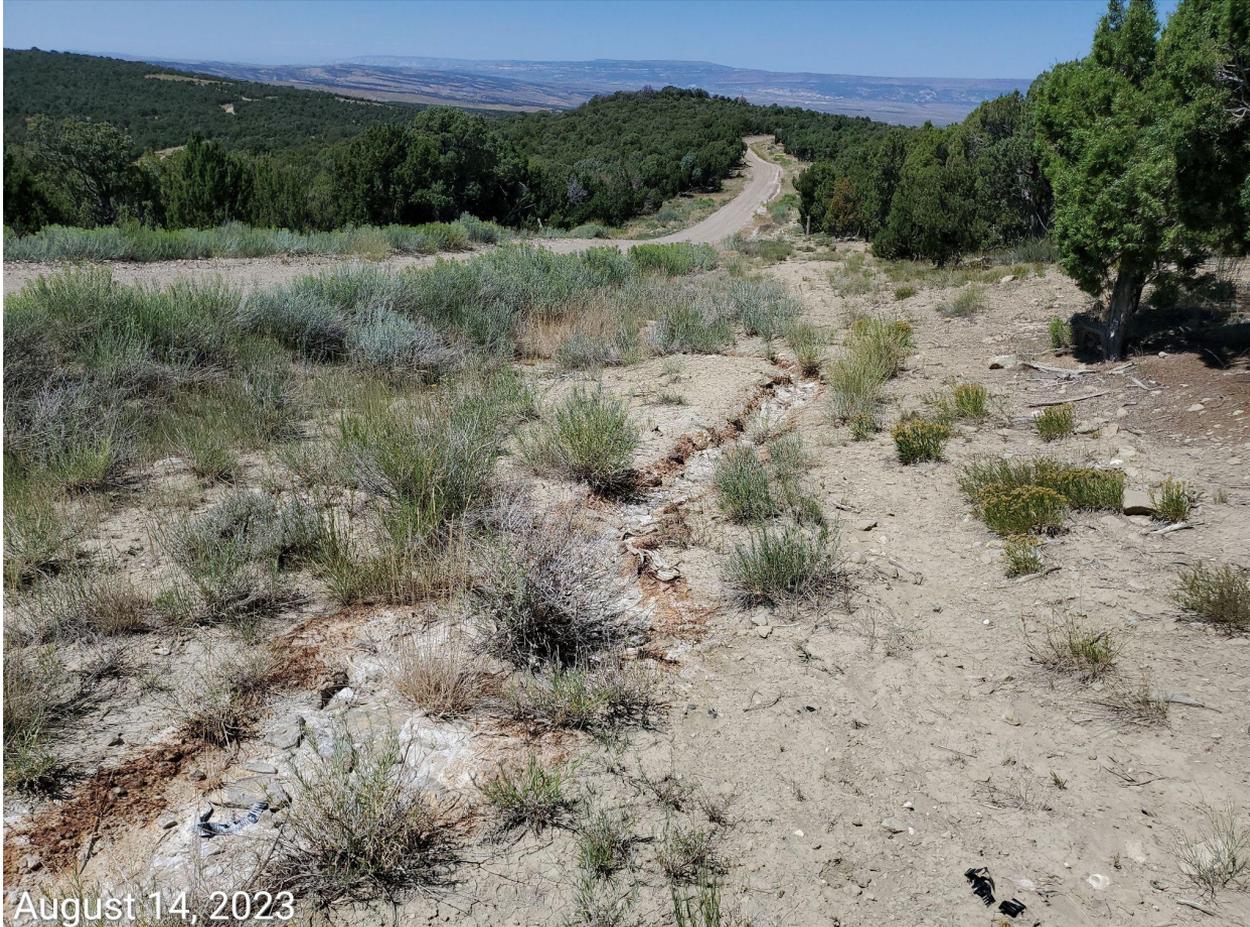
Photo 18: Photo shows spill/release originating from the well head had traveled and impacted areas along the access road.
