Inspection Photos

8/14/2023

Operator: GENESIS GAS & OIL COLORADO LLC
- 10384

Location Number: 316579
Rio Blanco County, CO

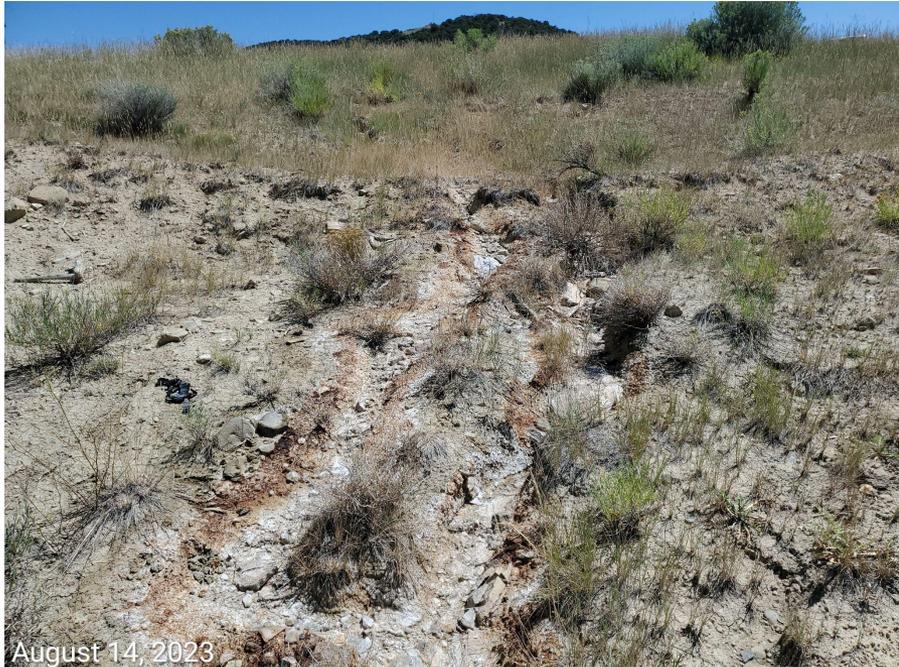
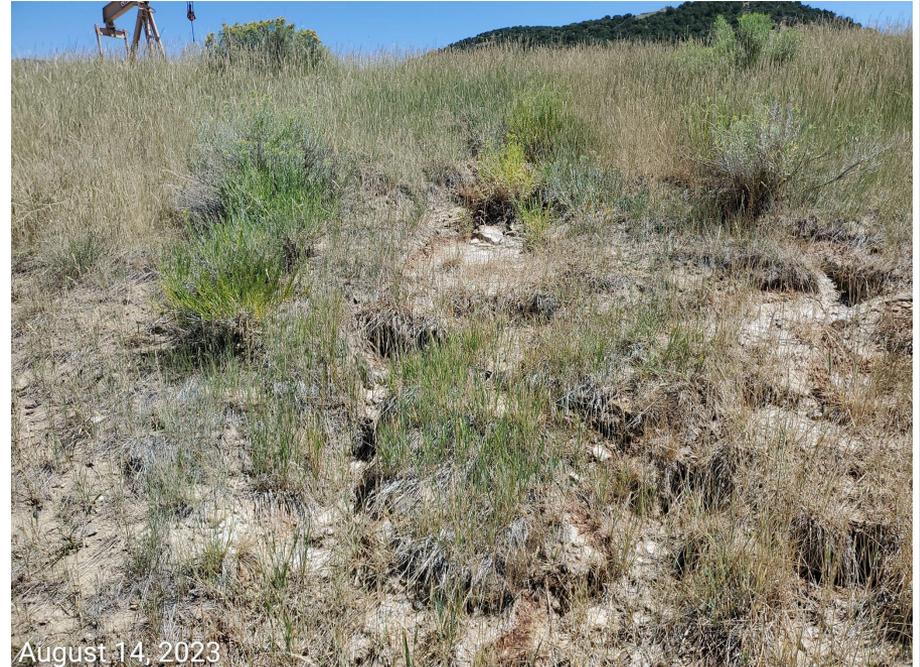
Photo 19: Photo shows degradation along the interim areas/slopes of the Location due to the spill/release.

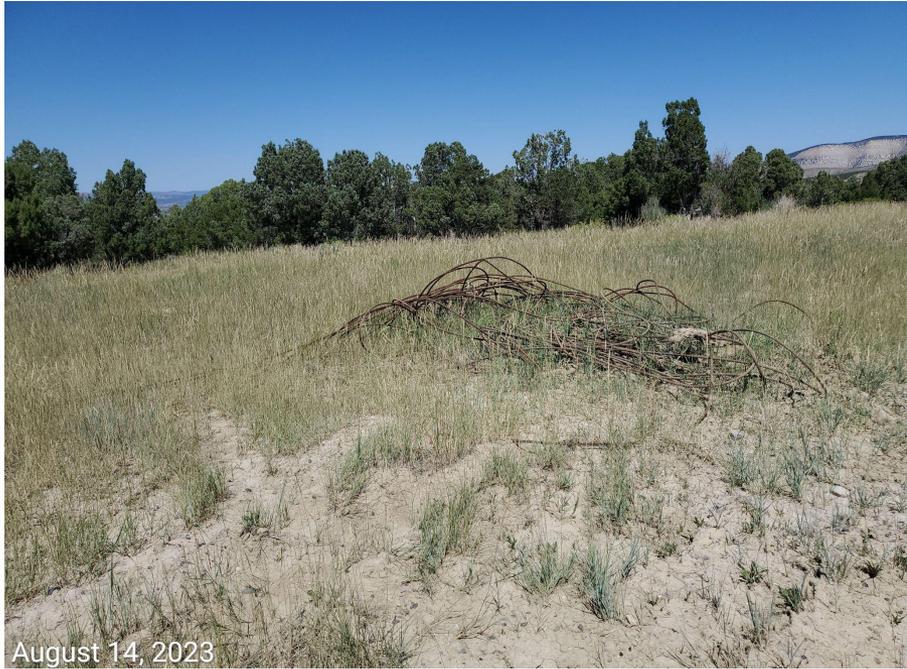
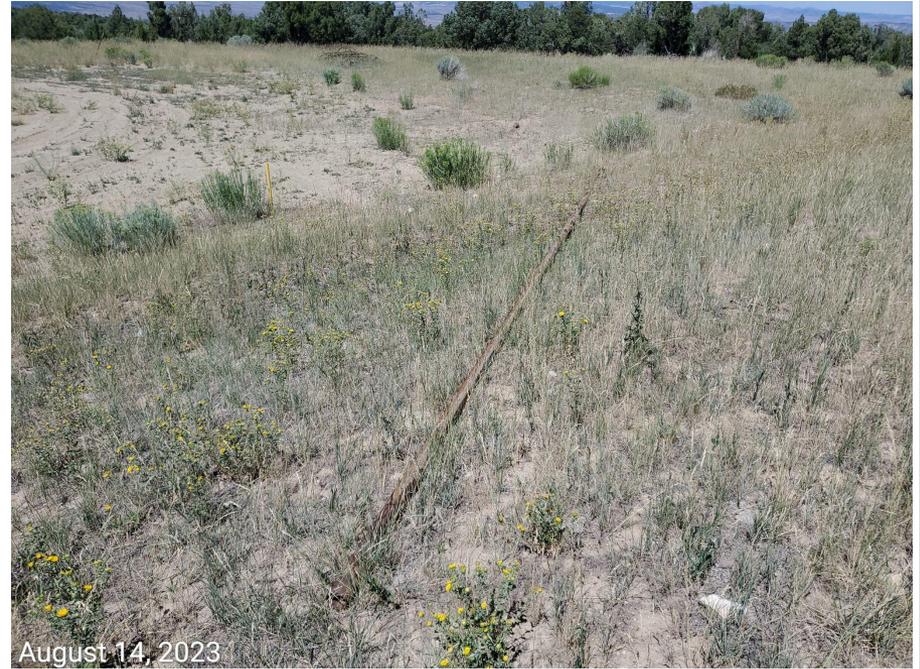
Photo 20: Unused cable and pipe improperly stored on the interim areas of the Location.

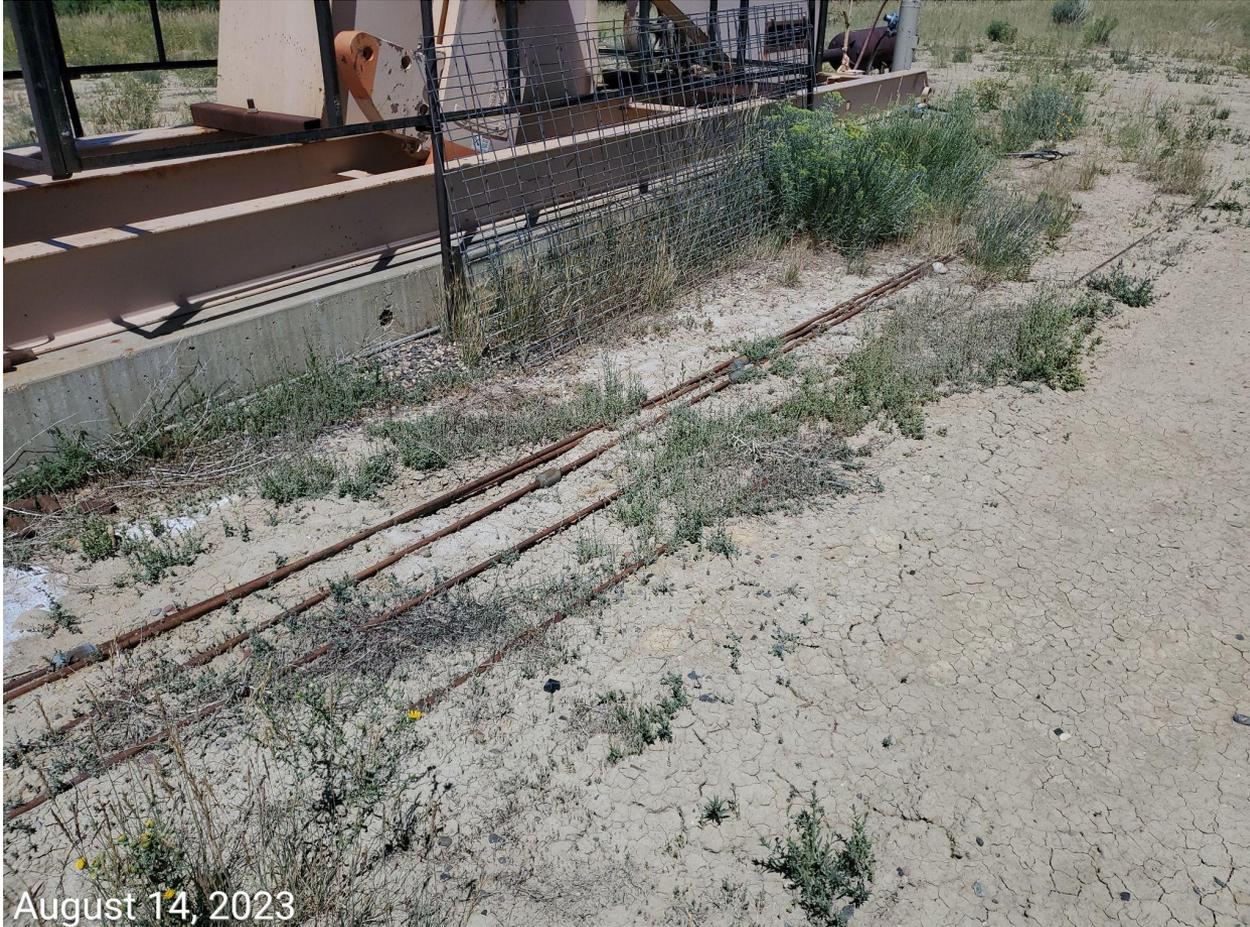
Photo 21: Sucker rod stored next to wellhead; this is considered unused equipment subject to Rule 606 requirements.
