# Final Reclamation Inspection

Operator: PDC ENERGY INC - 69175

Location ID: 307179

Inspection Photos  
Location Name: Laune 44-25  
Location ID: 307179

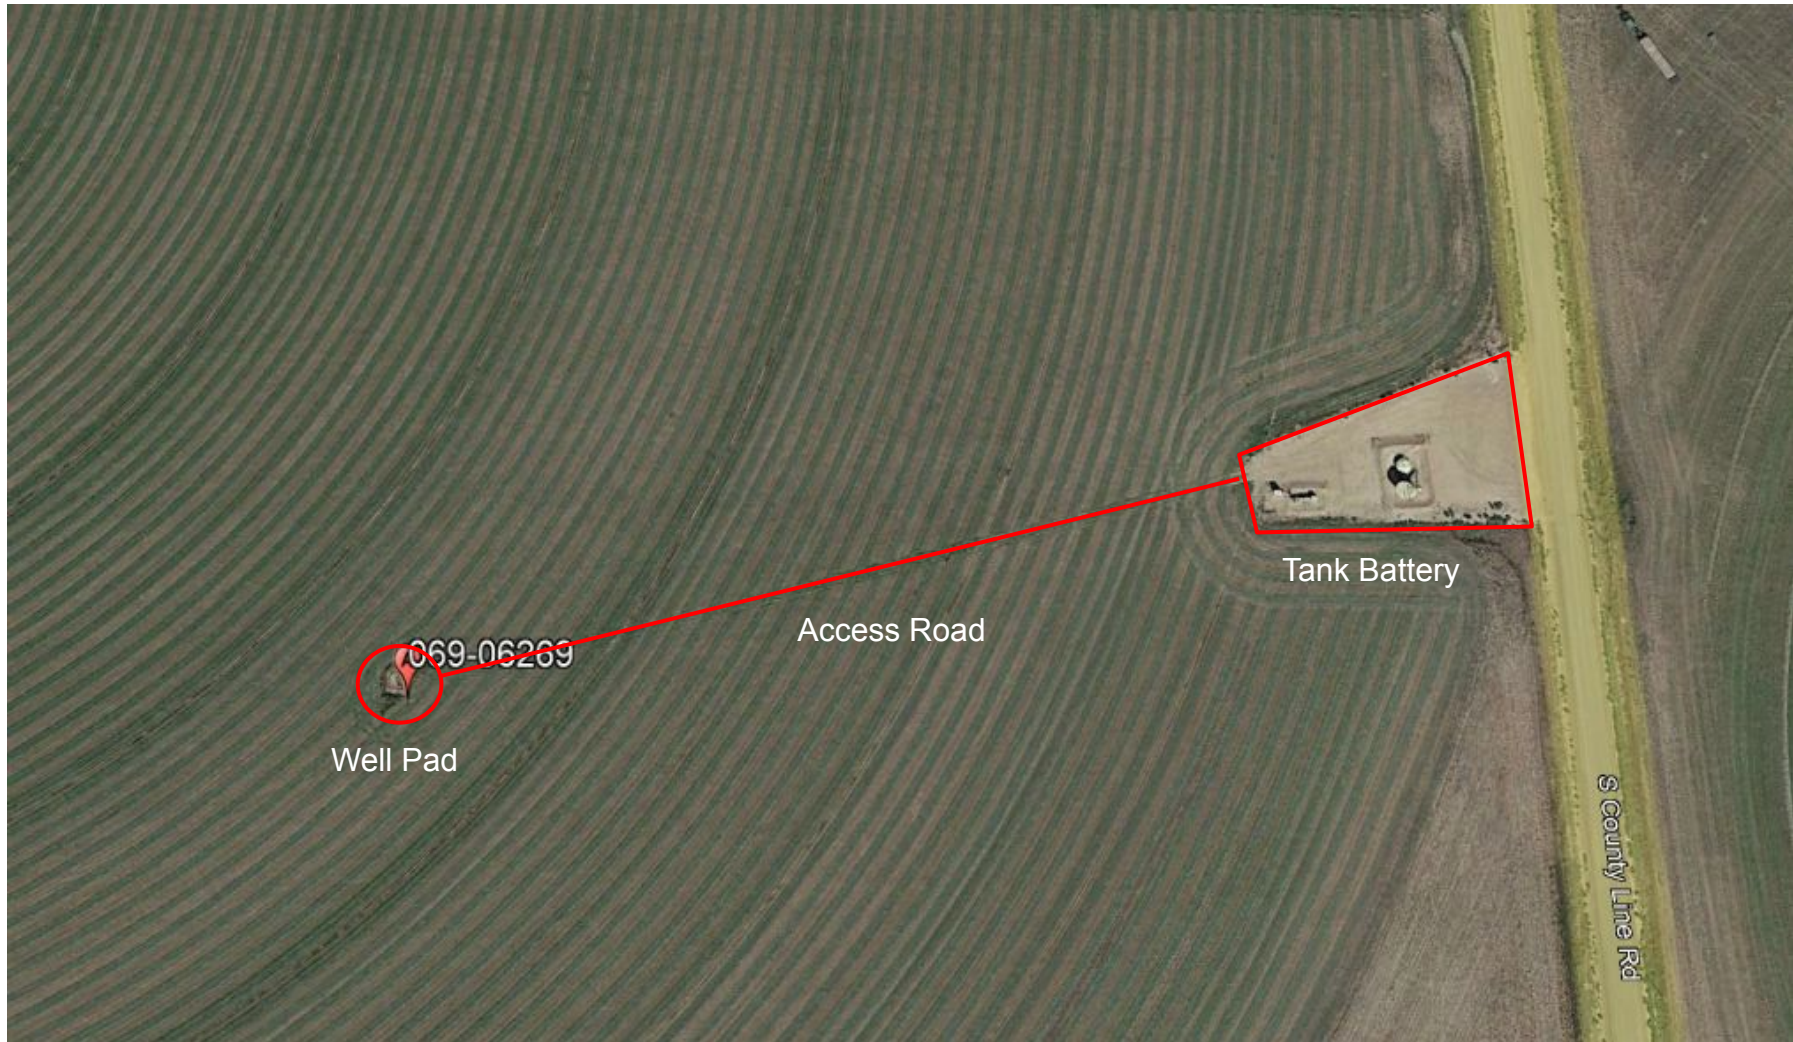
**Photo 1.** 2016 aerial imagery of the well pad, access road and associated tank battery (north is up).

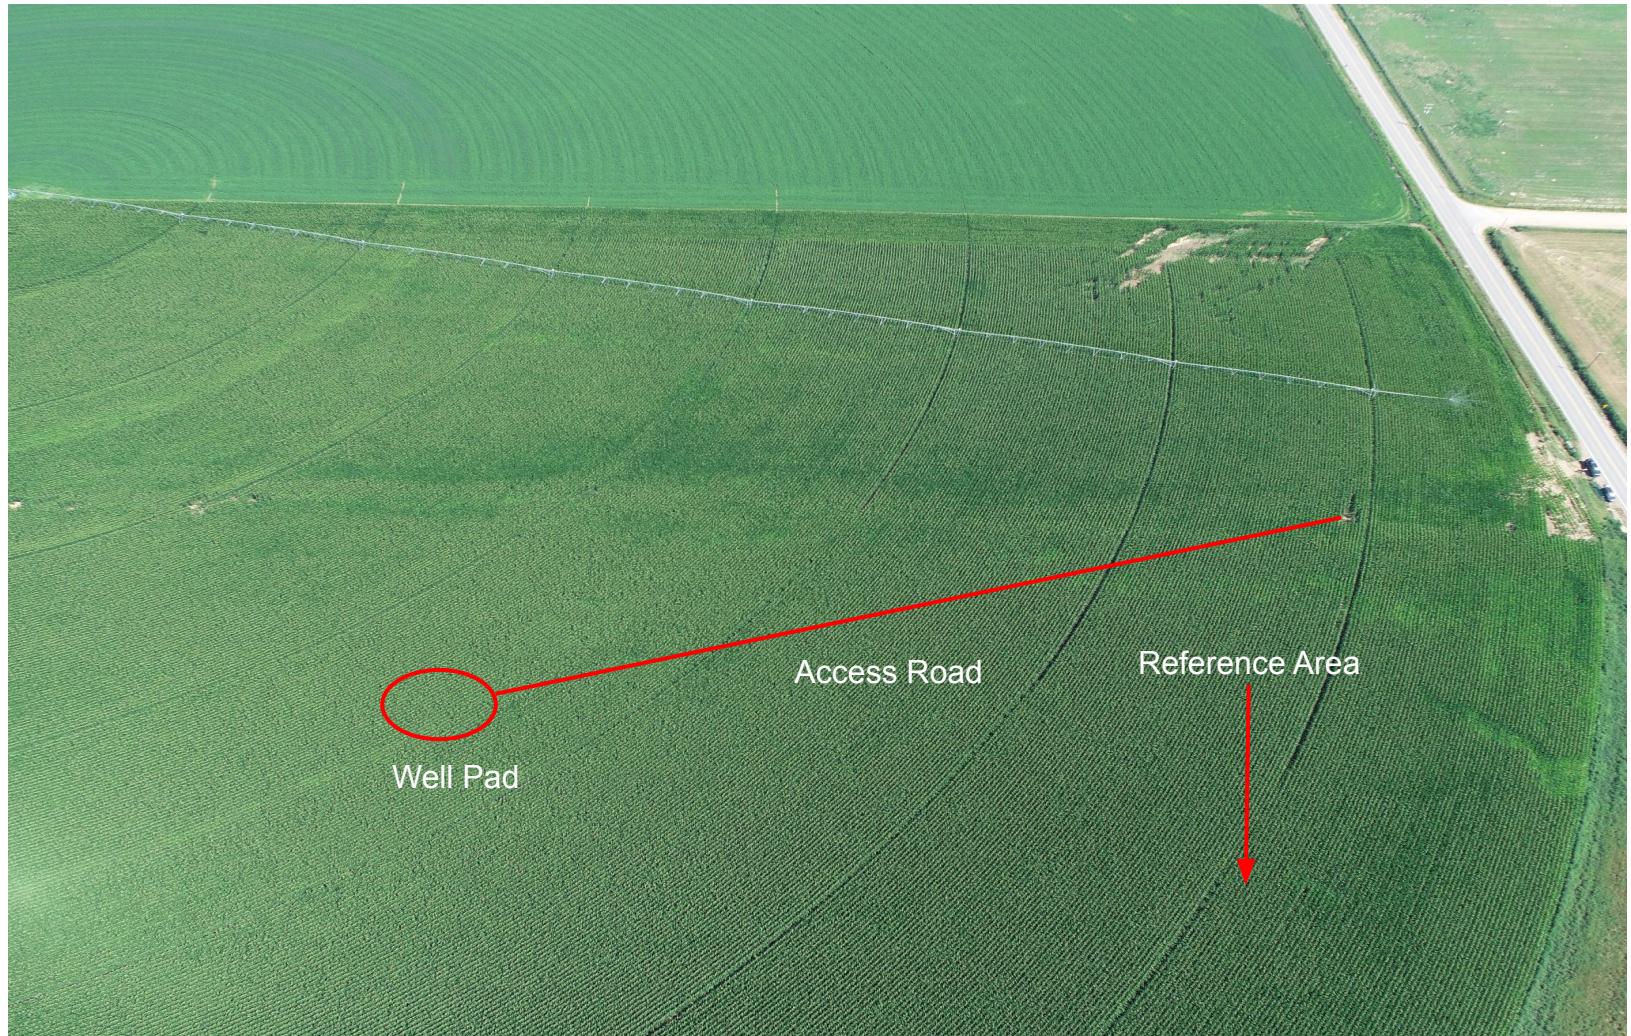
**Photo 2.** Overview photo of the well pad and access road taken from the southern edge facing north using a drone. Photo shows that the well pad and access road appear consistent with the adjacent reference area.

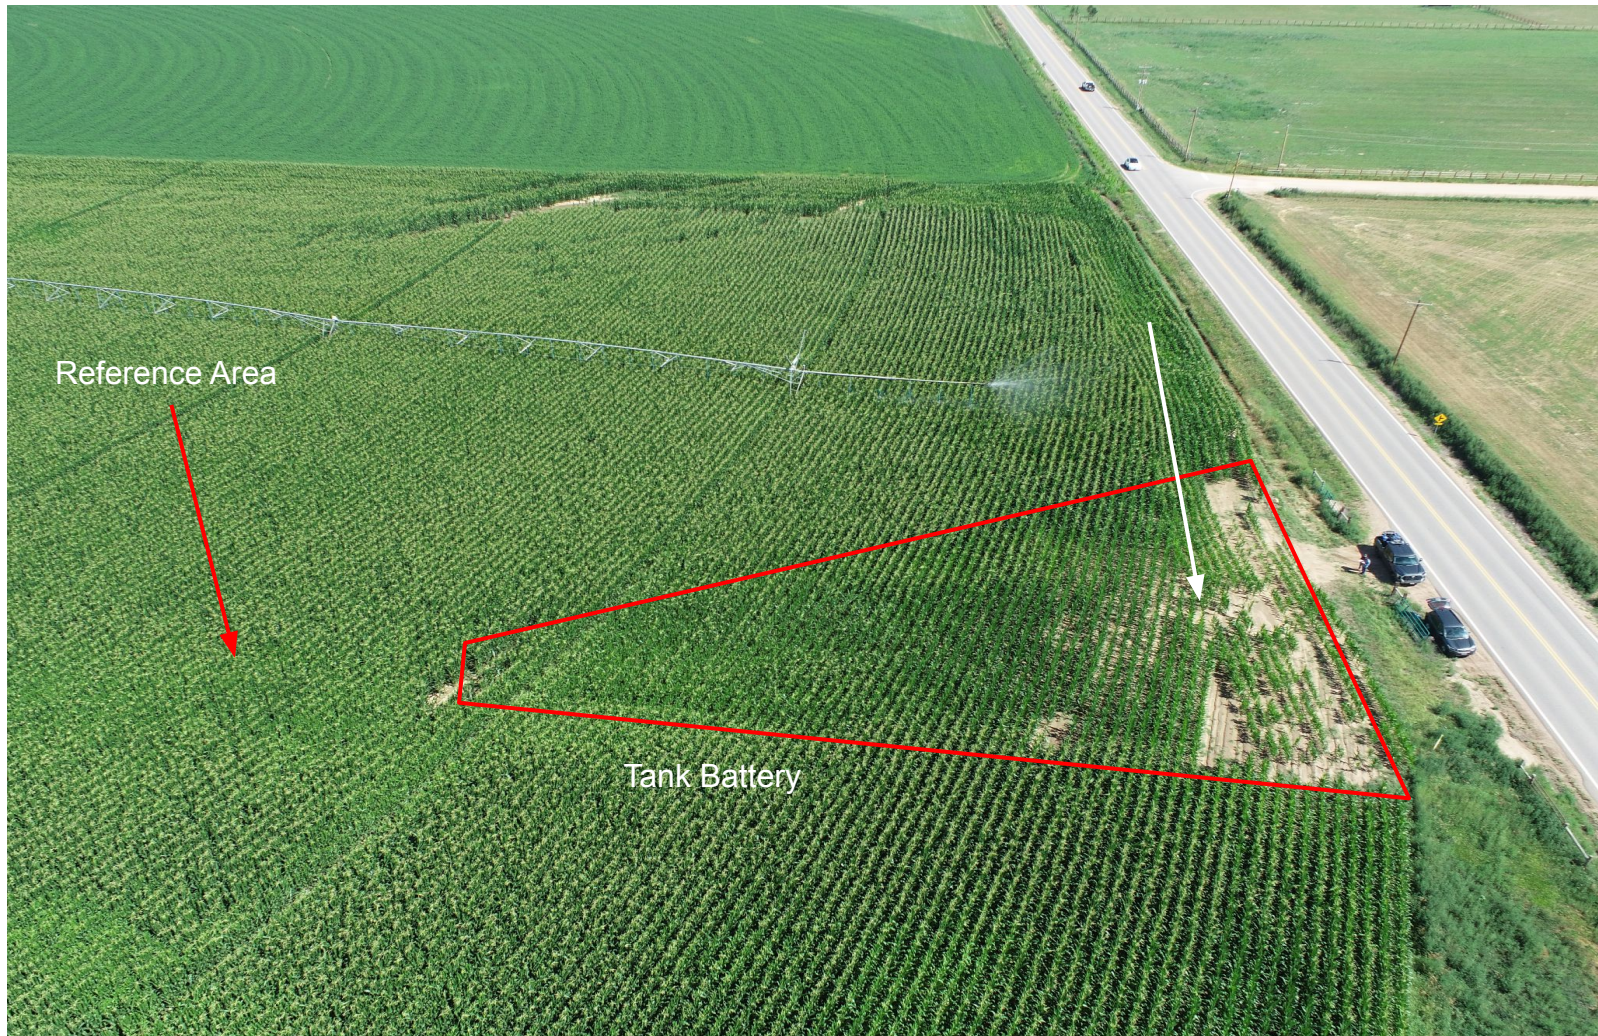
**Photo 3.** Overview photo of the tank battery taken from the southern edge facing north using a drone. Photo shows that the eastern edge of the tank battery has stunted crop growth that does not appear consistent with the adjacent crop reference area.

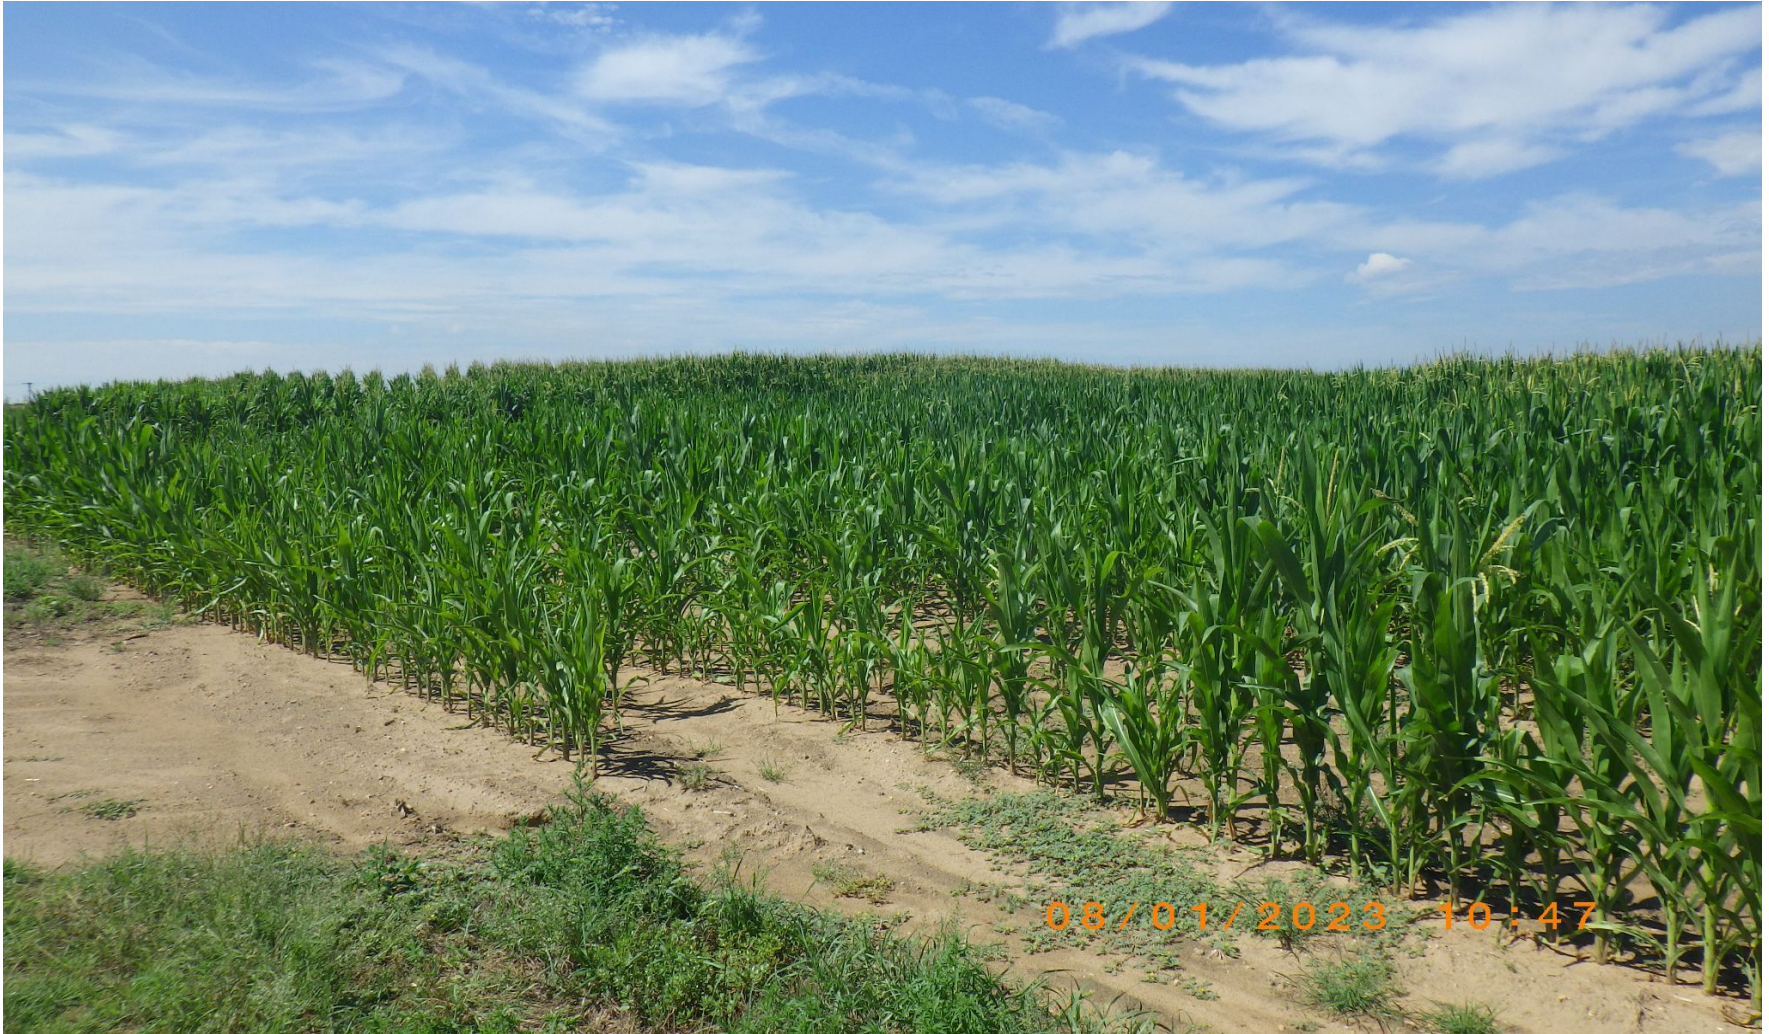
**Photo 4.** Ground photo of the tank battery taken from the eastern edge facing west.
