Inspection Photos

Operator: GENESIS GAS & OIL COLORADO LLC
- 10384

Location Number: 414116
Rio Blanco County, CO

Aaron Trujillo
NW Reclamation Specialist
CECMC

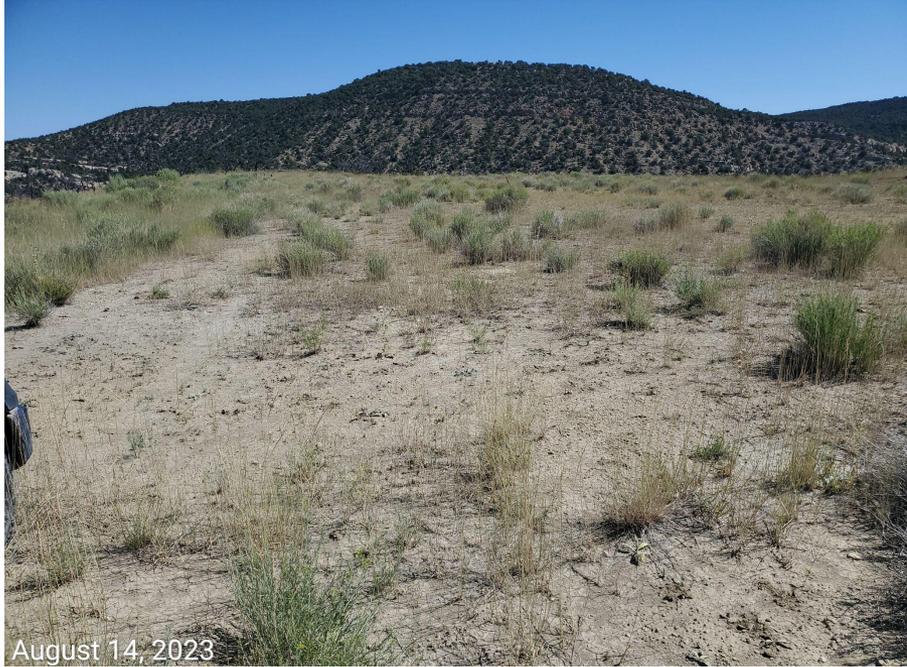
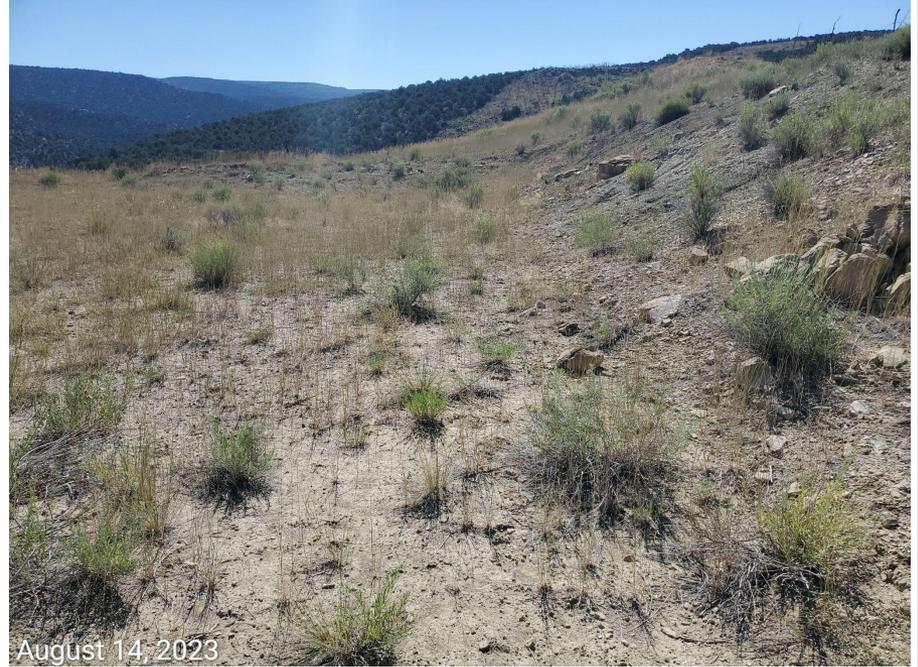
Photo 1: Location has not been decompacted, recontoured, regraded and reclaimed in accordance with 1004 Rules.

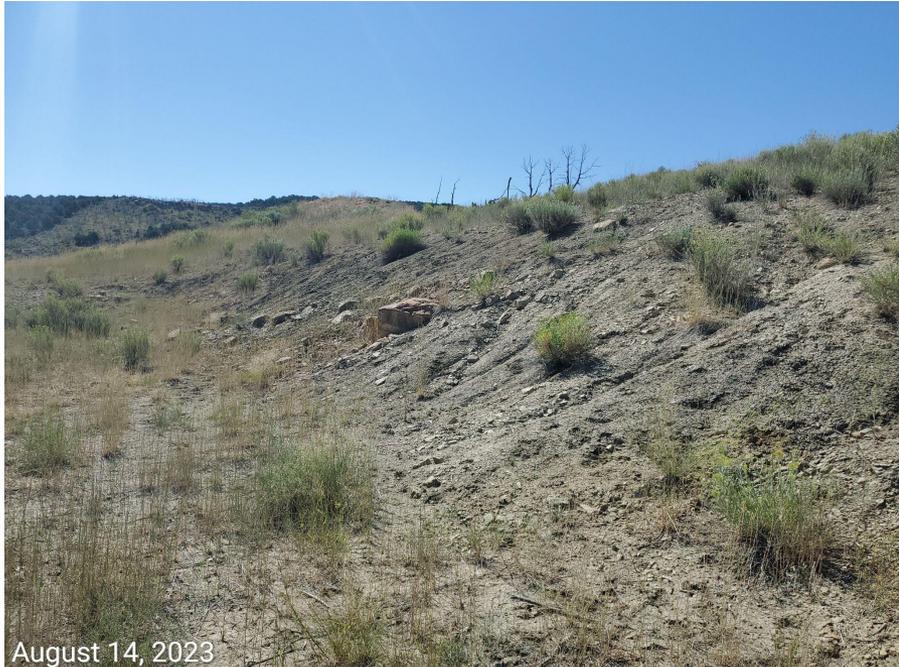
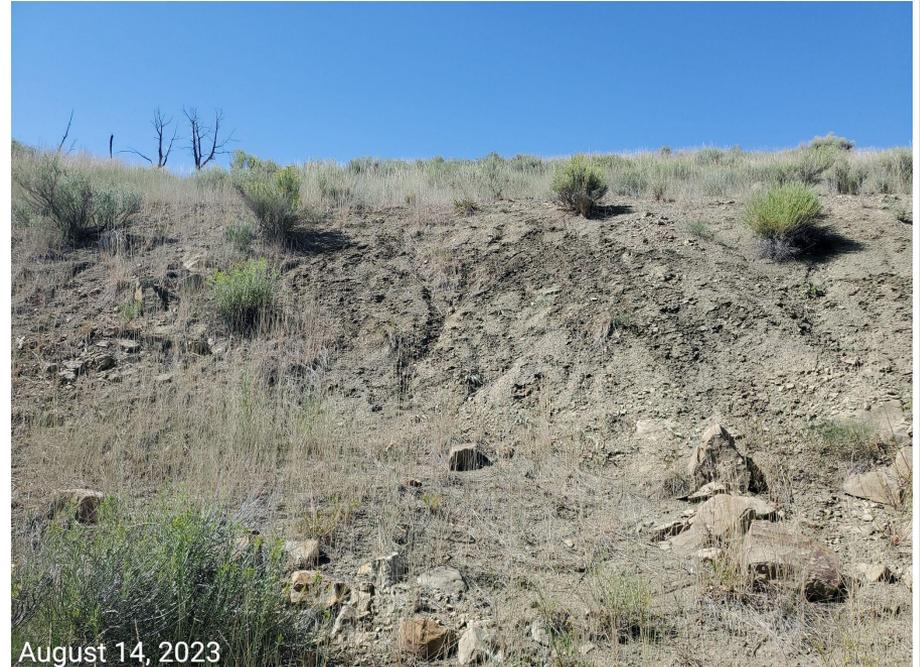
Photo 2: Photos show erosion and degradation at the cut slopes has persisted; cut slopes lack stabilization; Control measures to manage runoff , and to minimize erosion, degradation and sediment transport remain inadequate on the Location and access road- unable to find evidence that work to address the compliance issues was attempted.

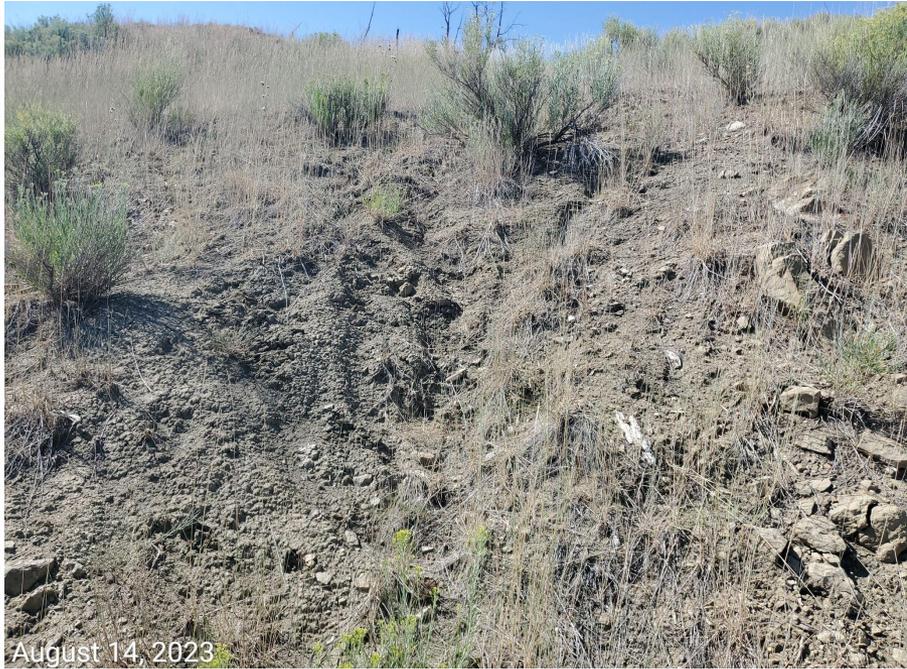
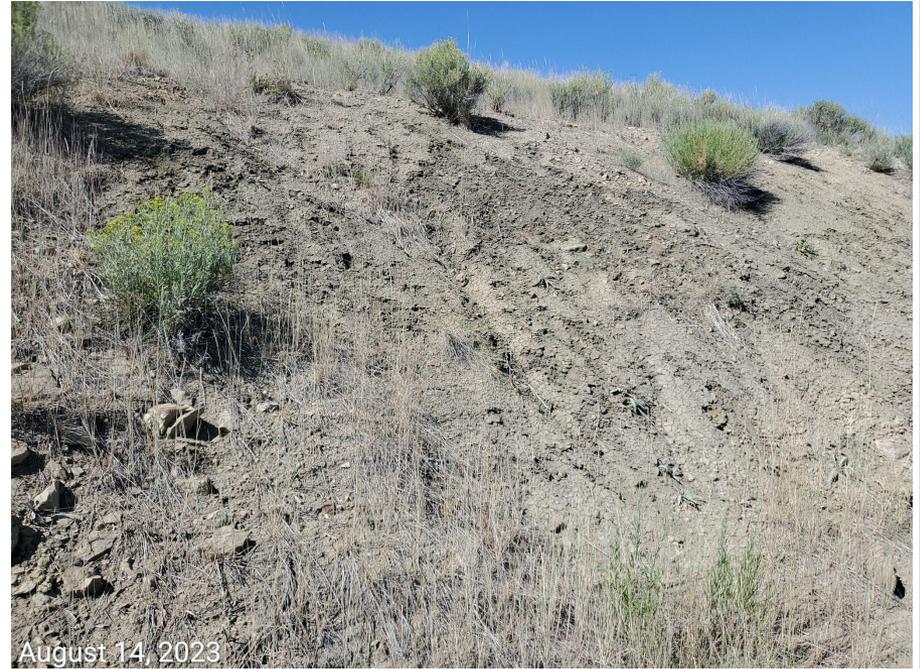
Photo 3: Photos show erosion and degradation at the cut slopes has persisted; cut slopes lack stabilization; Control measures to manage runoff , and to minimize erosion, degradation and sediment transport remain inadequate on the Location and access road- unable to find evidence that work to address the compliance issues was attempted.

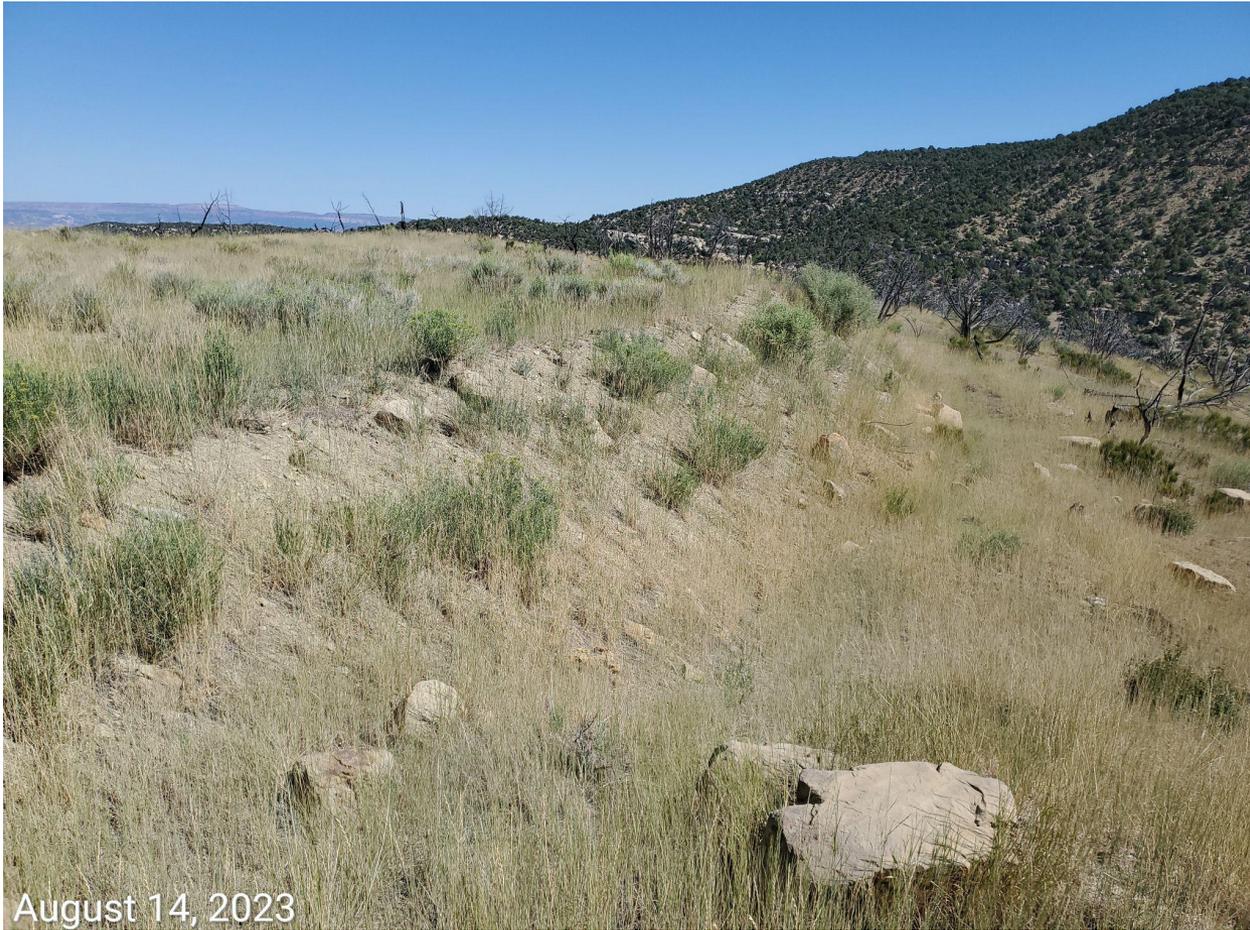
Photo 4: Fill slopes of the Location- Location has not been recontoured, regraded and reclaimed in accordance with 1004 Rules.

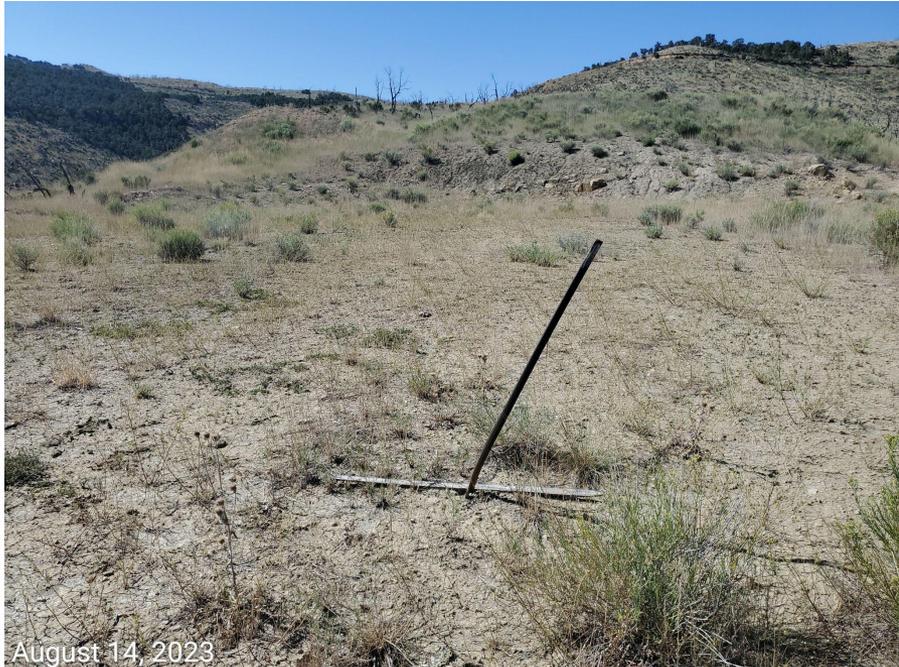
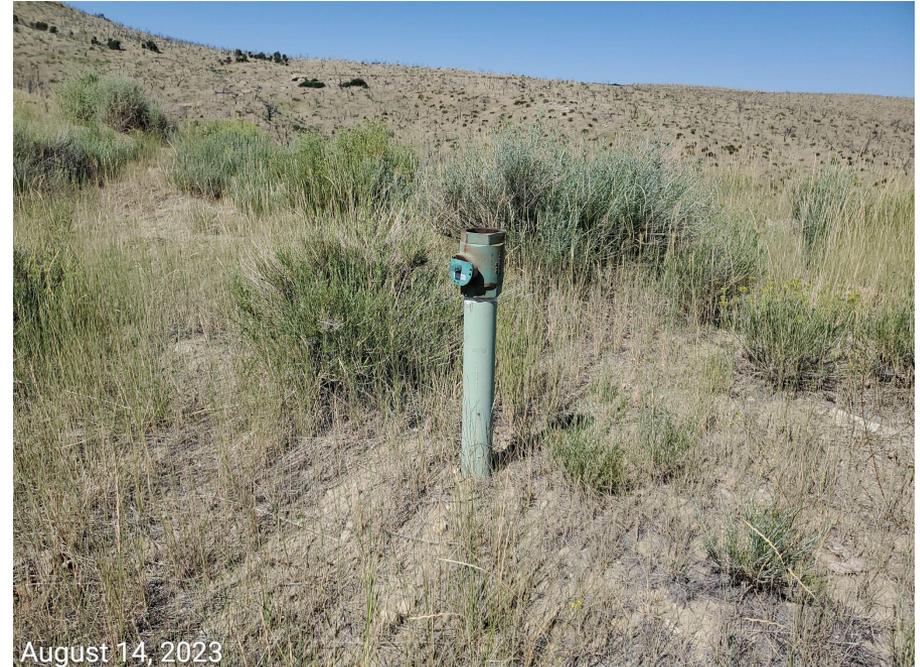
Photo 5: Well marker and equipment remaining on Location.

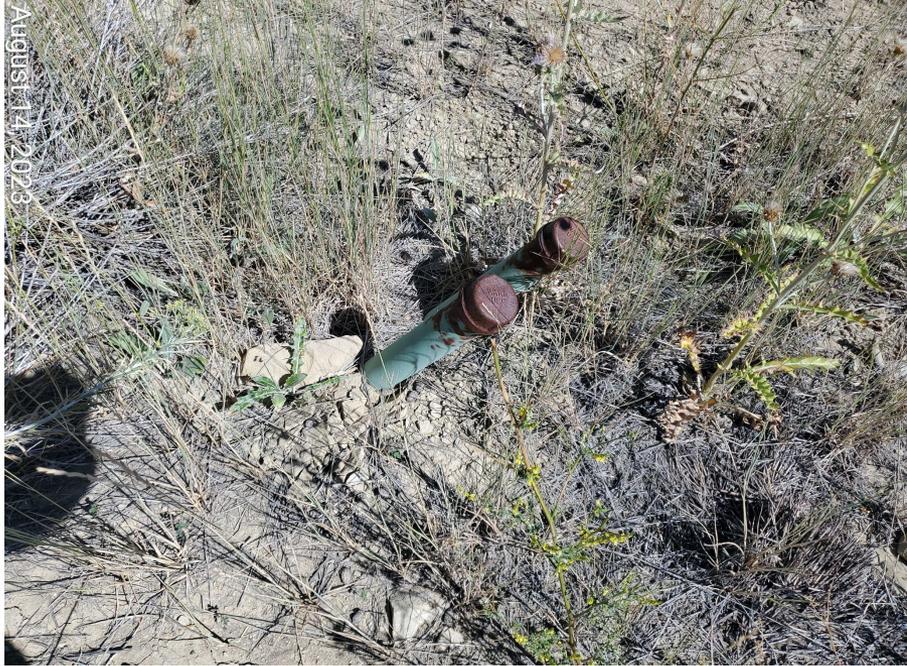
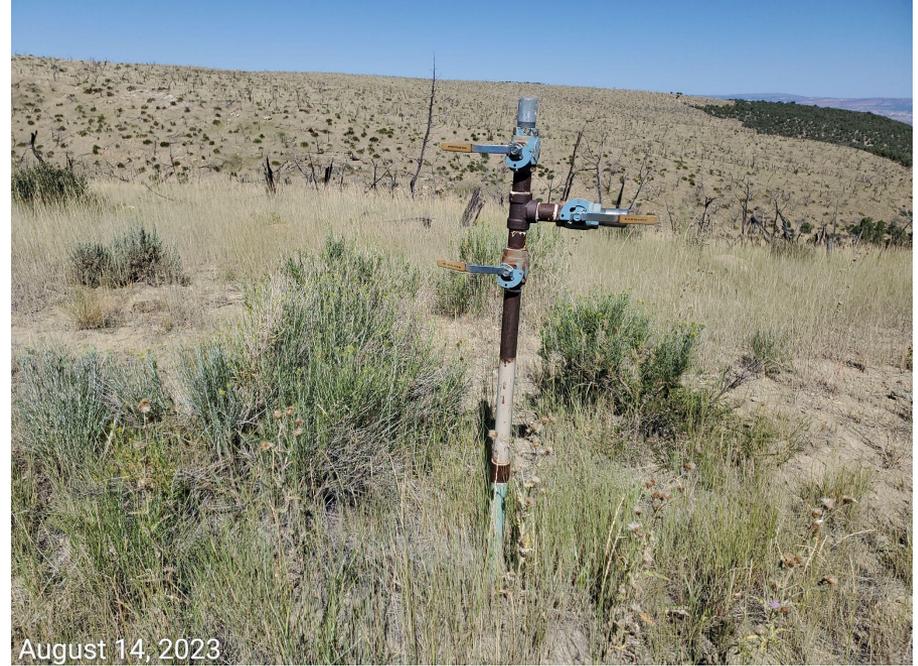
Photo 6: Surface equipment remaining on Location.

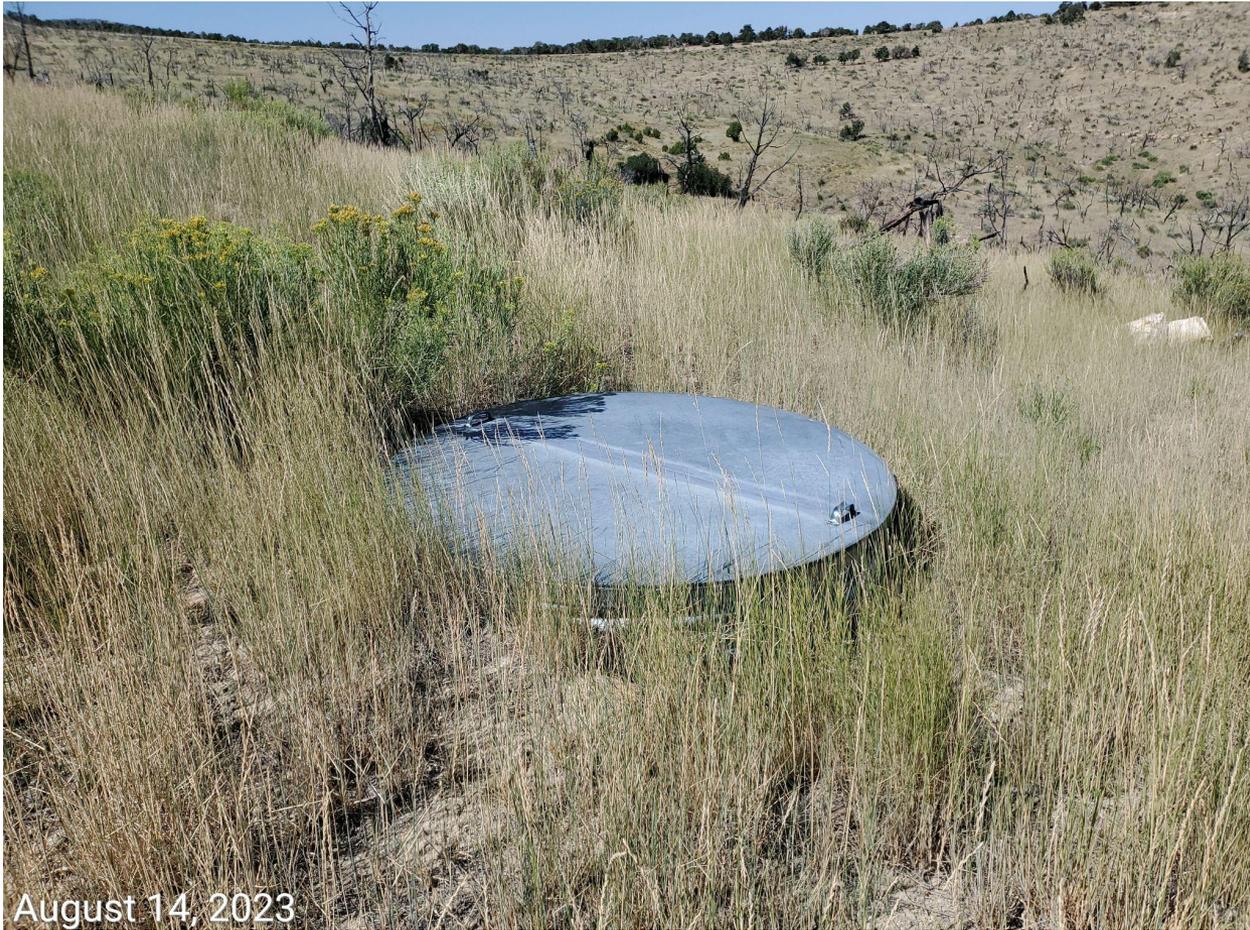
Photo 7: Surface equipment remaining along access road.

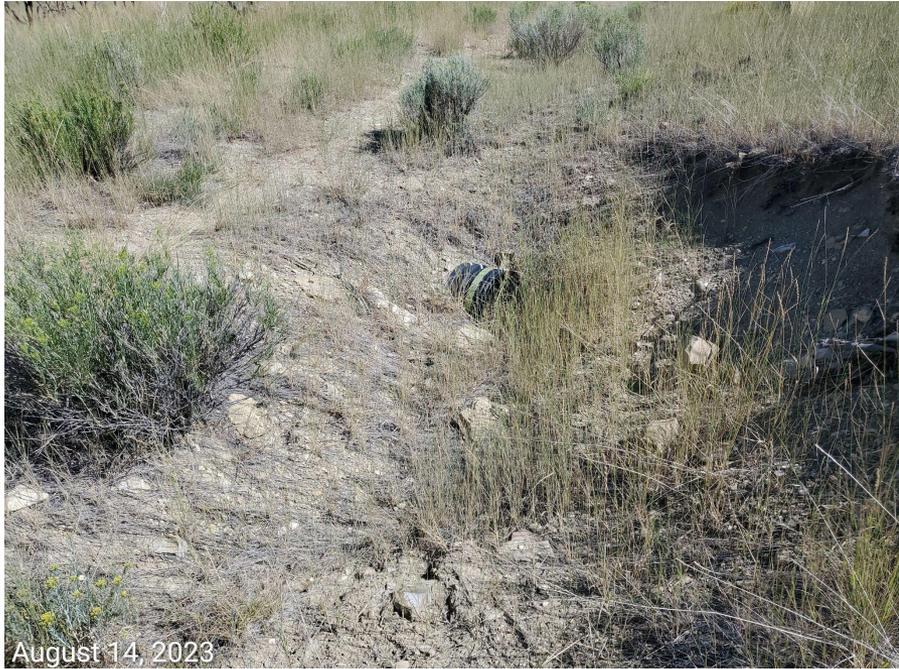
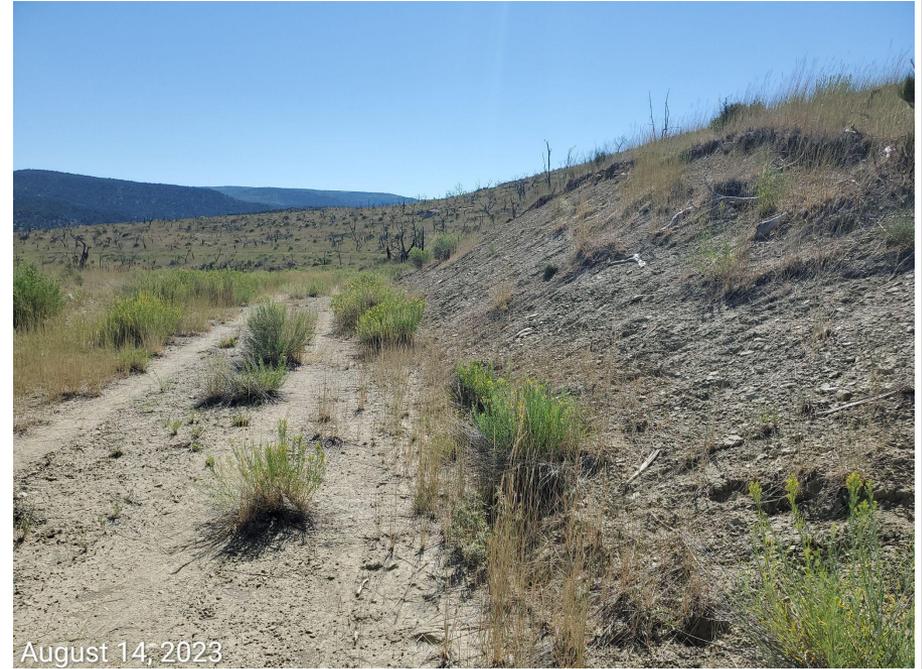
Photo 8: Photos examples showing culverts and cut slopes along access road; cut slopes lack stabilization; Location and access road has not been decompacted, recontoured, regraded and reclaimed in accordance with 1004 Rules.
