Inspection Photos

8/14/2023

Operator: GENESIS GAS & OIL COLORADO LLC
- 10384

Location Number: 413918
Rio Blanco County, CO

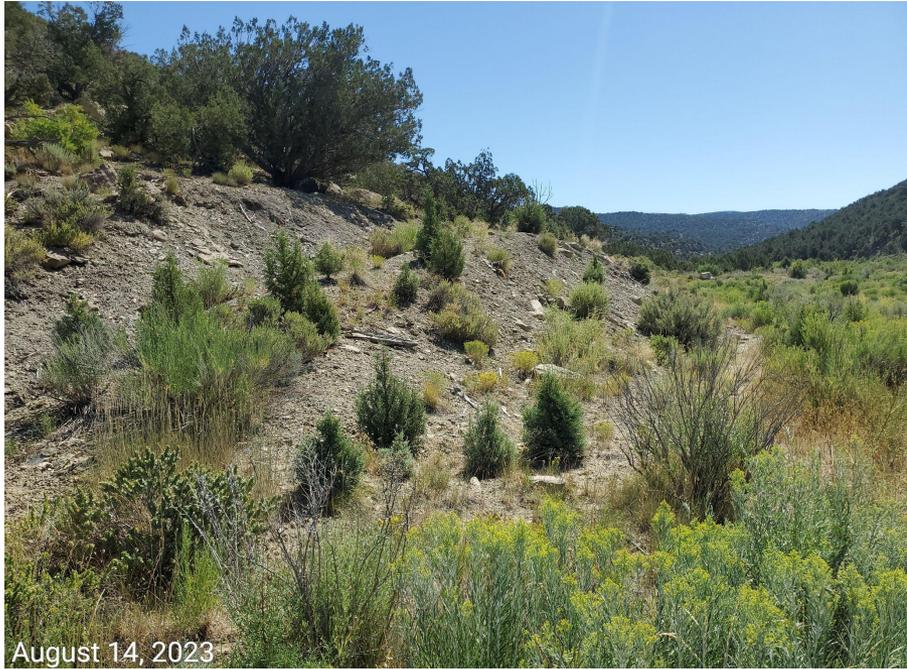
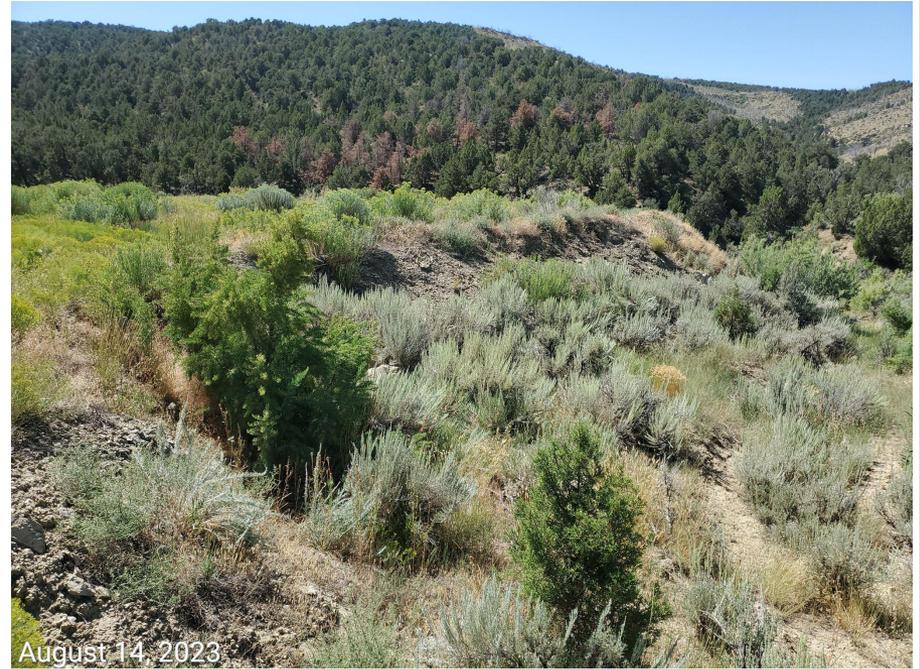
Photo 1: Photo shows cut and fill slopes of the Location; Location has not been decompacted, recontoured, regraded and reclaimed in accordance with 1004 Rules.

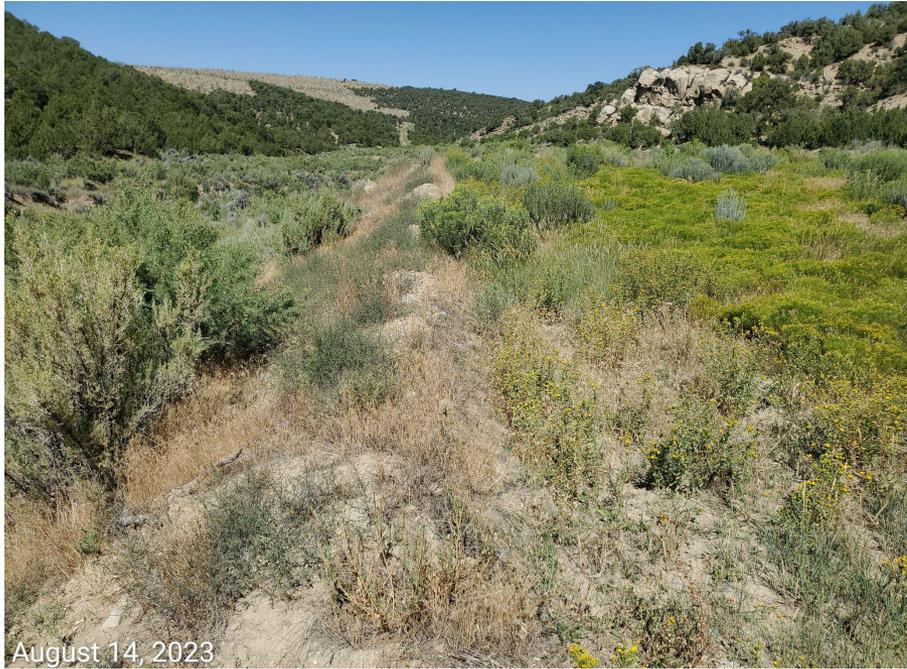
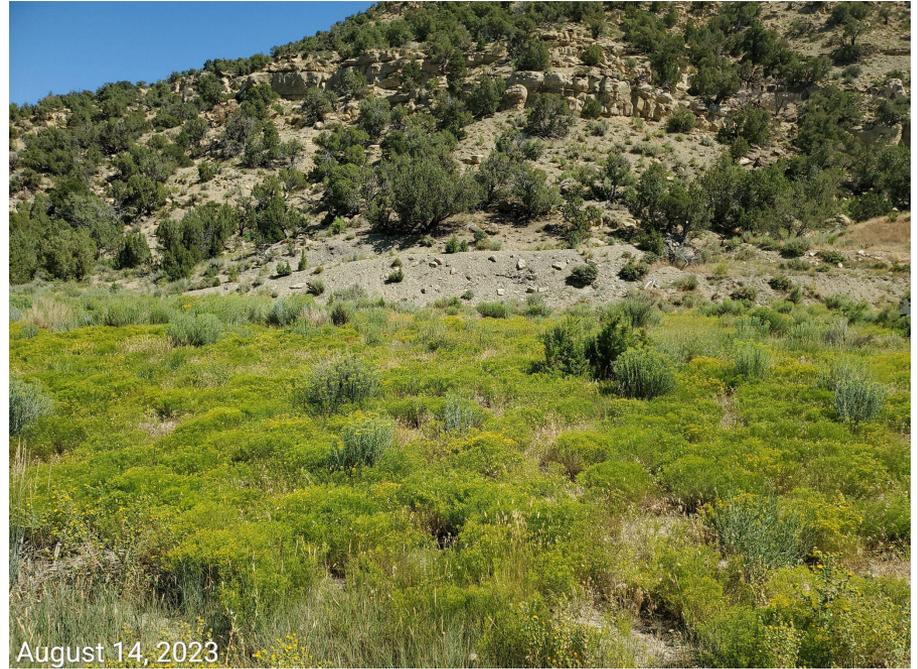
Photo 2: Photo 2-3 provides an overview of the Location; photos show the Location has not been decompacted, recontoured, regraded and reclaimed in accordance with 1004 Rules.

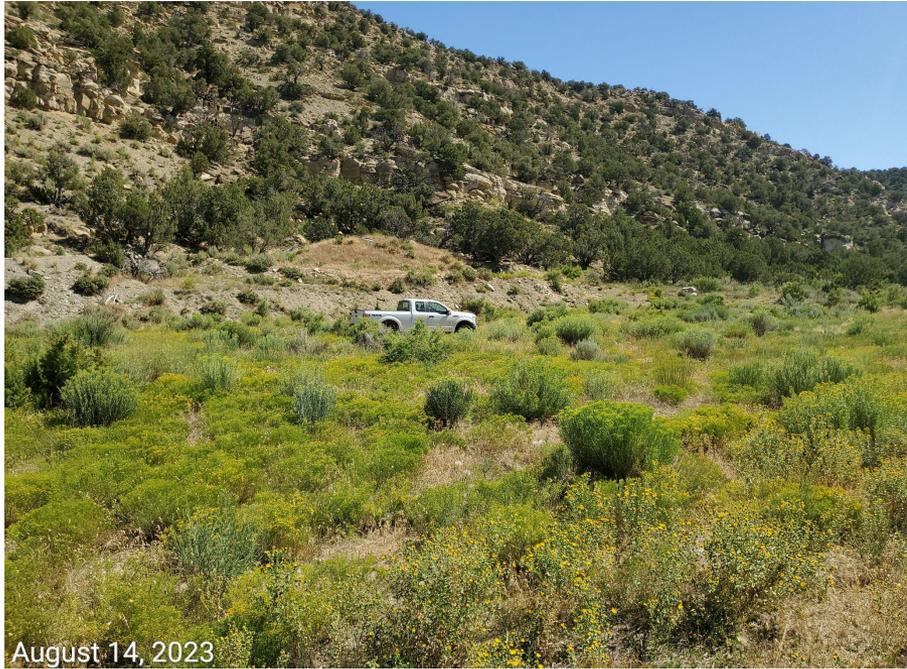
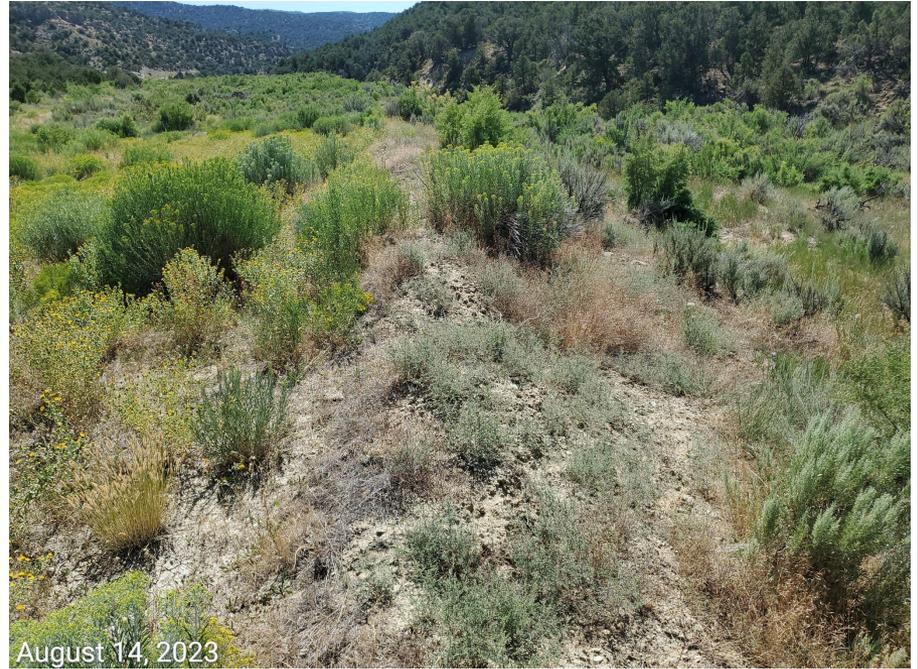
Photo 3: See comments under photo 2

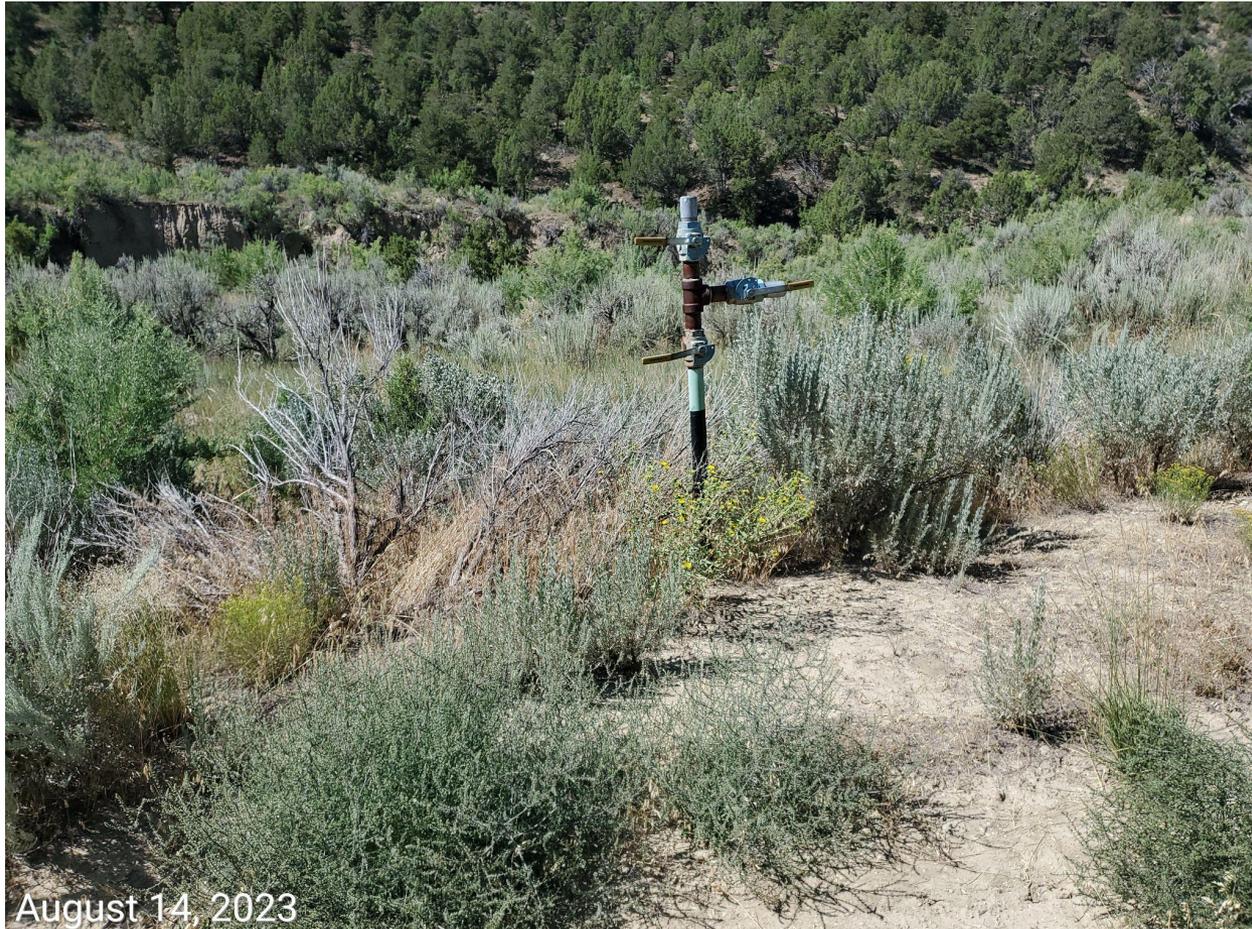
Photo 4: Equipment remaining along access road.

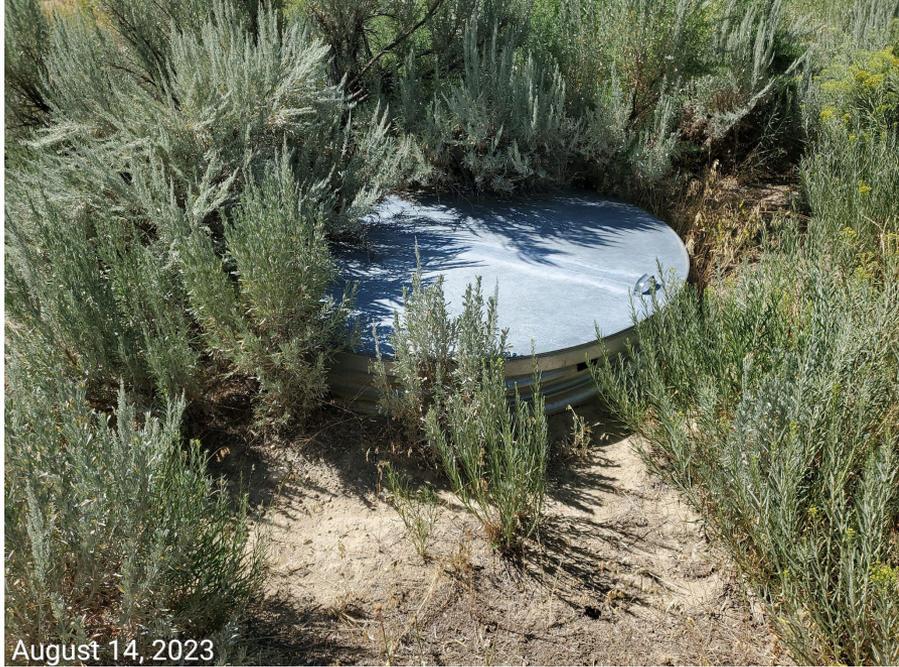
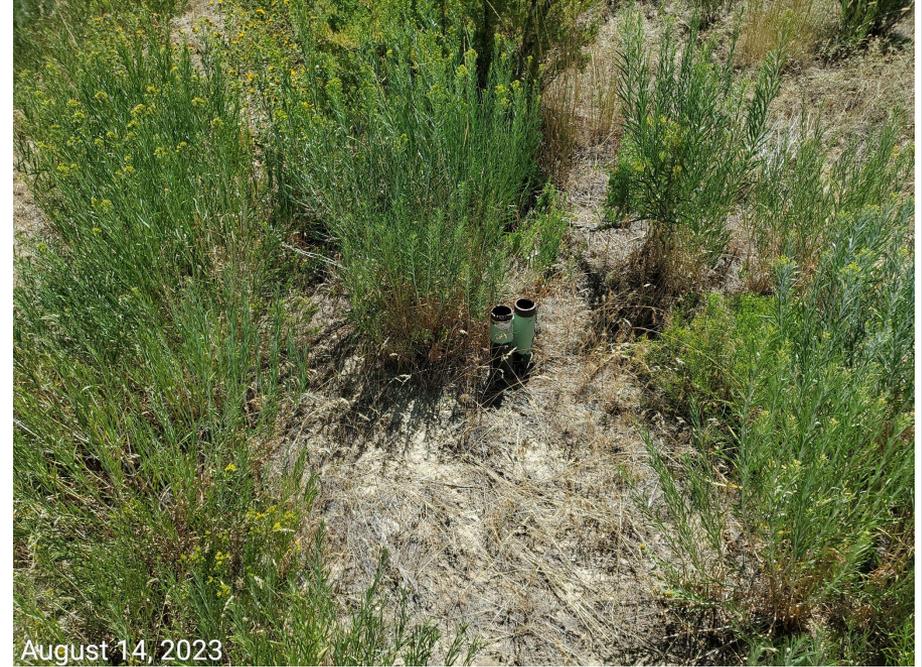
Photo 5: Equipment remaining on Location- risers have not been properly capped.

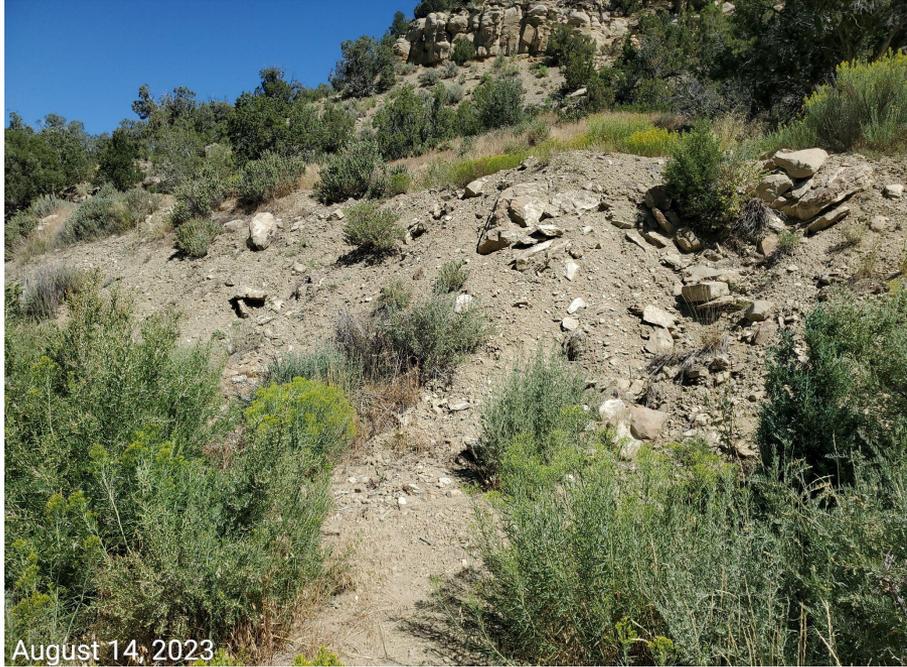
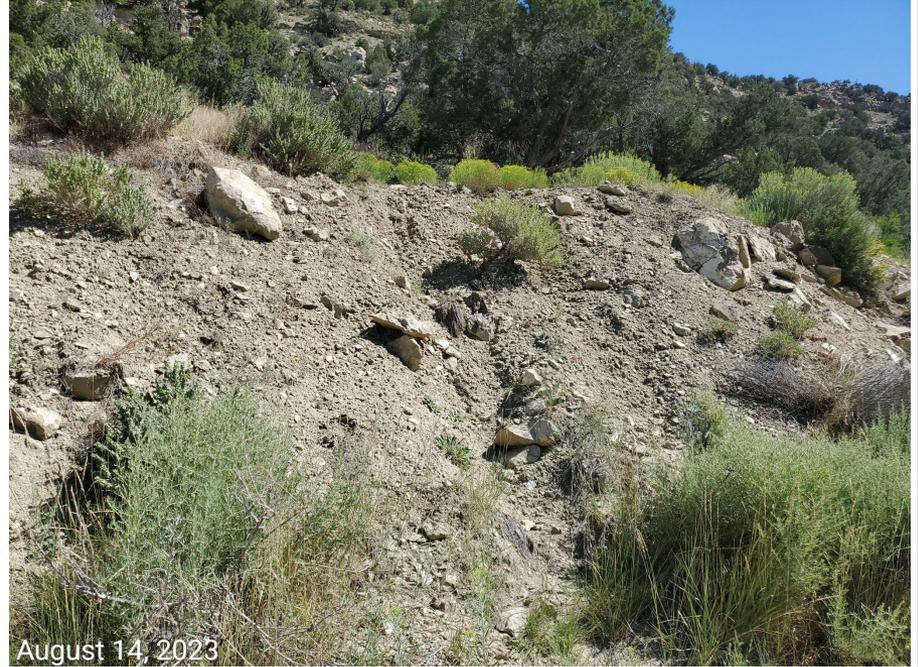
Photo 6: Unstabilized cut slopes.

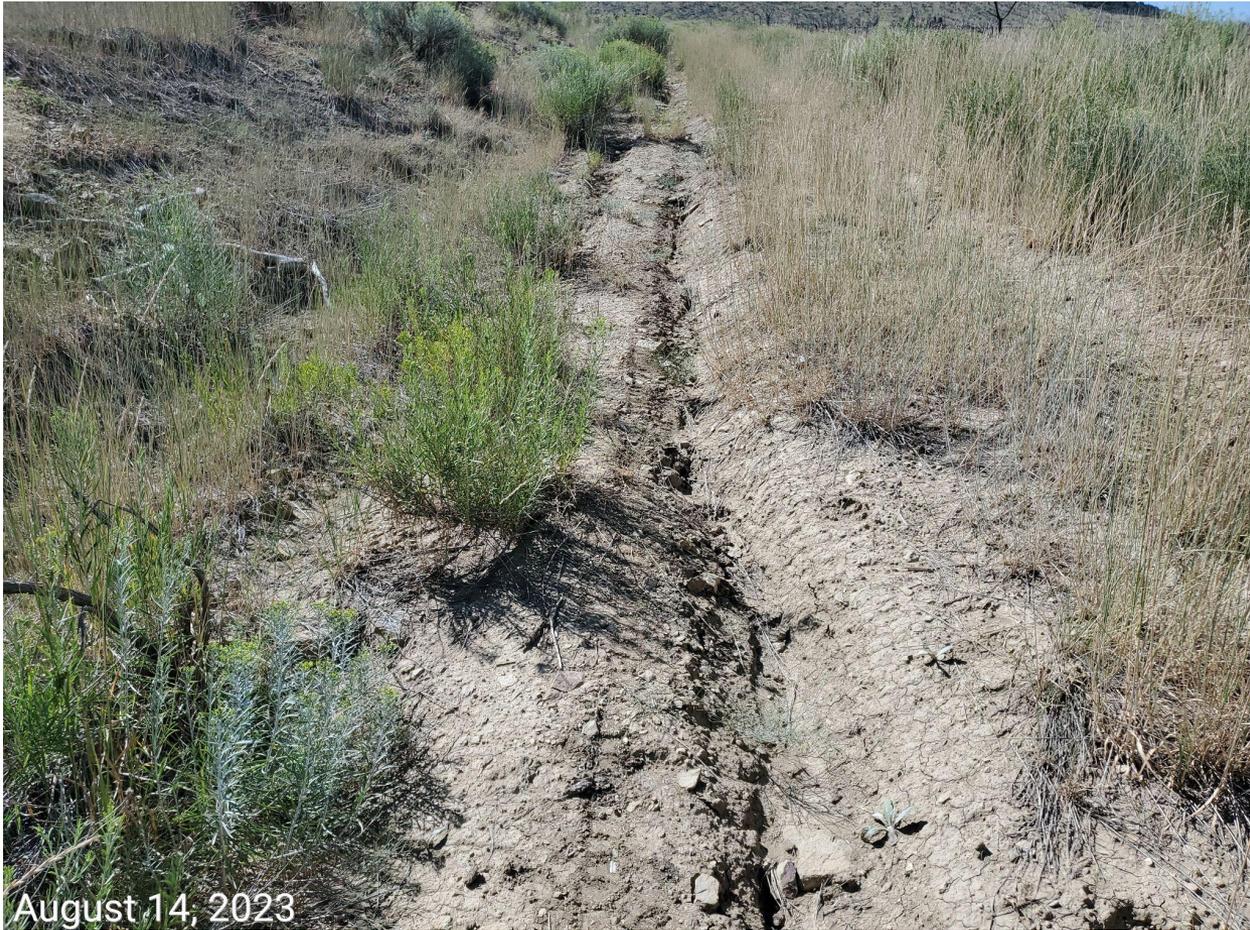
Photo 7: Photo example showing erosion degradation along access road. Stormwater and erosion control measures remain inadequate. Access road has not been decompacted, recontoured, regraded and reclaimed in accordance with 1004 Rules.

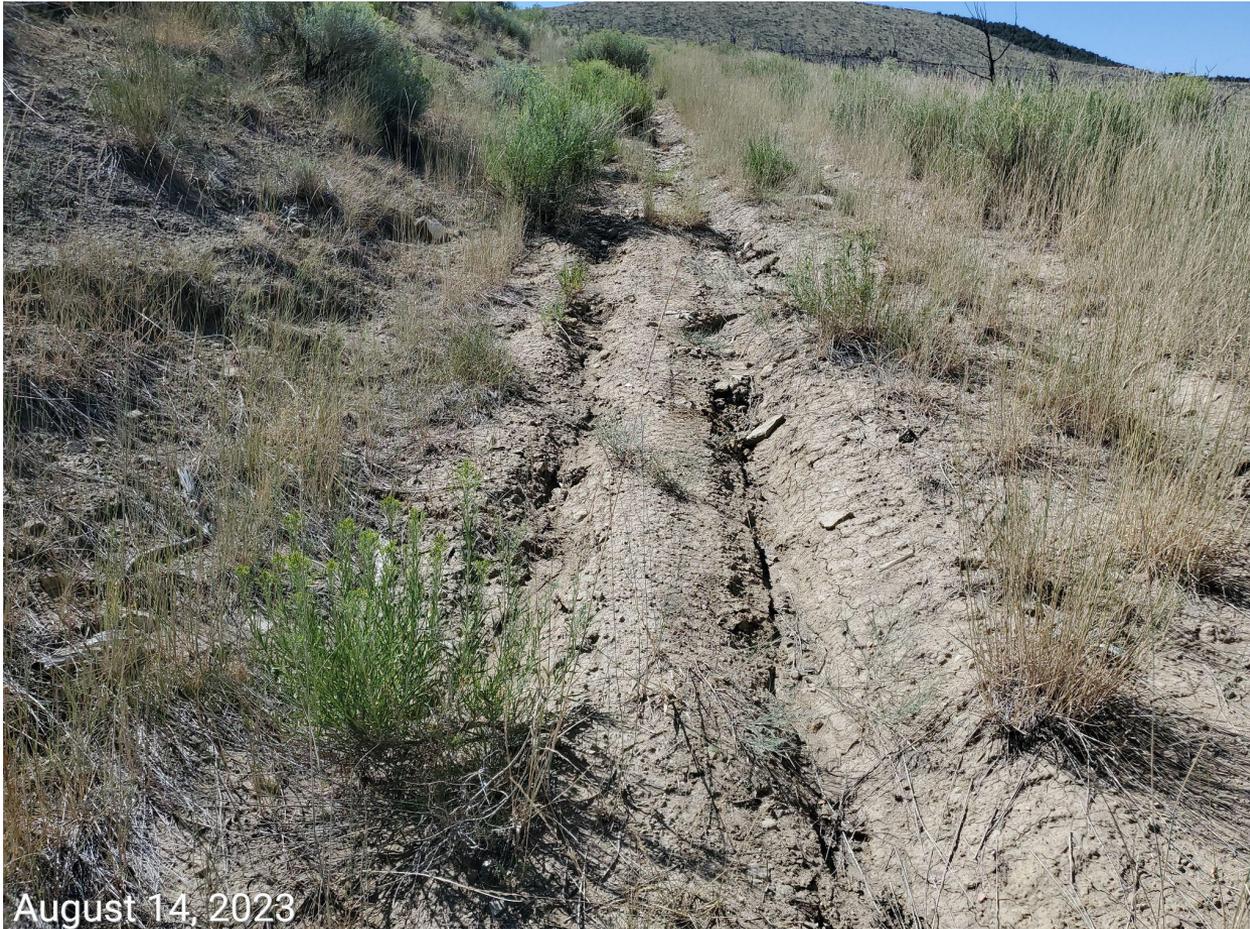
Photo 8: Photo example showing erosion degradation along access road. Stormwater and erosion control measures remain inadequate. Access road has not been decompacted, recontoured, regraded and reclaimed in accordance with 1004 Rules.

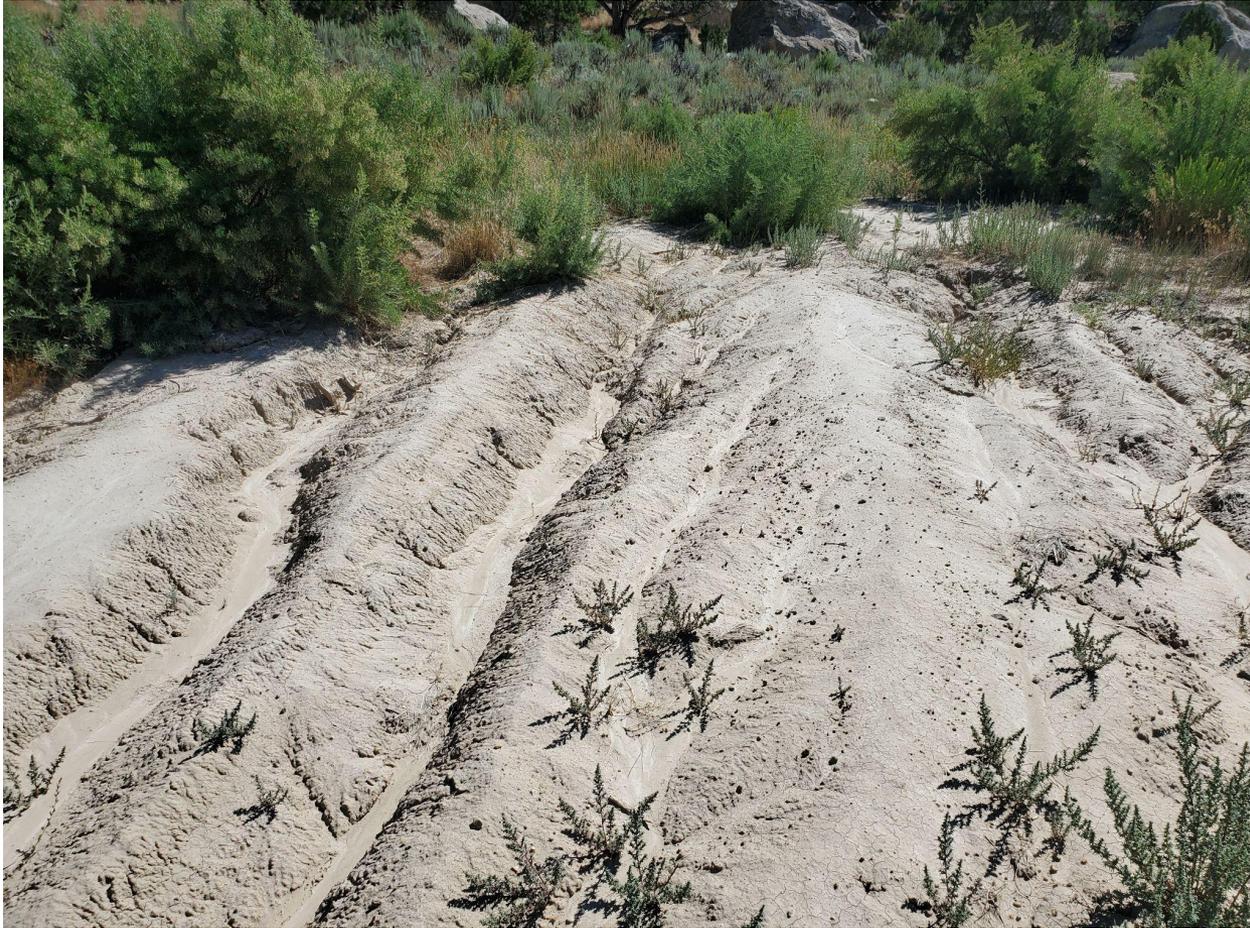
Photo 9: Photo example showing erosion degradation along access road. Stormwater and erosion control measures remain inadequate. Access road has not been decompacted, recontoured, regraded and reclaimed in accordance with 1004 Rules. Photo also shows Halogeton establishment on access road.

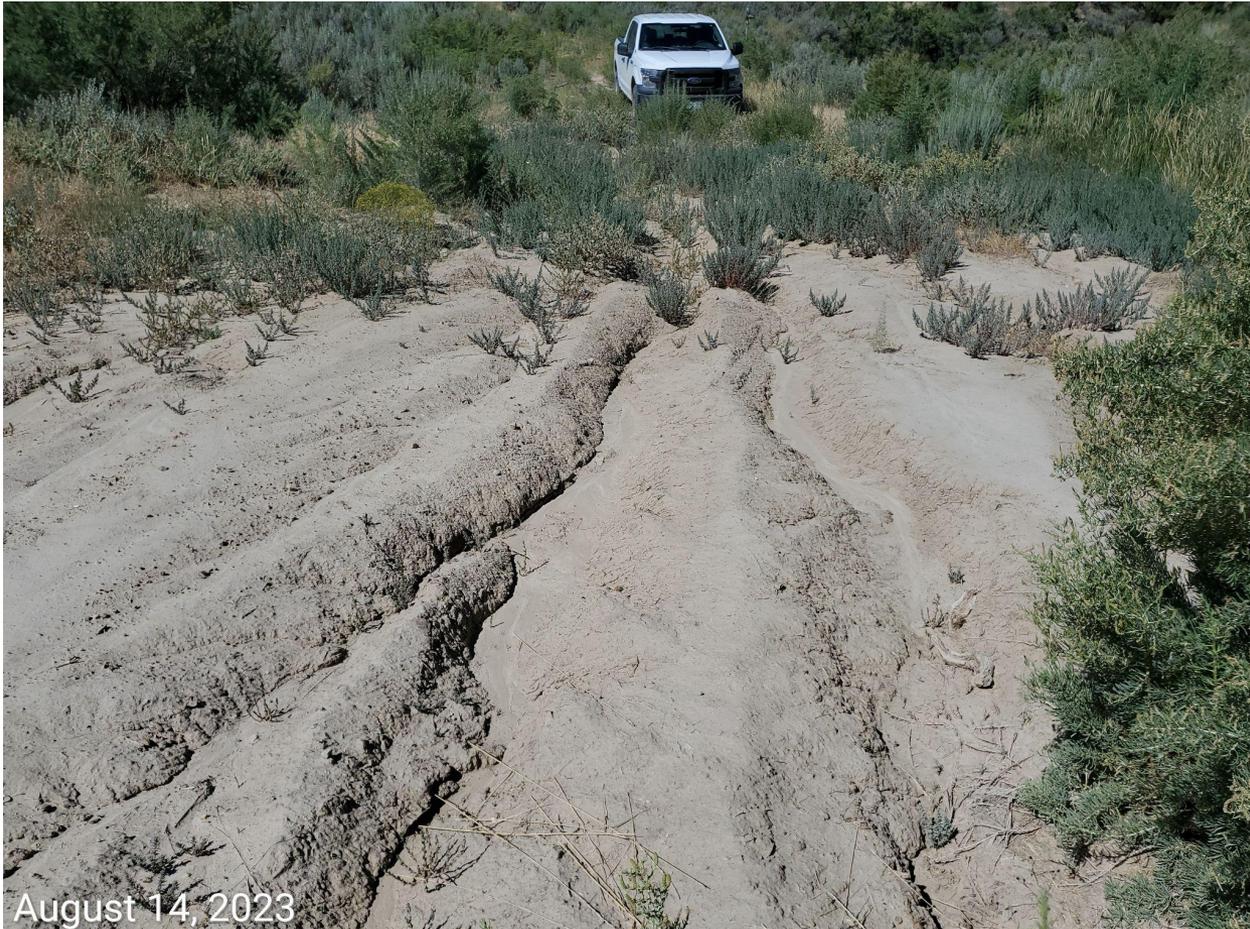
Photo 10: Photo example showing erosion degradation along access road. Stormwater and erosion control measures remain inadequate. Access road has not been decompacted, recontoured, regraded and reclaimed in accordance with 1004 Rules. Photo also shows Halogeton establishment on access road.

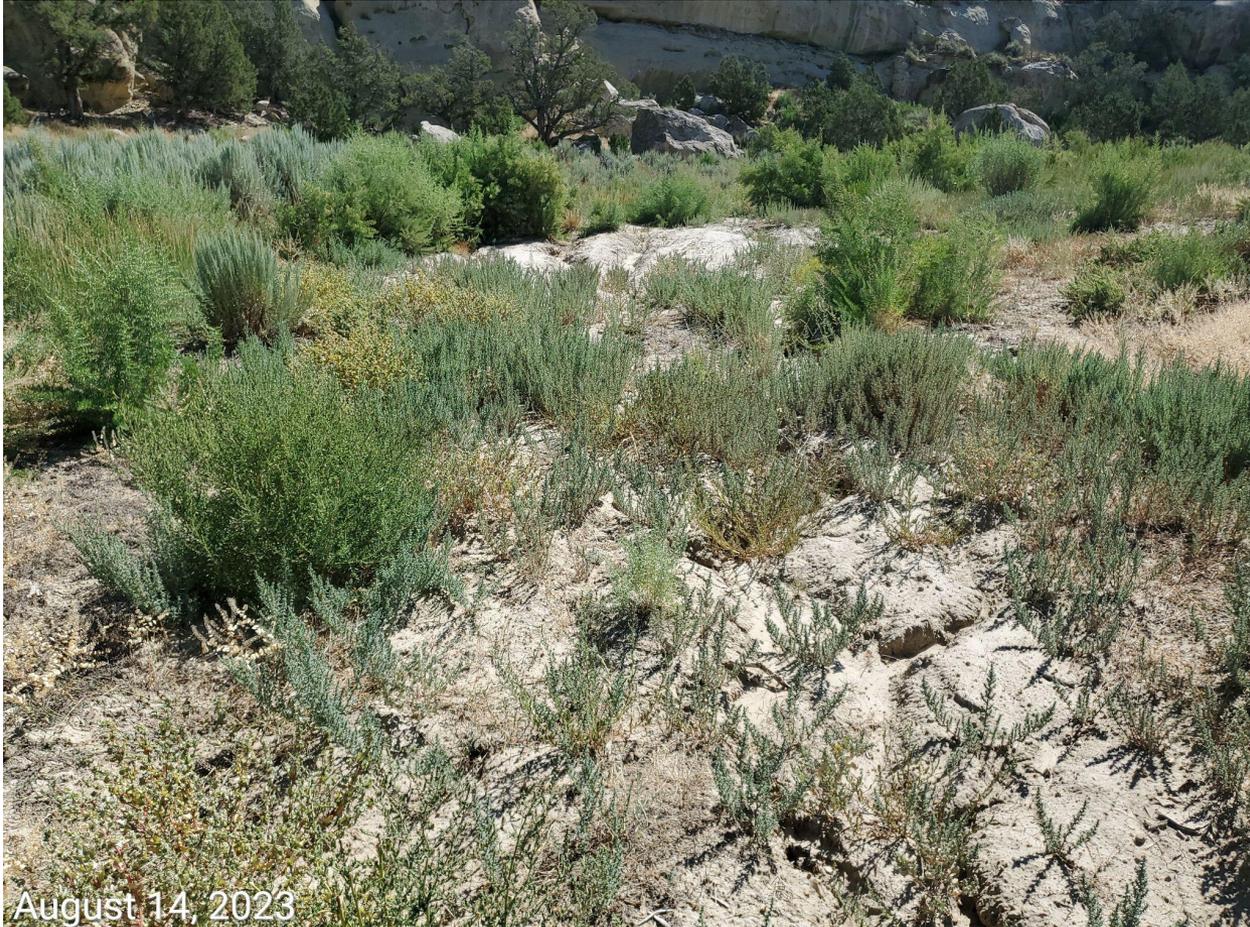
Photo 11: Photo example showing erosion degradation along access road. Stormwater and erosion control measures remain inadequate. Access road has not been decompacted, recontoured, regraded and reclaimed in accordance with 1004 Rules. Photo also shows Halogeton establishment on access road.
