Operator: 8 NORTH

Location Name: BASHOR PC GQ 15-13

Loc ID: 461104

Inspection: 696305238

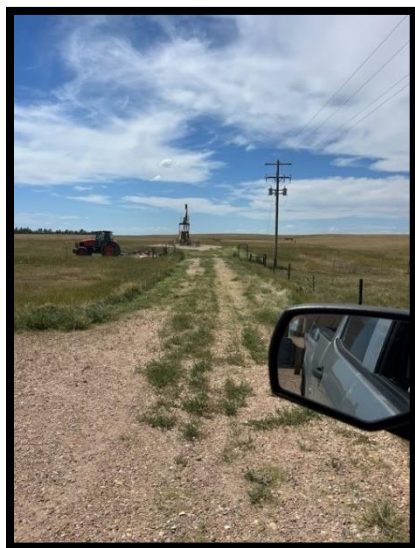
Exhibit A

CA: Weeds on Lease Road, see photos. Comply with Rule 606.

CA Resolution: Operator has reported and provided photo evidence that the identified weeds have been addressed and cleared to comply with Rule 606.

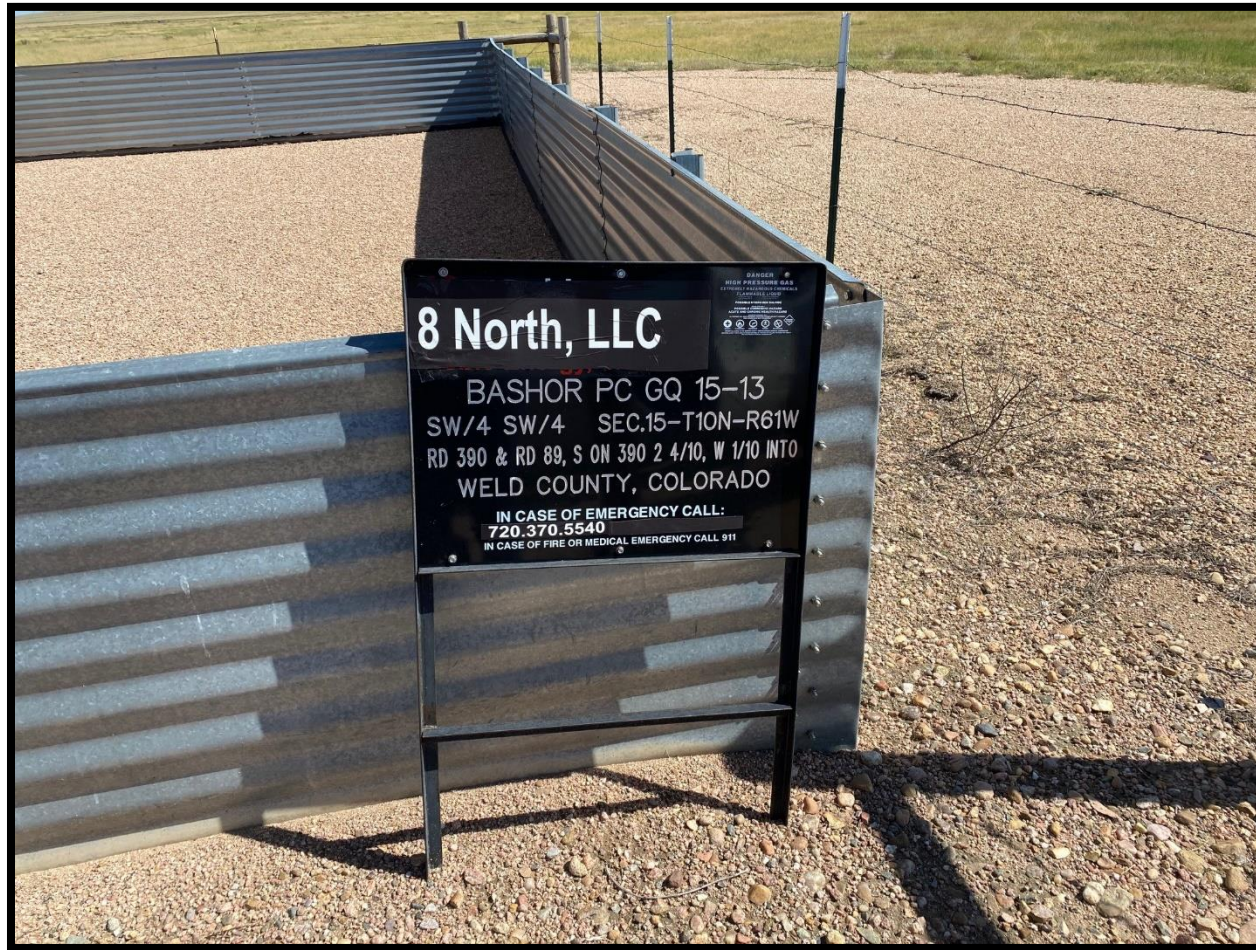
Exhibit A

CA: 24 Hour Contact Number NOT Current; see photos. Install sign to comply with Rule 605.e.

CA Resolution: Field has reported and provided photo evidence that the 24 hour contact number has been successfully updated to comply with Rule 605.e.

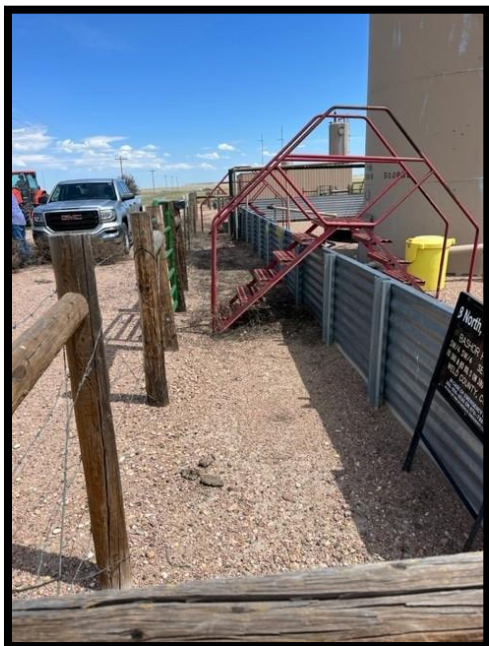
Exhibit A

CA: Tumbleweed Debris in and around Tank Berm; see photos. Comply with Rule 606

CA Resolution: Operator has reported and provided photo evidence that the identified debris at various locations has been cleared from to comply with Rule 606.
