# Inspection Photos

8/28/2023

Operator: CAERUS PICEANCE LLC #10456

Location Number: 334085

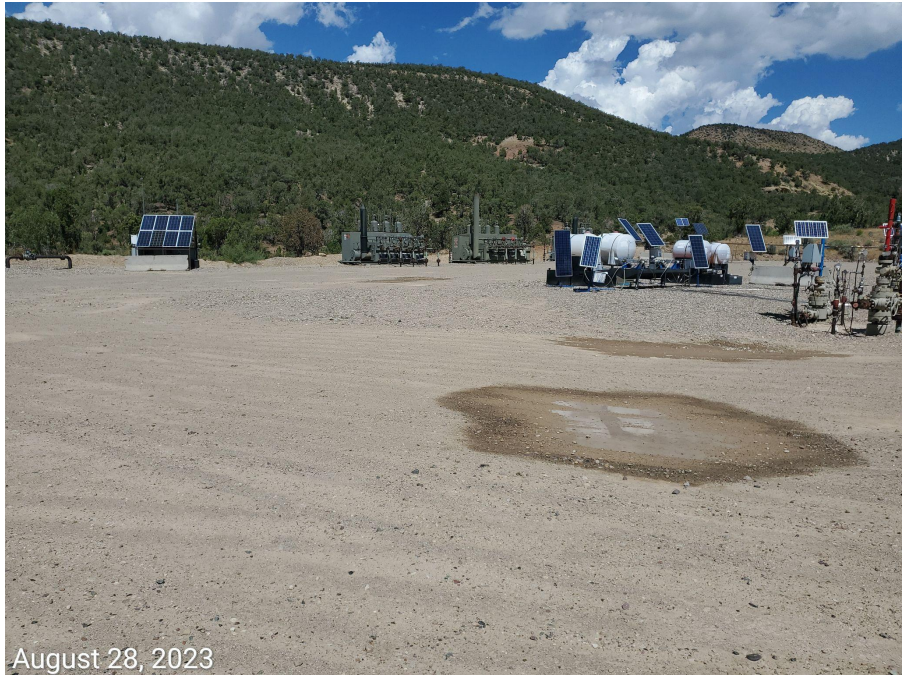
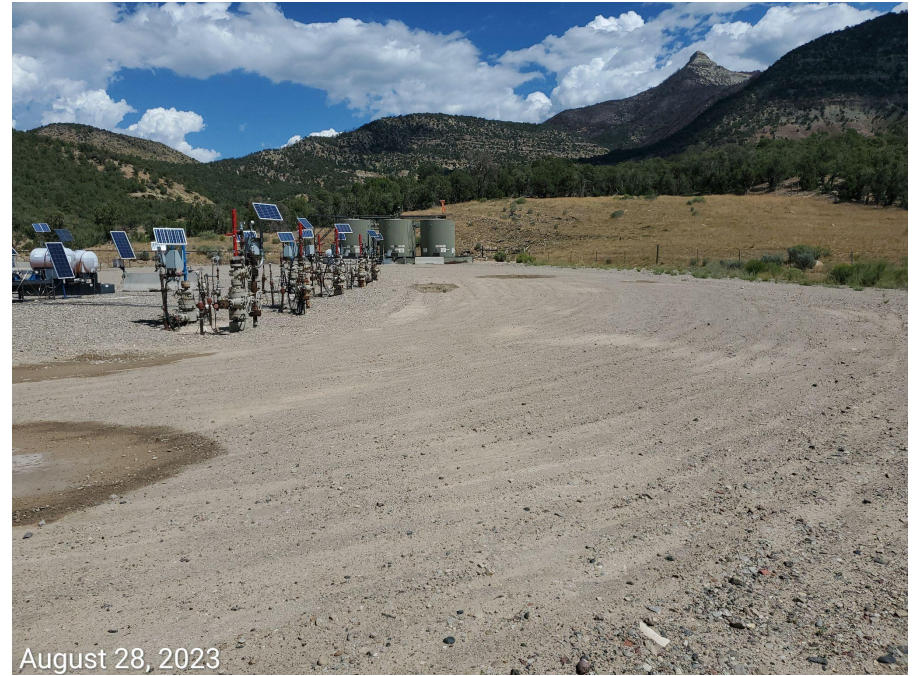
**Photo 1:** Overview of the WPS, facing northeast and southeast.

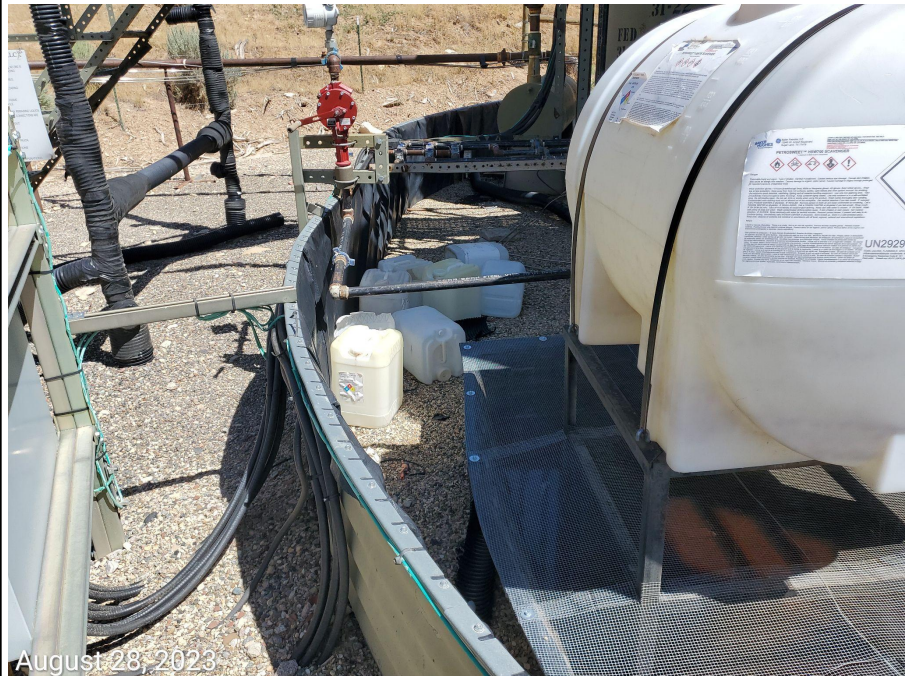
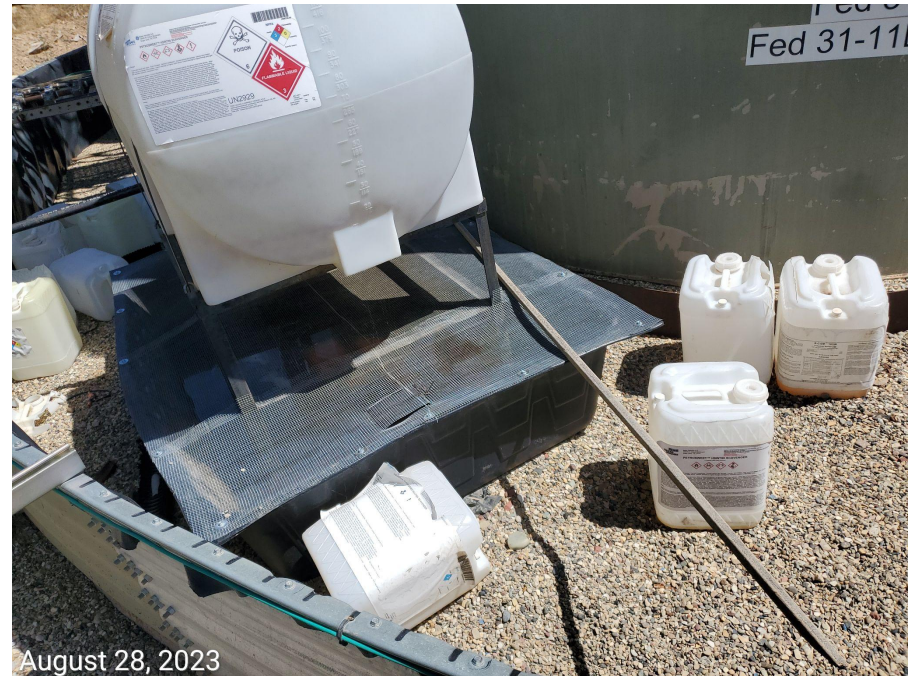
**Photo 2:** Unused and/or empty containers improperly stored within the secondary containment berm of the tank battery facility.

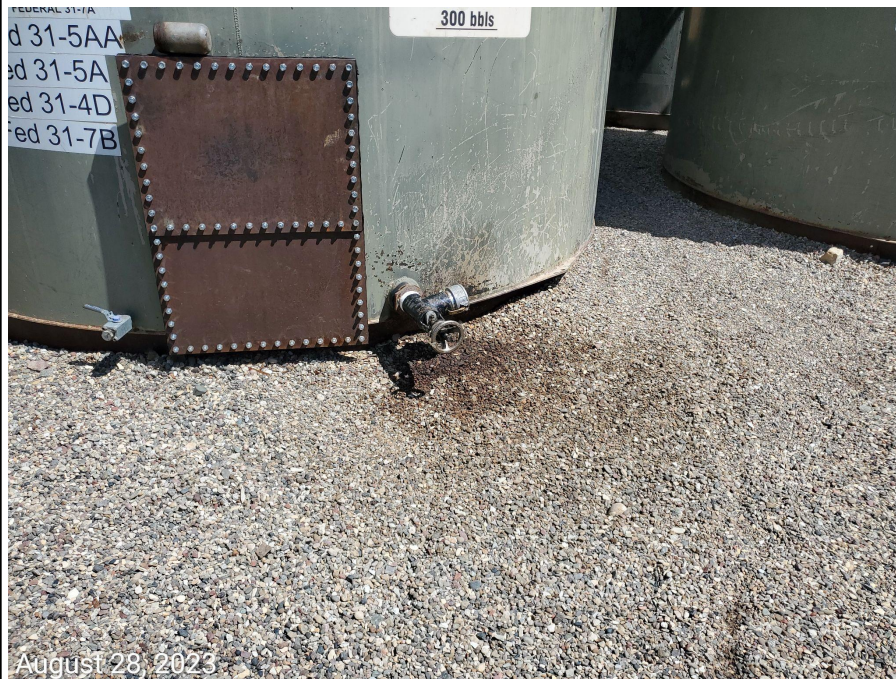
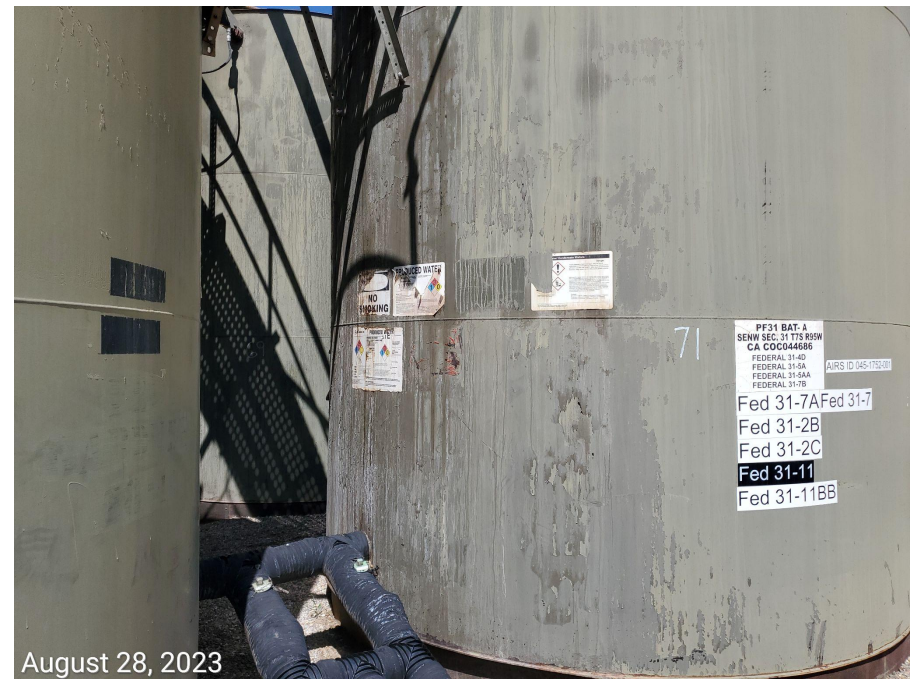
**Photo 3:** Photo left example of stained soils observed at the tank battery facility. Photo right example showing label information missing, or in disrepair at tanks.

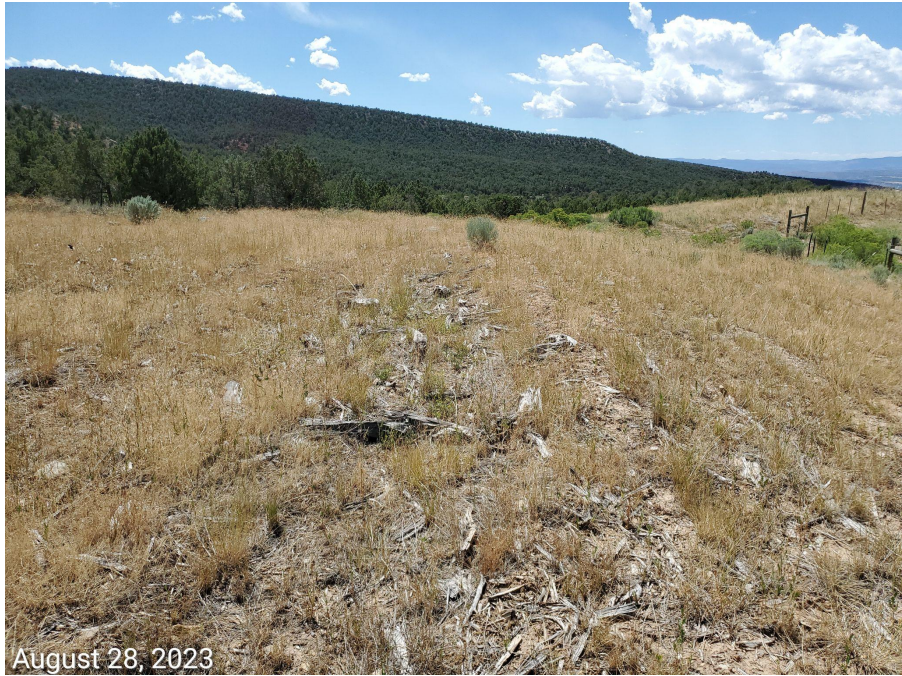
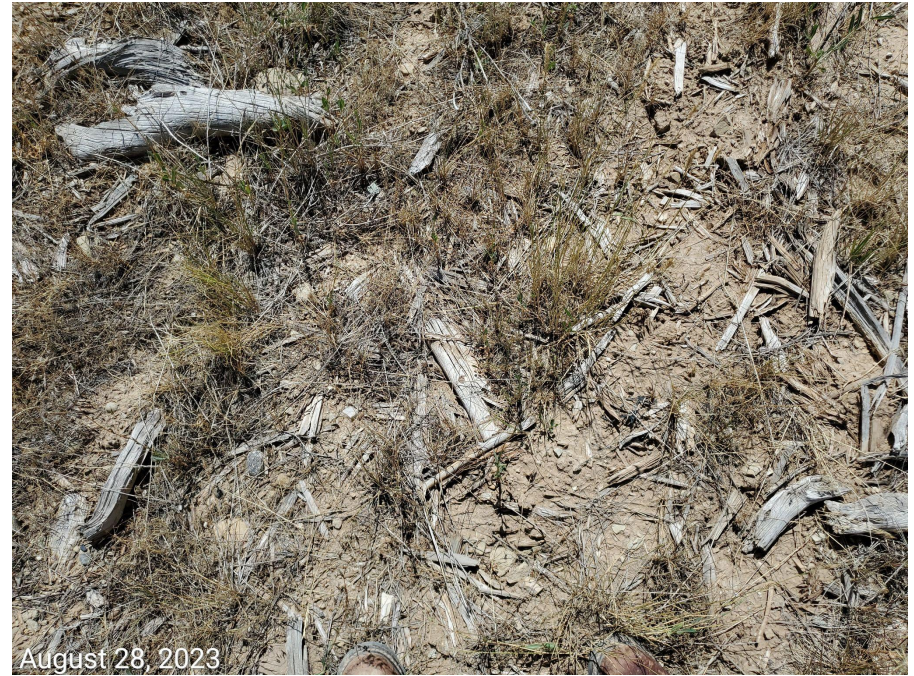
**Photo 4:** Photos taken from the interim areas on the east/southeast end of the Location. Vegetation within these areas is predominantly desirable perennial vegetation; areas are progressing towards 1003 standards.

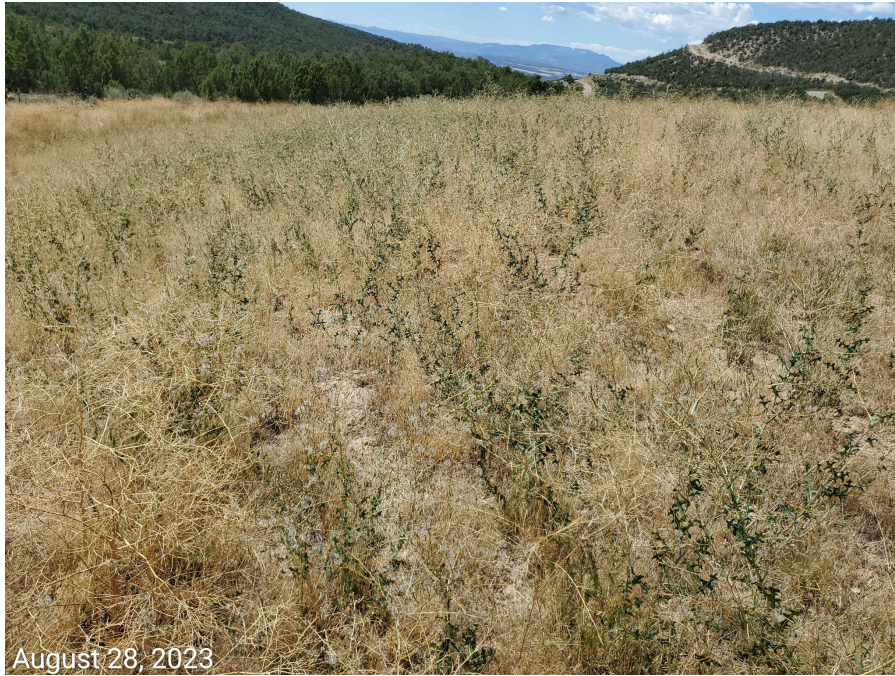
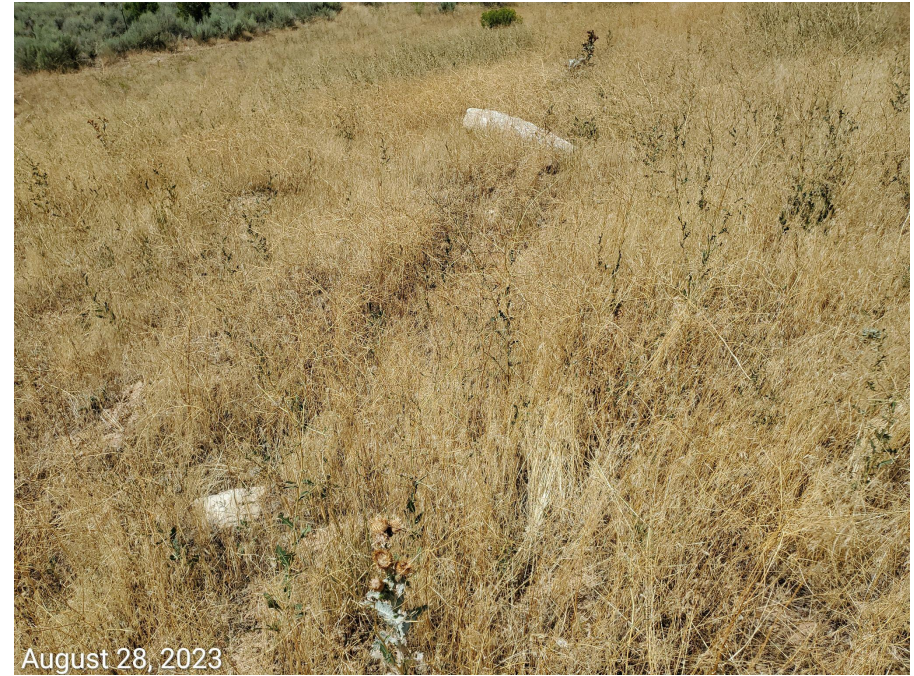
**Photo 5:** Photos taken from the southwestern / western interim areas of the Location. Vegetation observed is predominantly undesirable weedy plant species such as Tumble Mustard, Prickly lettuce, cheatgrass, etc... These areas are not progressing towards 1003 standards.
