# Inspection Photos

Operator: CAERUS PICEANCE LLC - 10456

Location Number: 316202

Rio Blanco County, CO

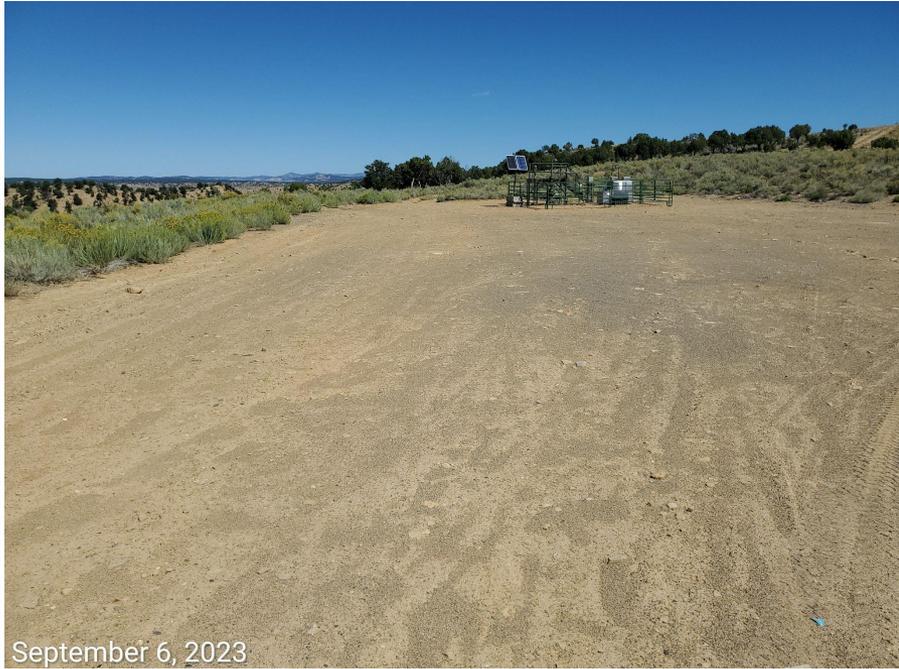
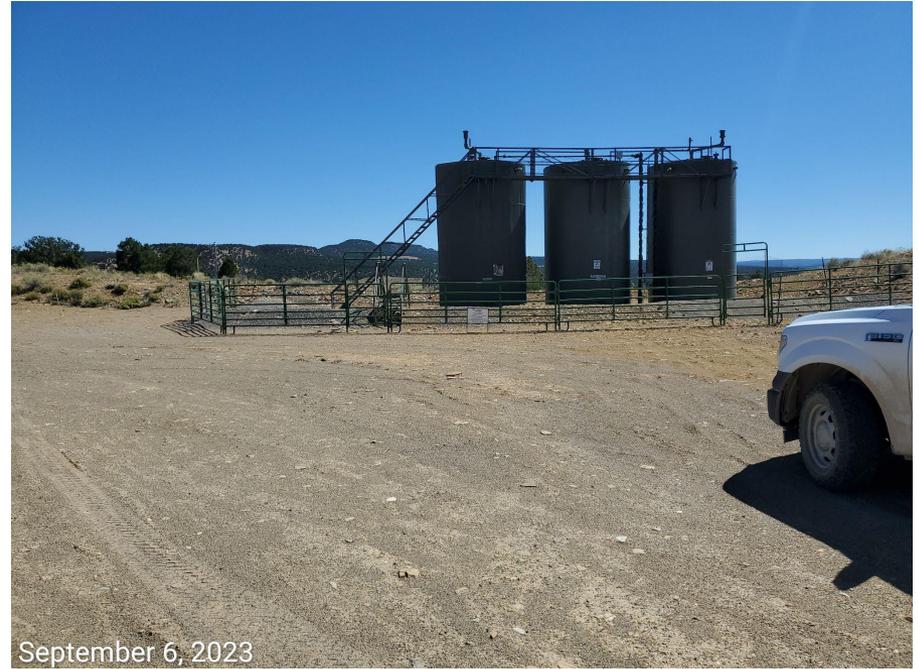
**Photo 1:** Photos provide overview of the working pad.

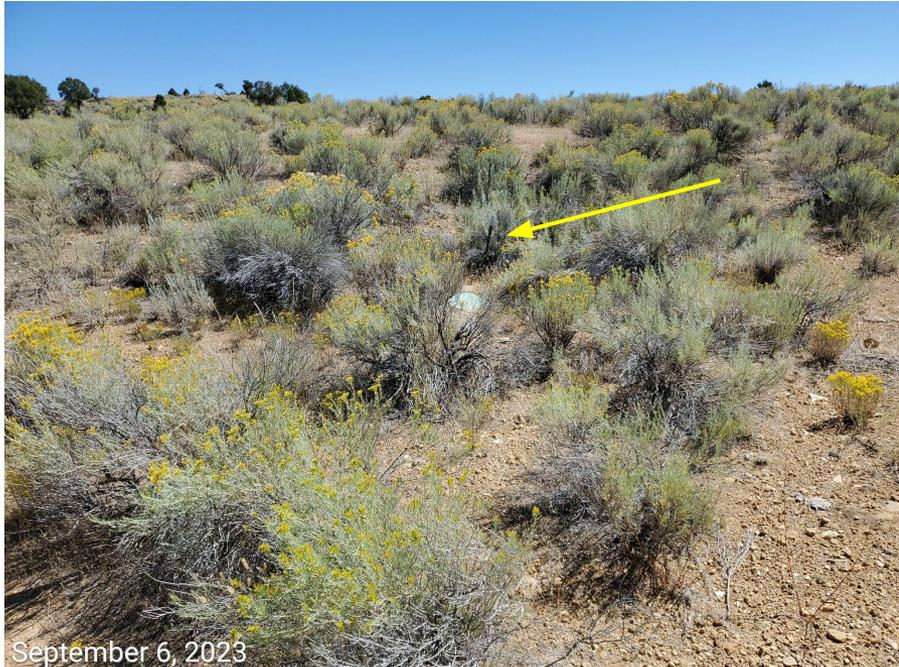
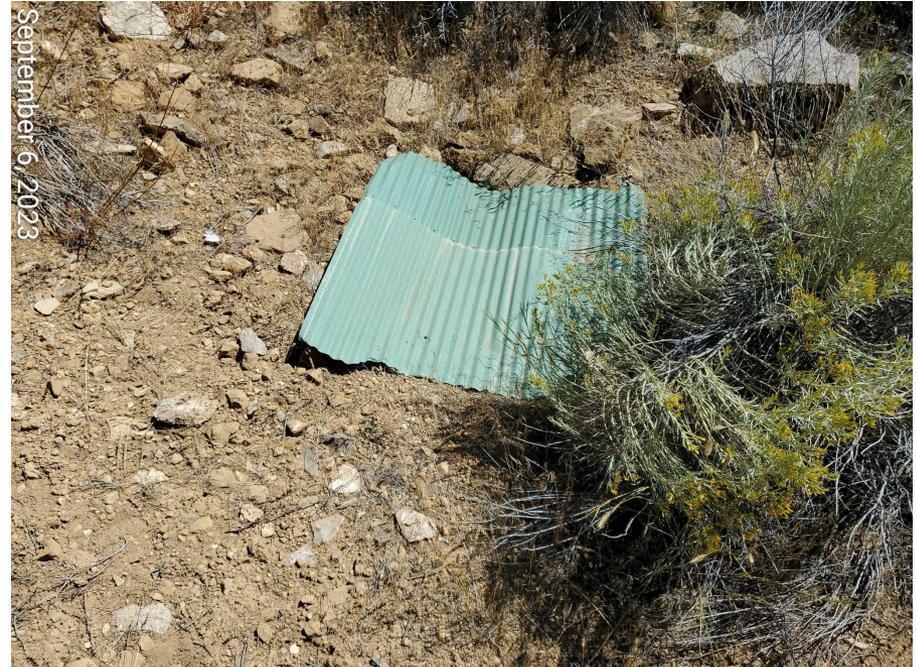
**Photo 2:** Photo taken from the northeastern corner of the Location. Photo left example showing anchors have not been properly identified with a marker of bright color not less than 4 feet in height. Photo right shows trash debris next to marker.

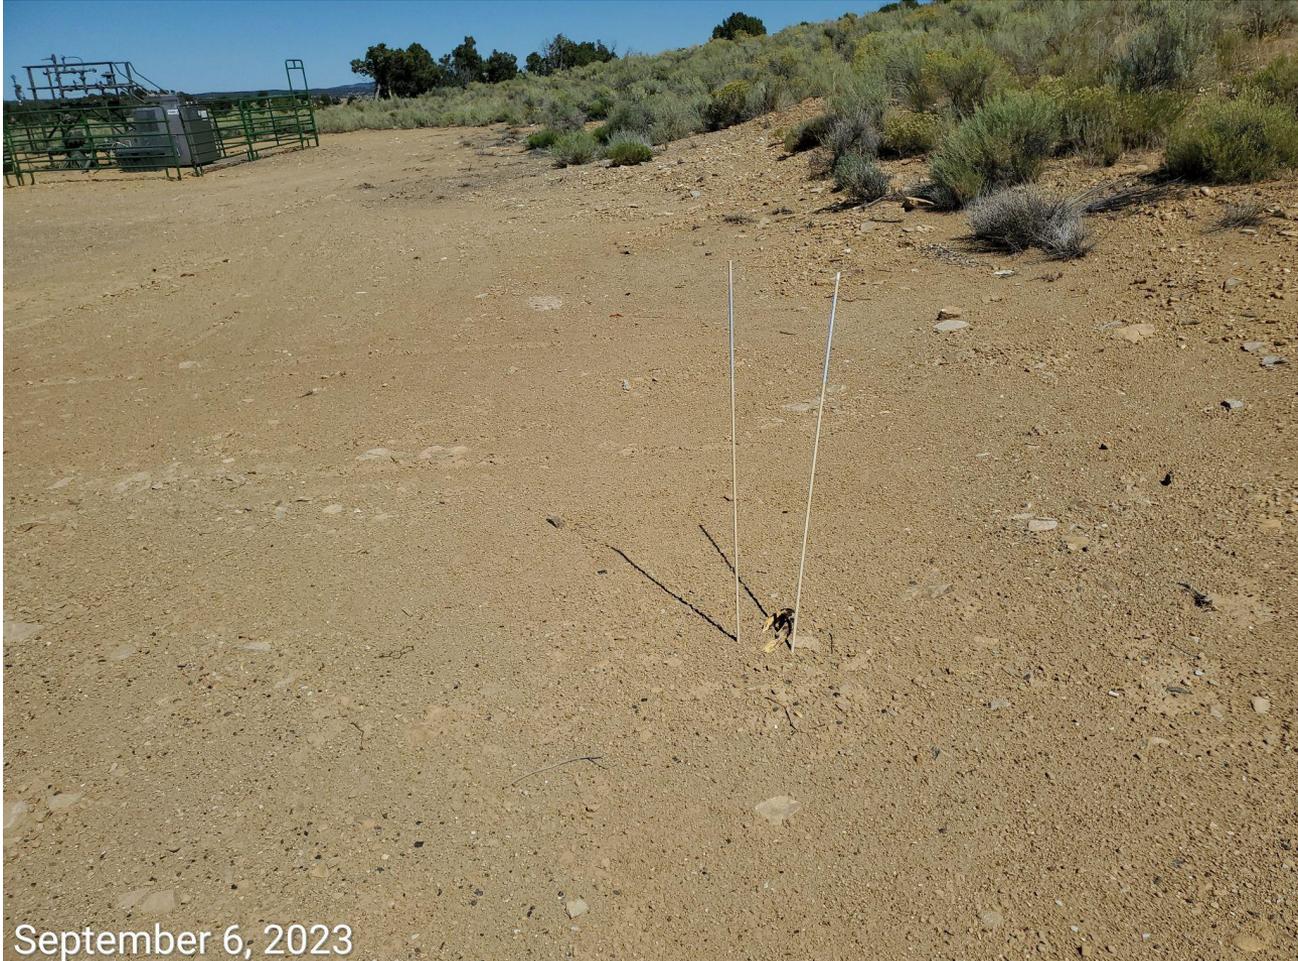
**Photo 3:** Photo example showing anchors have not been properly identified with a marker of bright color not less than 4 feet in height. Marker for the SW anchor missing.

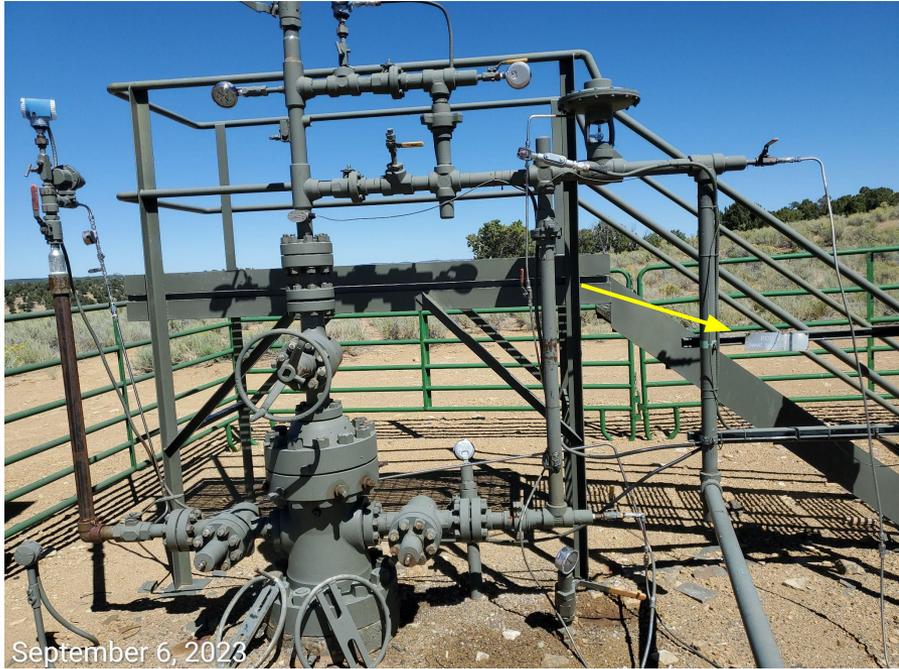
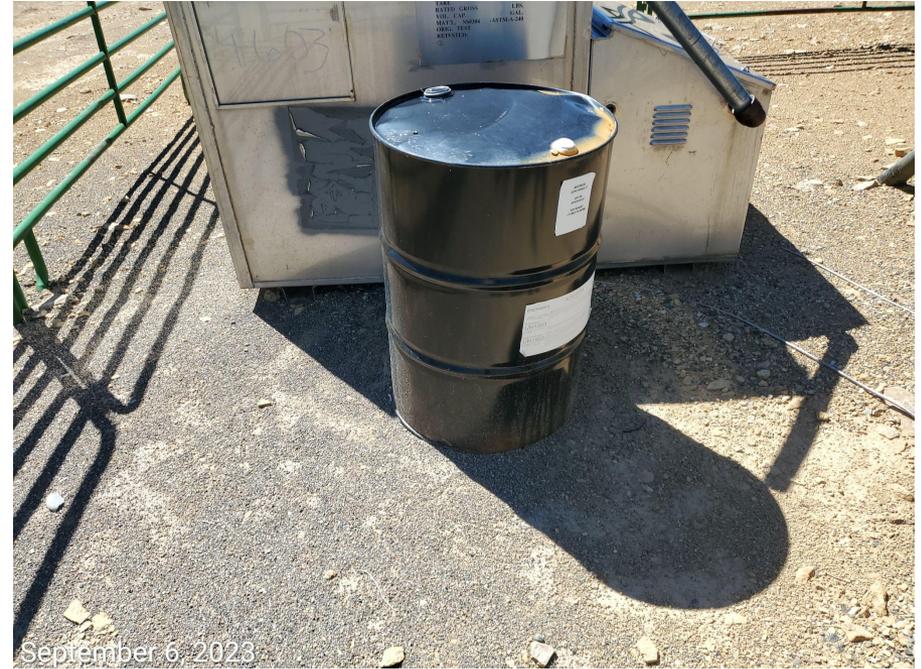
**Photo 4:** Photos taken from the well. Photo left shows signage does not comport with ECMC requirements. Photo right shows unused barrel of “Paraffin” stored on Location.
