# Interim Reclamation and Stormwater Inspection

Operator: NGL WATER SOLUTIONS DJ LLC- 10373

Location ID: 444710

Inspection Document #: 697504851

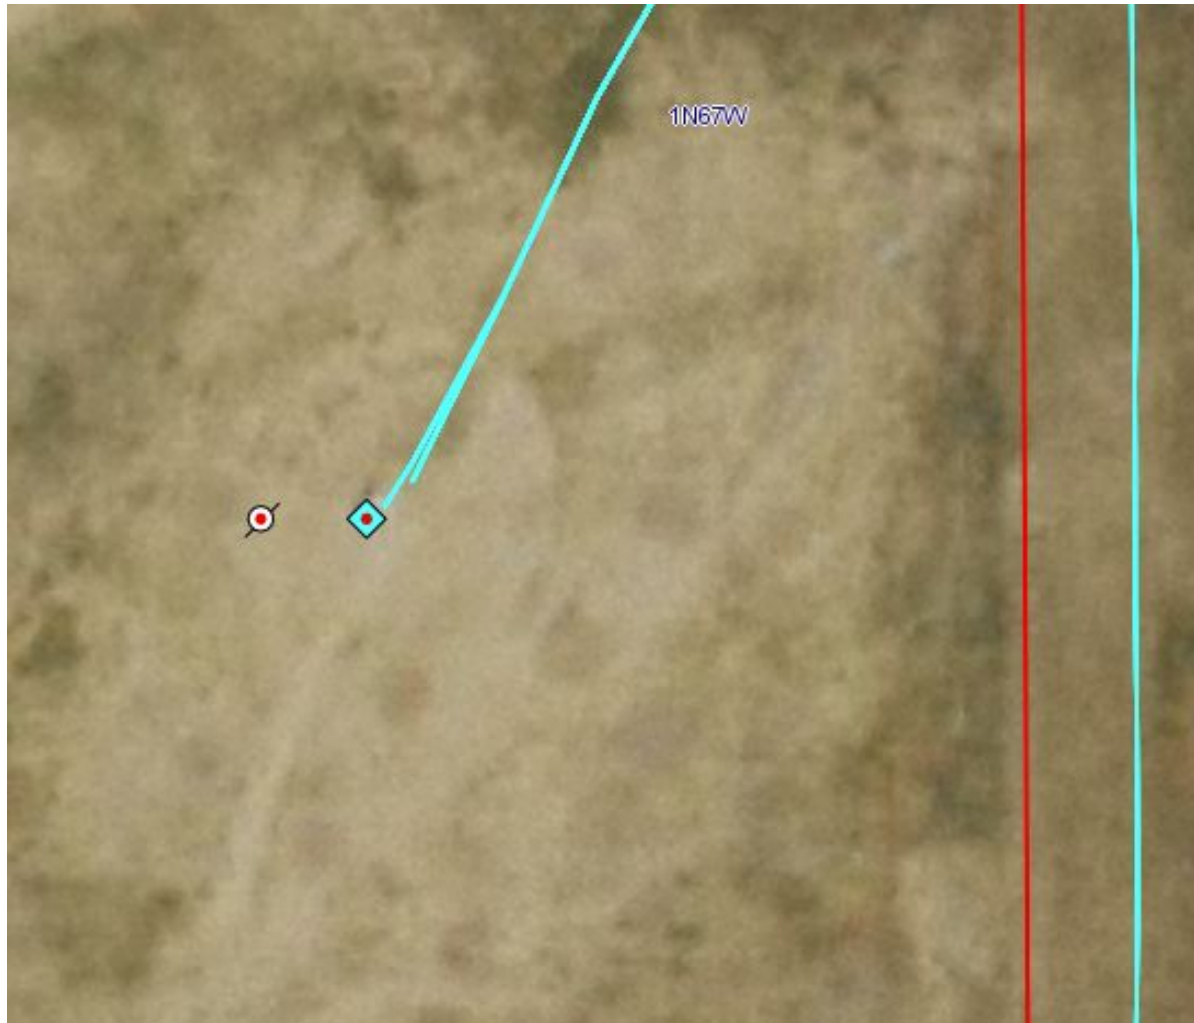
**Photo 1.** ECMC aerial imagery from 2021 illustrates the Class II Disposal Well and a portion of its flowline which travels to the NGL Major Facility (Location ID 443339).

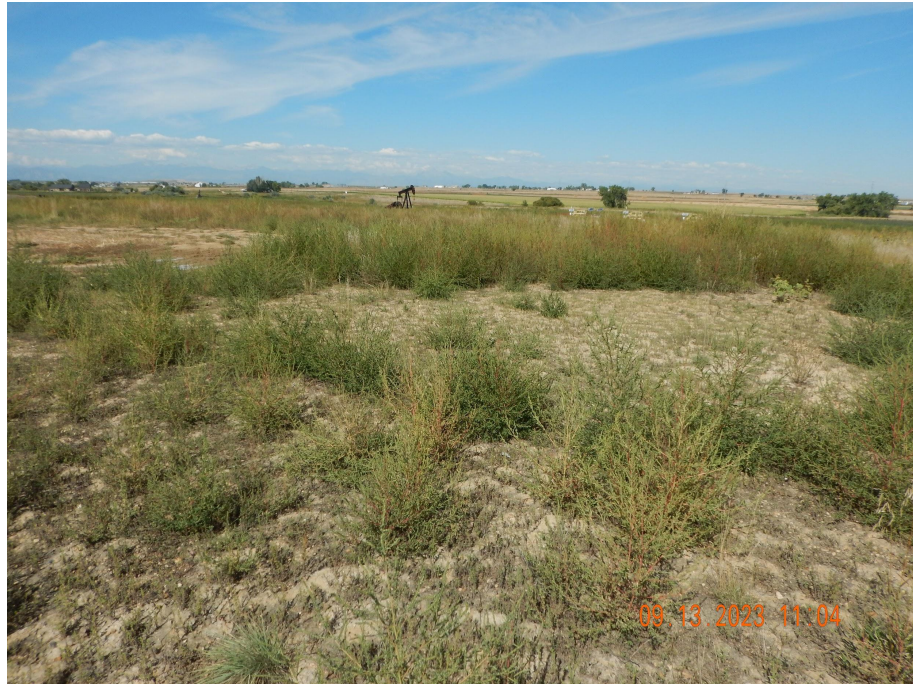
**Photo 2.** Photo taken from the northeastern interim reclamation area, facing West. Photo illustrates the Operator has performed interim reclamation and desirable vegetation was observed; however, unmanaged tumbleweeds were observed.

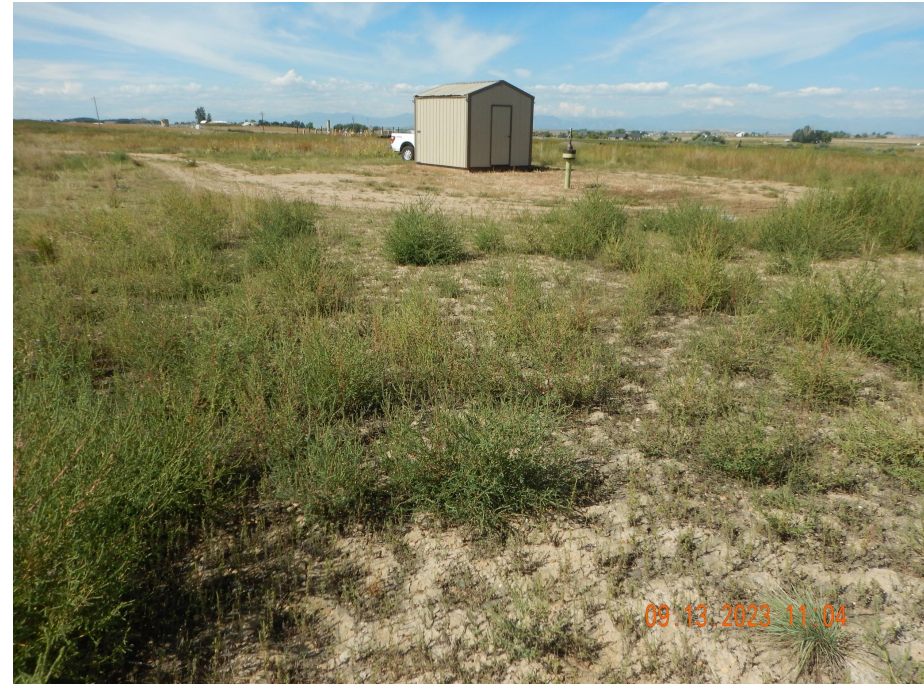
**Photo 3.** Photo taken from the northeastern interim reclamation area, facing Southwest. See comments under Photo 2.

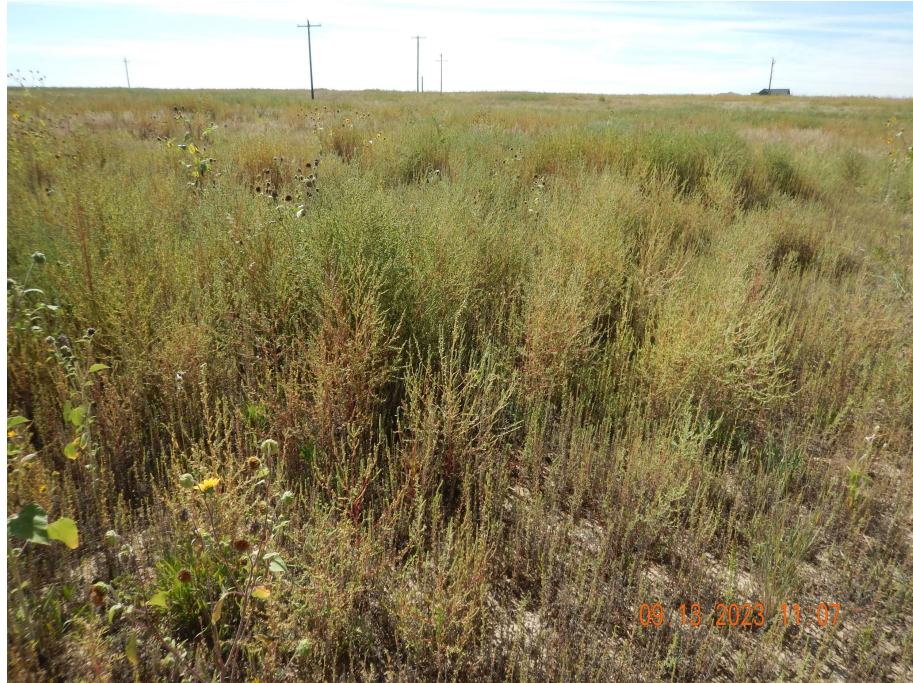
**Photo 4.** Photo taken from the eastern interim reclamation area, facing South. Photo illustrates an area of unmanaged tumbleweeds as the dominant vegetative growth.

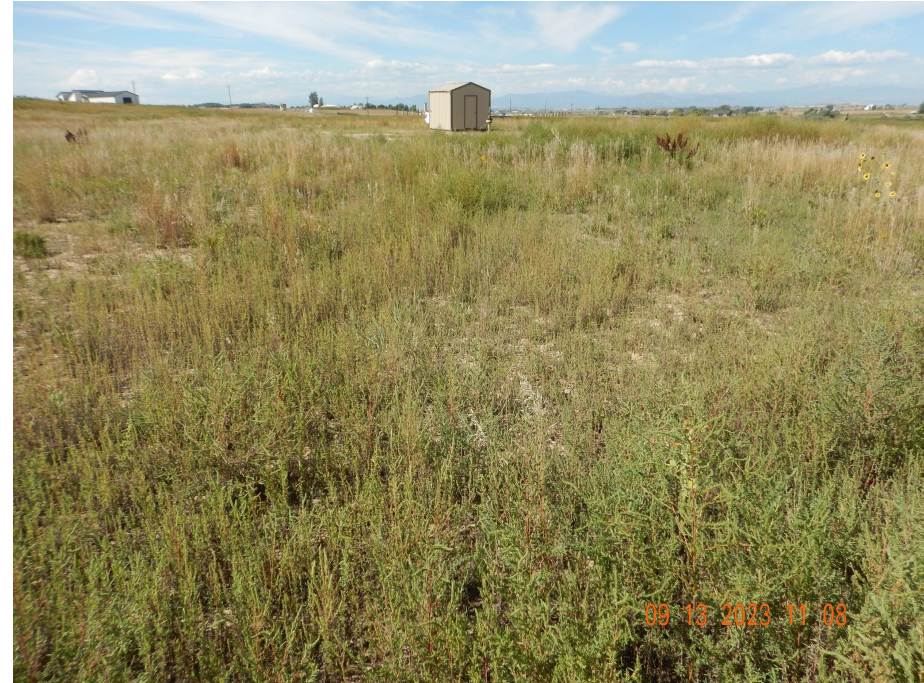
**Photo 5.** Photo taken from the northeastern interim reclamation area along the flowline, facing Southwest. See comments under Photo 4.
