Interim Reclamation and Stormwater Inspection

Operator: KERR MCGEE OIL & GAS ONSHORE LP - #47120

Location ID: 470407

Inspection Photos
Location Name: PROWANT 4-18HZ PAD
Location ID: 470407

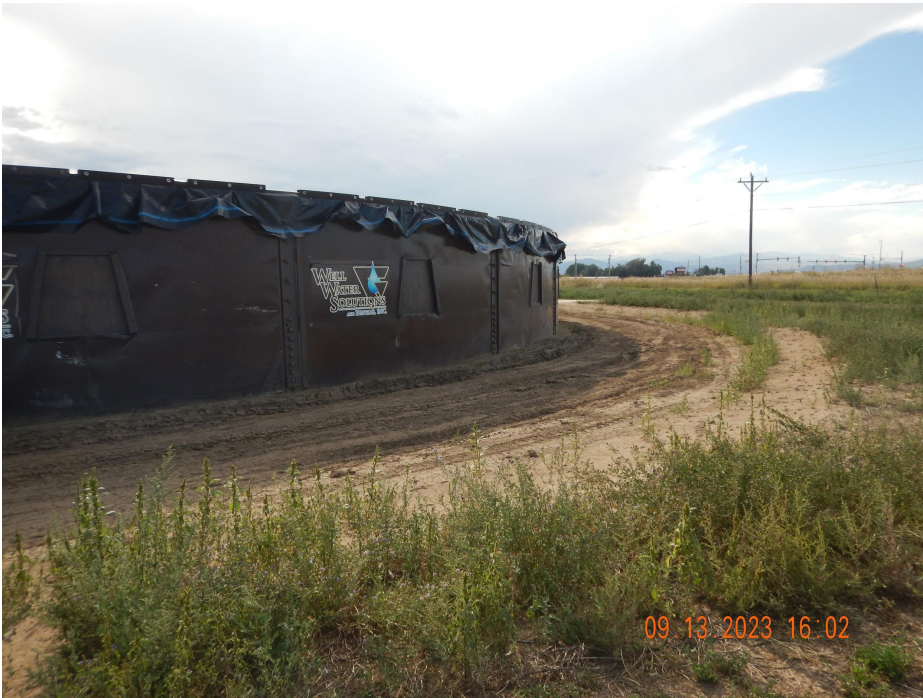
Photo 1. Photo taken from the northeastern interim reclamation area, facing West. Photo illustrates a MLVT has been constructed for subsequent well operations with heavy equipment. Operator has graded and disturbed the area for the purposes of constructing a MLVT.

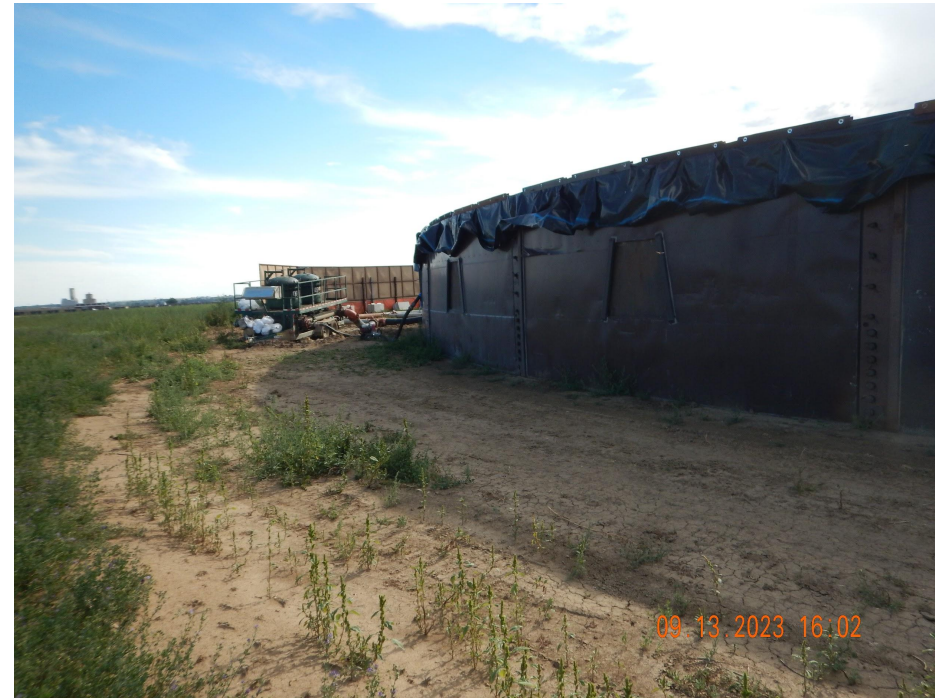
Photo 2. Photo taken from the northeastern interim reclamation area, facing South. See comments under Photo 1.
