Inspection Photos

Operator: LARAMIE ENERGY LLC #10433

Location ID: 452807

Inspection No: 696205261

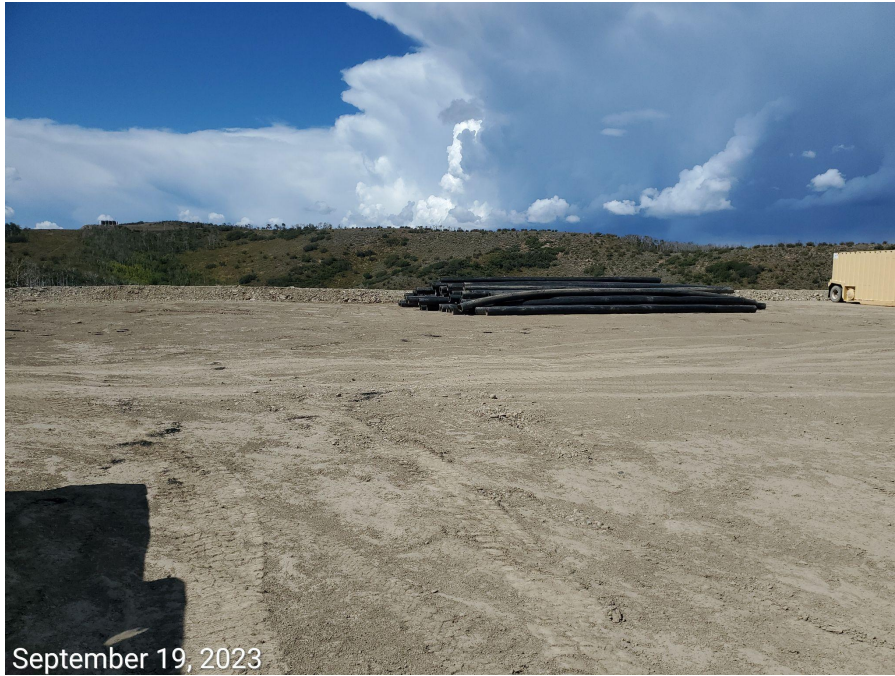
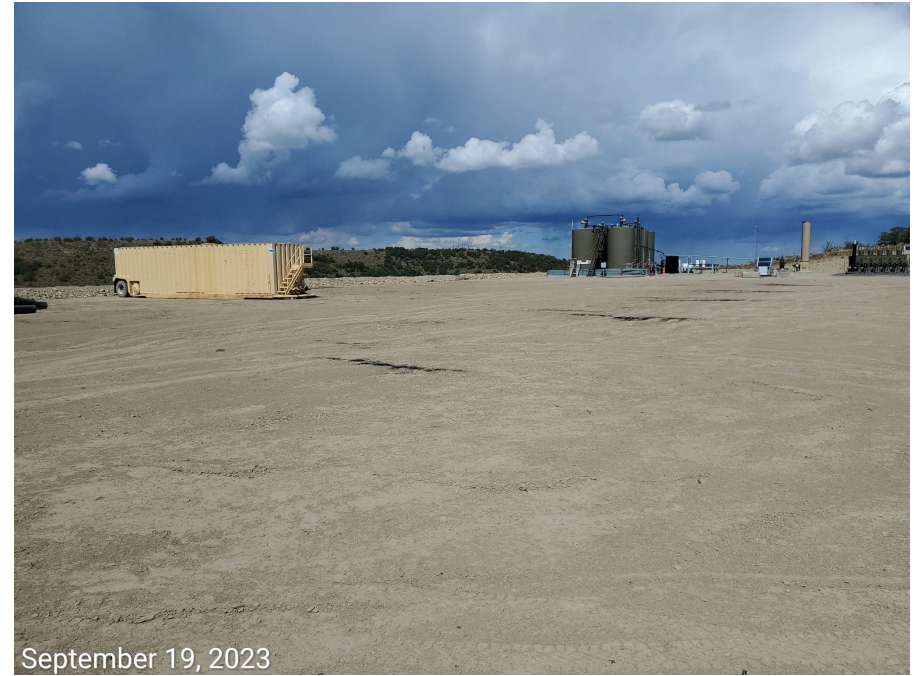
Photo 1: Photos taken from the south end of the Working Pad Surface. Photos 1-2 provide an overview of the Location from west, northwest, northeast to east. Photos also show frac operations have completed, and the majority of the tanks and other related equipment have been removed. Interim reclamation now required.

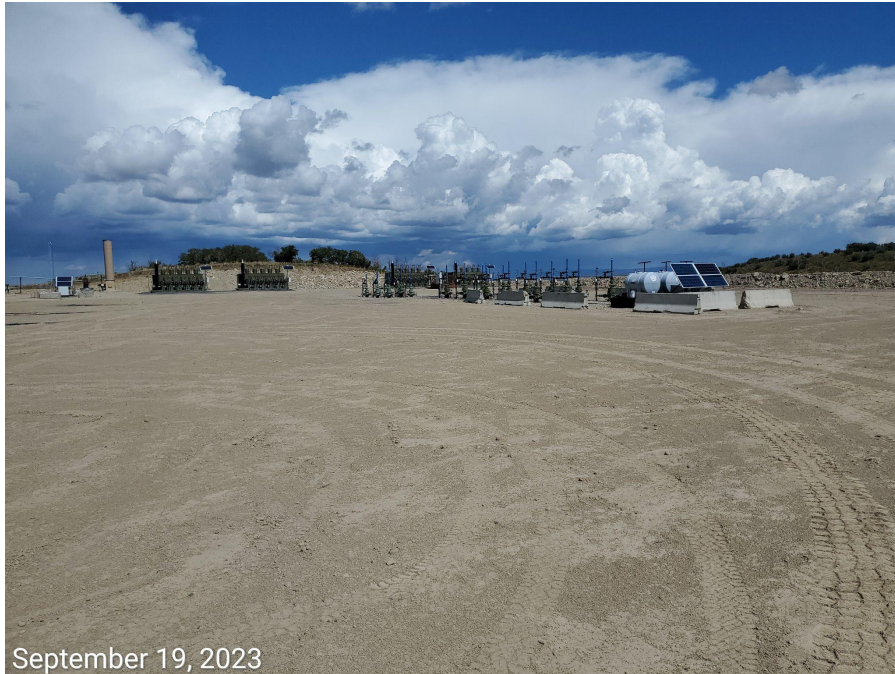
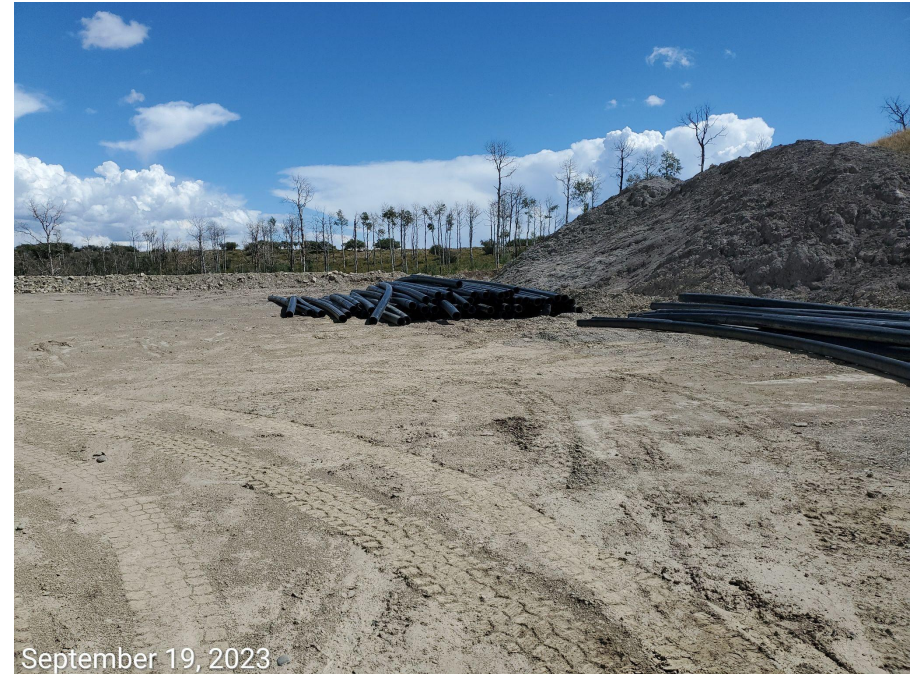
Photo 2: See comments under photo 1.

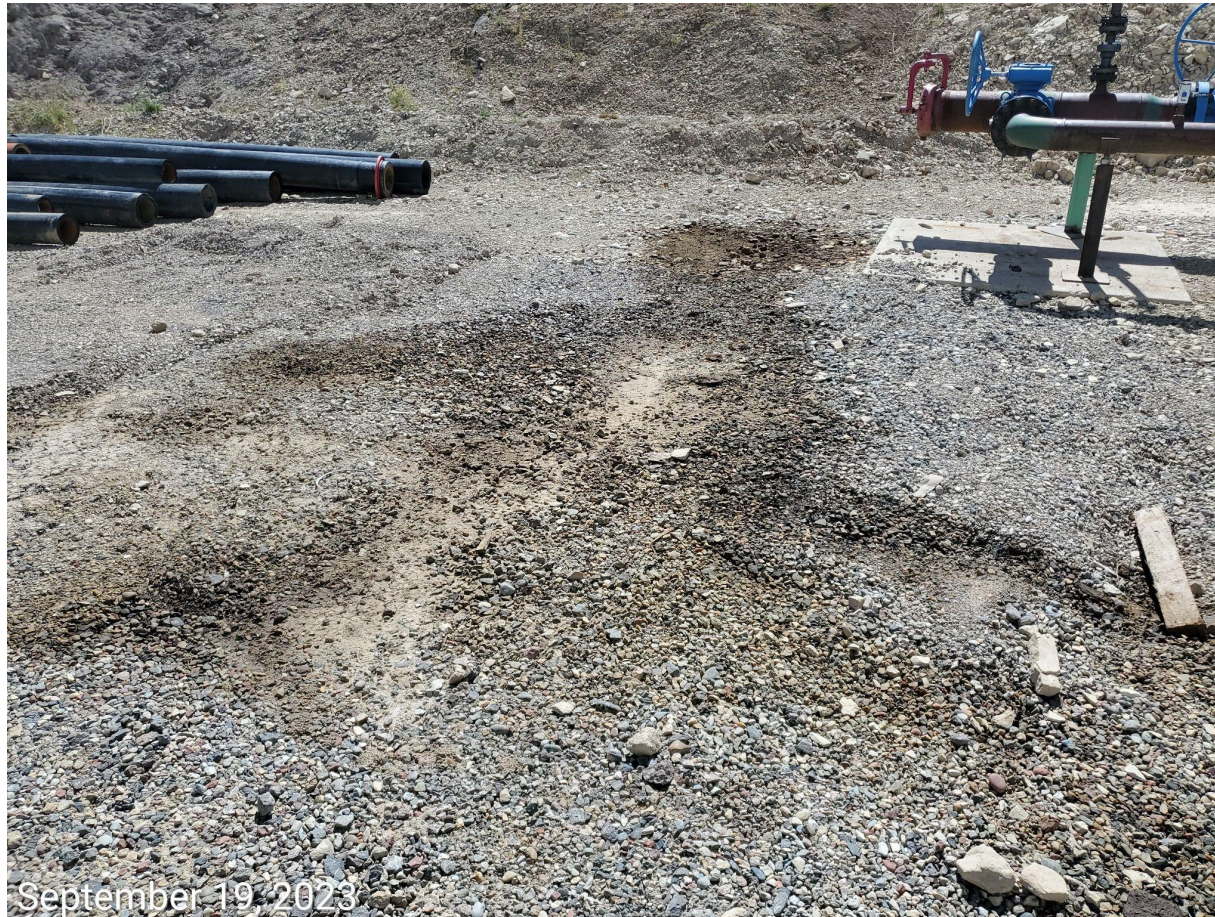
Photo 2: Photo taken from the south end of the Location. Photo shows stained soils observed next to the pipeline equipment.

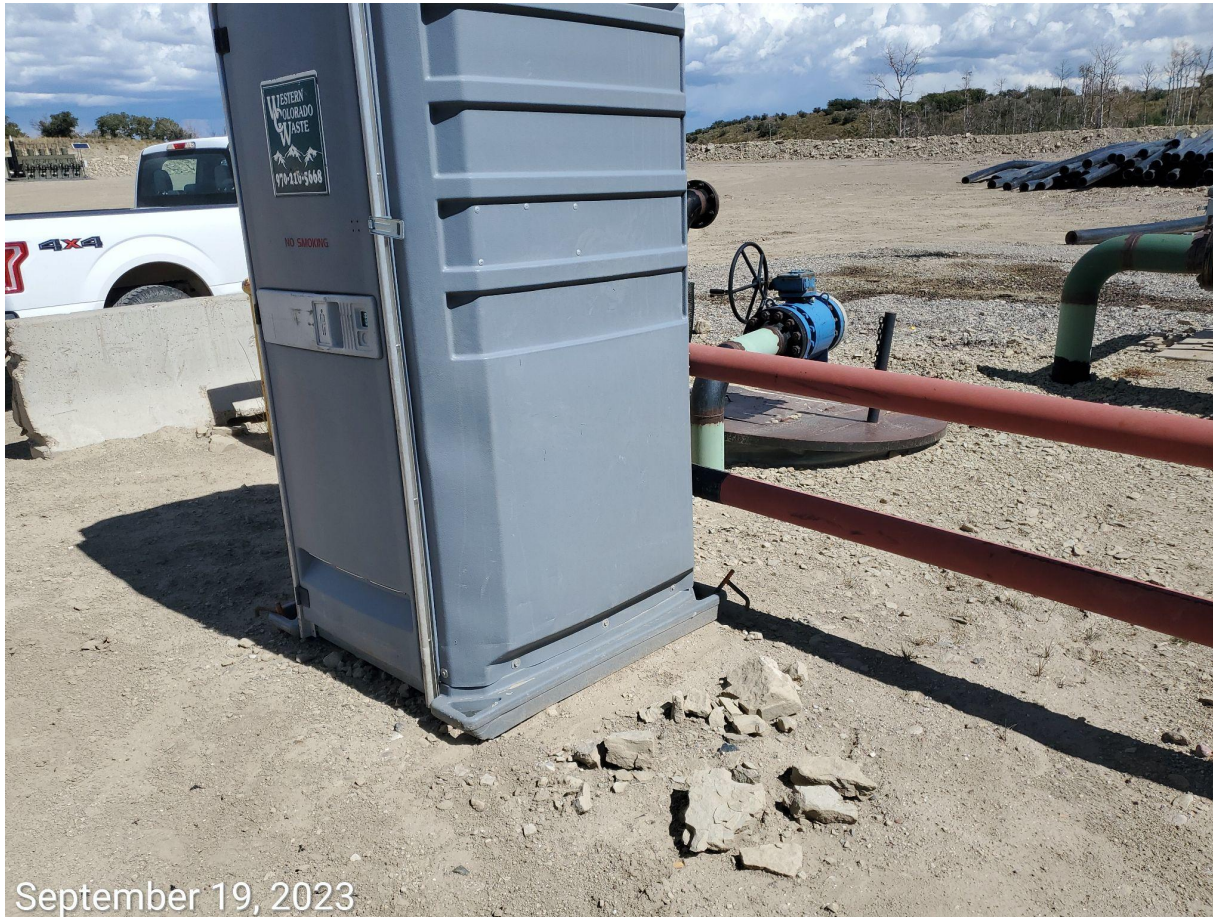
Photo 4: Photo taken from the south end of the Location. Photo shows porta-john has been secured, and spill has been cleaned.

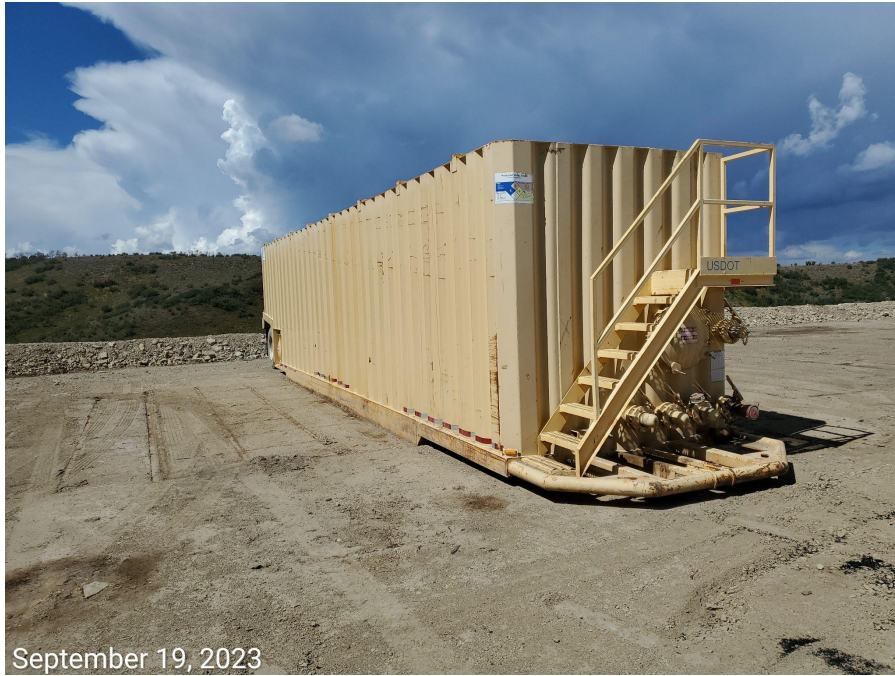
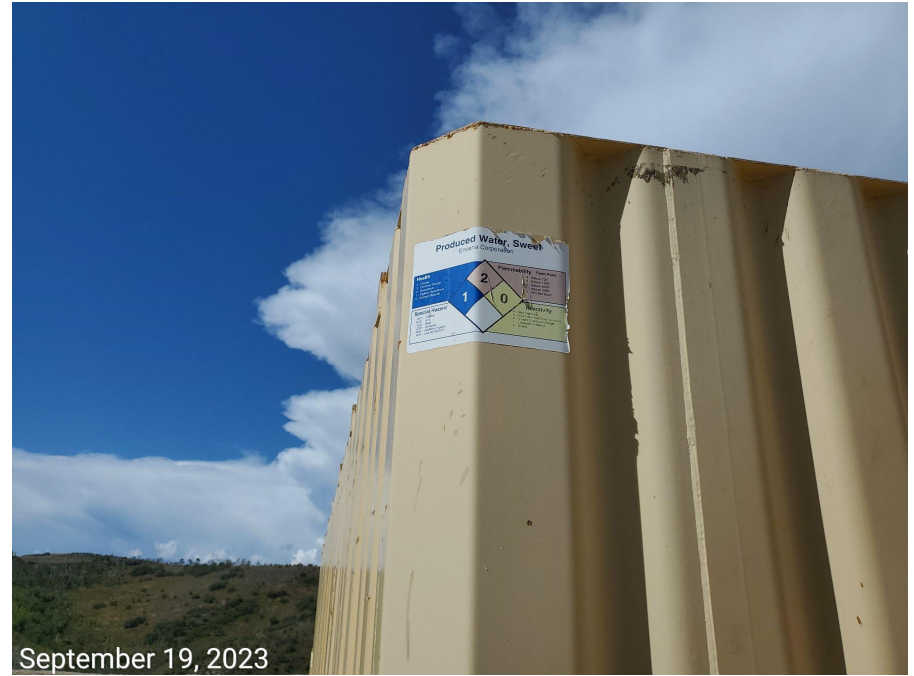
Photo 5: Photo shows single tank remaining on the Location from frac Operations. Photo also show tank labeling remains out of compliance with 605 rules.

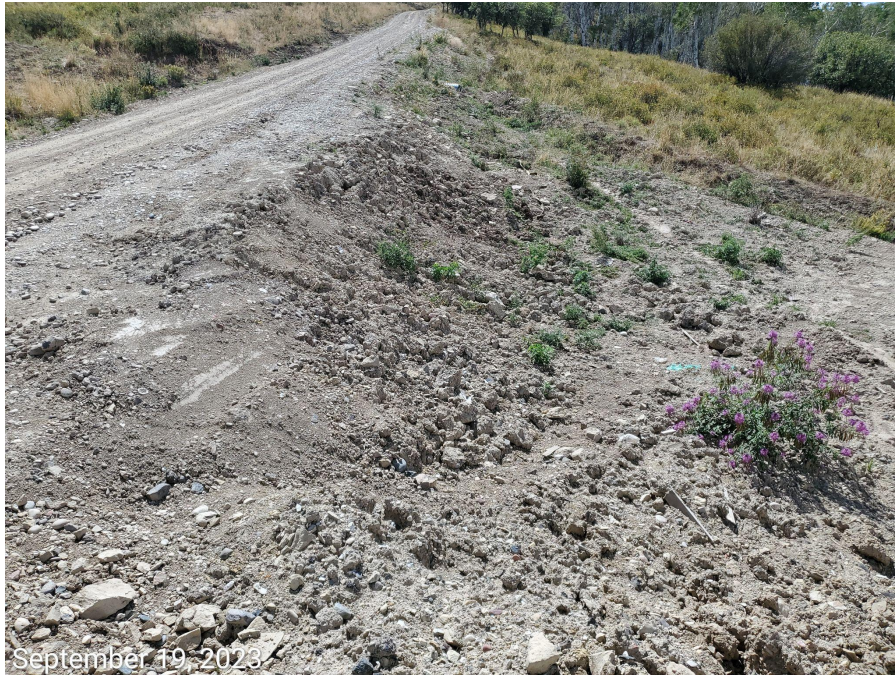
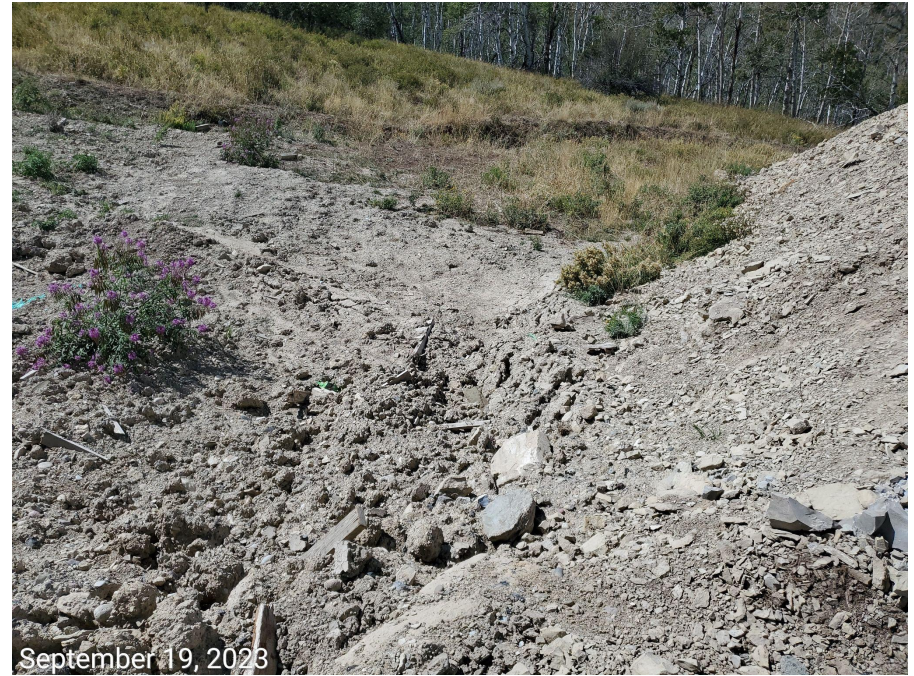
Photo 6: Photos taken from the Location entrance, on the southwest end of the Location. Photos show control measures to stabilize slopes remain missing or insufficient.

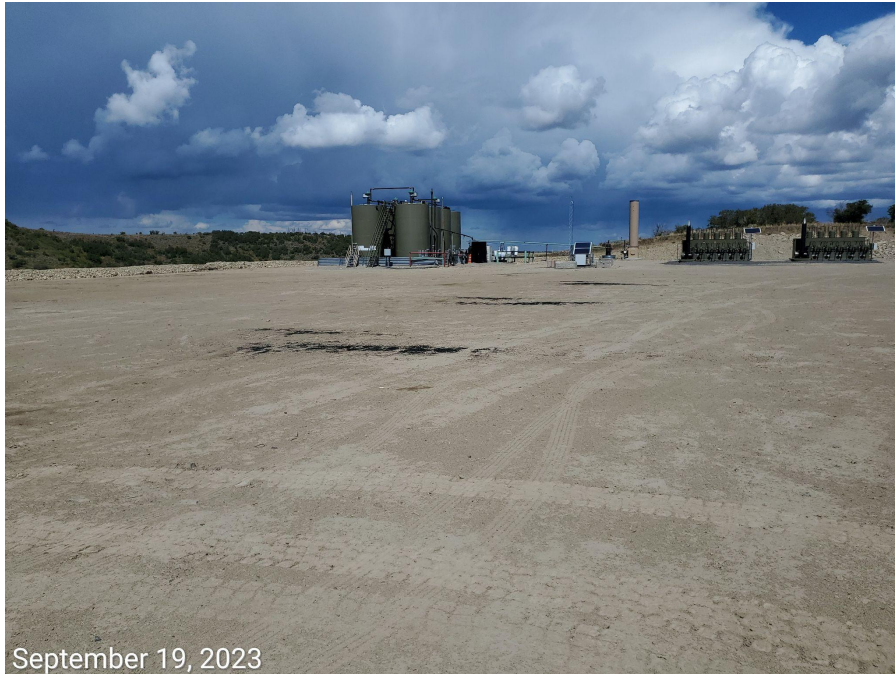
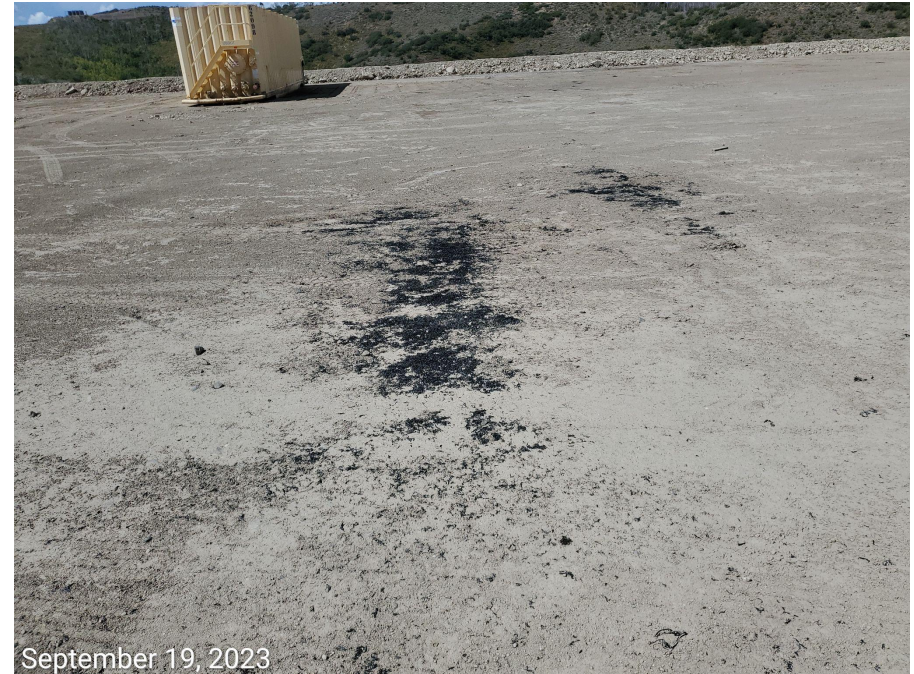
Photo 7: Photos examples showing an unknown black material that has been spilled upon the working pad surface, and areas of the access road.
