## **ATTACHMENT B**

<b>SITE NAME:</b> Briggs Aggregate 1-25 Facility & Wellhead							<b>DATE:</b> 8/30/2023		<b>REM. PROJECT #:</b> 29948		<b>WEATHER:</b> 90	
<b>SITE DIRECTIONS:</b> CR 4.5 and CR 23.5, south 0.5 miles and east 0.1 miles							<b>CLIENT:</b> PDC					
<b>LEGALS AND LAT/LONG:</b> 40.016775, -104.841505							<b>TASMAN PERSONNEL:</b> JH					
<b>SOIL TYPES:</b> Poorly Graded Sand - SP							<b>SURFACE GRADIENT:</b> Northeast					
SOIL SAMPLING							FACILITY INFRASTRUCTURE					
Date/Time	Soil Sample ID	PID (ppm)	Visual	Olfactory	Photo?	Grab or Lab Sample?	EQUIPMENT		Quantity			
							Above Ground Storage Tank (AST)					
8/30/2023 10:00	SL01-06-B @ 7'	2.3	No Staining	No Odor	Yes	Lab	Buried or Partially Buried Vessel					
8/30/2023 10:05	SL01-06-N @ 6'	10.1	No Staining	No Odor	Yes	On-Hold	Separator					
8/30/2023 10:10	SL01-06-W @ 6'	178.1	HC Staining	Strong HC Odor	Yes	On-Hold	Emission Control Device (ECD)

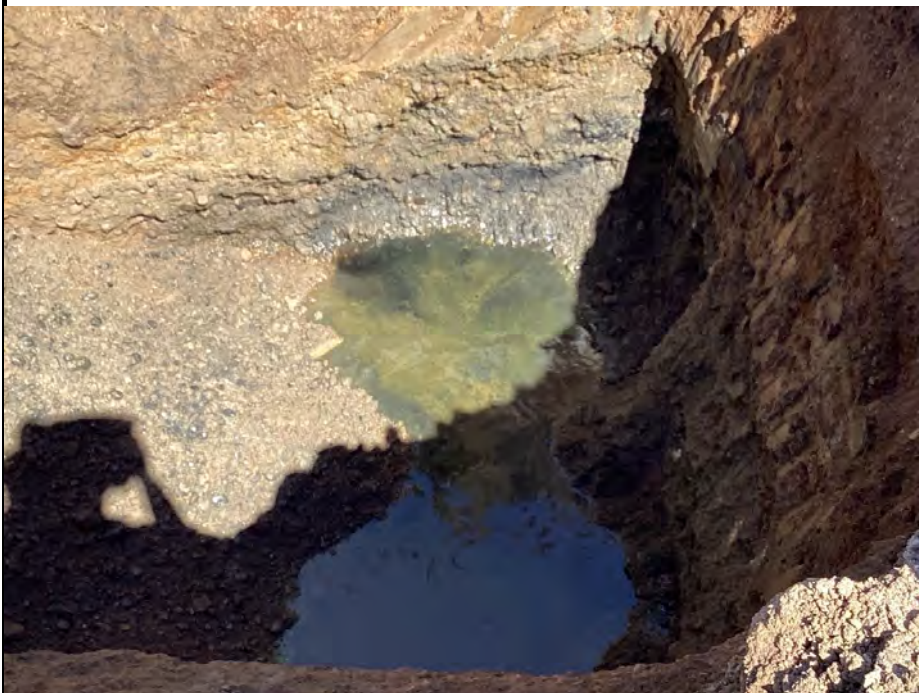
<b>Equipment ID:</b>		<b>Equipment Type:</b>		<b>Equipment ID:</b> SS01 @ 13'		<b>Equipment Type:</b>			
<b>Material:</b>		<b>Volume:</b>		<b>Material:</b>		<b>Volume:</b>		<b>Contents:</b>	
<b>Notes/Conditions:</b> Sheen on water in separator dig					<b>Notes/Conditions:</b> Separator dig
