WELL NAME: SHEEP MOUNTAIN UNIT WELL 4-23-L, API #: 055-06314 INSP. # 695108643

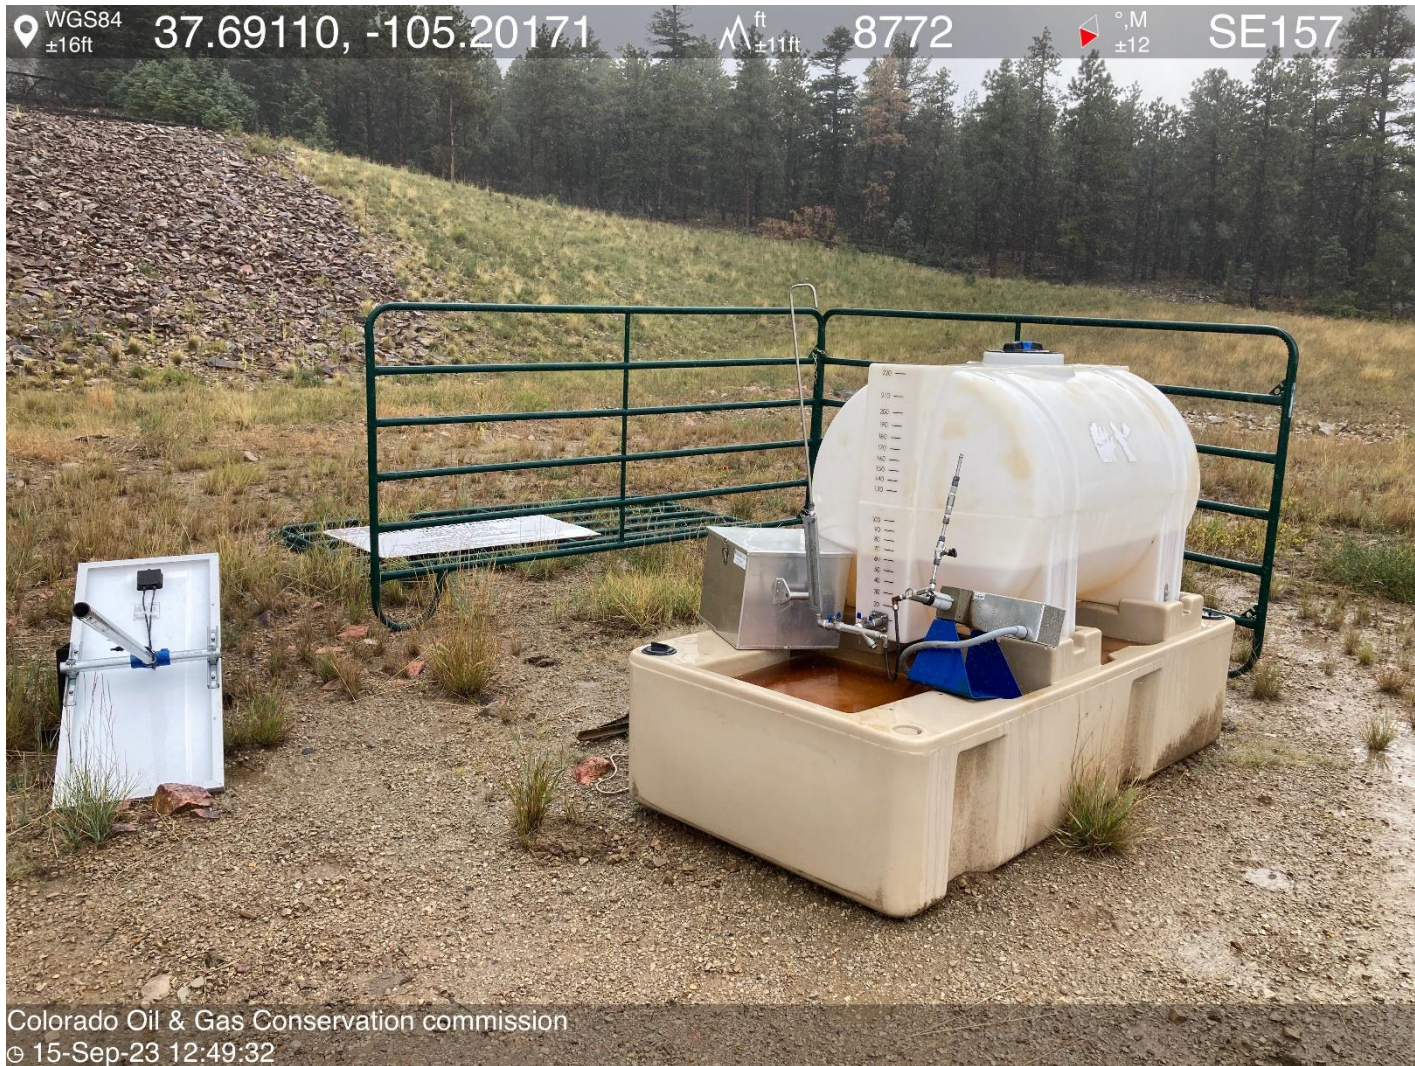
PHOTO 4: There is no labeling at the chemical tank next to the well. Install sign to comply with Rule 605.h. THIS IS THE SECOND NOTICE OF THIS CORRECTIVE ACTION, IMMEDIATE ACTION IS REQUIRED.

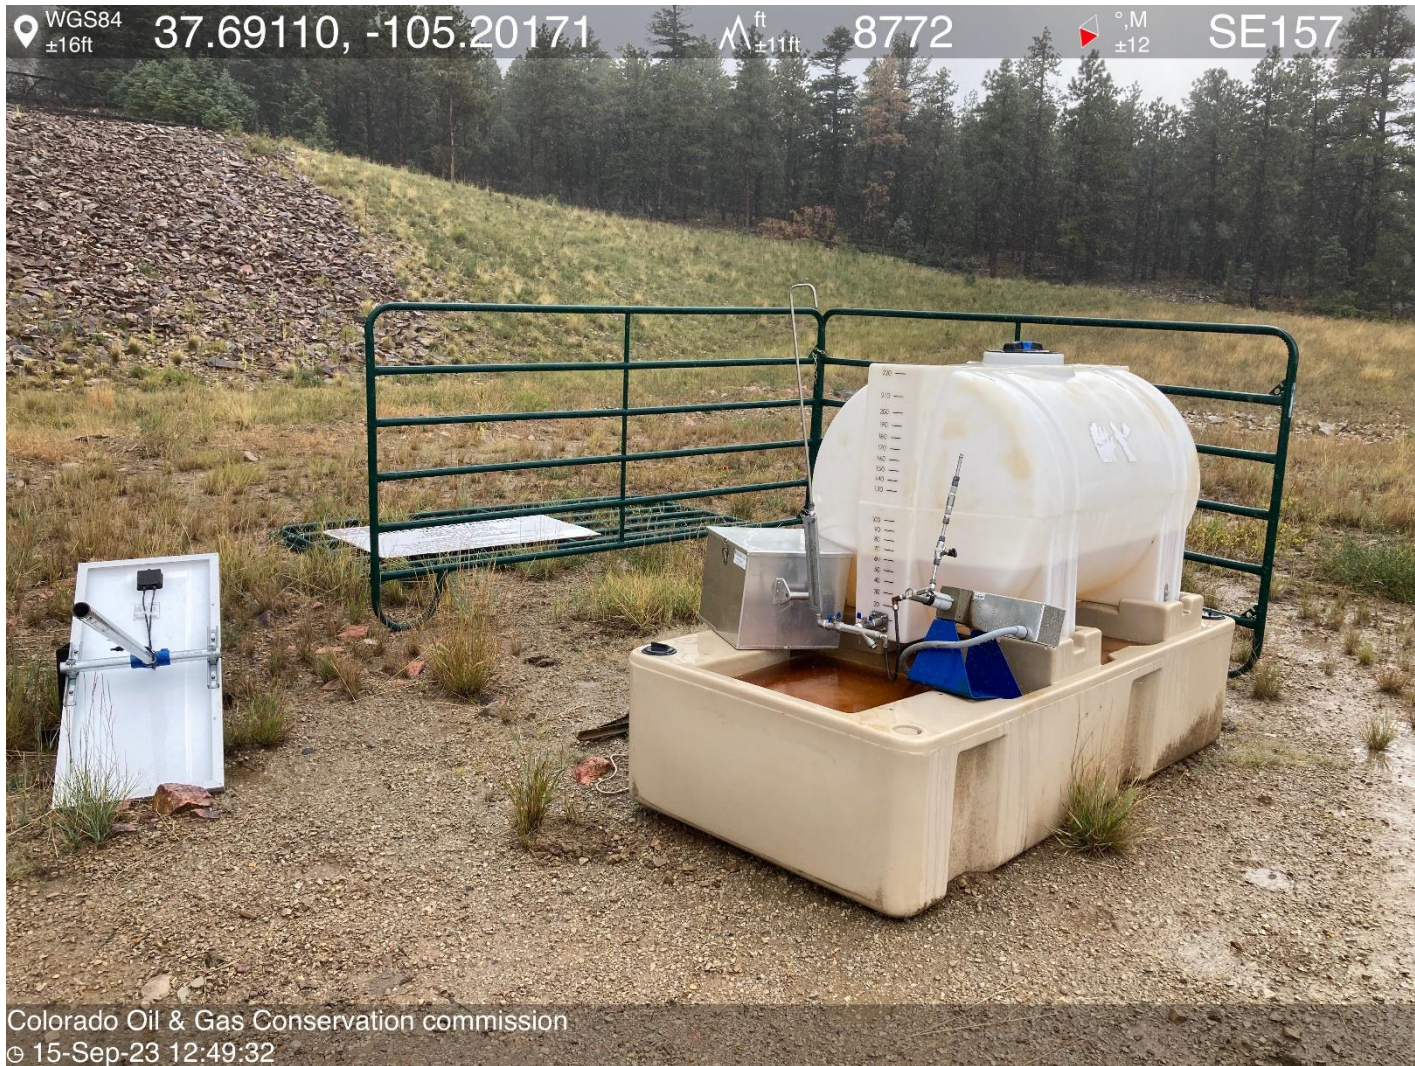
PHOTO 5: There is a dripping leak coming from the chemical tank line next to the well and there is no lid on the tank. Implement or modify BMPs for improved material handling and spill prevention. Conduct maintenance on equipment, cleanup stained material and review self inspection processes. THIS IS THE SECOND NOTICE FOR THIS CORRECTIVE ACTION, IMMEDIATE ACTION IS REQUIRED.
