# Interim Reclamation and Stormwater Inspection

Operator: UPLAND EXPLORATION LLC- #10701

Location ID: 462919

Inspection Photos  
Location Name: Little Lady 21/South Well Pad  
Location ID: 462919

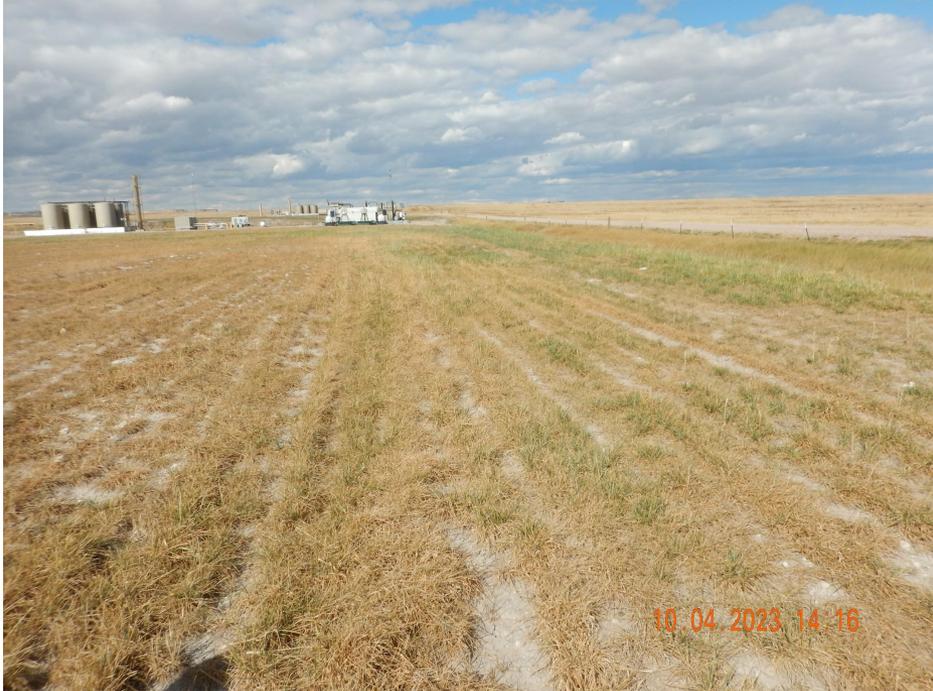
**Photo 1.** Photo taken from the southeastern location, facing North. Photo illustrates much of the vegetative growth to be an introduced grass species, which was falsely reported to Staff, and is in the process of senescing. There is a lack of desirable germination throughout the interim area.

Cereal rye was still observed throughout portions of the interim reclamation area.

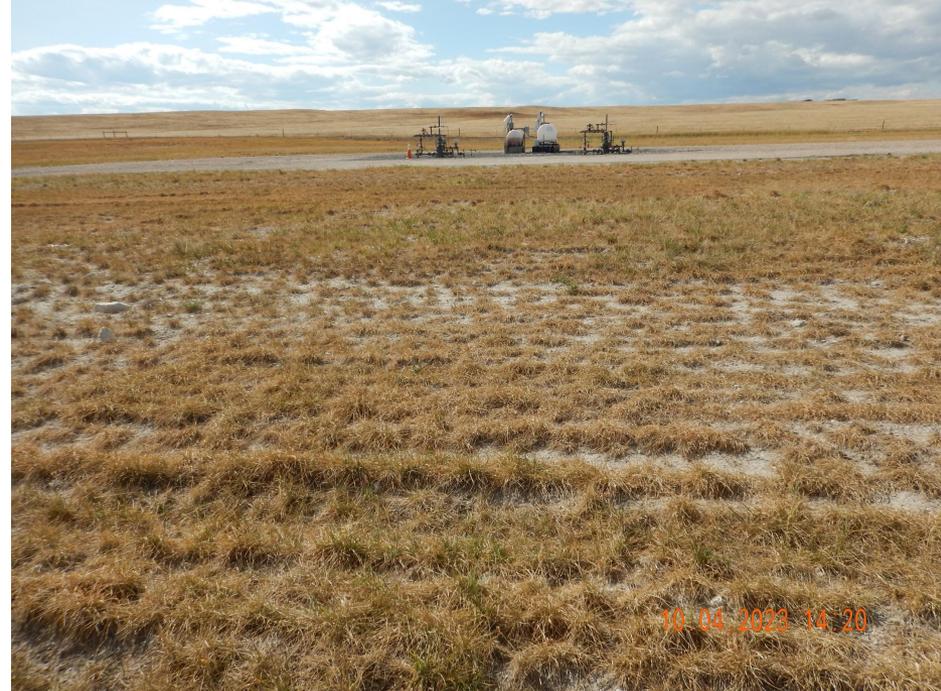
**Photo 2.** Photo taken from the southeastern location, facing West. See comments under Photo 1.

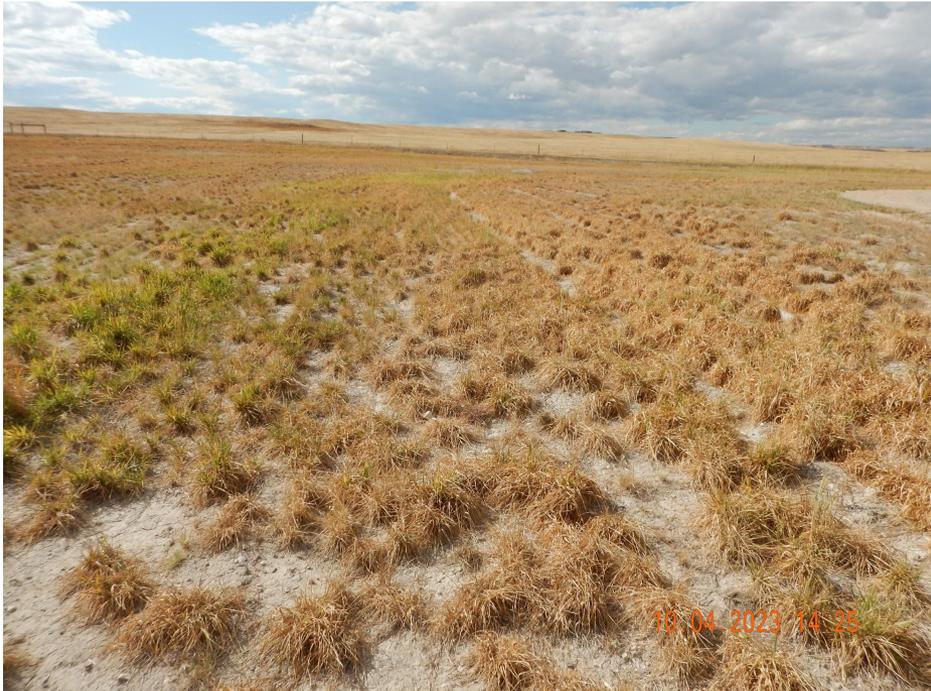
**Photo 3.** Photo taken from the southern location, facing West. See comments under Photo 1.

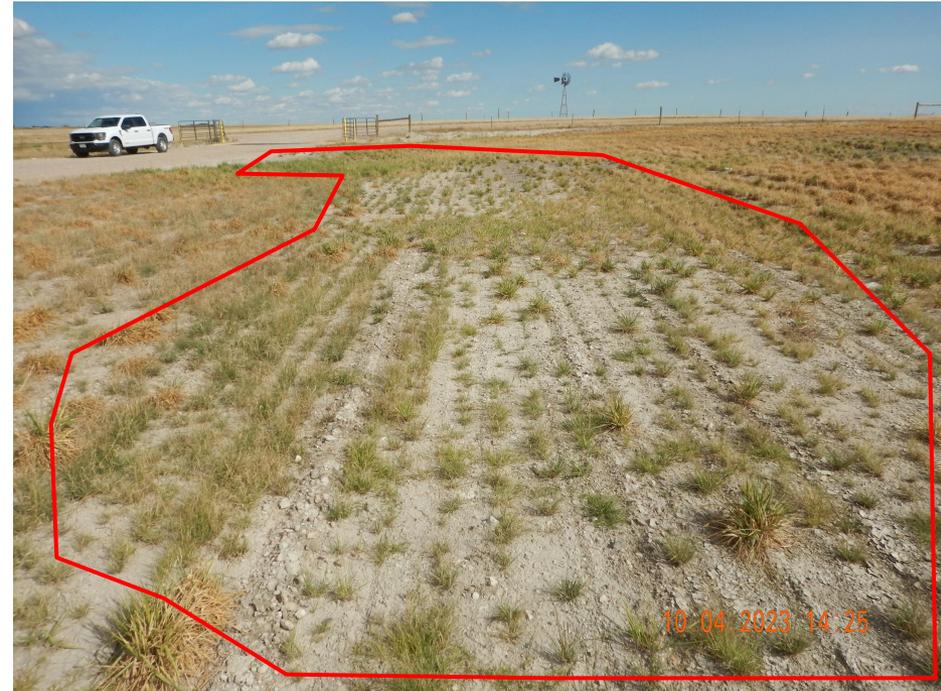
**Photo 4.** Photo taken from the southern location, facing East. Photo illustrates a portion along the southern interim area where the introduced grass was not seeded and how native, desirable vegetation has established.

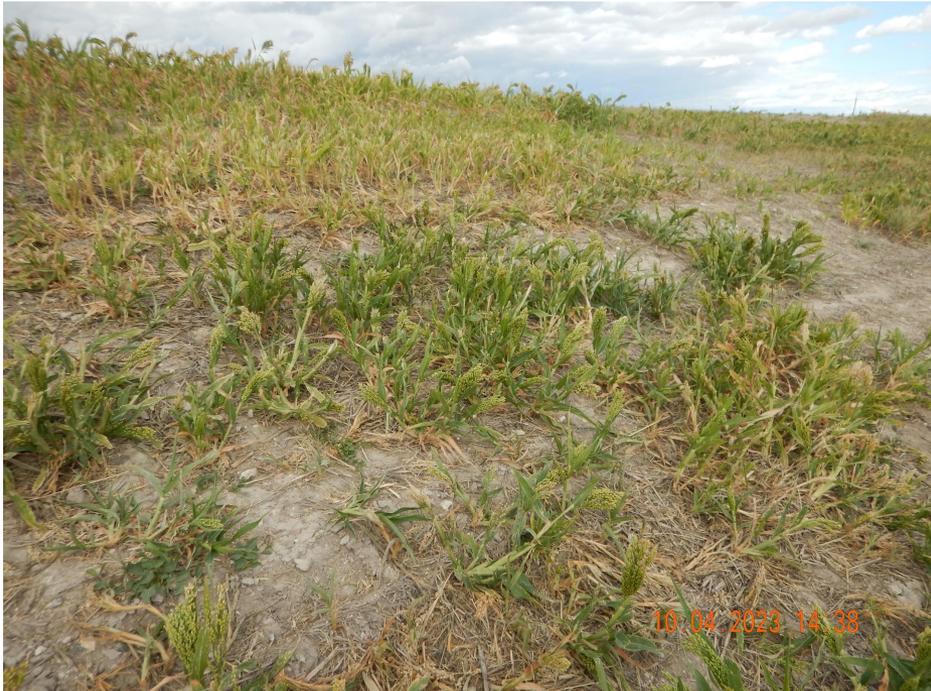
**Photo 5.** Photo taken from the eastern topsoil stockpile. Photo illustrates what appears to be cultivated millet, which should not persist. If this turns out to be Wild proso millet, then this is problematic and is a List C Colorado noxious weed.

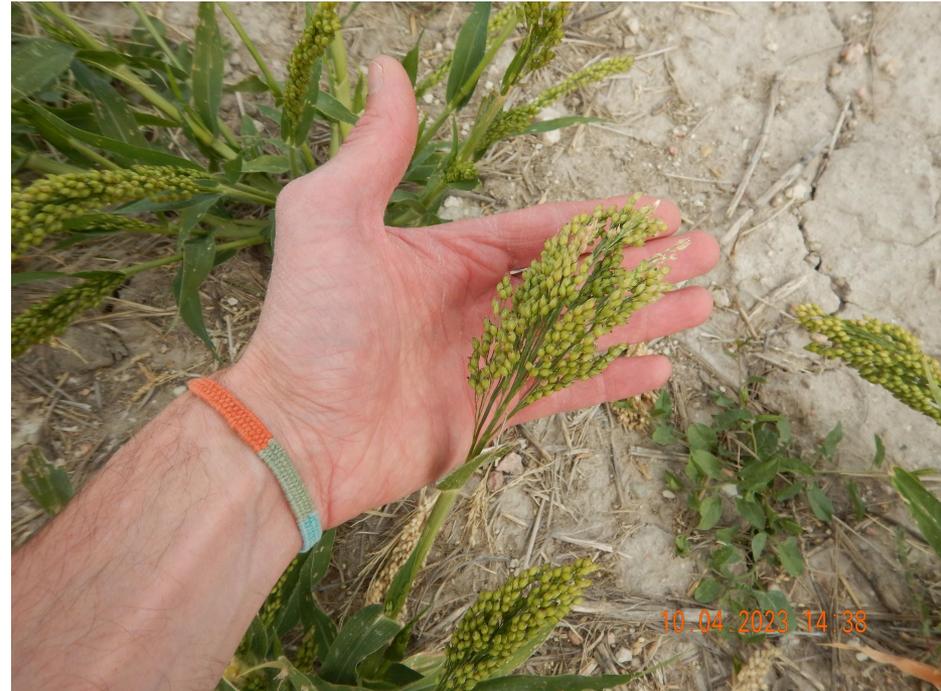
**Photo 6.** Close up photo of what appears to be cultivated millet.

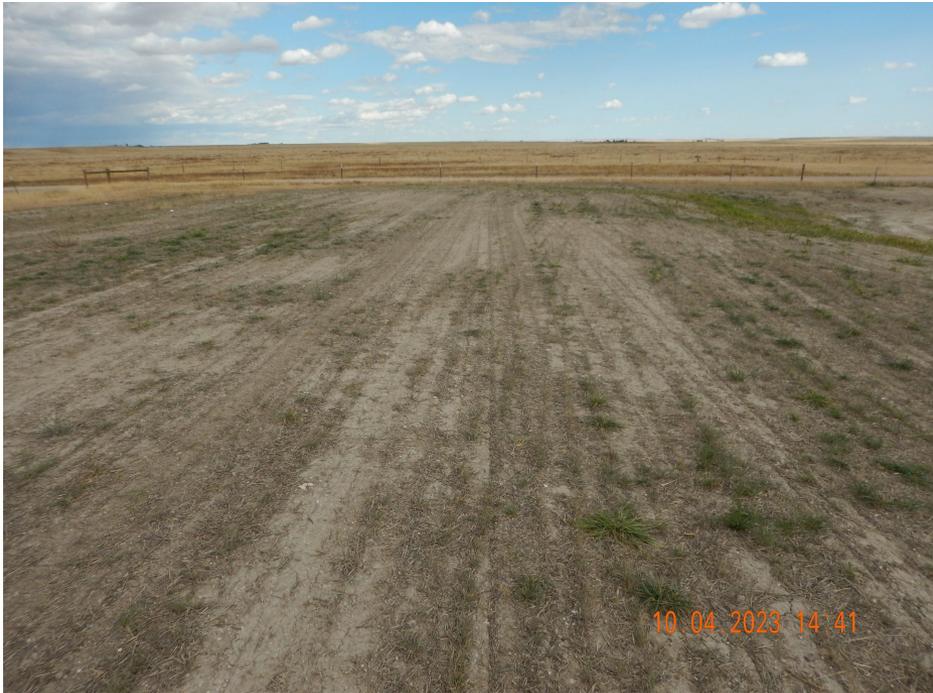
**Photo 7.** Photo taken from the topsoil stockpile, facing East. Photo illustrates desirable vegetation that is in process of establishing. There are bare patches that will still need to be reseeded.

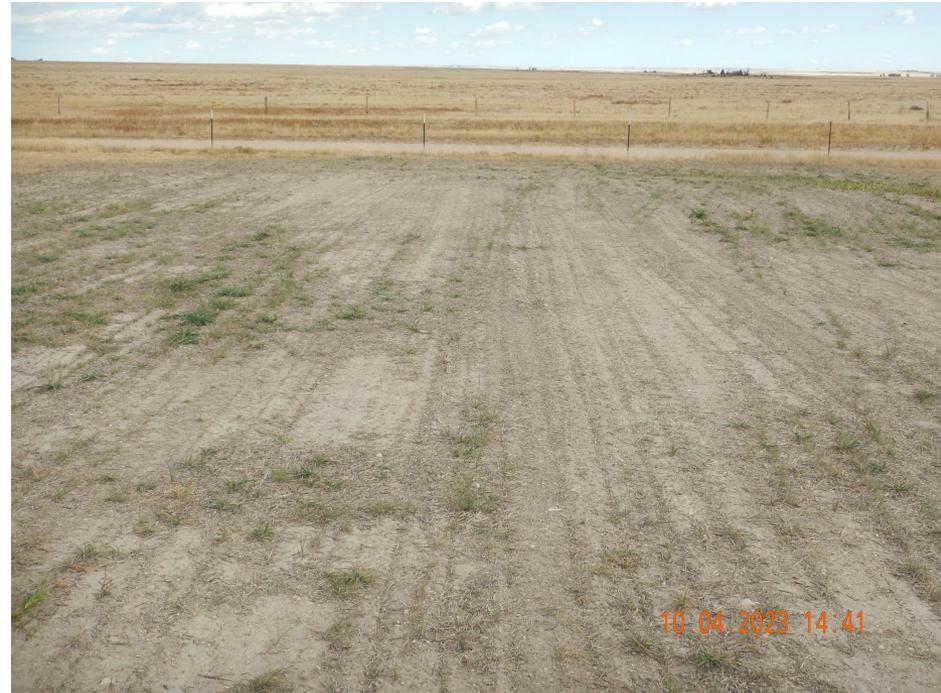
**Photo 8.** Photo taken from the eastern topsoil stockpile, facing East. Photo illustrates bare patches that will still need to be reseeded.
