# Inspection Photos

Loc: 481042

Operator: BNL (ENTERPRISE) INC

Inspection Date: 10/4/2023

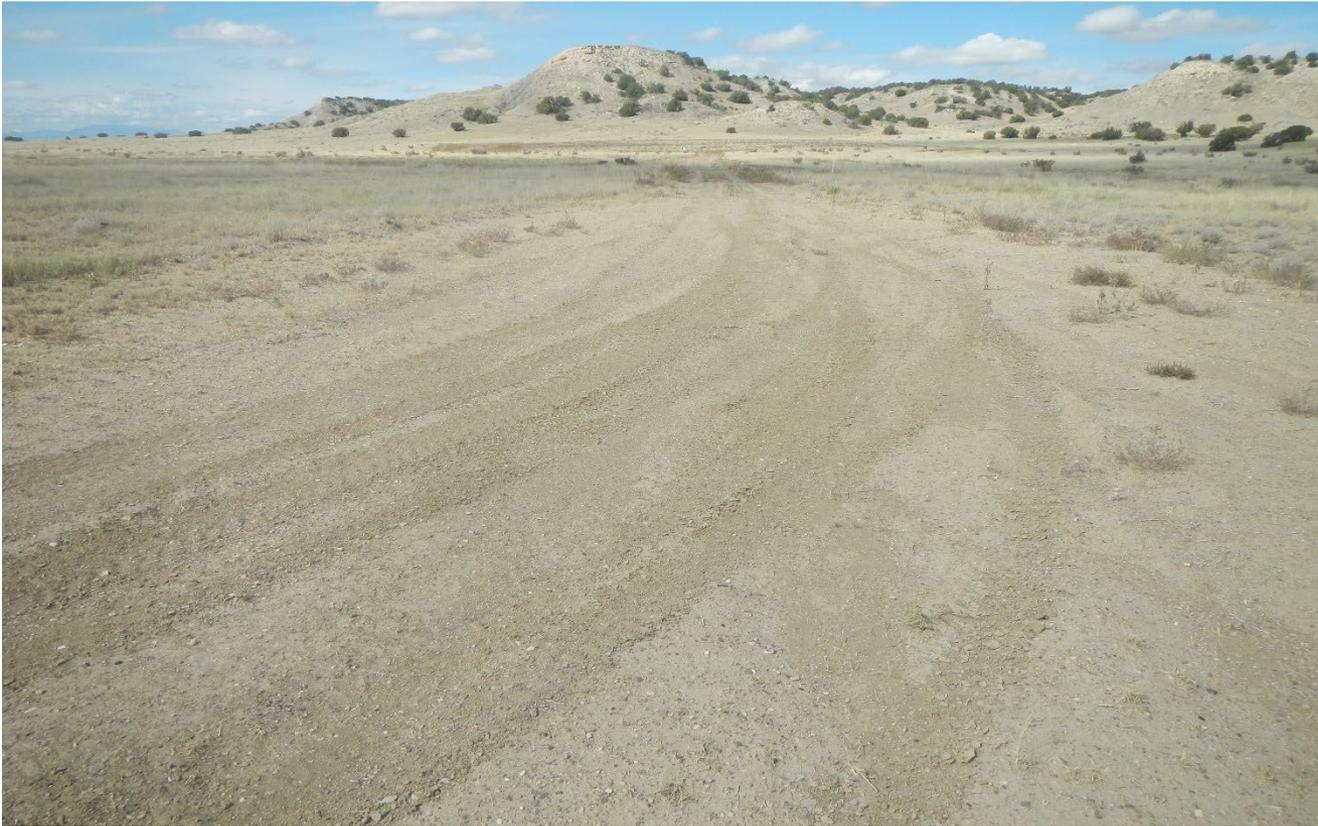
**Photo 1.** Facing west toward the access road.

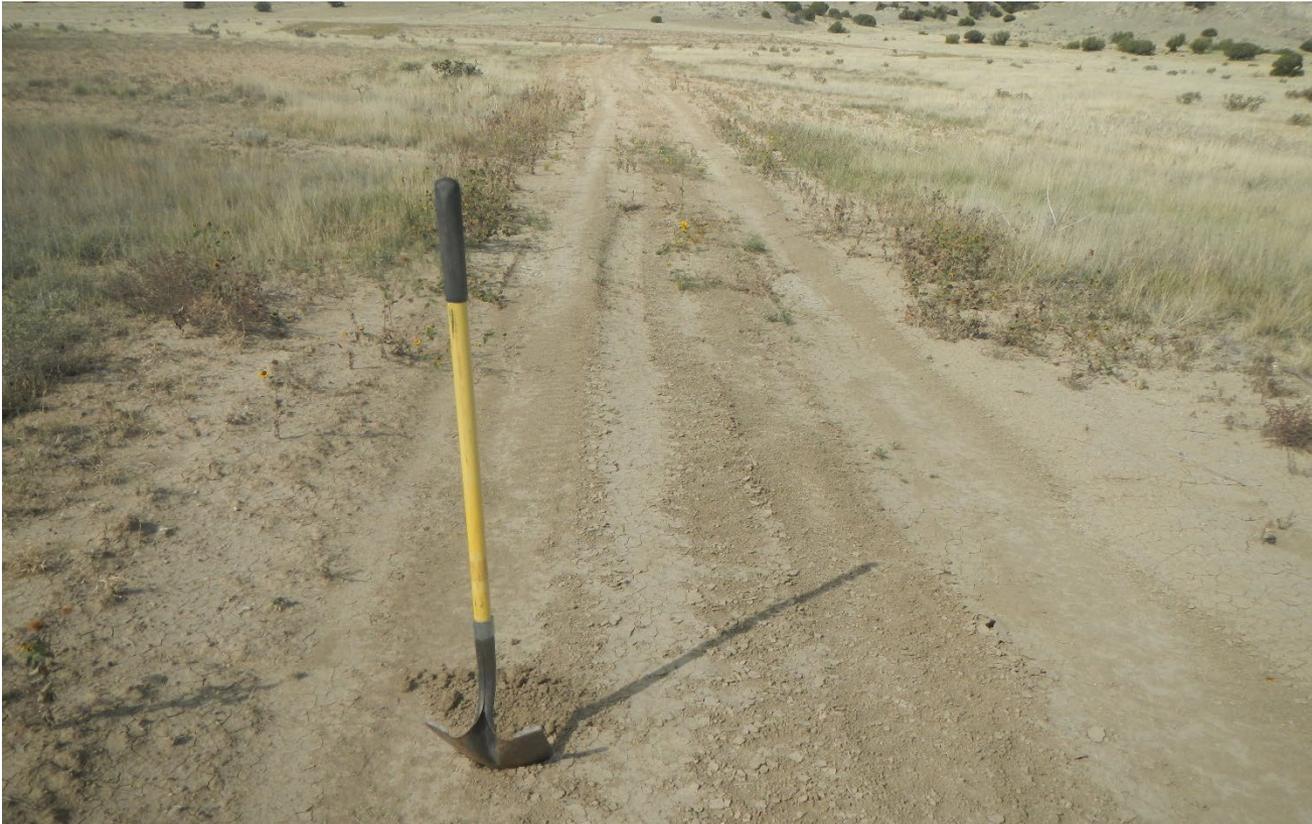
**Photo 2.** Facing west along the access road. Soils appear to be compacted along areas of the road.

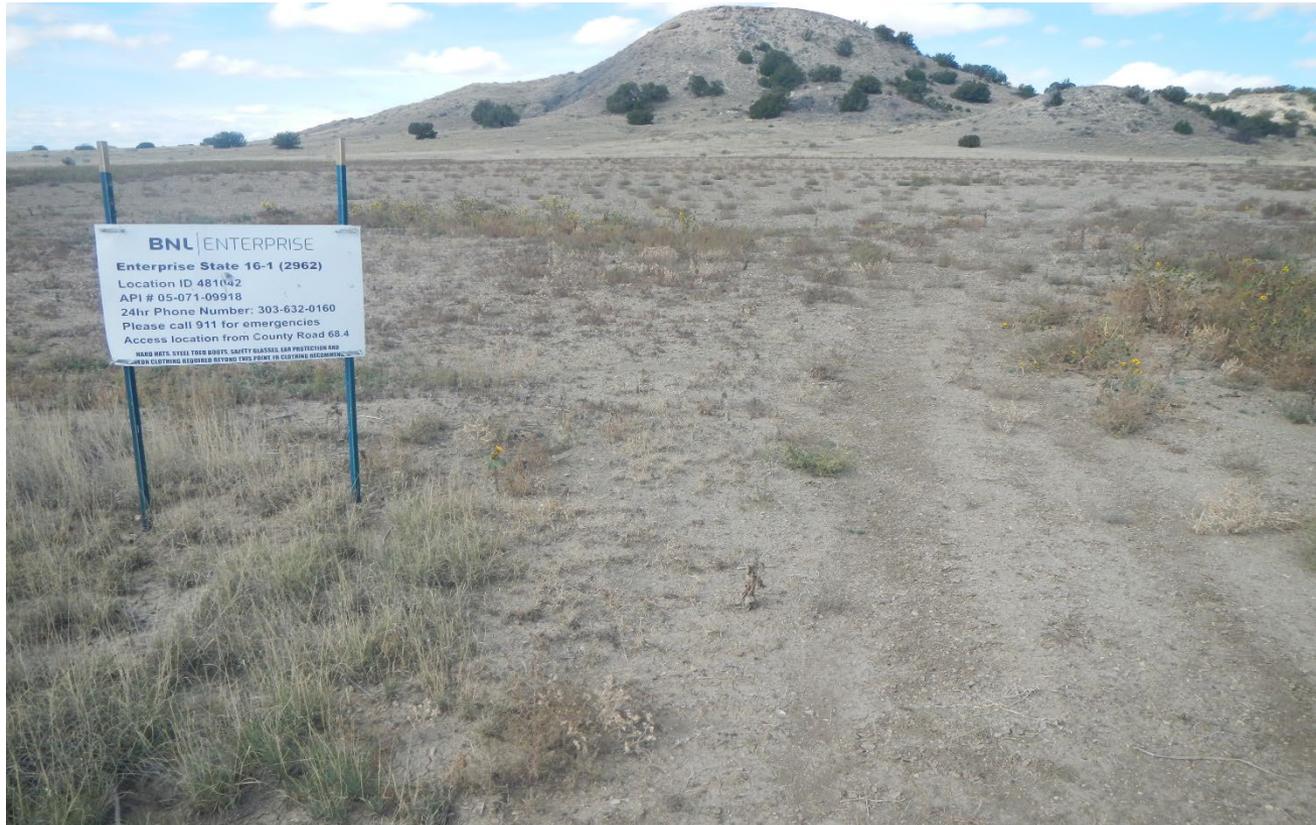
**Photo 3.** Facing west toward the location.

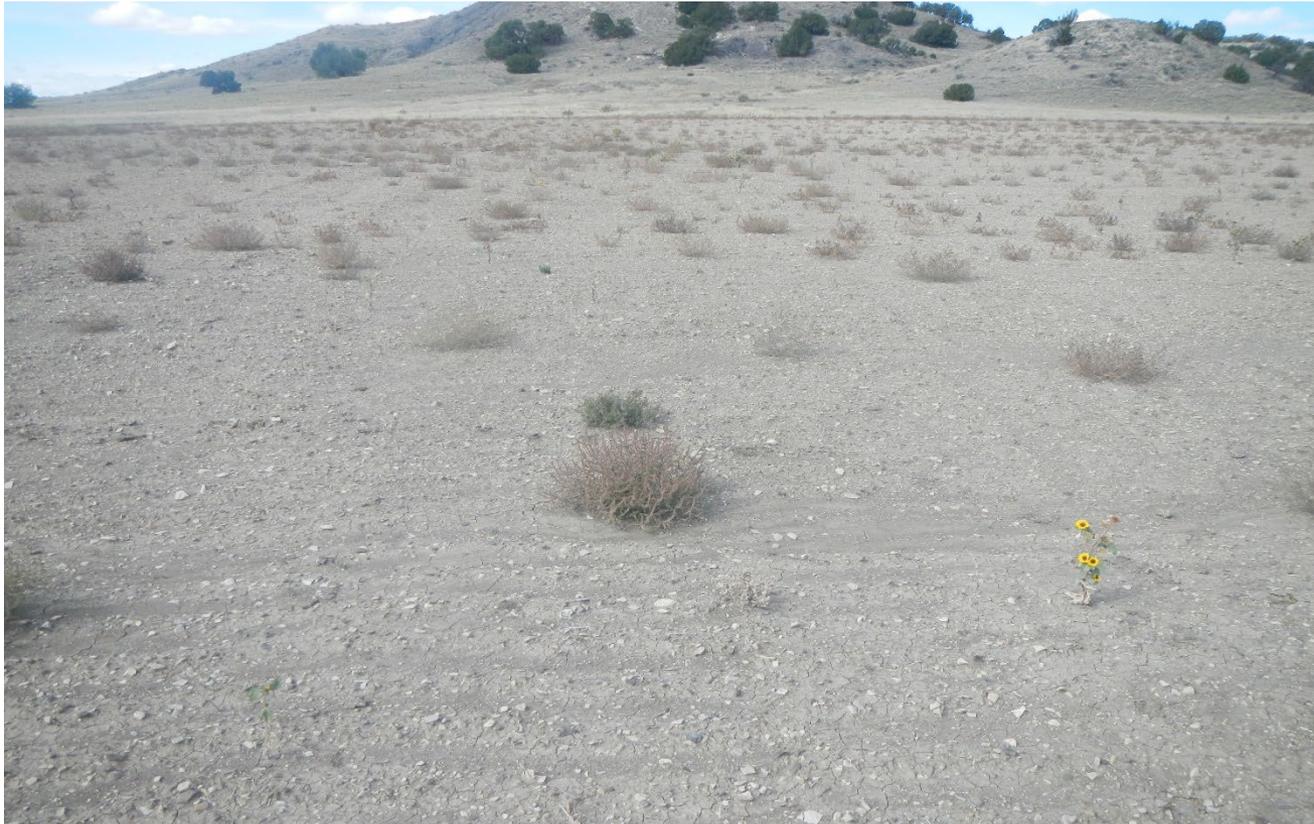
**Photo 4.** Center of the location facing west. The vegetation does not appear to be germinating very well at the location. There are undesirable weeds which can be seen in the photo.

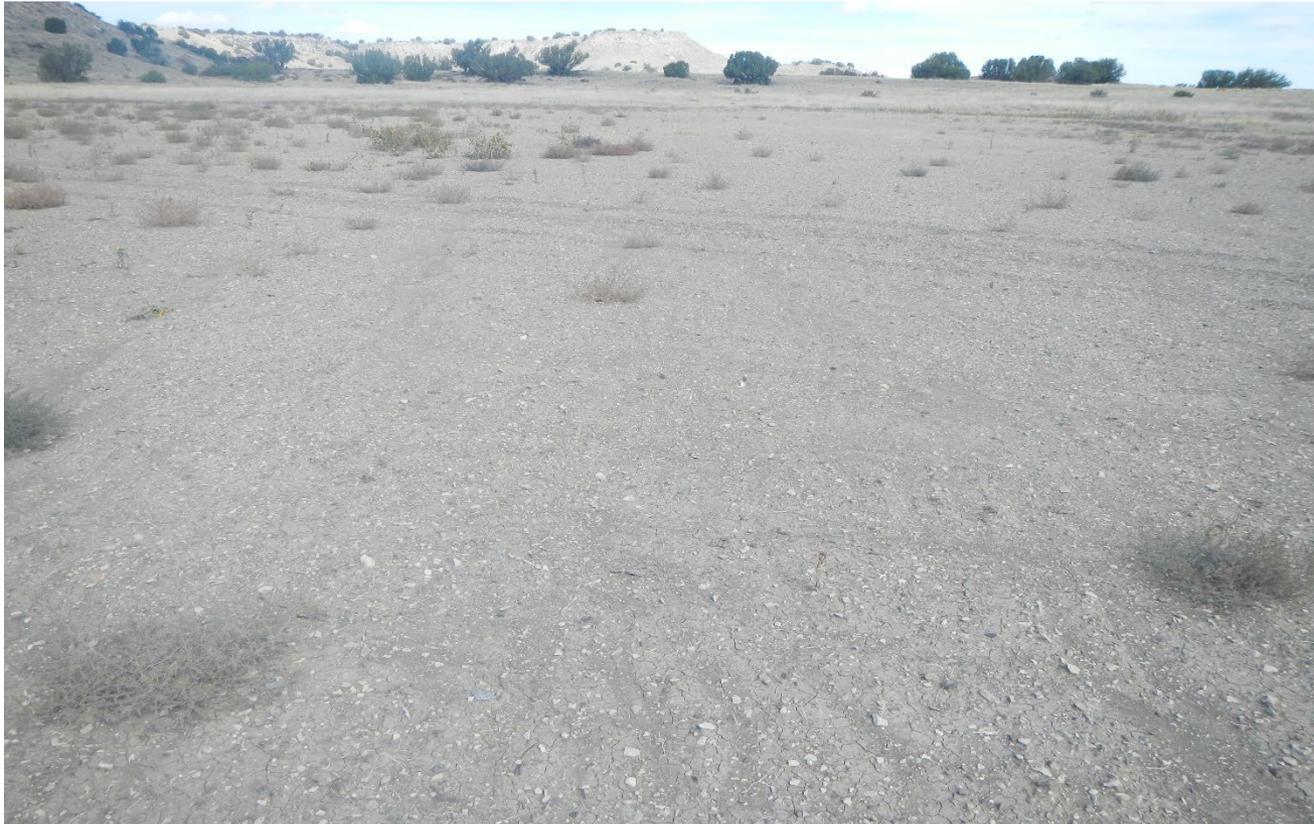
**Photo 5.** Center of the location facing north. The vegetation does not appear to be germinating very well at the location.

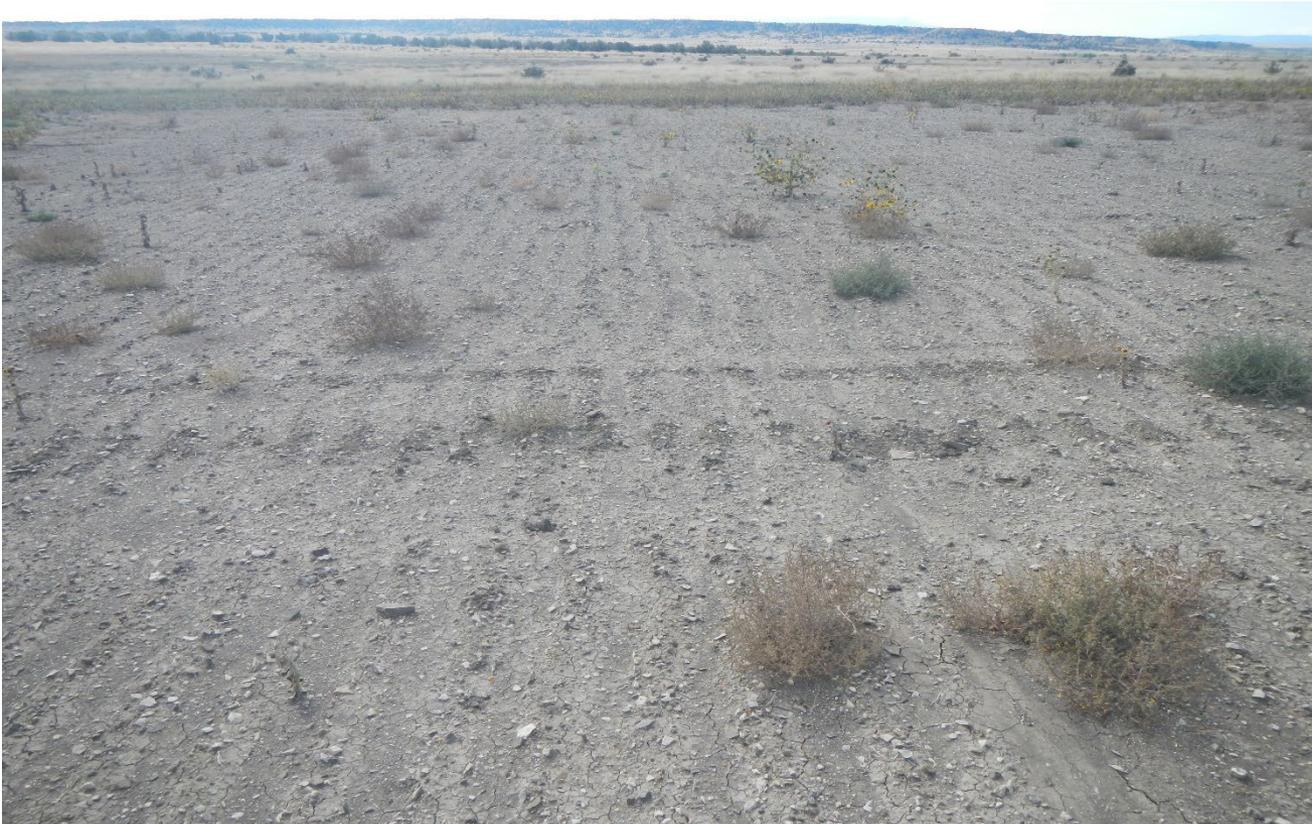
**Photo 6.** Center of the location facing south. The vegetation does not appear to be germinating very well at the location.

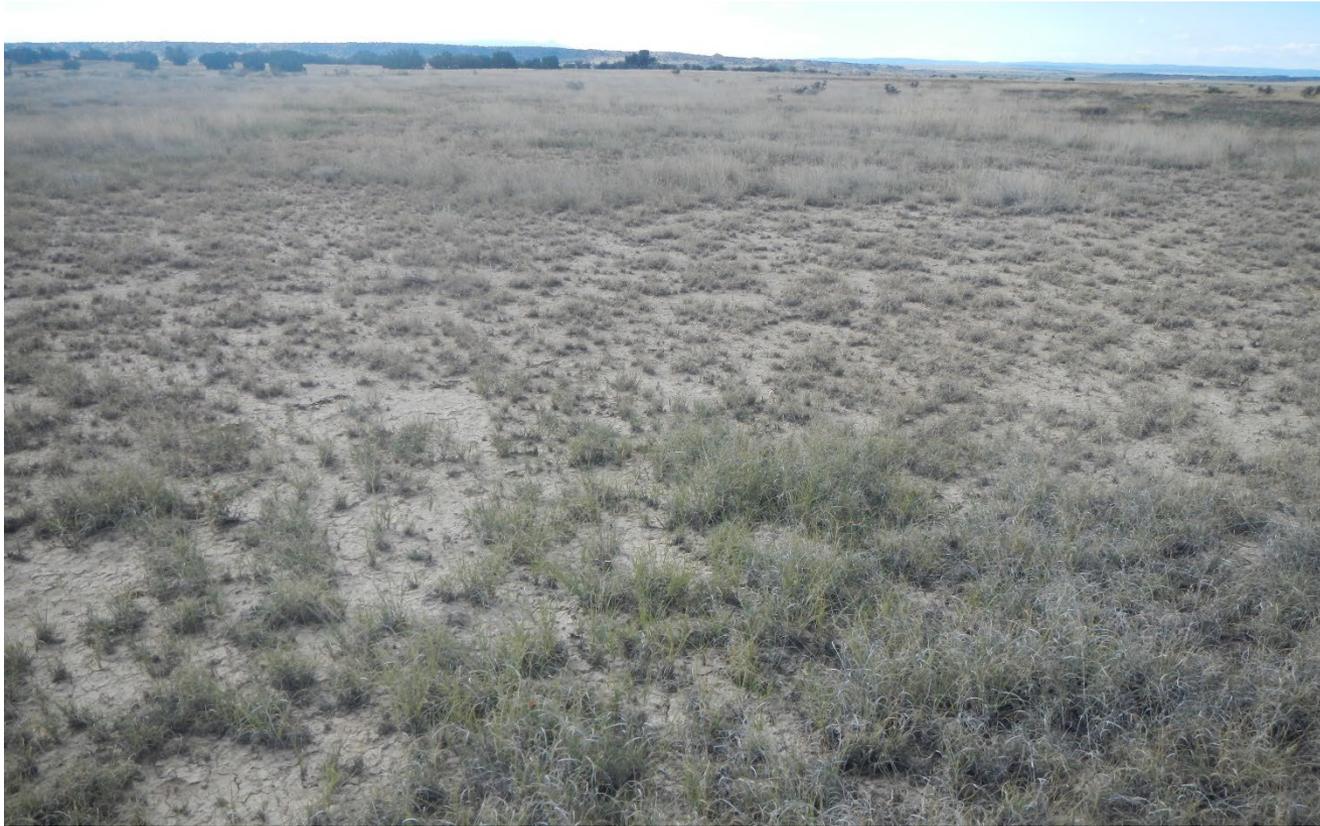
**Photo 7.** Facing south toward the undisturbed native grass consisting of Sand dropseed, Blue grama, Galleta grass, among other species.
