Final Reclamation and Stormwater Inspection

Operator: STRACHAN EXPLORATION LLC - 83130

Location ID: 330670

Inspection Photos
Location Name: Showers 32-5-7
Location ID: 330670

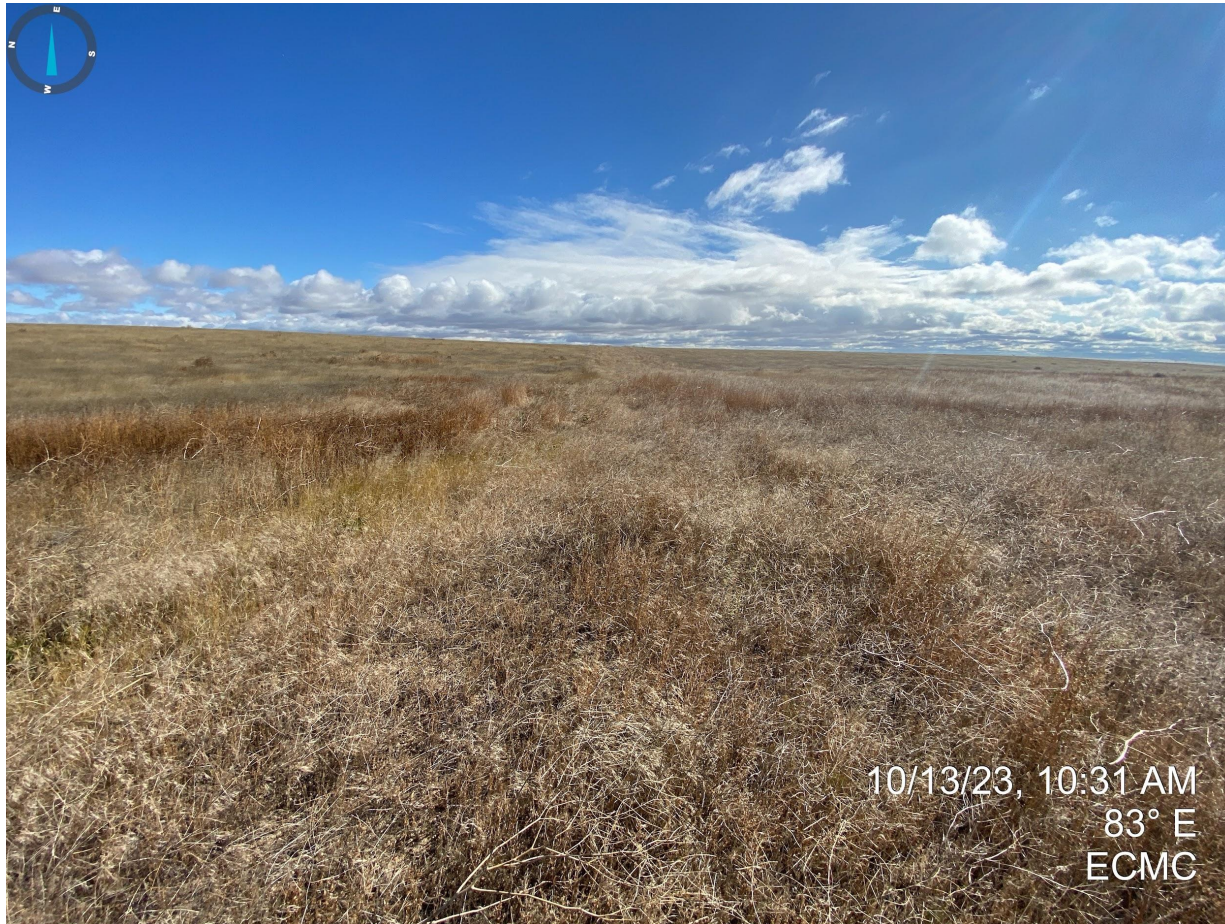
Photo 1. Taken near the access road entrance. Photo illustrates weedy debris (CO List C Noxious Weed- Cheatgrass) throughout the reclaimed portions. Additional revegetation/weed management activities are required.

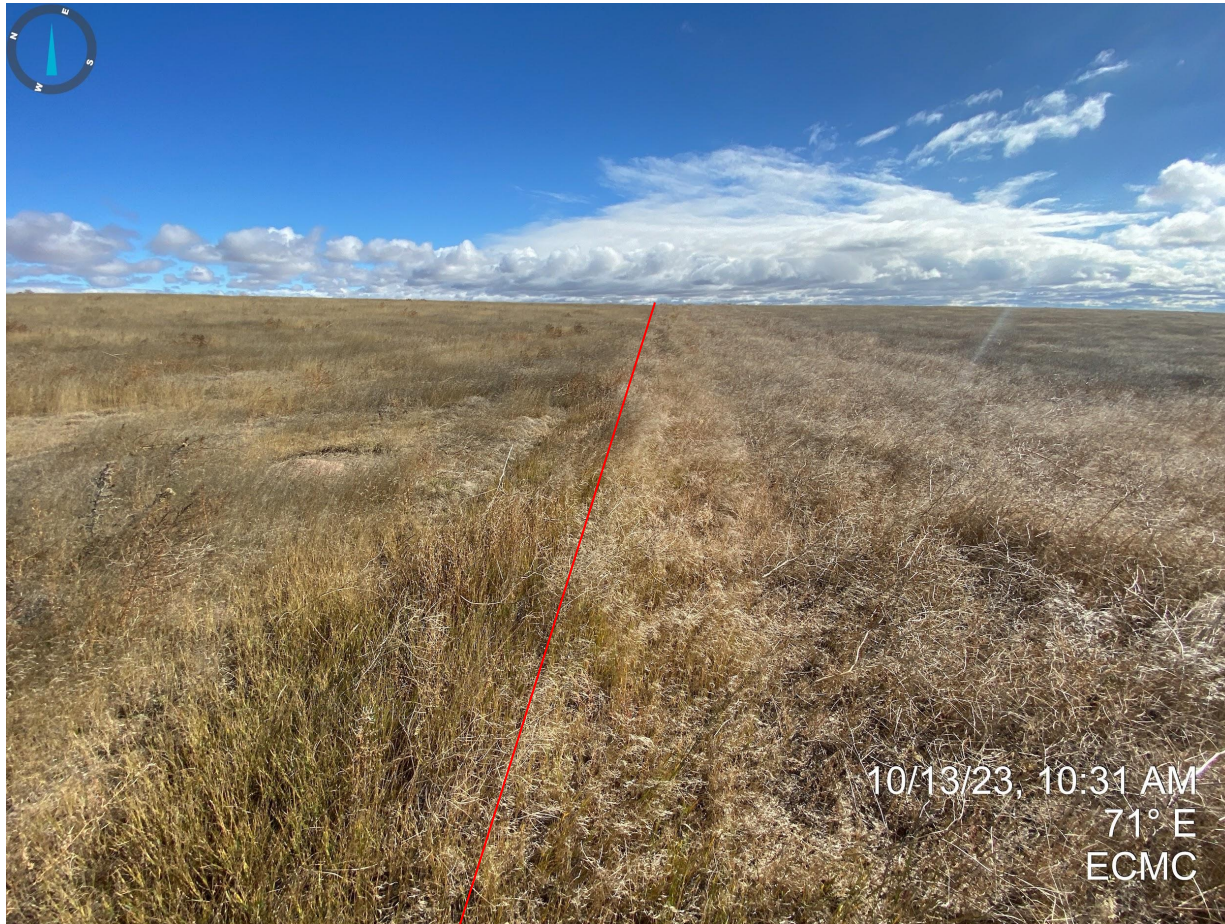
Photo 2. Continued from photo 1. Red line delineates the reference area (left of line) and the reclaimed portion (right of line).

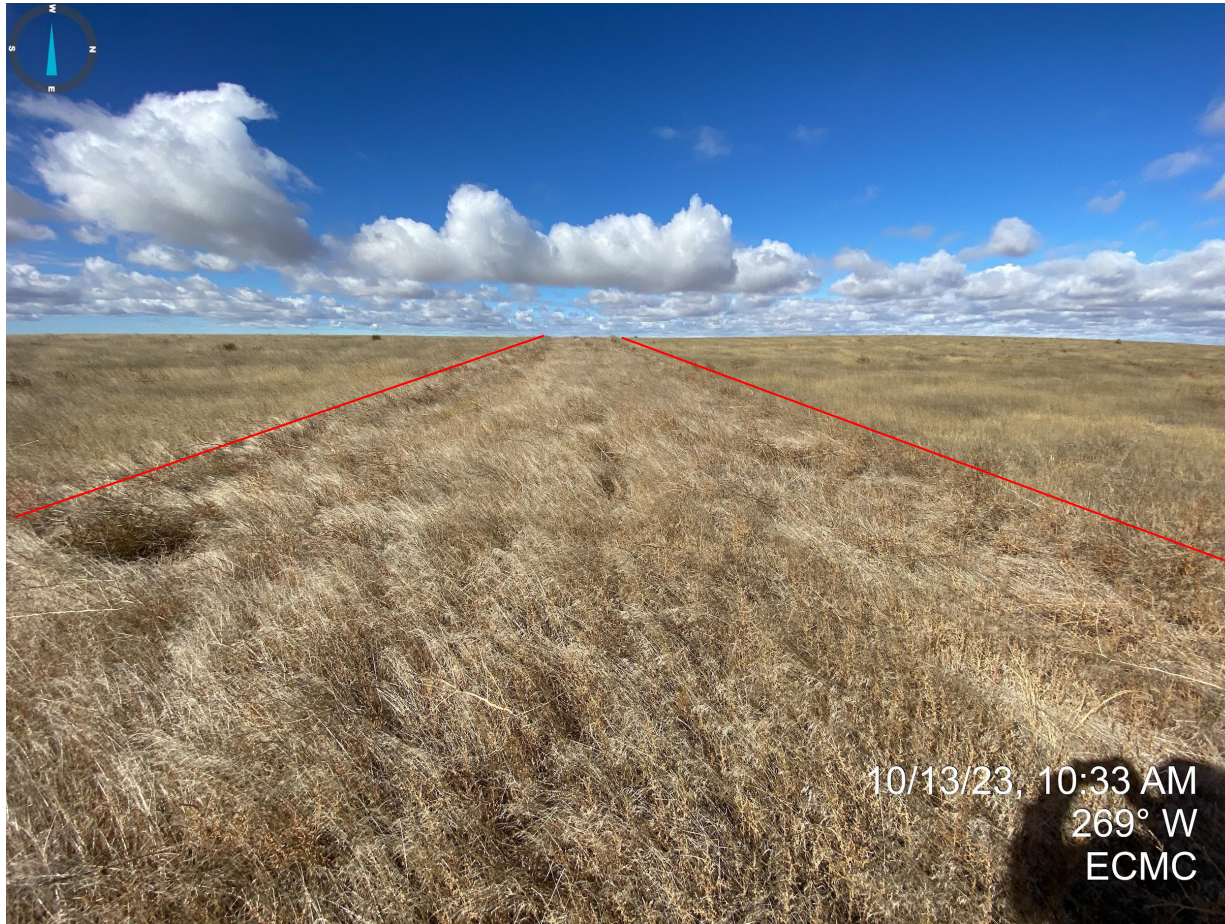
Photo 3. Taken from the location, facing the access road. See comments in Photos 1 & 2.

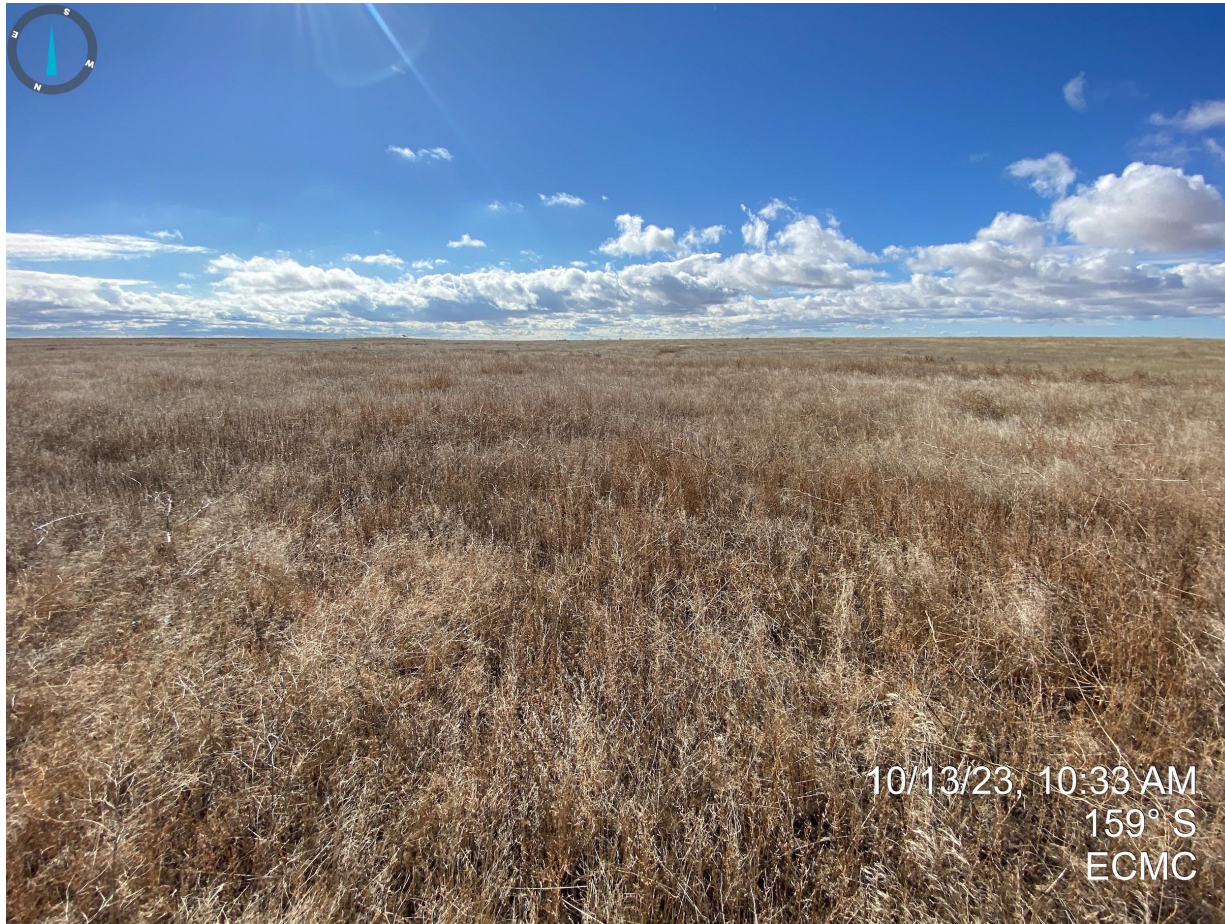
Photo 4. Taken from the location. The well location is not progressing towards Rule 1004 standards with evidence of undesirable vegetation (eg Cheatgrass) that is not reflective of the adjacent reference areas.

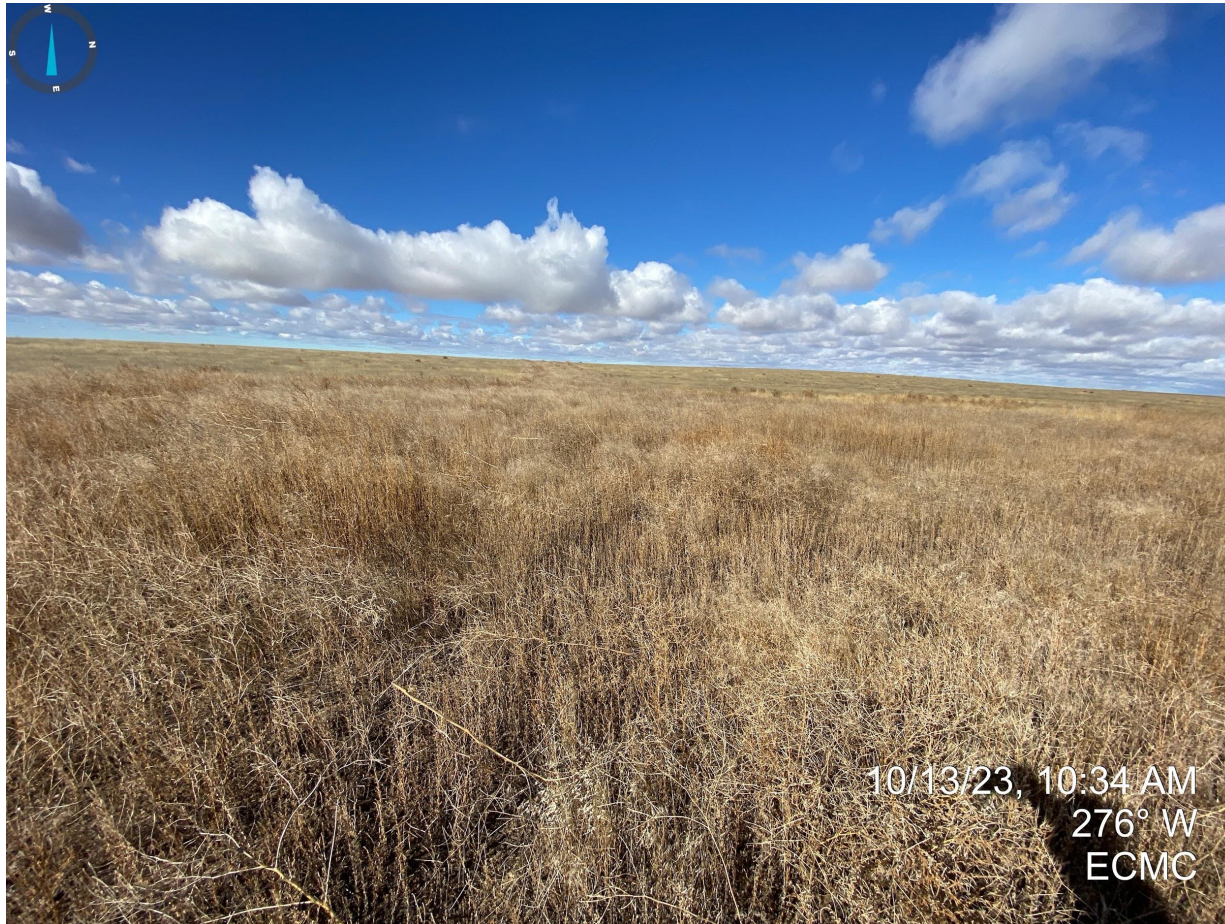
Photo 5. Facing west at the well location; see comments in Photo 4.

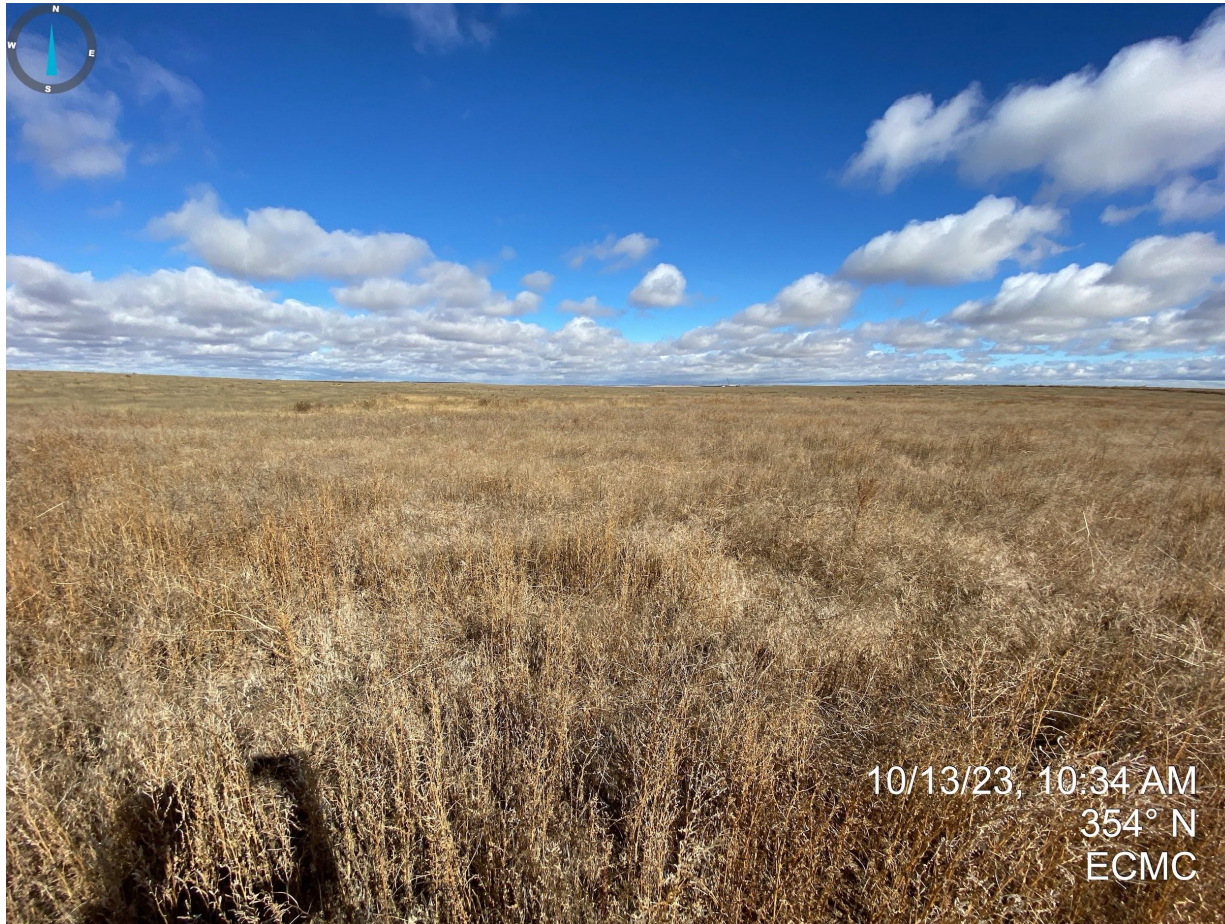
Photo 6. Facing north at the well location; see comments in Photo 4.
