Final Reclamation and Stormwater Inspection

Operator: STRACHAN EXPLORATION INC - 83130

Location ID: 330622

Inspection Photos
Location Name: Hill 31-15-8
Location ID: 330622

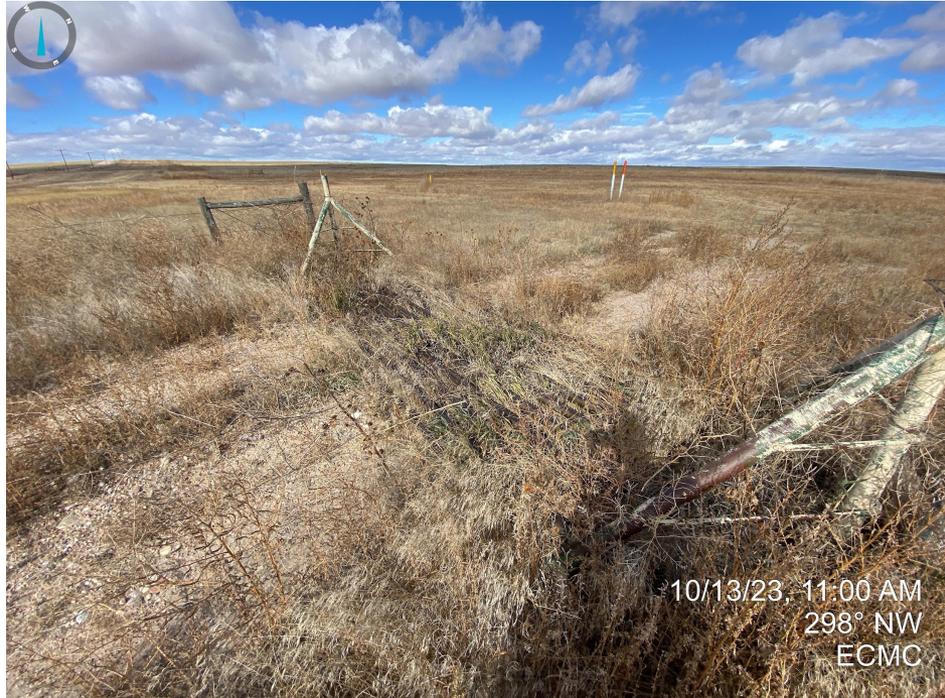
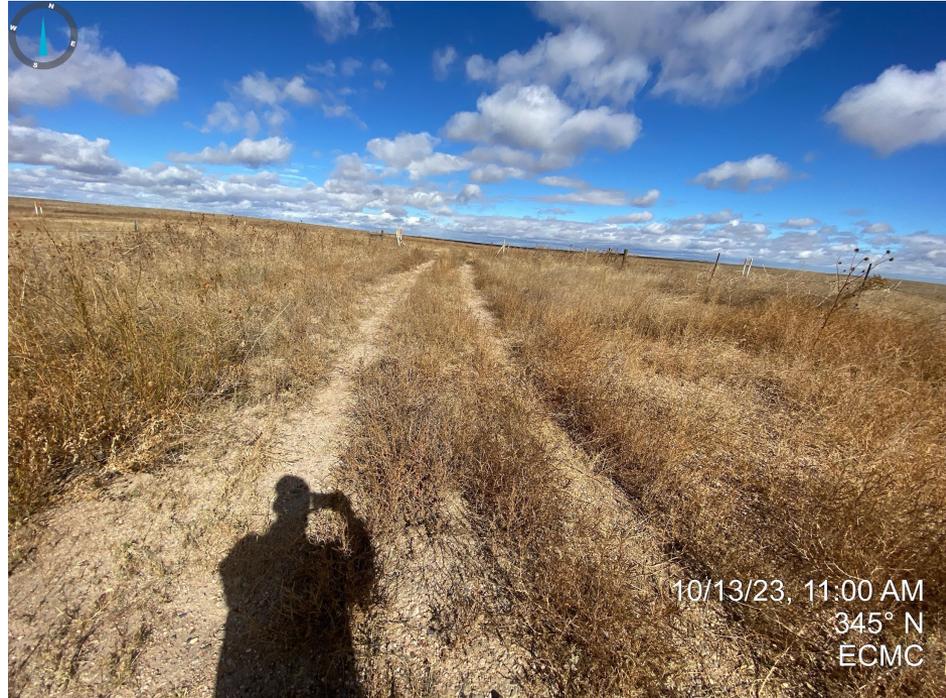
Photos 1 & 2. Taken near the location entrance. Photo illustrates that the access road and cattle guard have not been removed.

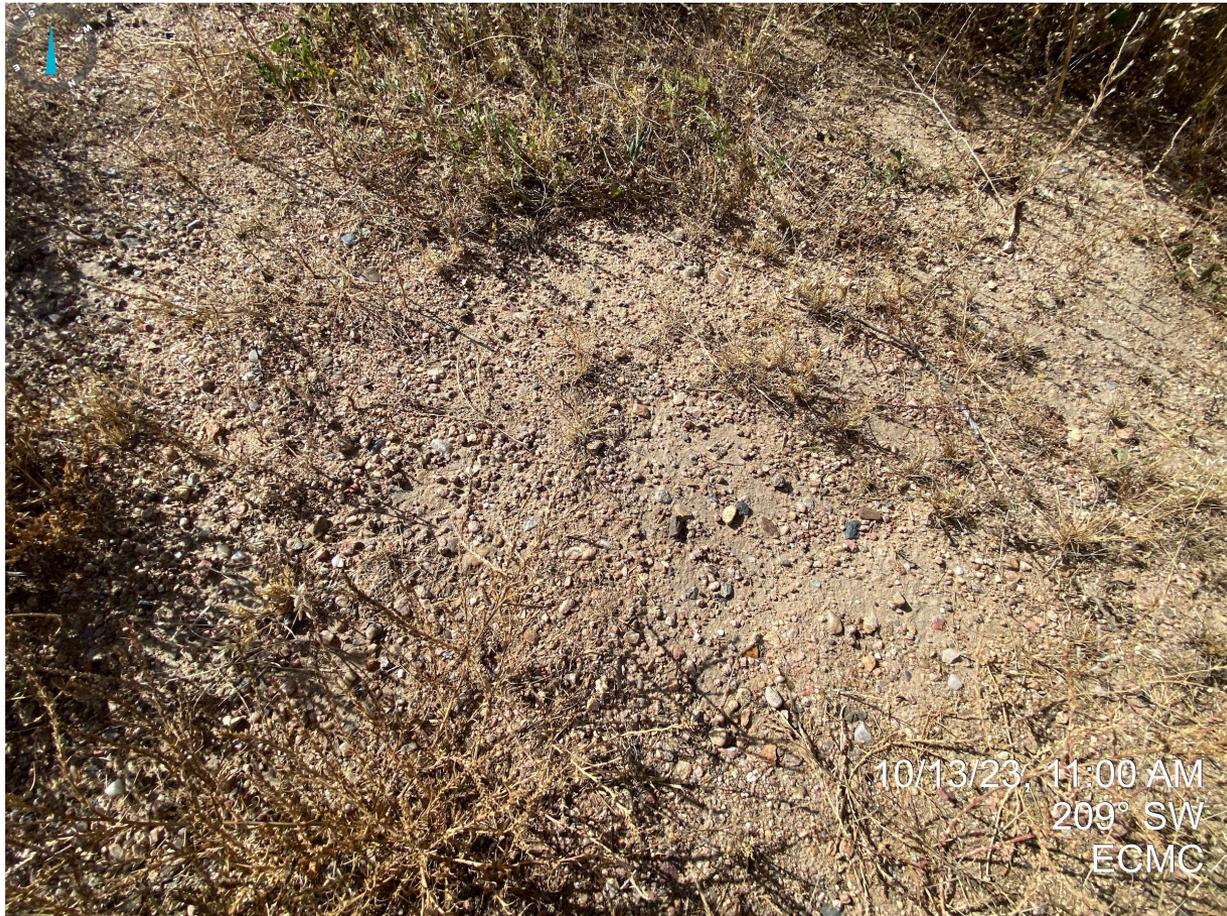
Photo 3. Continued from Photos 1 & 2; road base material remains on the access road.

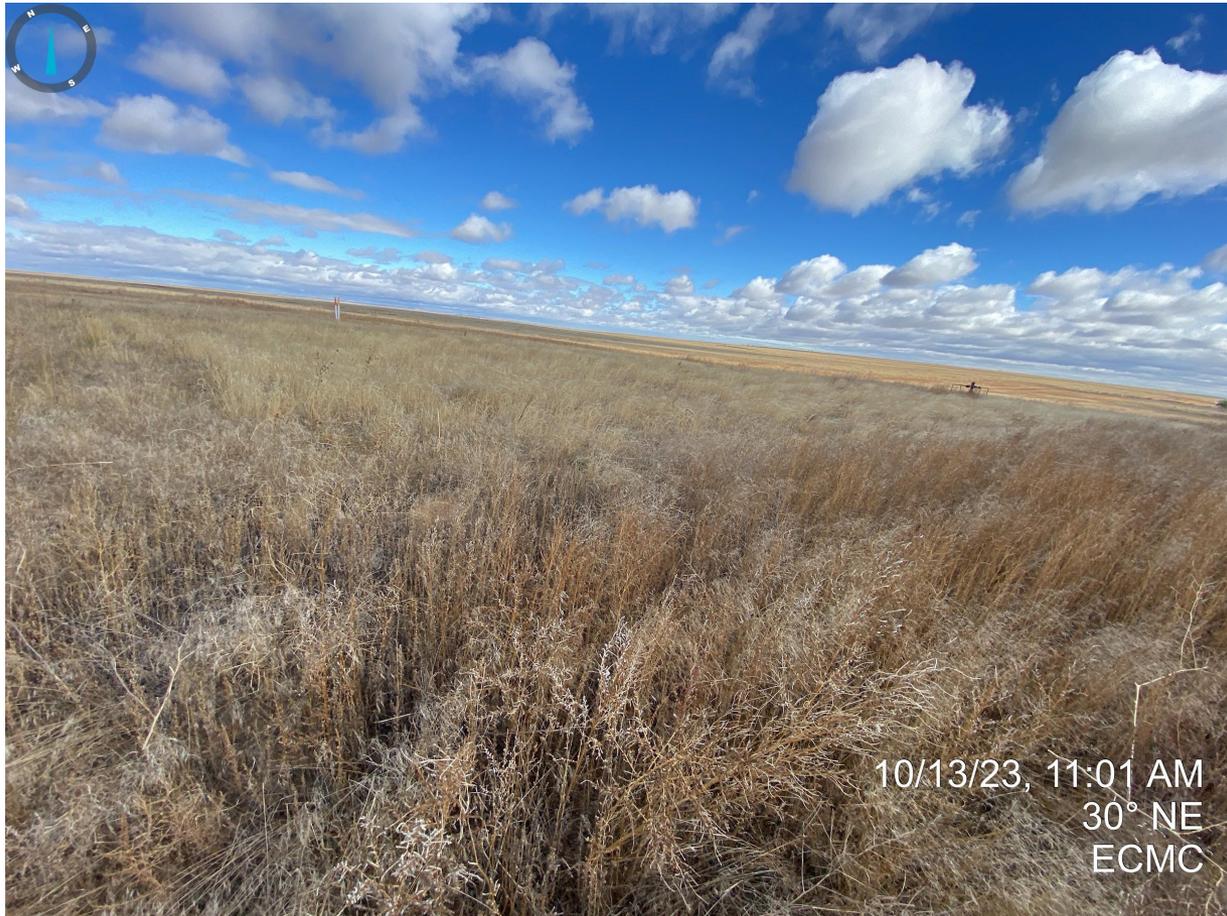
Photo 4. Taken from the southern portion of the former tank battery location. Undesirable vegetation (CO List C Noxious Weed-Cheatgrass; russian thistle and kochia) were observed. It should also be noted that some desirable vegetation was also observed throughout the former tank battery location.

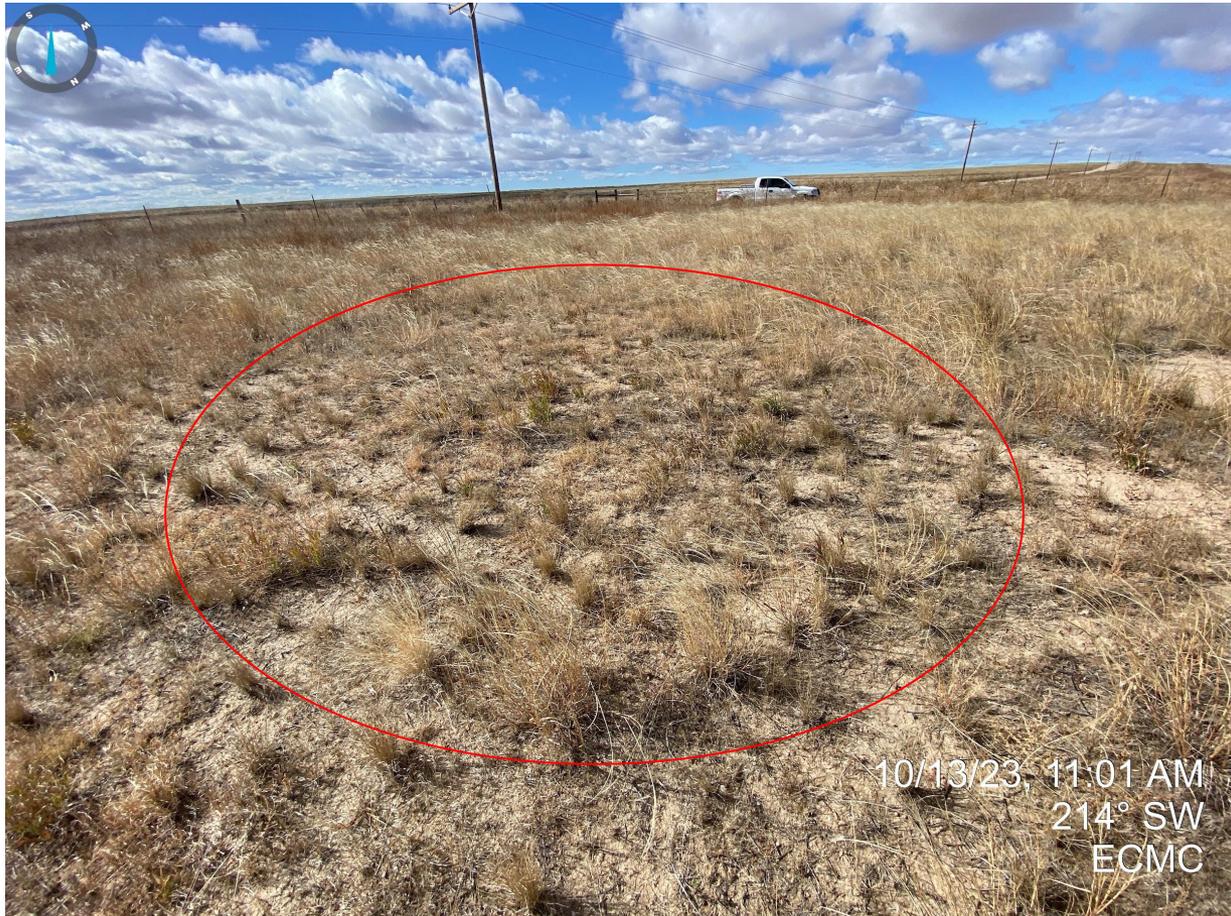
Photo 5. Taken from the eastern portion of the tank battery location. Non-uniform vegetative cover resulting in areas of bare/exposed soils.

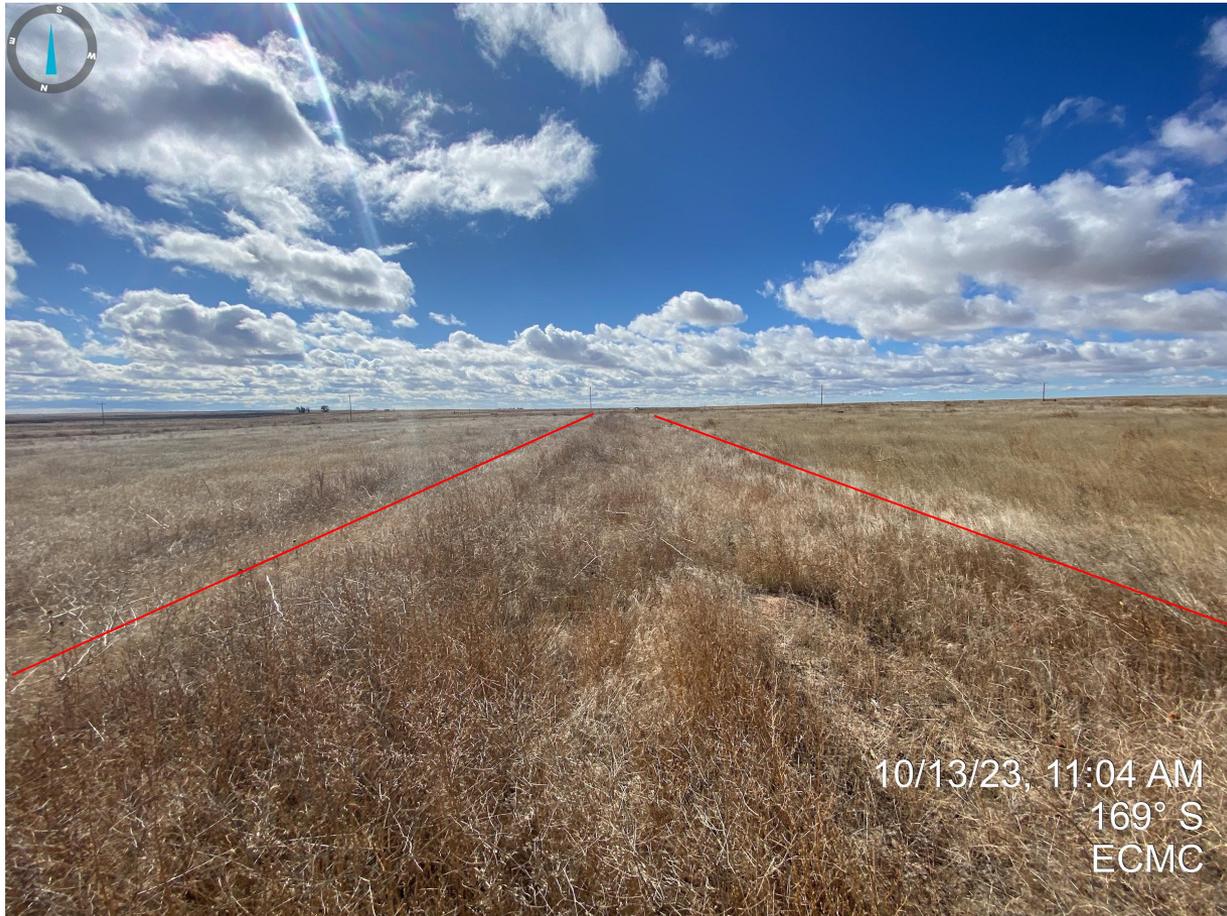
Photo 6. Taken from the middle portion of the access road. Undesirable vegetation (CO List C Noxious Weed- Cheatgrass; russian thistle and kochia) was observed on the access road.

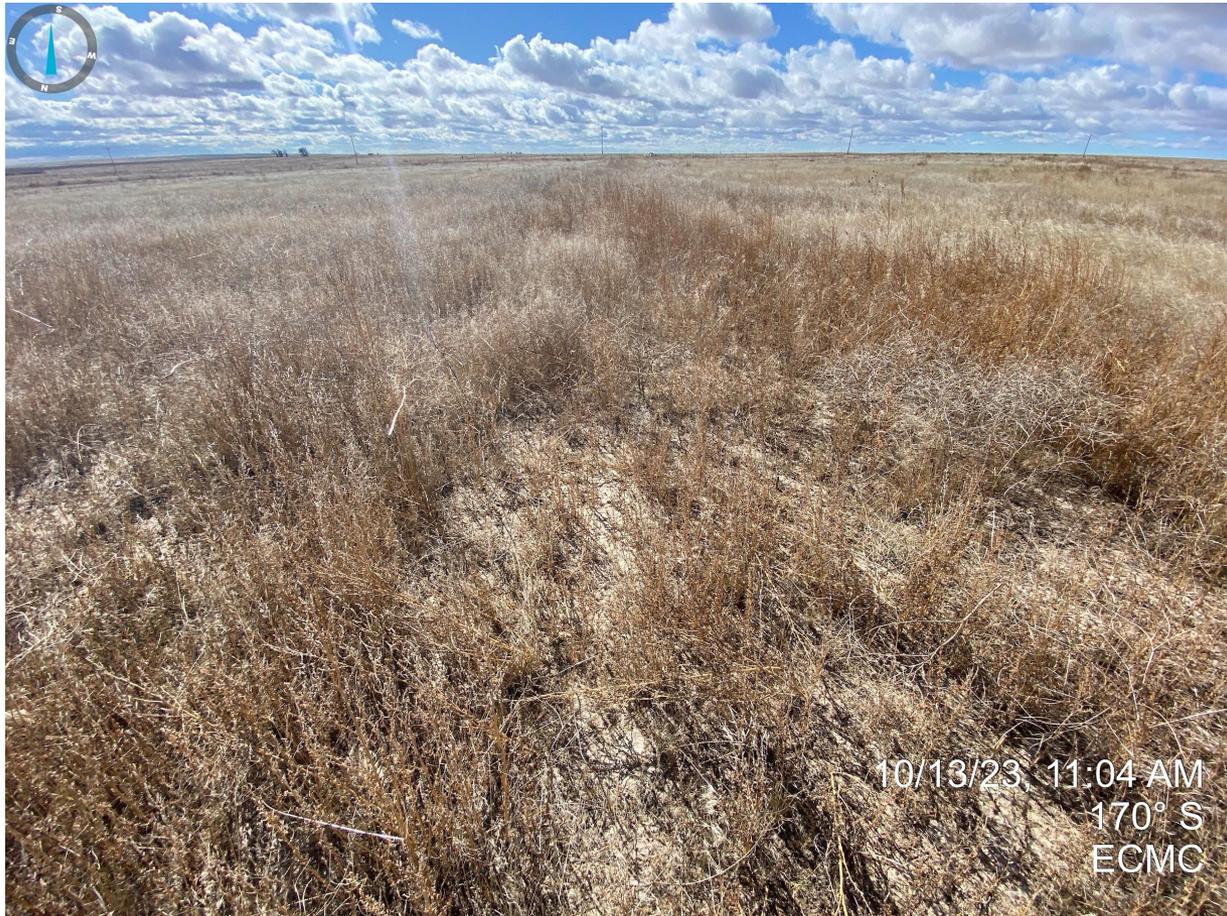
Photo 7. Taken near the former well location. See comments in Photo 6.

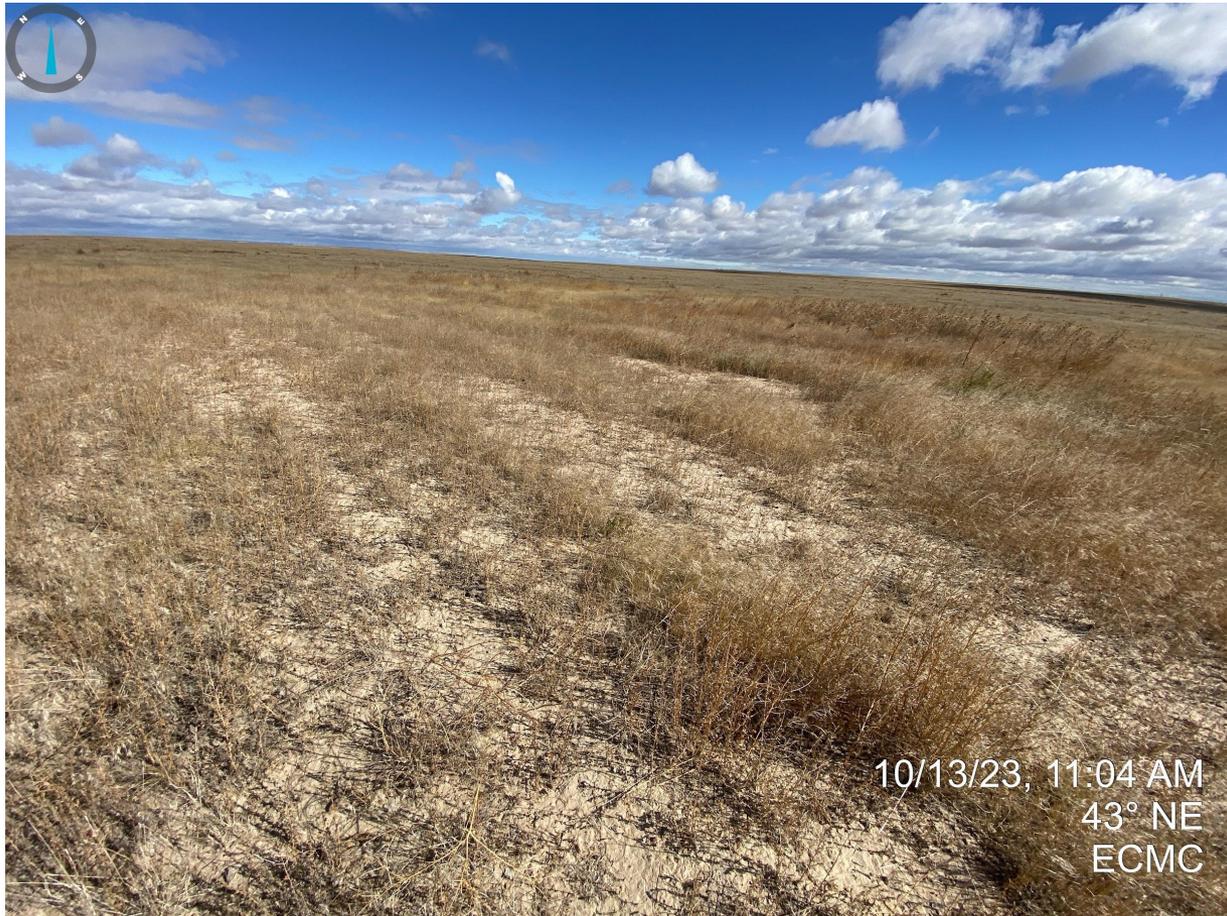
Photo 8. Taken from the center portion of the former well. Non-uniform vegetation cover resulting in bare/exposed soils.

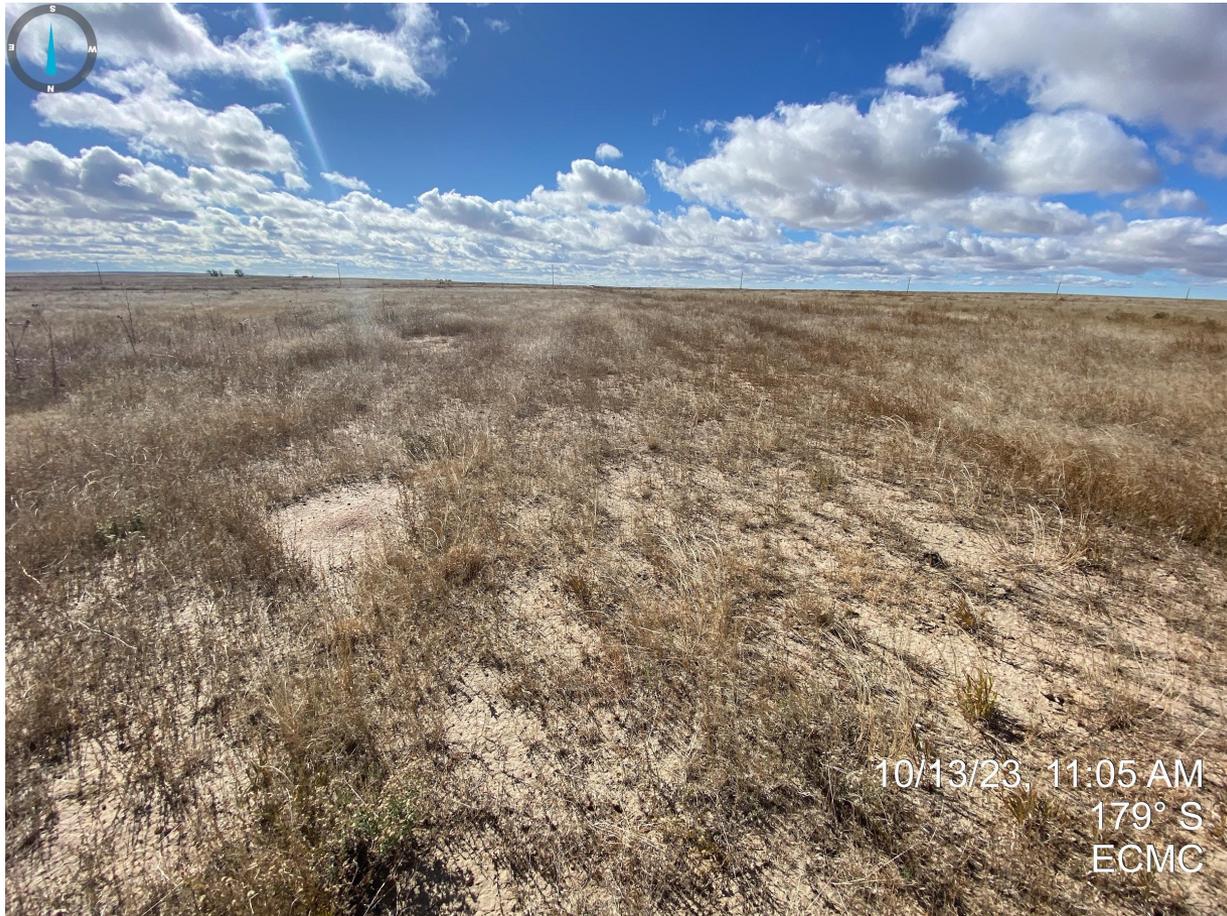
Photo 9. Taken from the northern portion of the well location; see comments in Photo 8.
