Interim Reclamation and Stormwater Inspection

October 11, 2023

Operator: CCRP OPERATING INC - #10665

Location Name: True Ranch Fee/2326 East

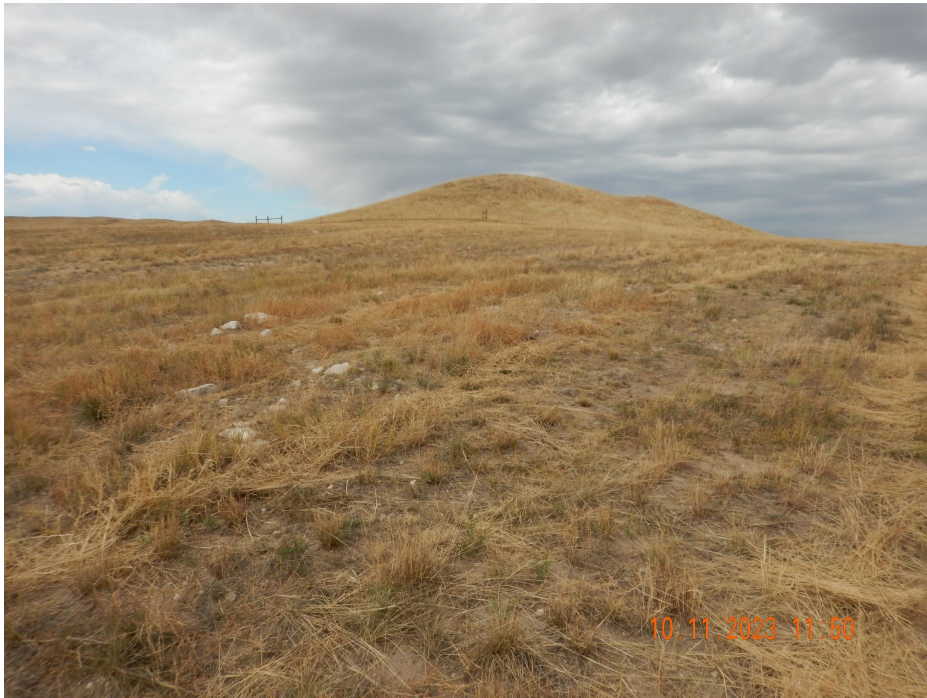
Photo 1. Photo taken from the western location, facing Northwest. Photo illustrates interim reclamation has been performed and perennial vegetation was observed and meets Rule 1003 standards.

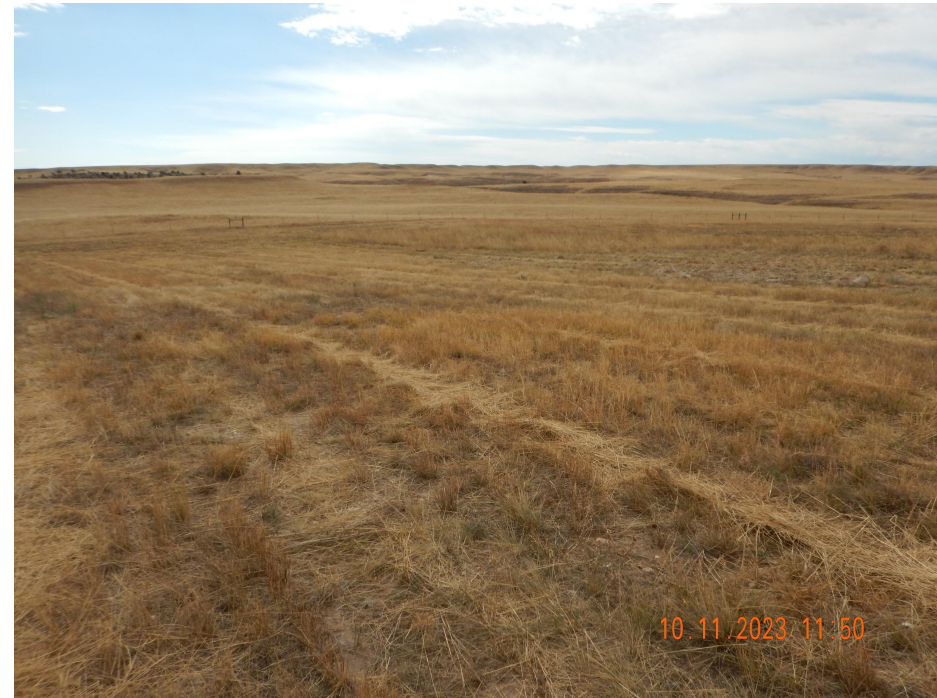
Photo 2. Photo taken from the western location, facing Southwest. See comments under Photo 1.

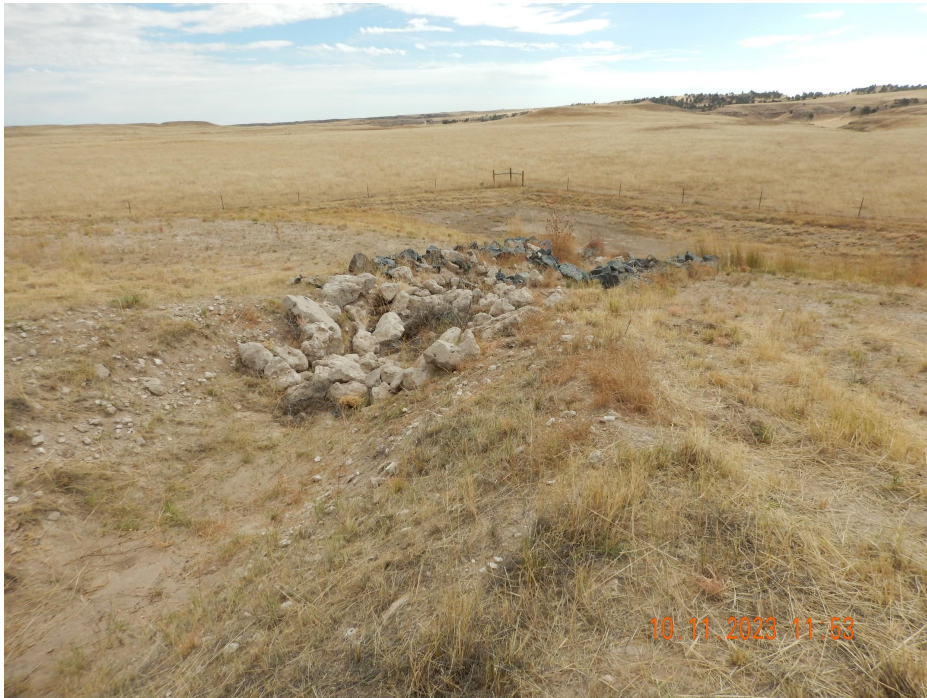
Photo 3. Photo taken from the southeastern interim area, facing Southeast. Photo illustrates the Operator has made stormwater erosion repairs.

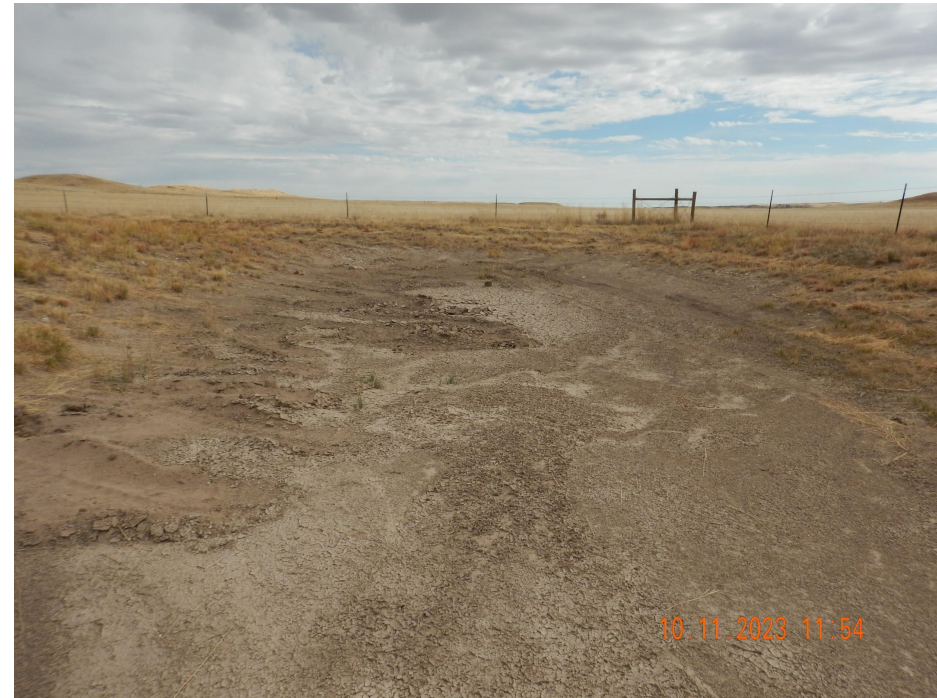
Photo 4. Photo taken from the southeastern interim area, facing East. Photo illustrates the retention pond is functioning properly and no observed sediment discharge from location.

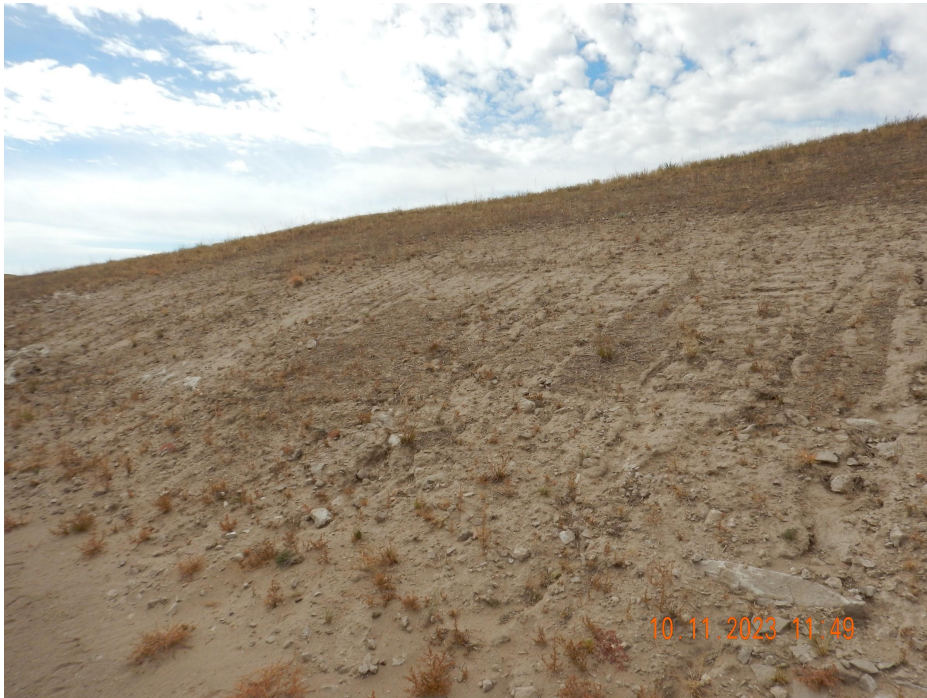
Photo 5. Photo taken from the western cut slope, facing West. Photo illustrates rill erosion is evident. Operator continues to try and seed the cut slope which is not sufficient.

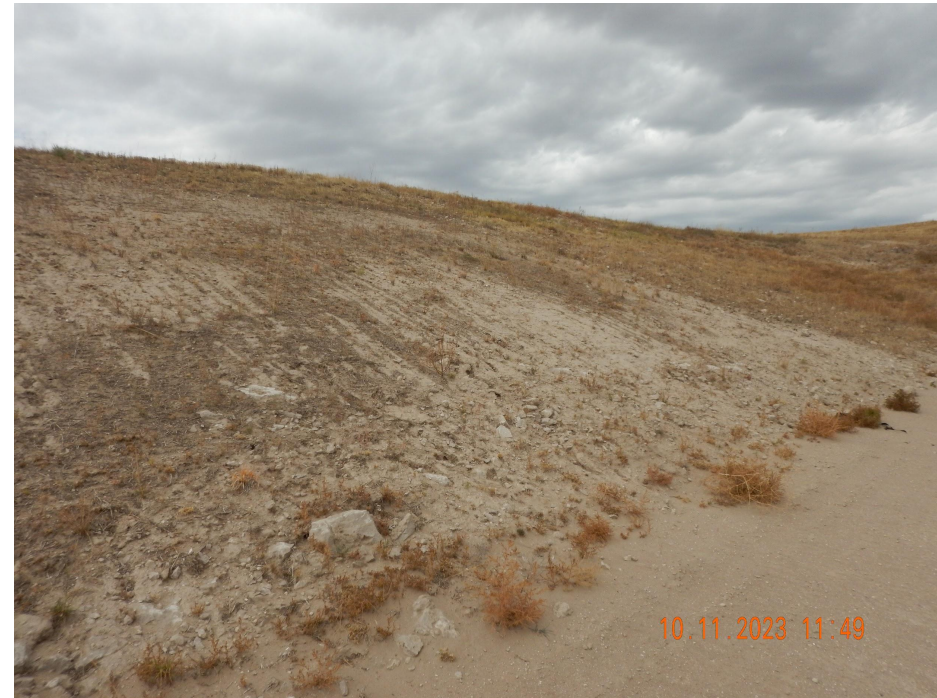
Photo 6. Photo taken from the western cut slope, facing Northwest. See comments under Photo 5.
