Final Reclamation and Stormwater Inspection

Operator: NOBLE ENERGY INC - 100322

Location ID: 431544

Inspection Photos
Location Name: Hunt
LF18-62HN Multi
Location ID: 431544

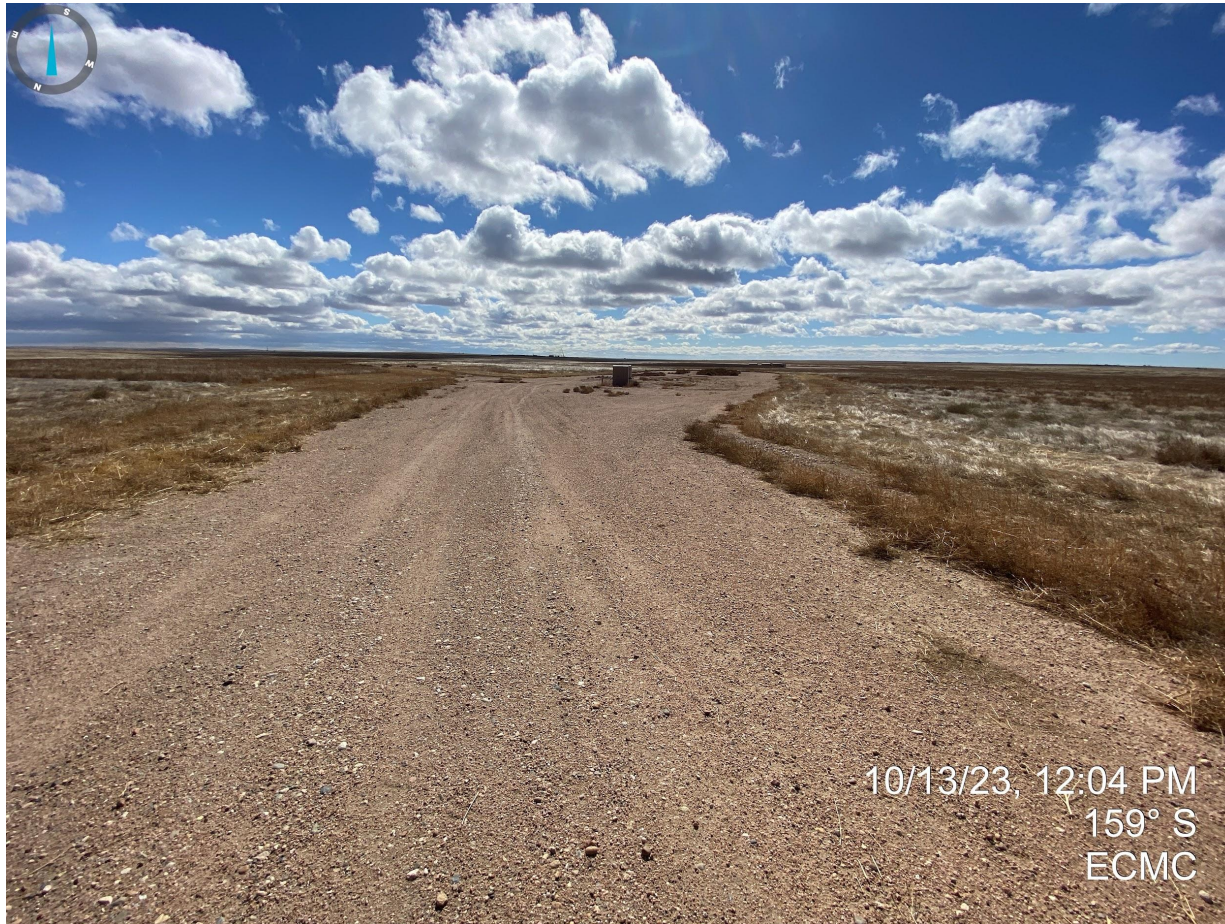
Photo 1. Taken near the entrance. It does not appear any reclamation work has been conducted. Access road/road base material remains on location.

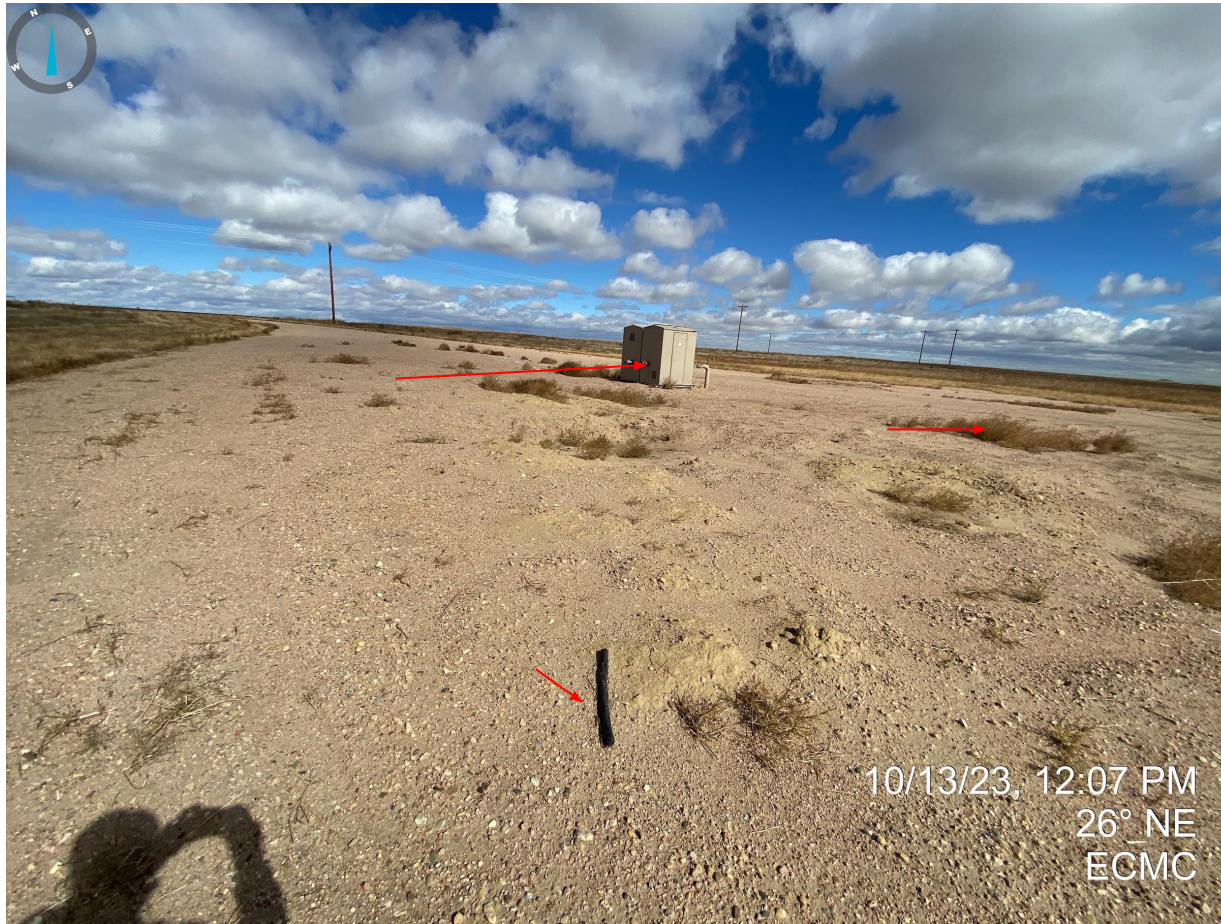
Photo 2. Taken near the former tank battery. It does not appear all surface equipment has been removed with evidence of two meter sheds and flowline risers. Trash and debris, and undesirable vegetation was also observed throughout.

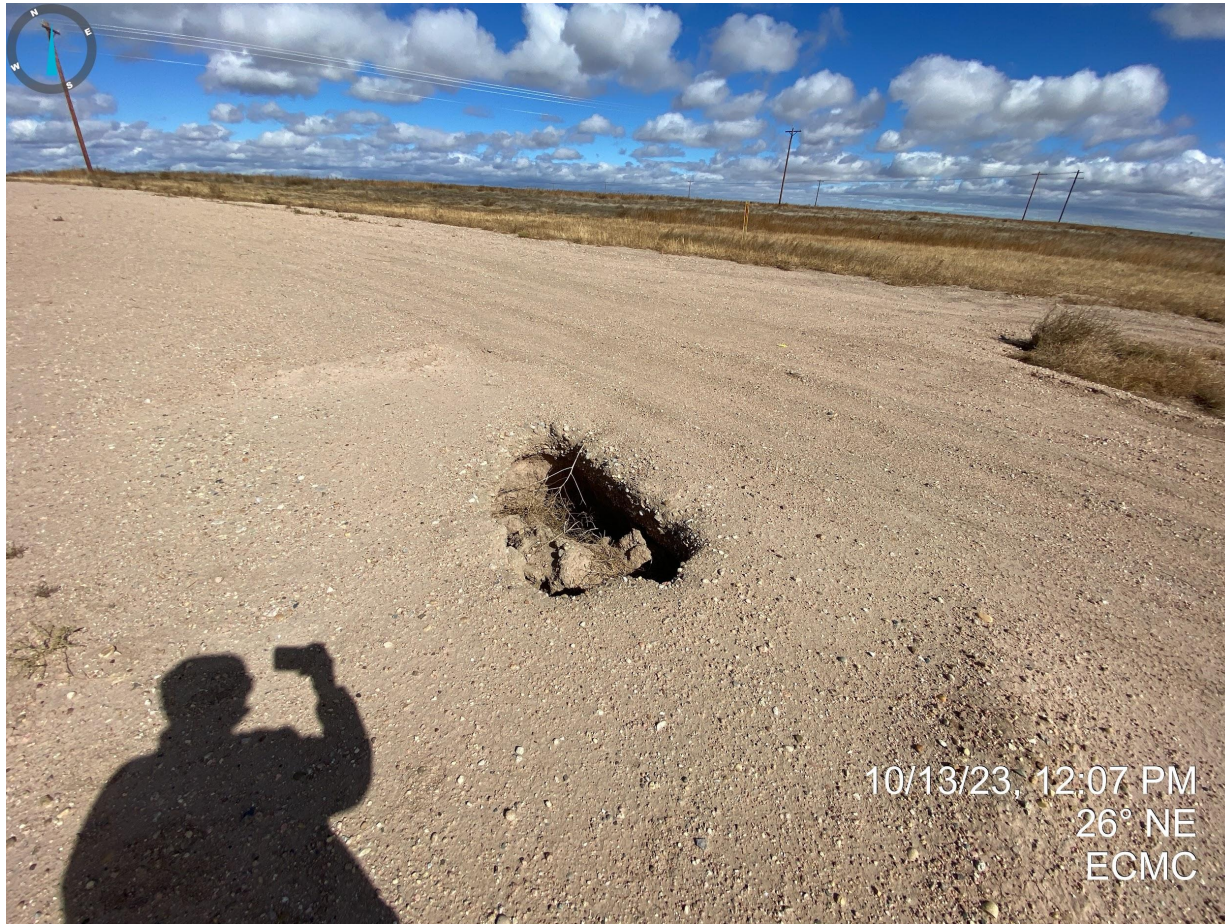
Photo 3. Subsidence/hole was observed on the former production facilities. The Operator was immediately contacted and instructed to mark/cover the opening to ensure safe operations.

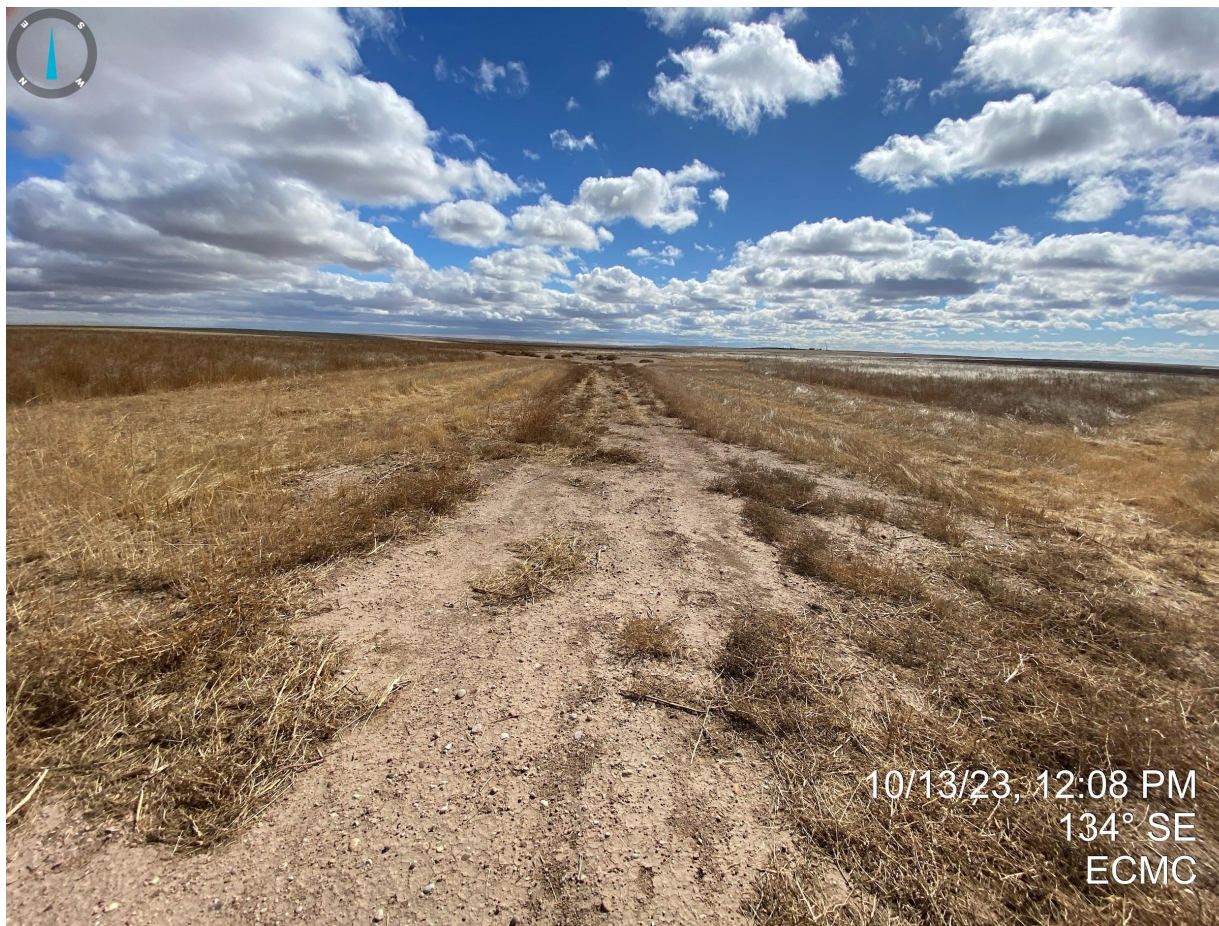
Photo 4. The access road to the well location has not been reclaimed.

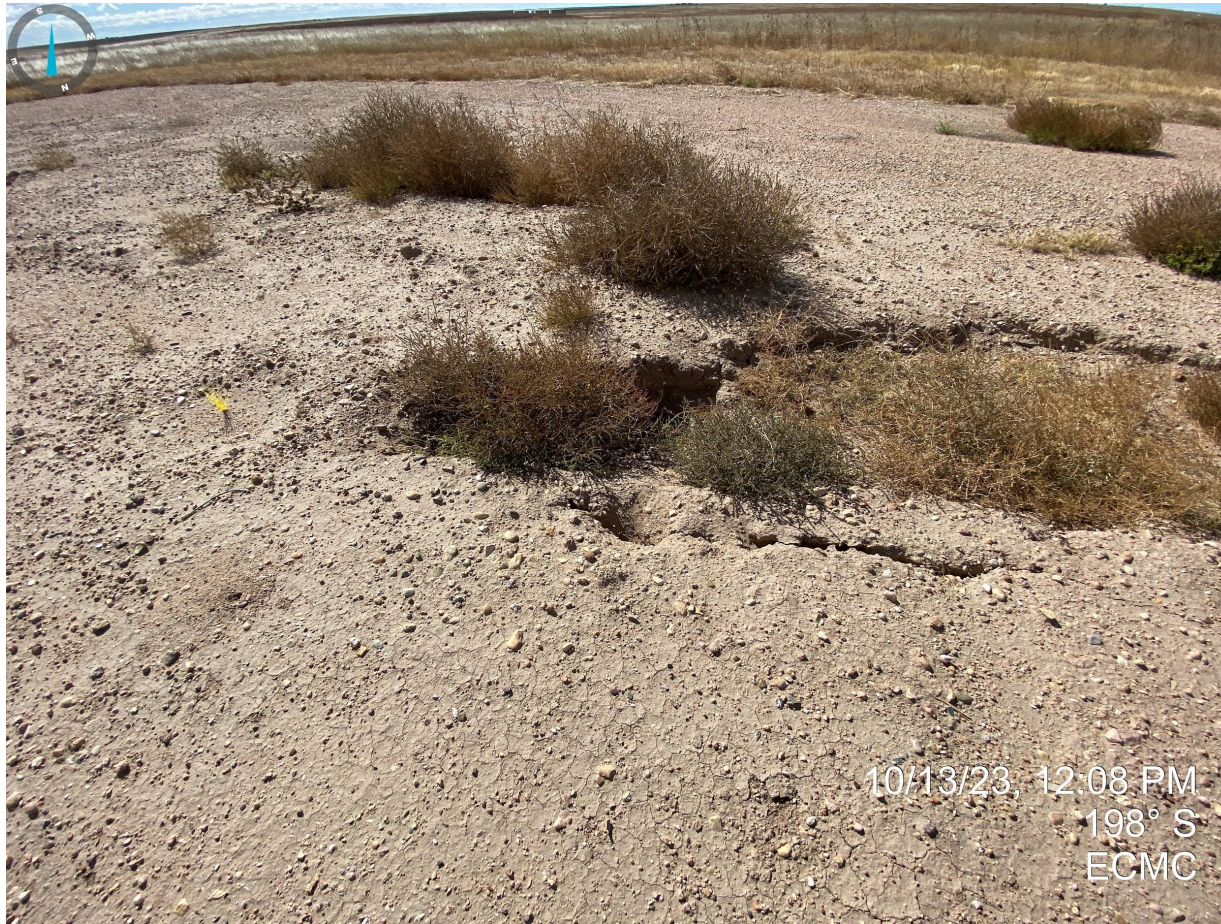
Photo 5. Taken near the former well. Subsidence/hole was observed. The Operator was immediately contacted and instructed to mark/cover the opening to ensure safe operations.

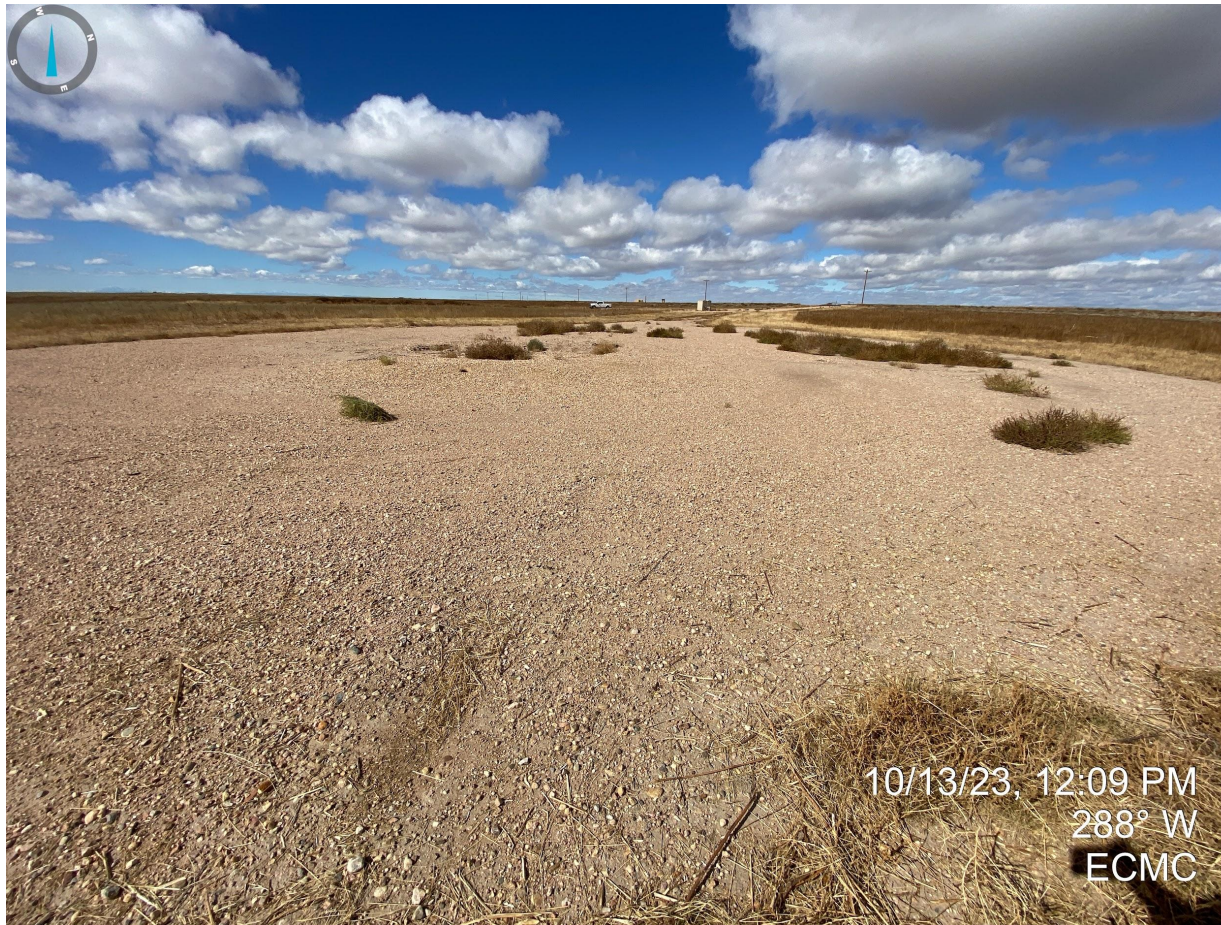
Photo 6. The former well location has not been reclaimed.

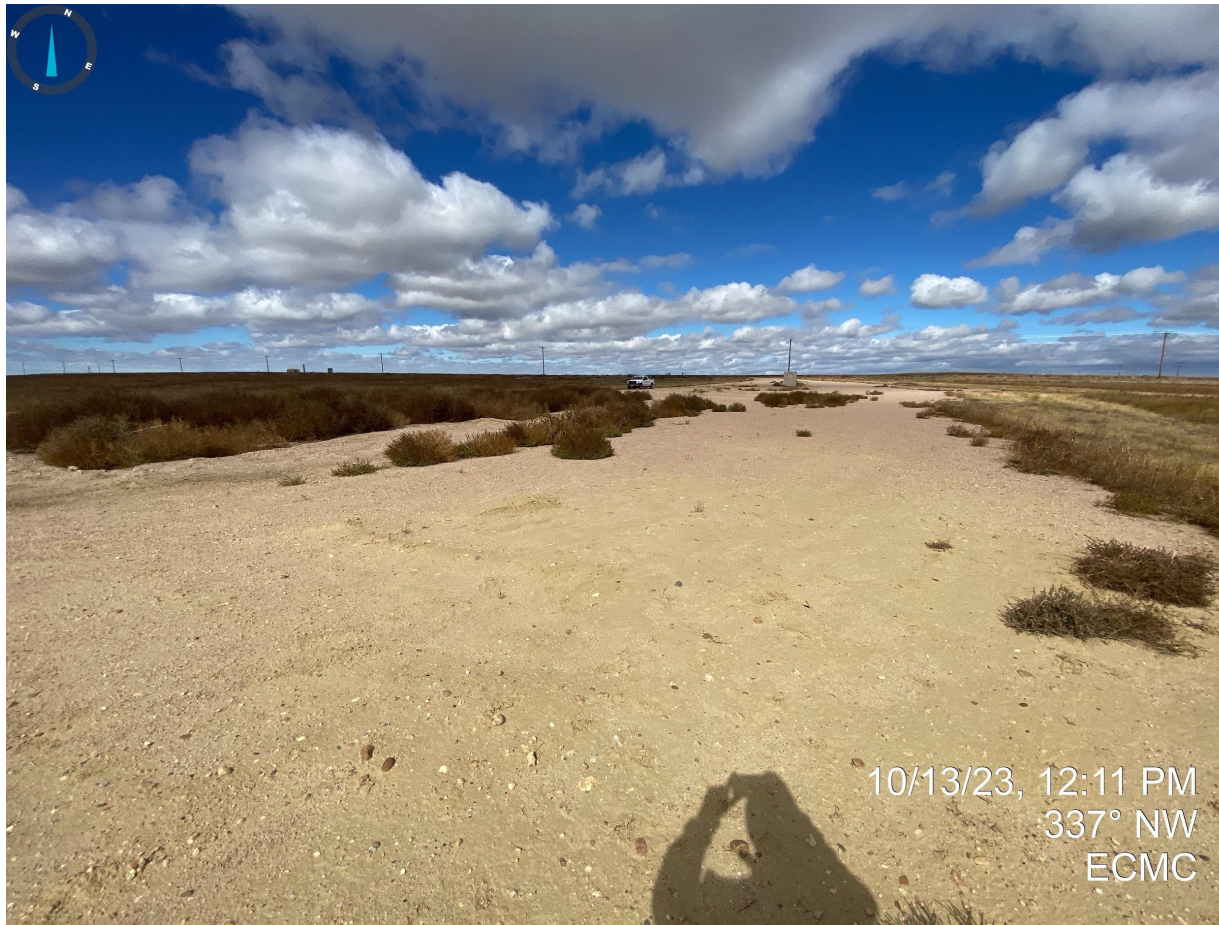
Photo 7. The former tank battery location has not been reclaimed.

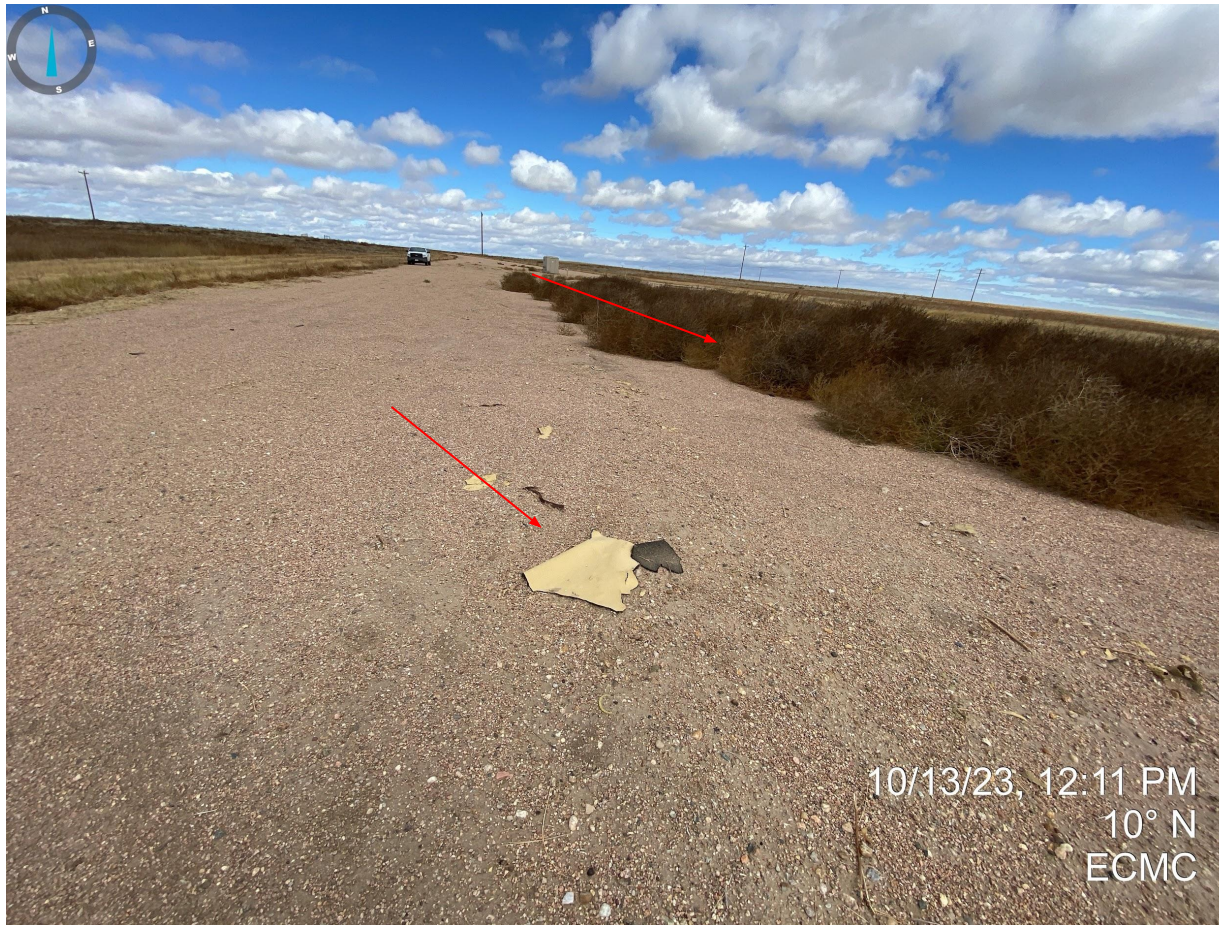
Photo 8. Debris/trash and undesirable vegetation observed near the former tank battery facilities.
