Interim Reclamation and Stormwater Inspection

Operator: Verdad Resources LLC - 10651

Location ID: 472202

Inspection Photos
Location Name: Timbro Fed 1931
Location ID: 472202

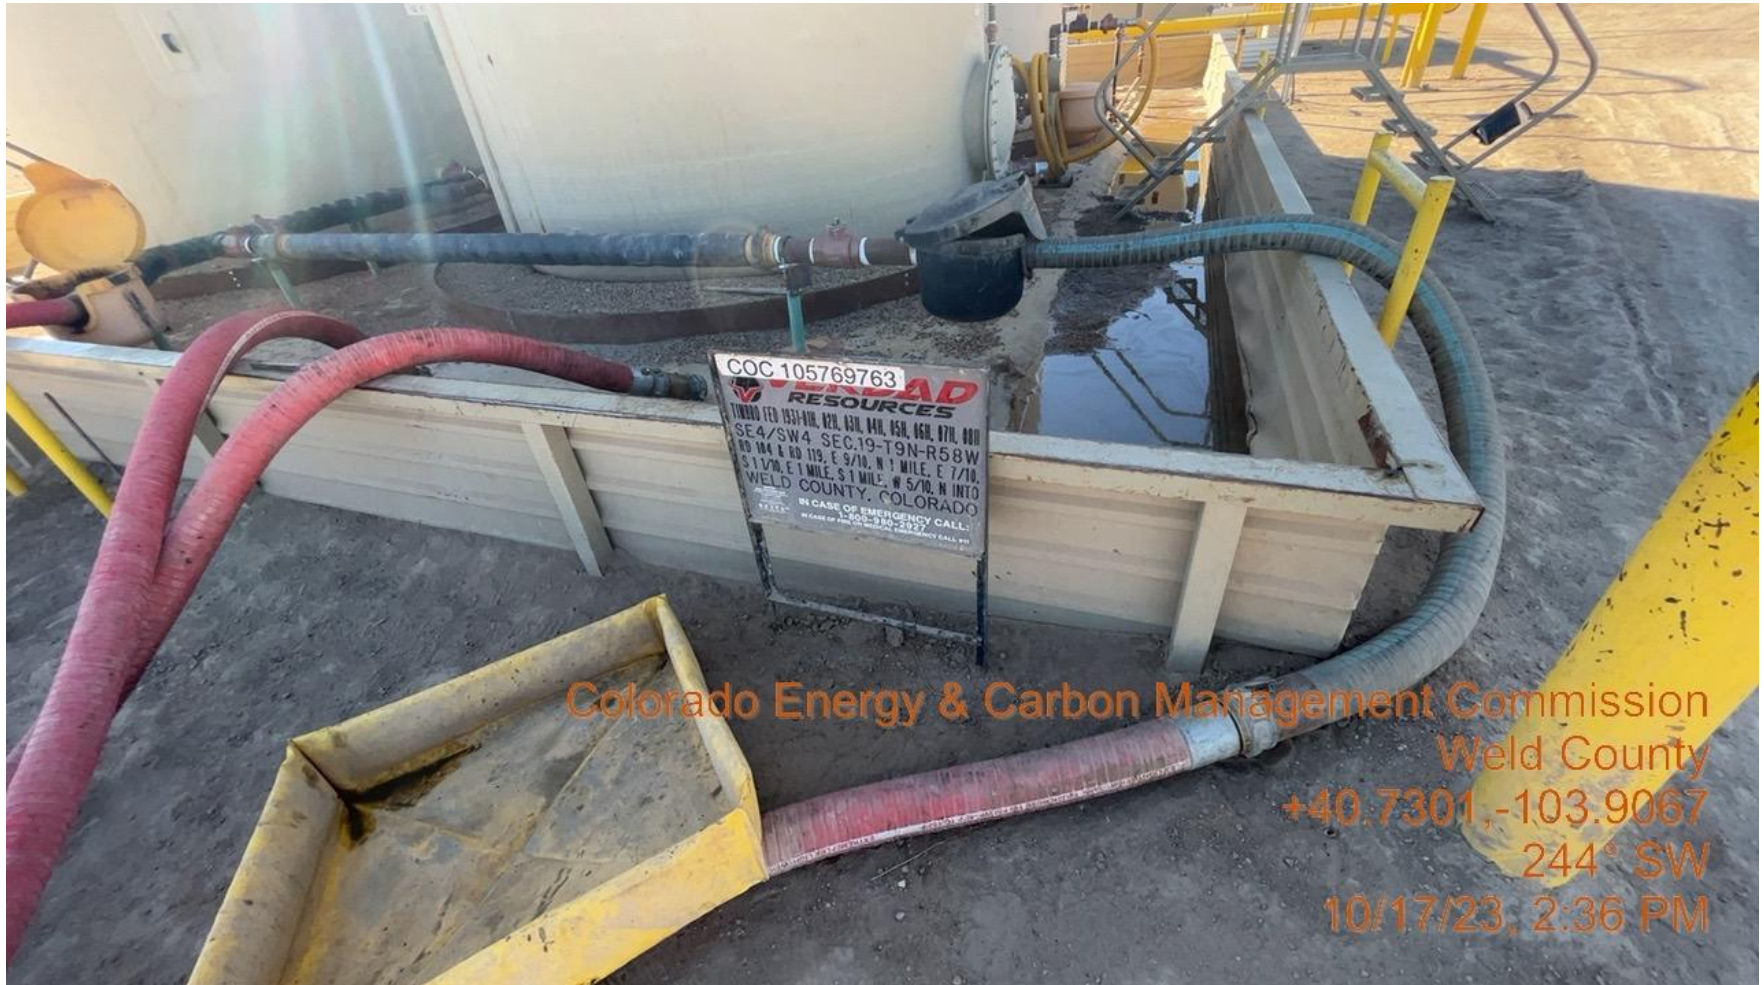
Photo 1. The photo was taken of the location sign. Photo illustrates produced water spilled into secondary containment as well as hoses outside secondary containment.

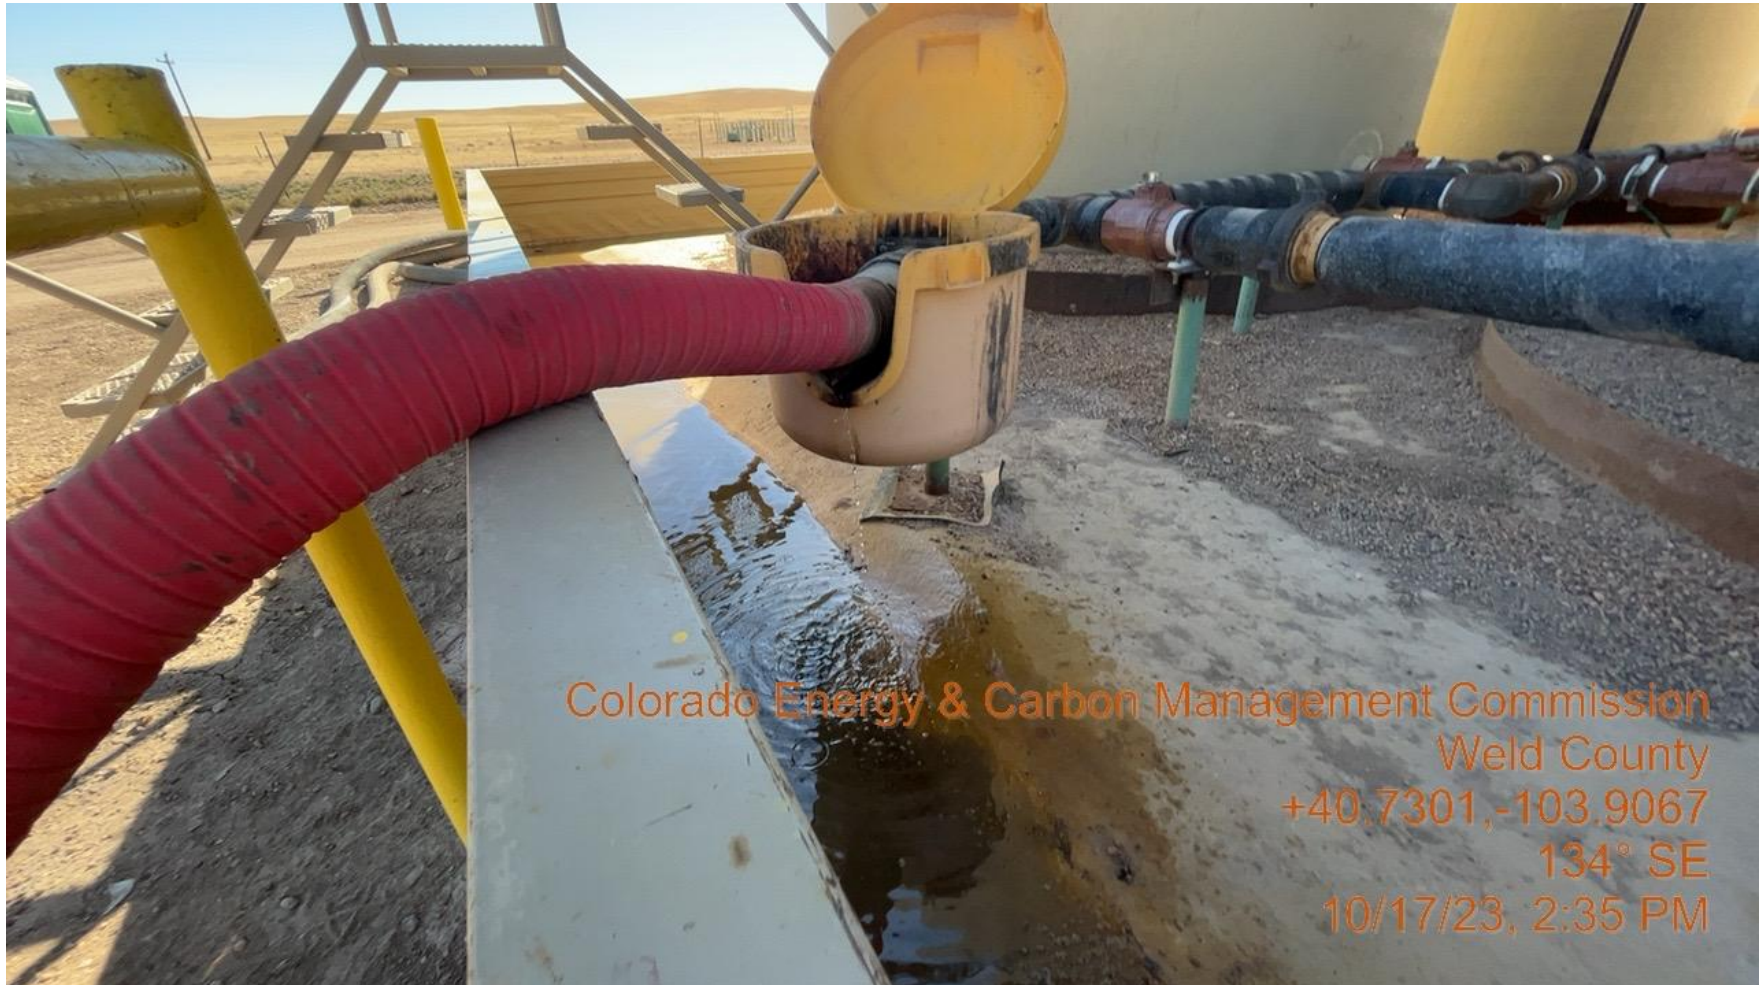
Photo 2. The photo was taken at the East end of the tank batteries facing Southeast. The photo illustrates produced water actively spilling into secondary containment.

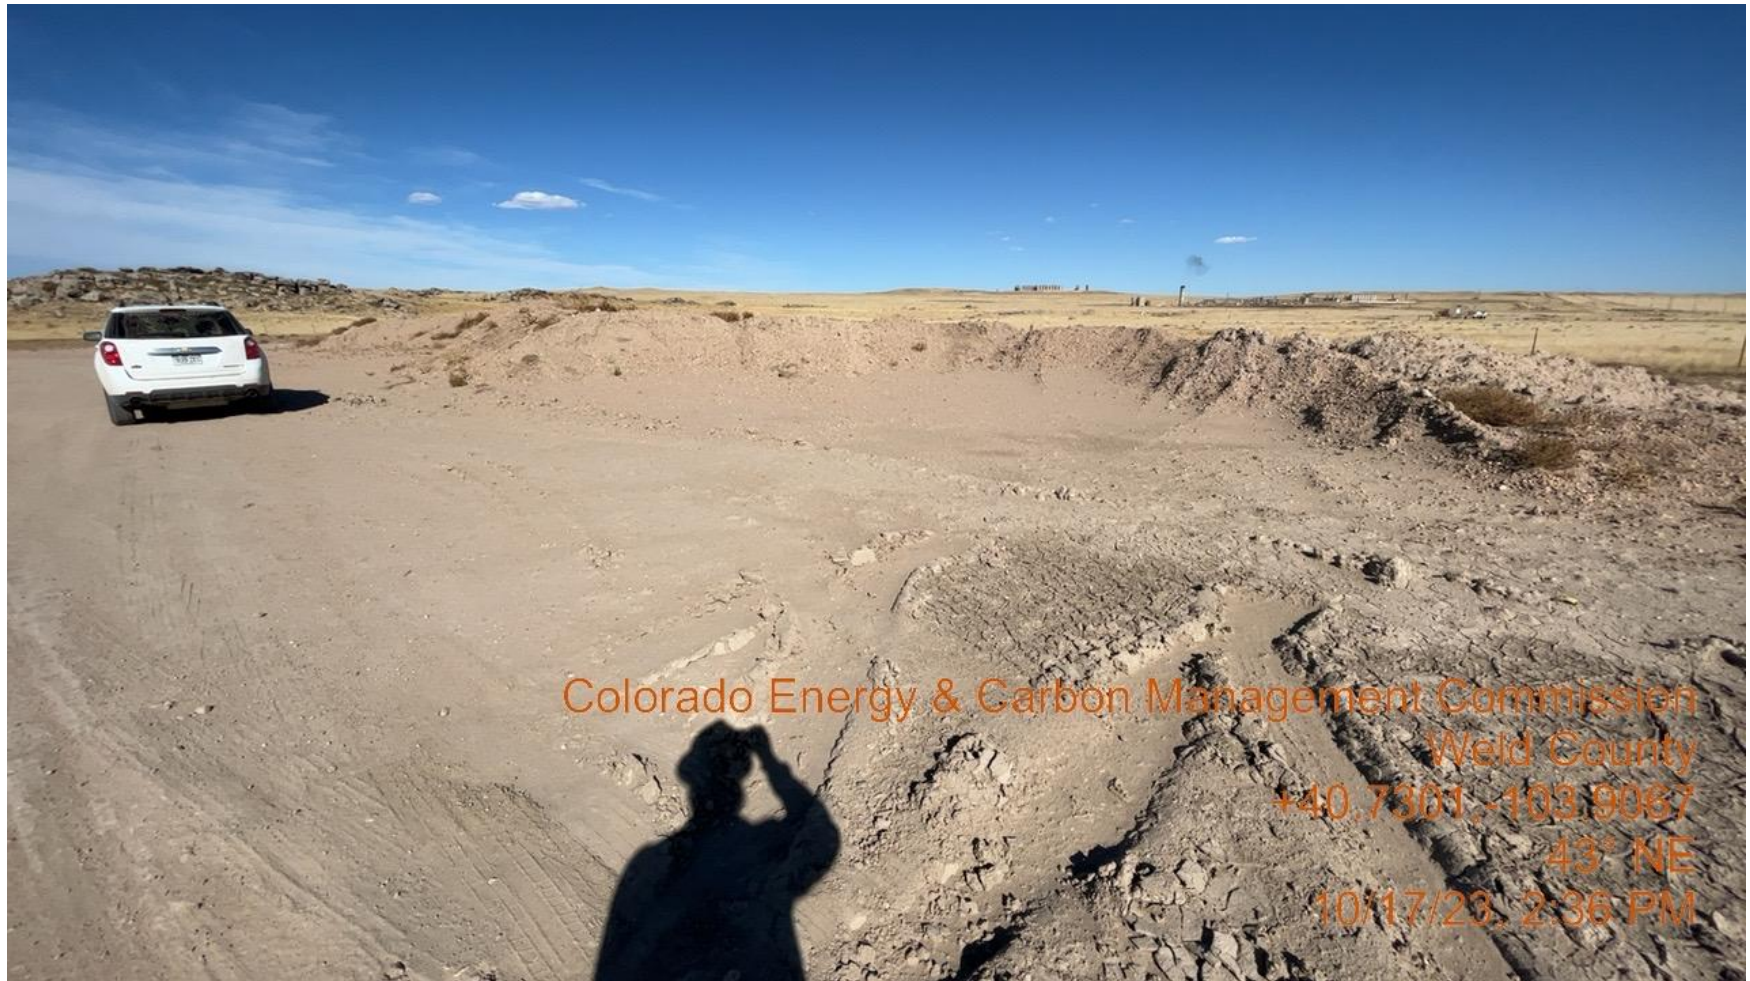
Photo 3. The photo was taken at the well location entrance facing Northeast. The photo illustrates a gravel stockpile being stored on site. The stockpile is accumulating kochia and russian thistle.

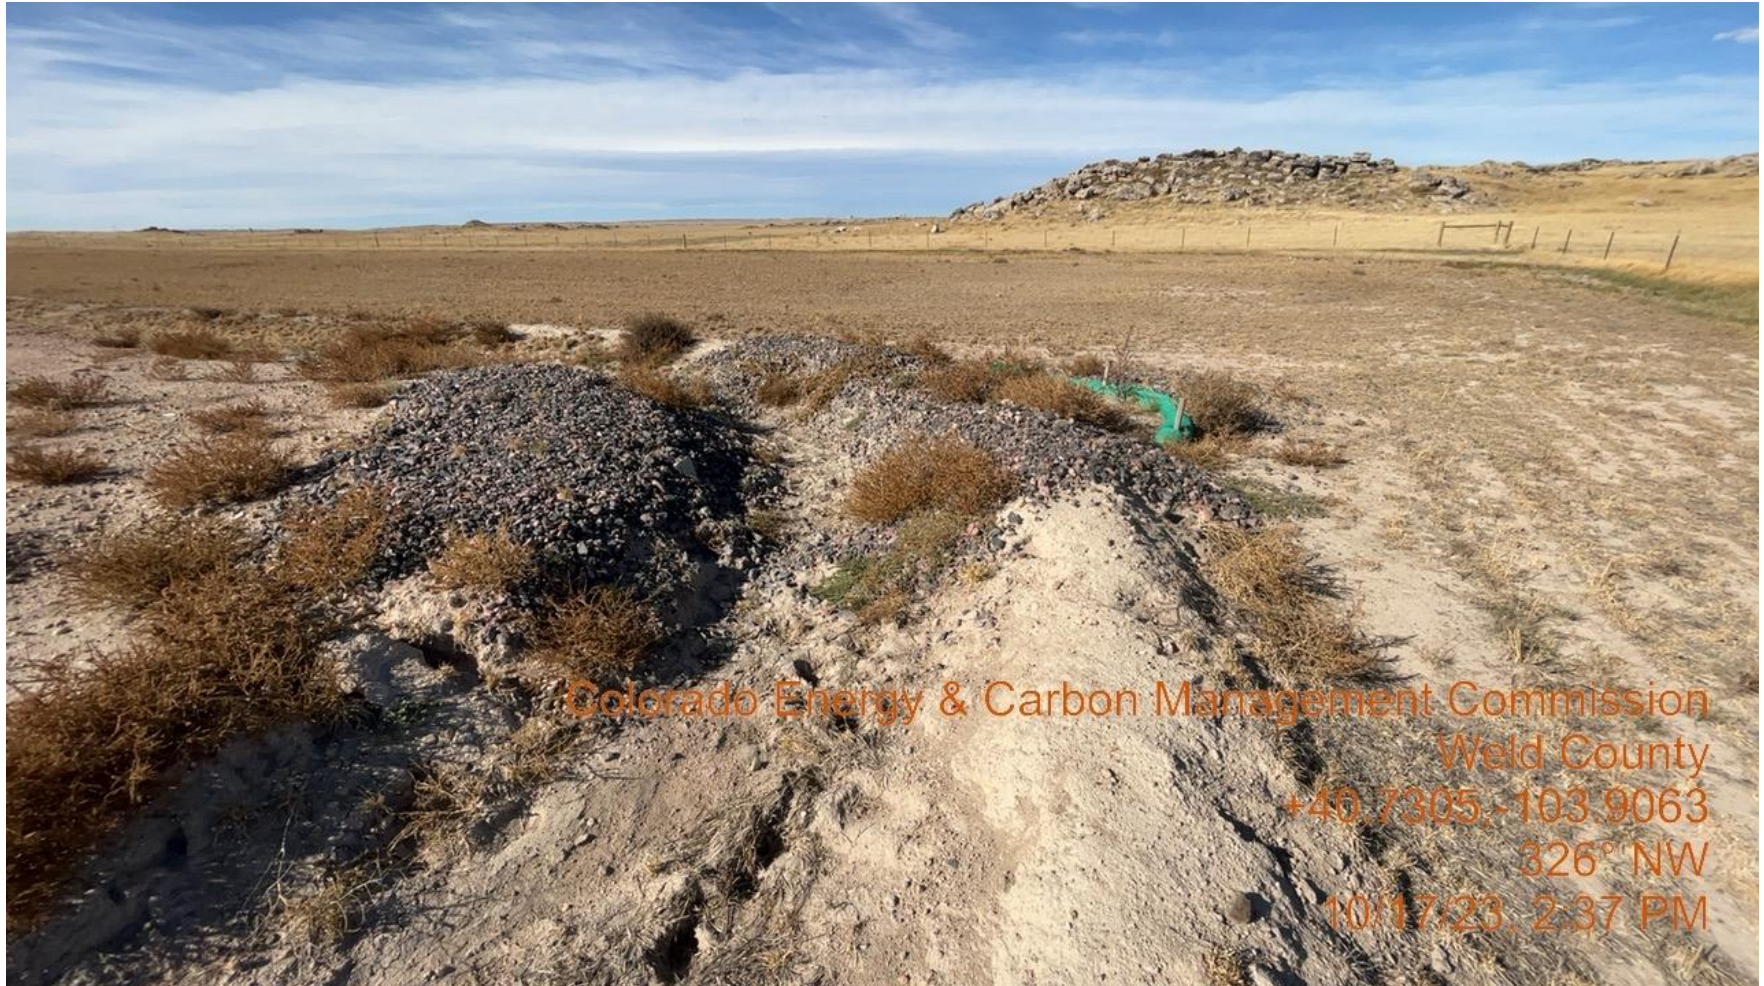
Photo 4. The photo was taken at the east end of the well location facing Northwest. The photo illustrates a stormwater bmp with russian thistle and kochia growing throughout.

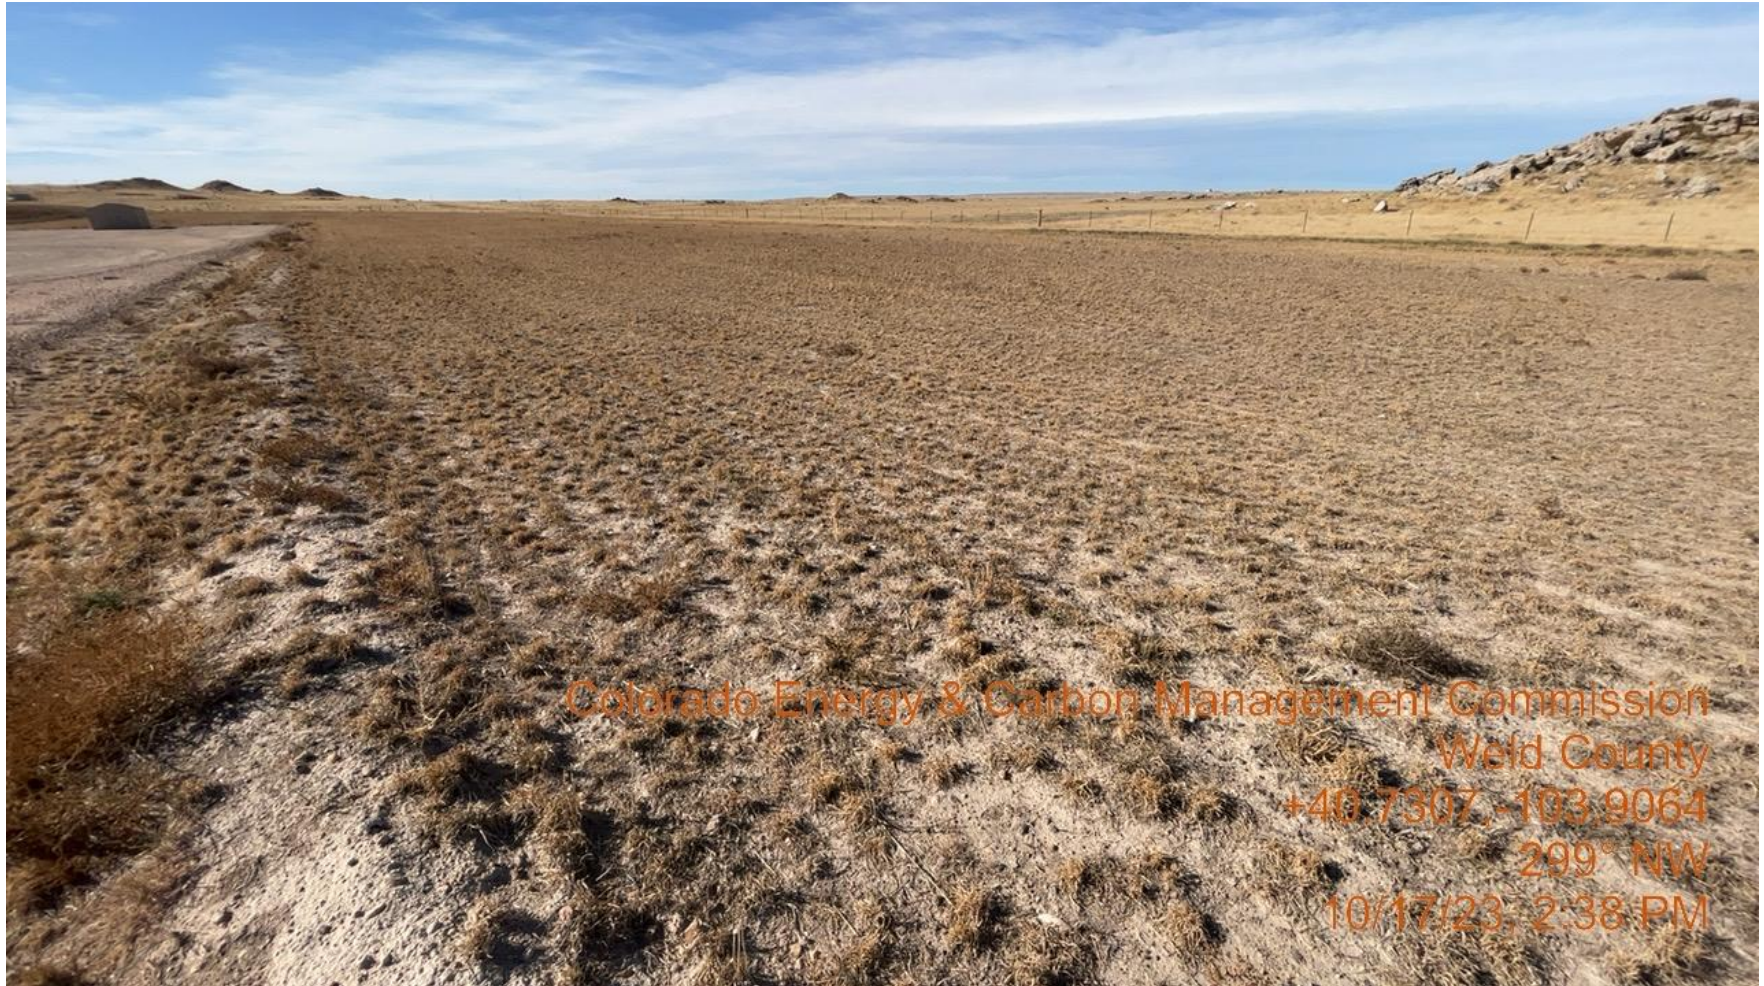
Photo 5. The photo was taken at the North end of the well location facing Northwest. The photo illustrates the seeded and mowed interim reclamation area.

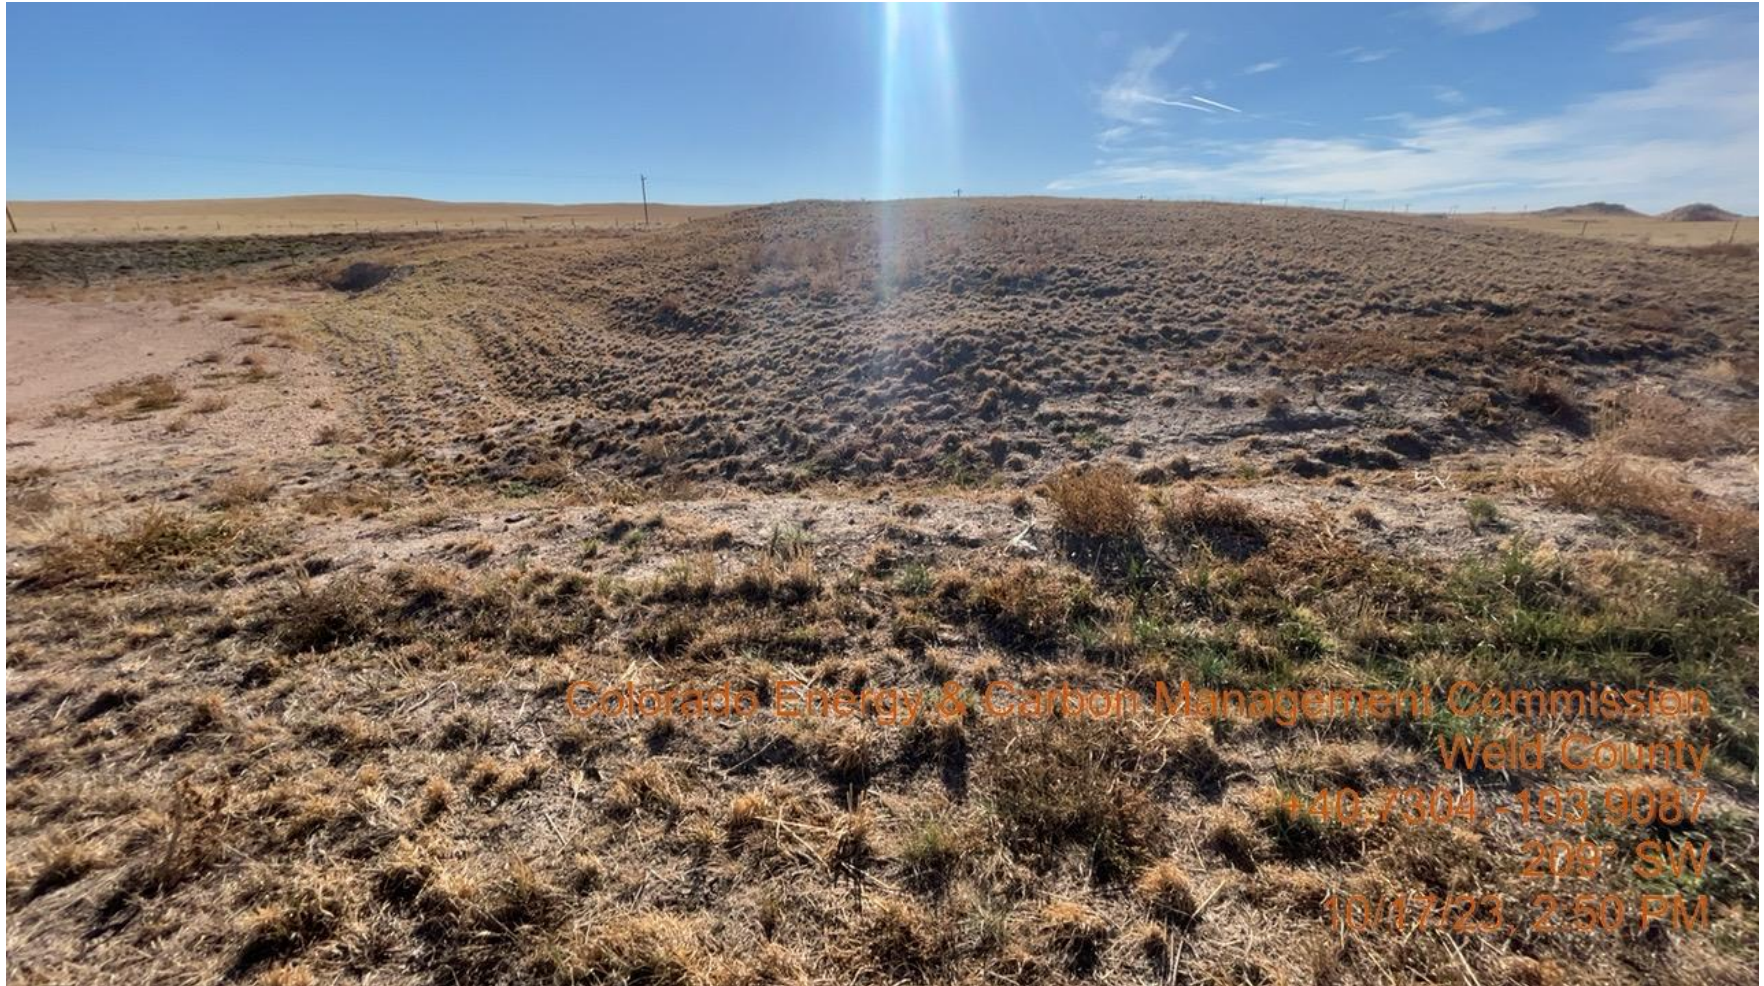
Photo 6. The photo was taken at the West end of the well location facing Southwest. The photo illustrates the topsoil pile has been seeded and has good accumulation of vegetation that has been mowed and stabilized by vegetation. Since being mowed it is unclear what the vegetation is, potentially a native seed mix with triticale.

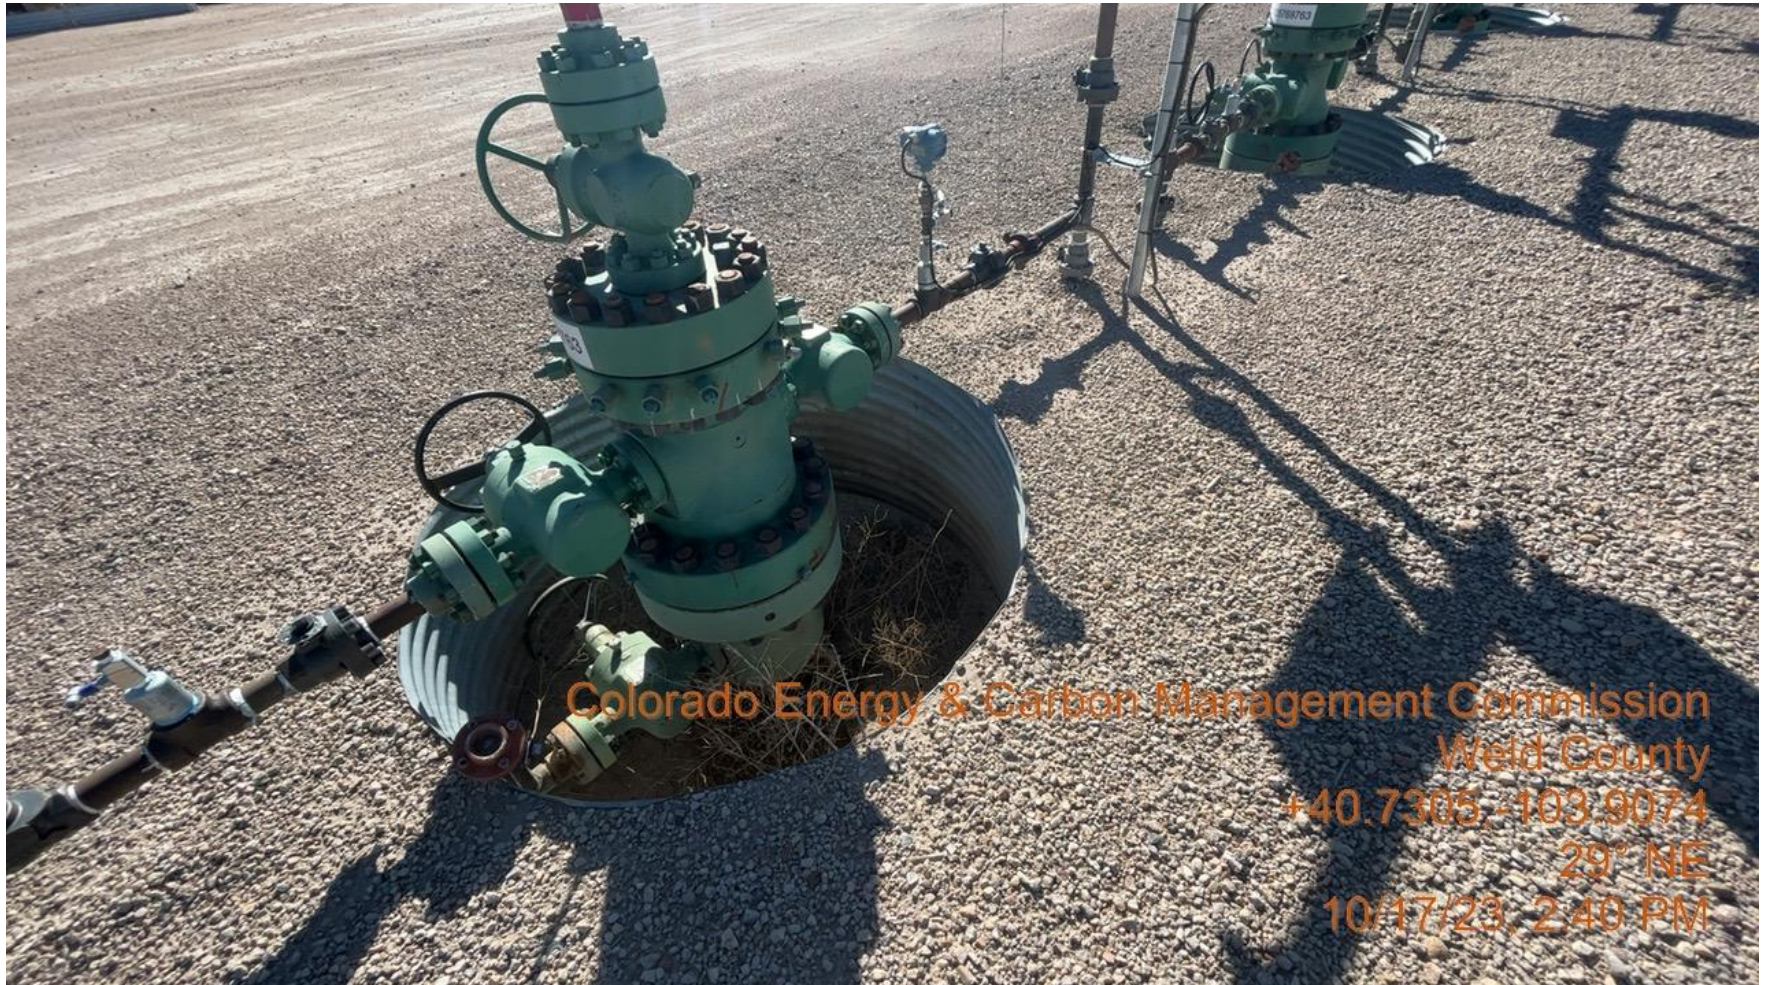
Photo 7. The photo was taken on the well location facing Northeast. The photo illustrates uncovered cellars around the wellheads.

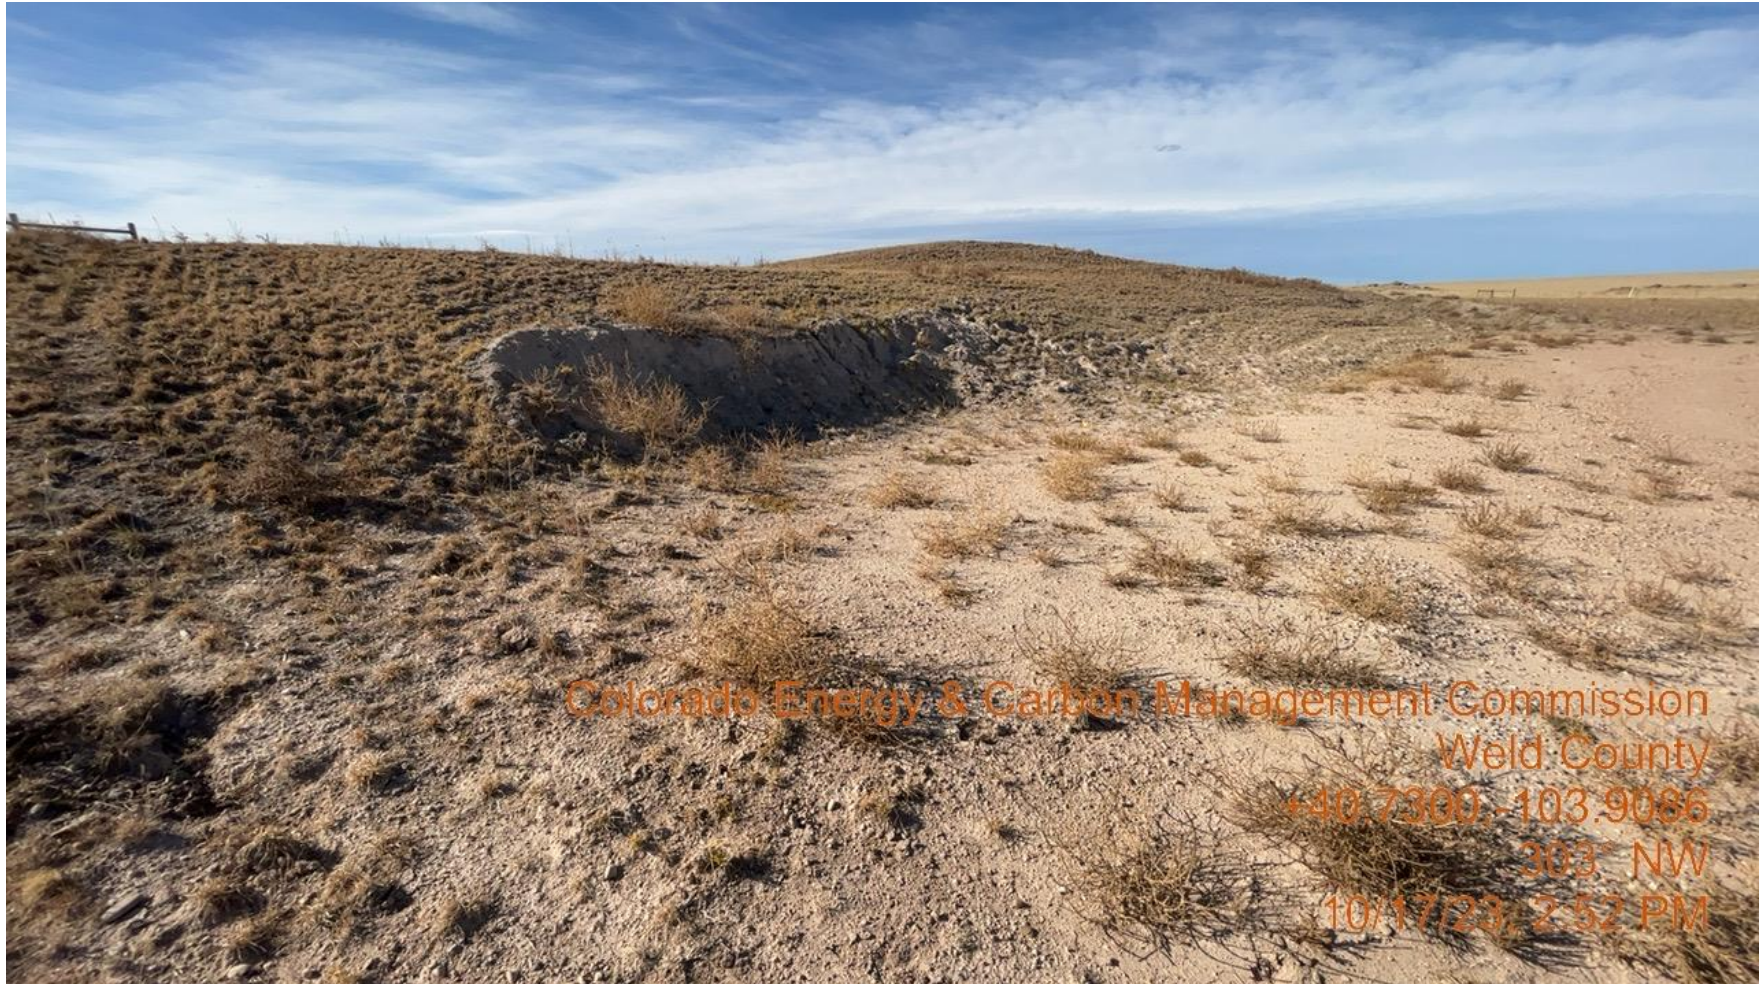
Photo 8. The photo was taken on the well location facing Northwest. The photo illustrates an area where topsoil was removed from the stockpile.
