# Final Reclamation and Stormwater Inspection

Operator: Whiting Oil & Gas Corporation - 96155

Location ID: 305647

Inspection Document #: 713900037

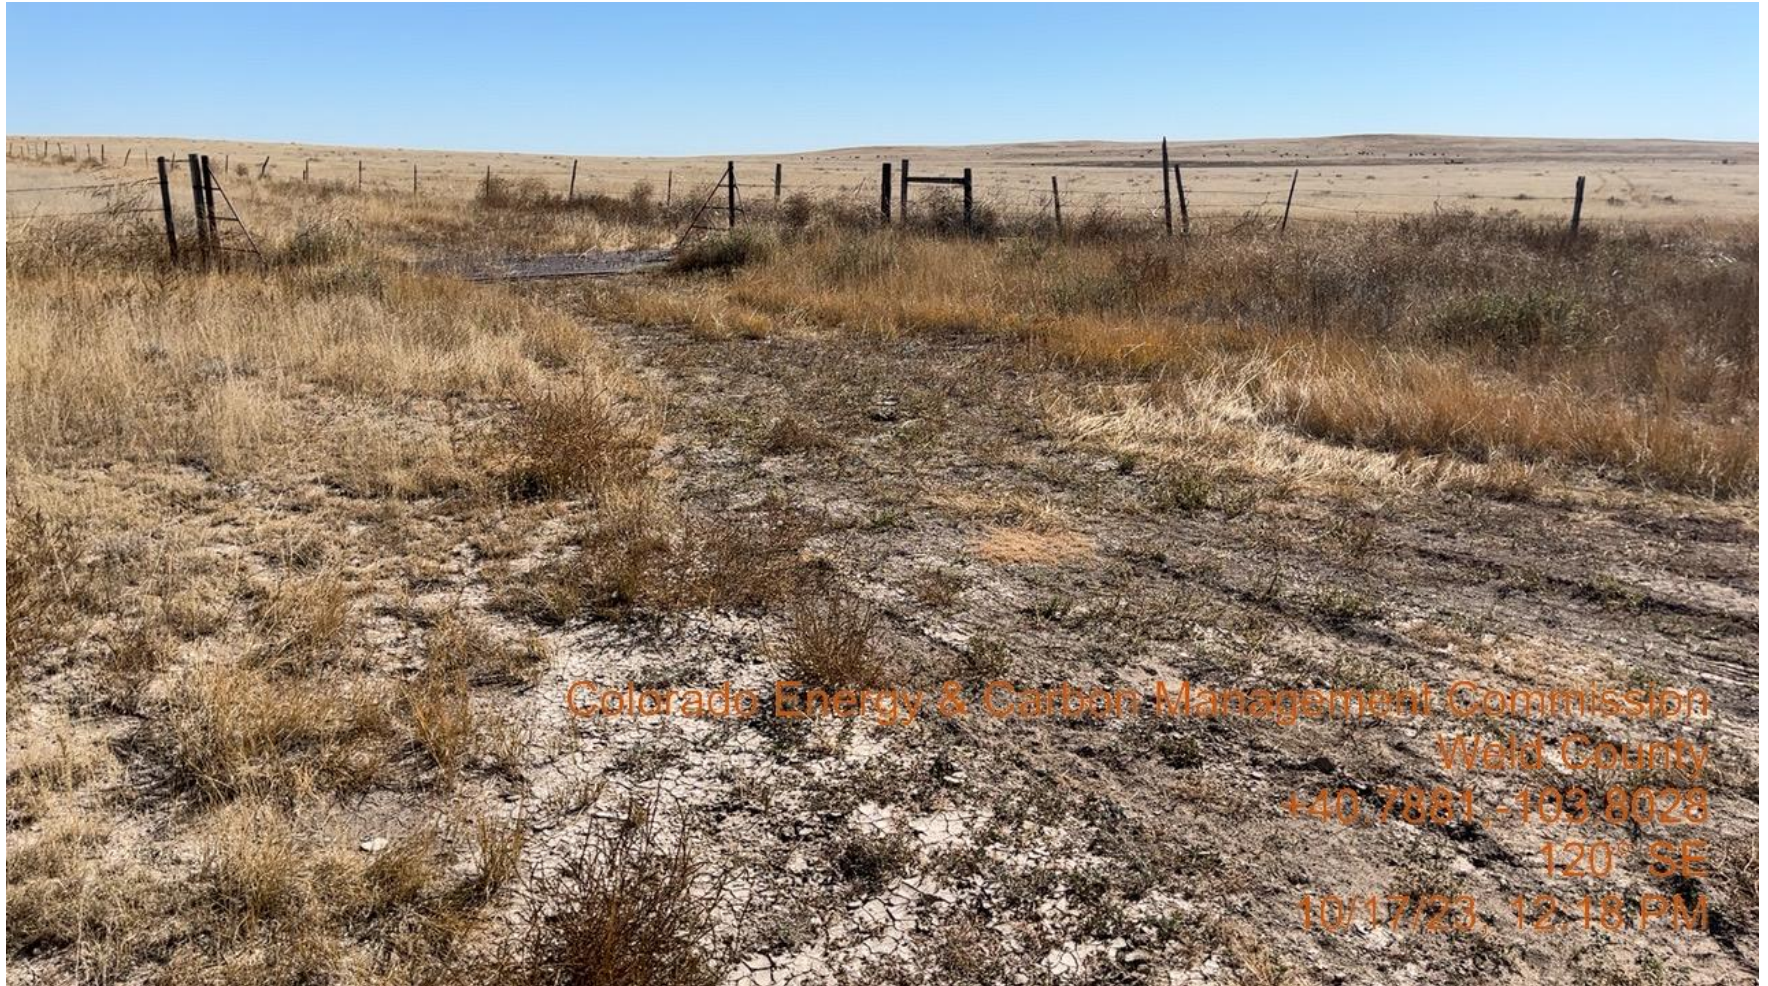
**Photo 1.** Photo at the access road entrance facing Southeast. The photo illustrates the entrance has bare soil and tumbleweeds (Kochia and Russian thistle).

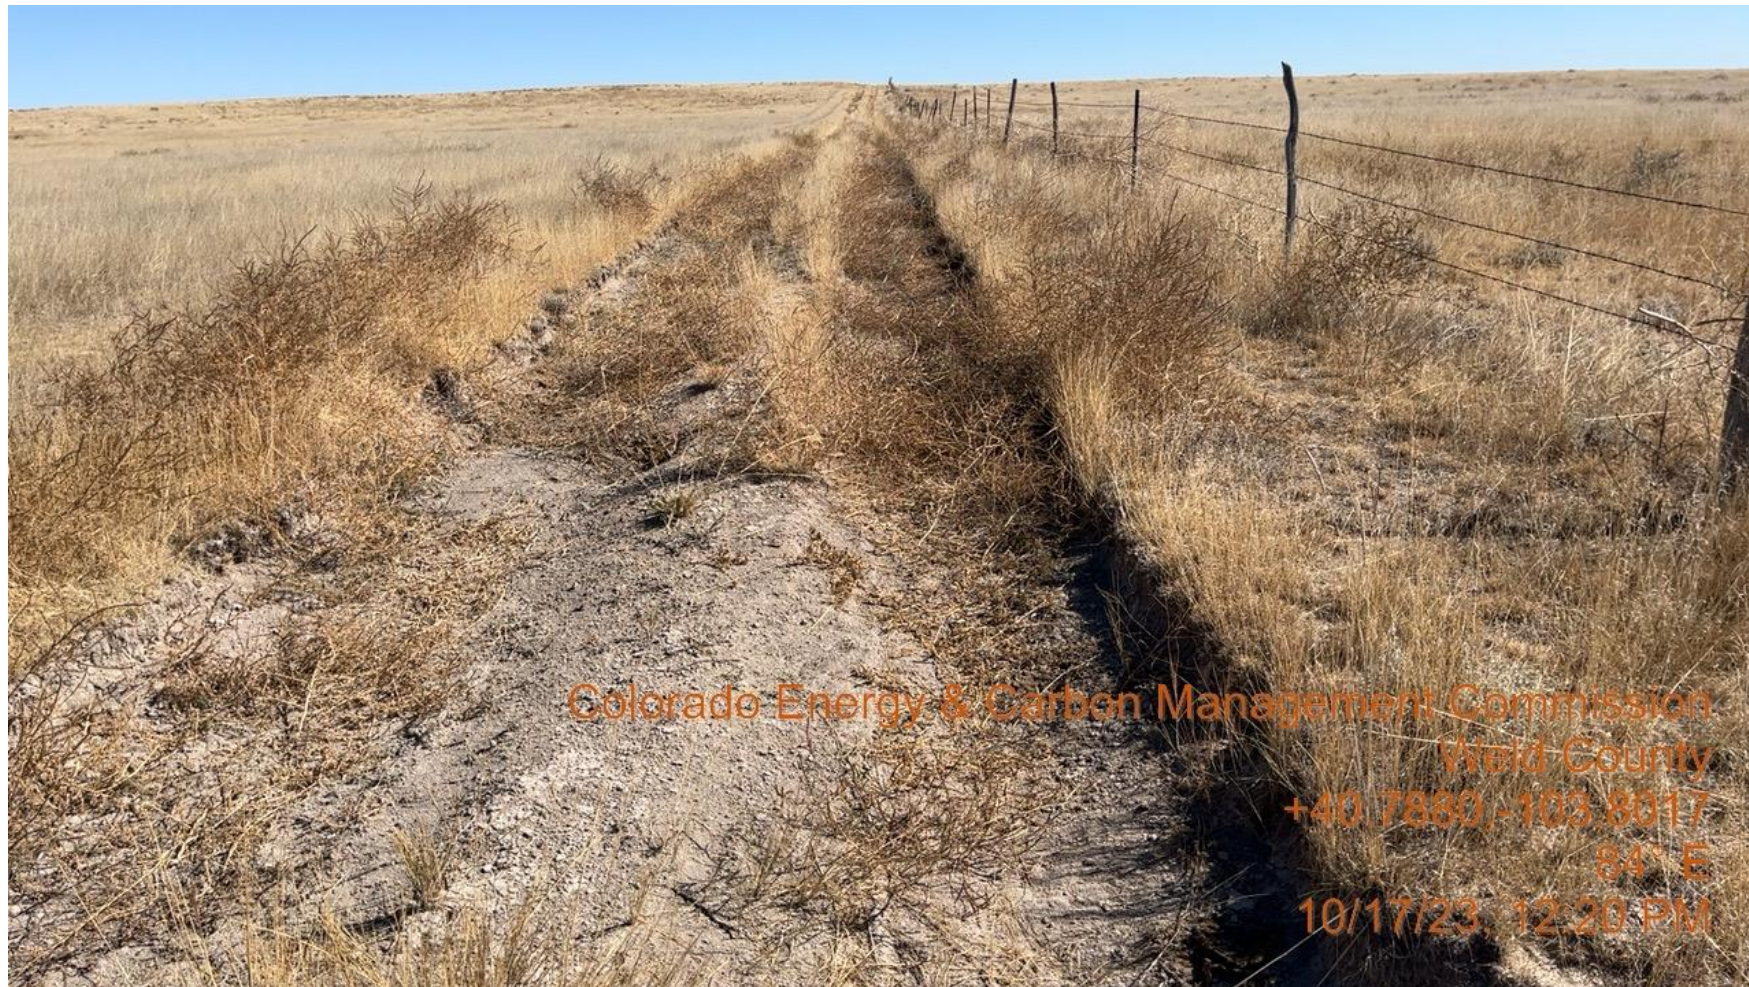
**Photo 2.** The photo was taken along the access road facing East. The photo illustrates the road is compacted and incised as well having large areas of bare soil and undesirable plant establishment.

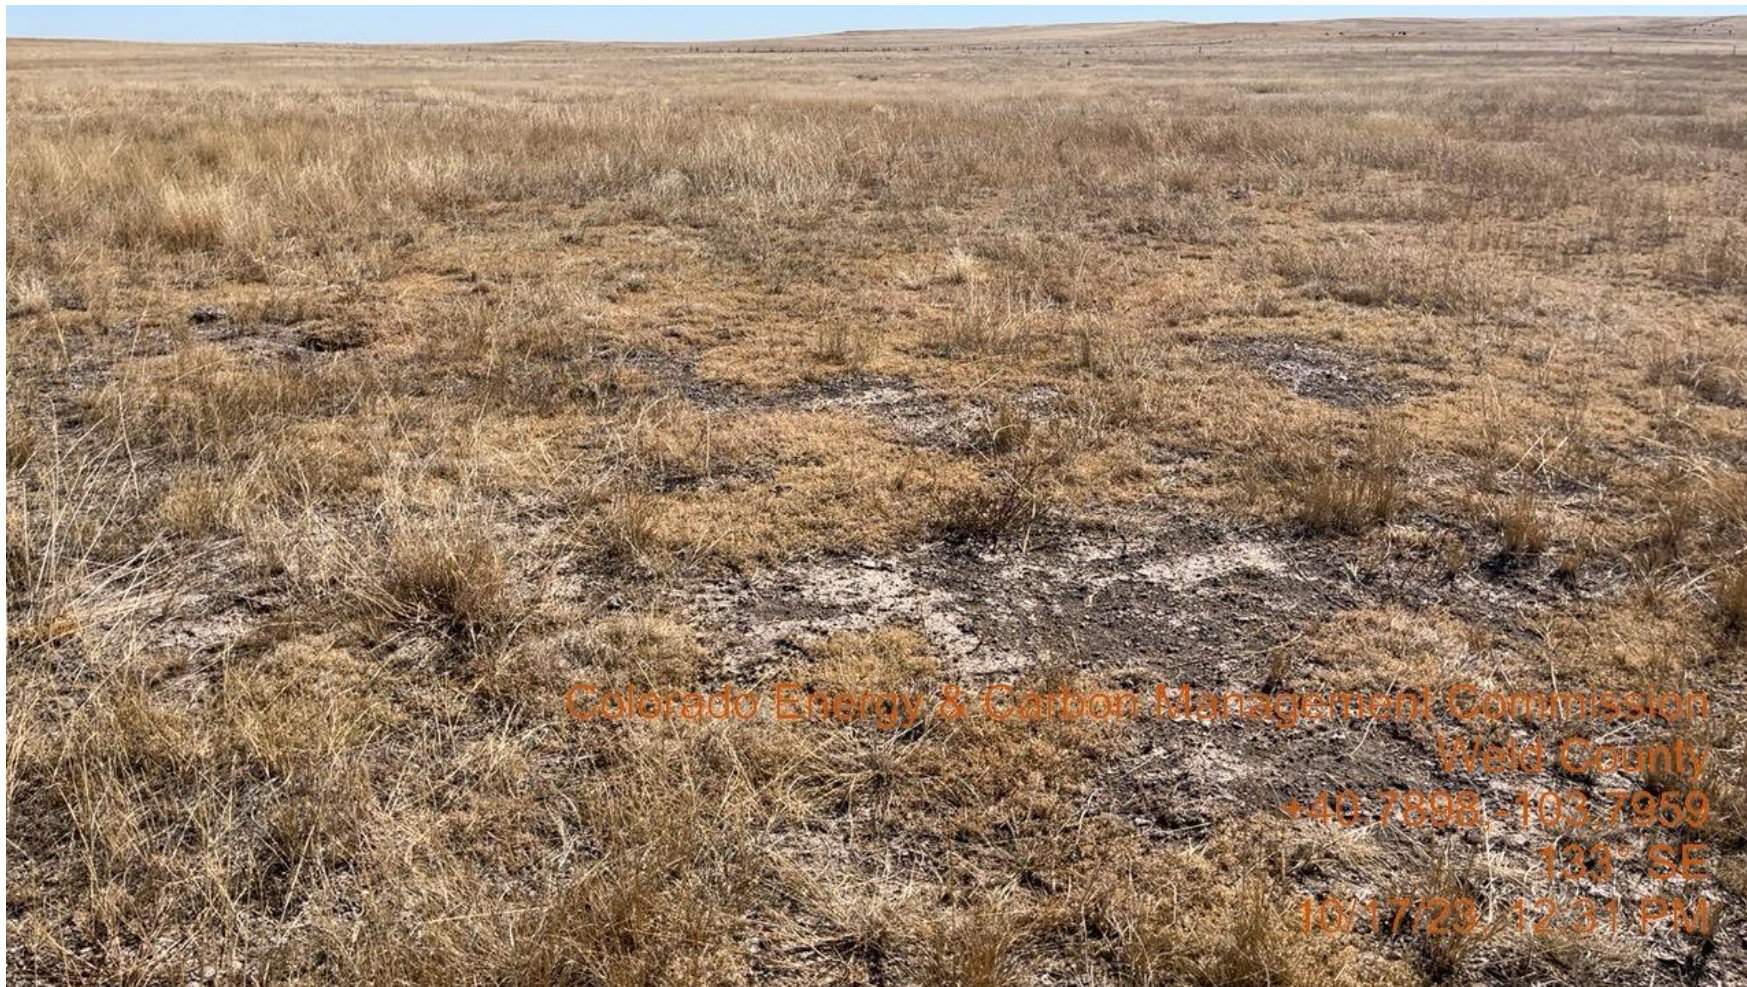
**Photo 3.** The photo was taken at the center of the Maddy pad facing Southeast. The photo illustrates bare soil across the location.

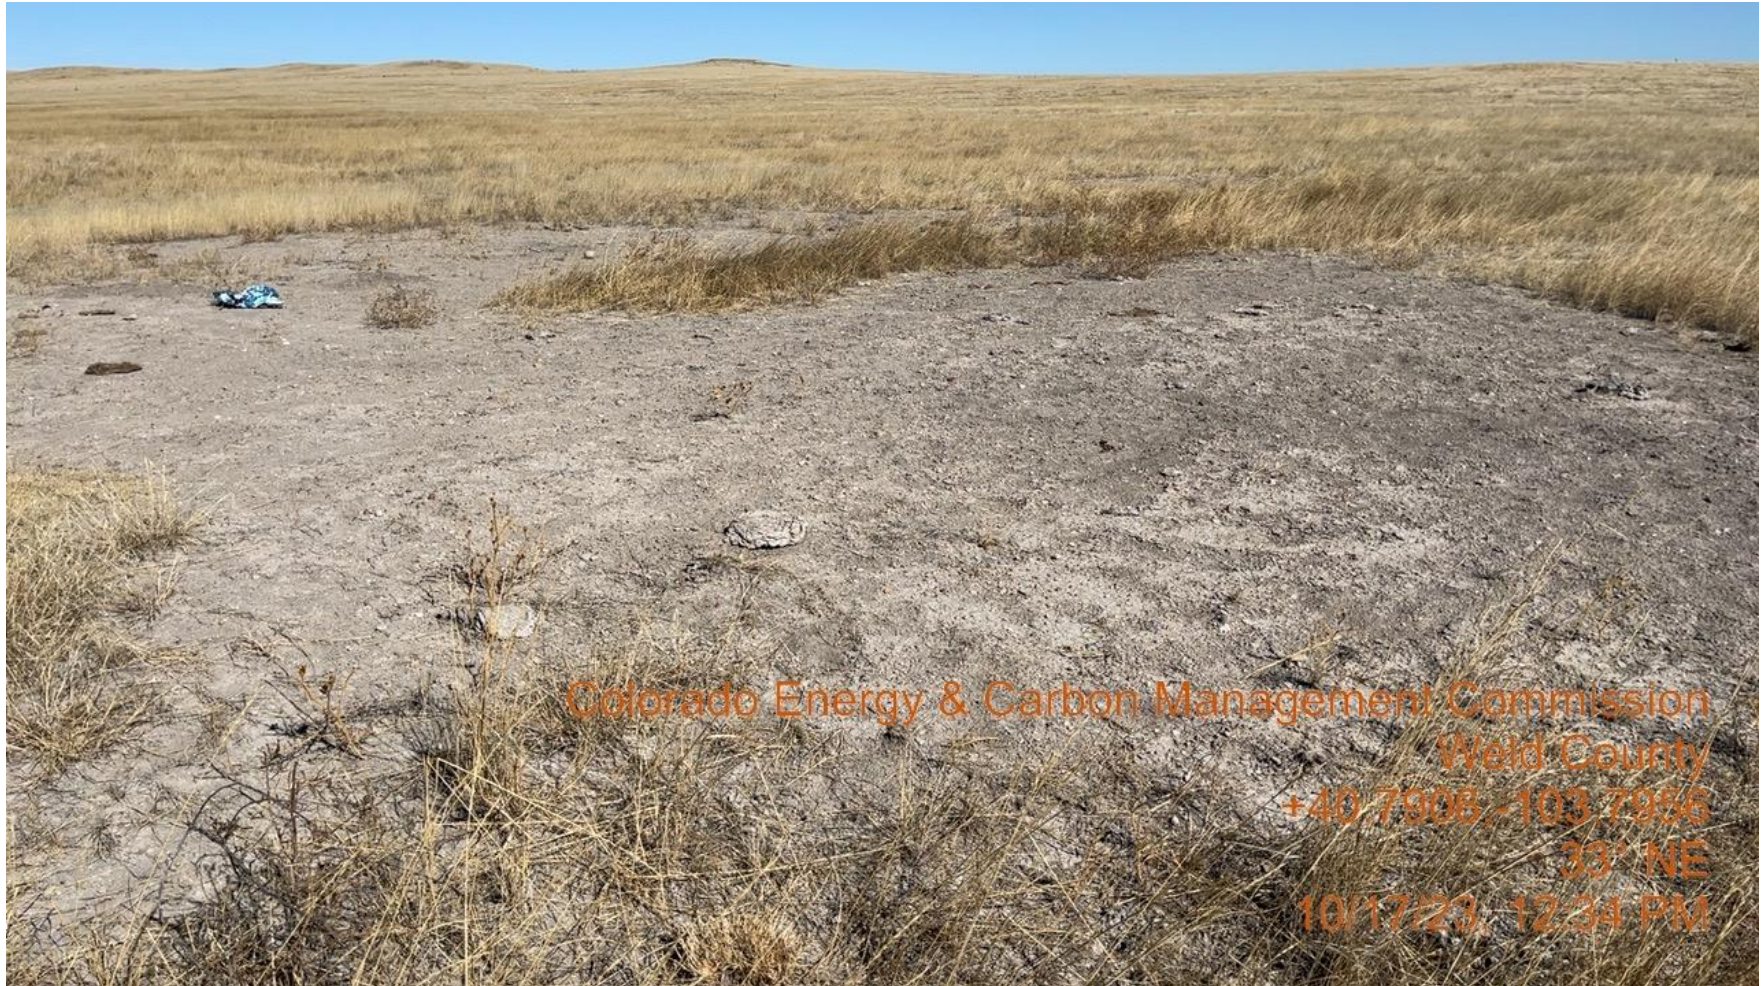
**Photo 4.** The photo was taken just North of the well location facing Northeast. The photo again illustrates large areas of bare soil in the Northern part of the Maddy pad.

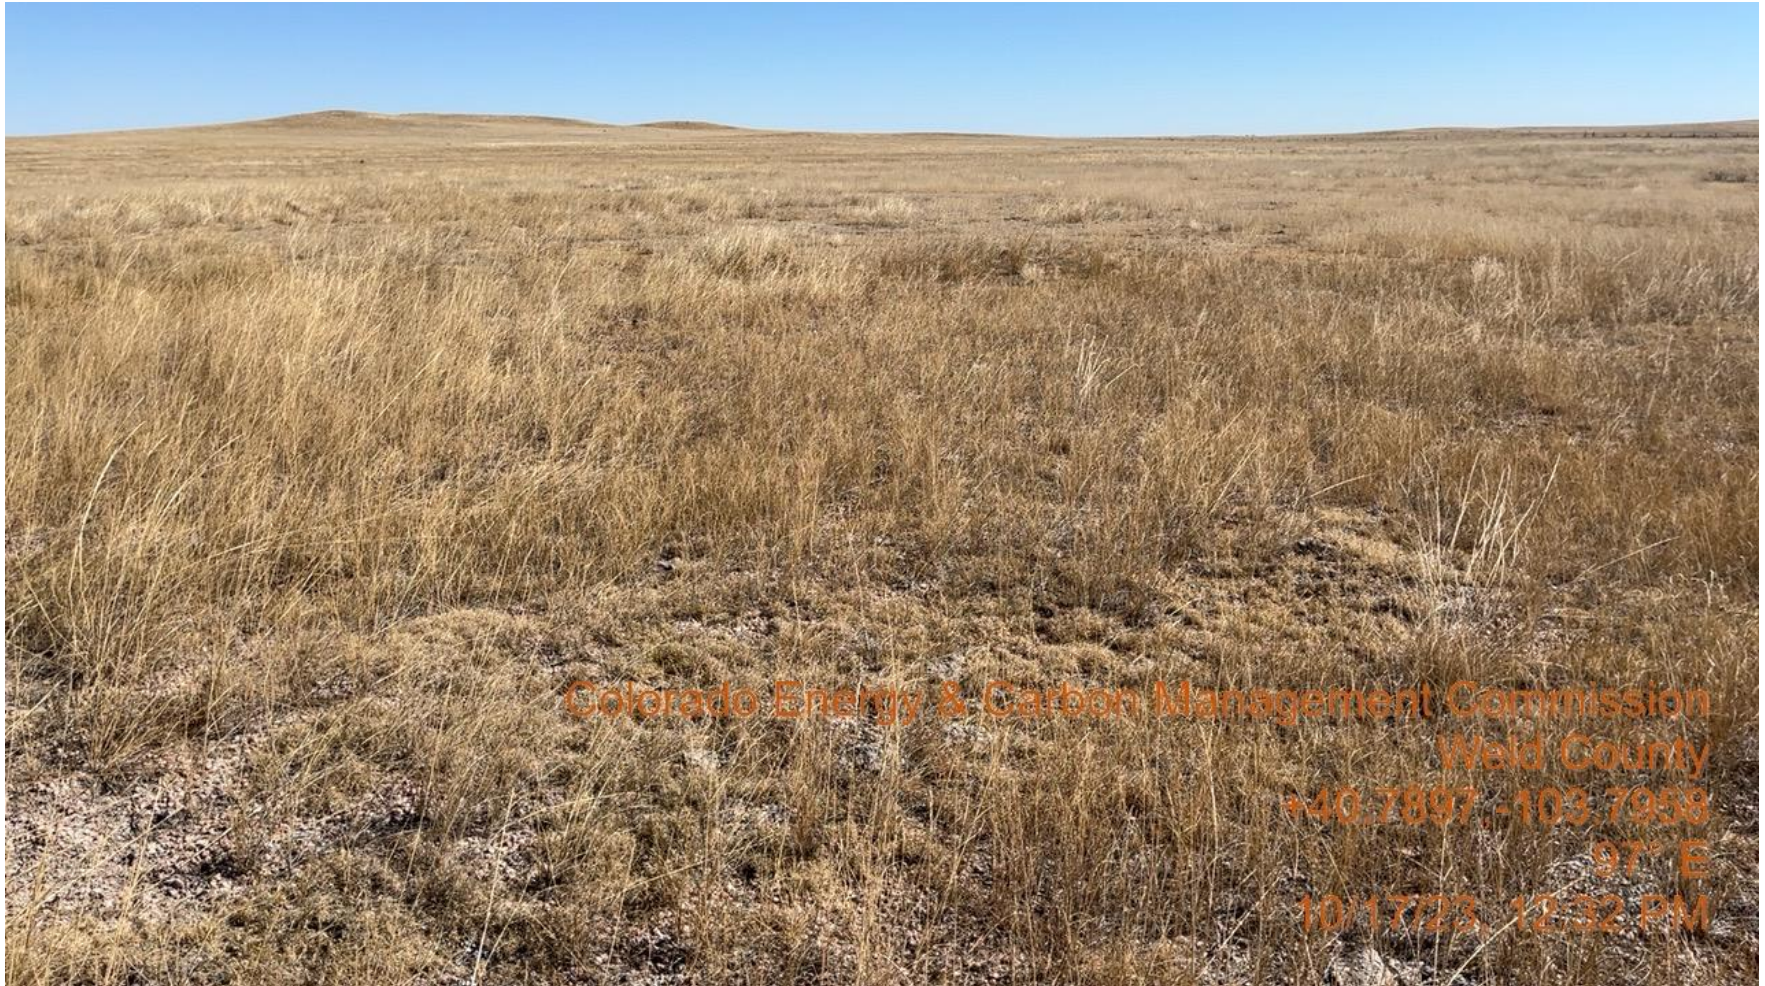
**Photo 5.** The reference photo was taken in the center of the Maddy pad facing East.
