Interim Reclamation and Stormwater Inspection

Date: 10/26/2023

Operator: FUNDARE RESOURCES OPERATING
COMPANY LLC - 10773

Inspection Photos
Location Name: Horsetail 29G Pad
Location ID: 435861

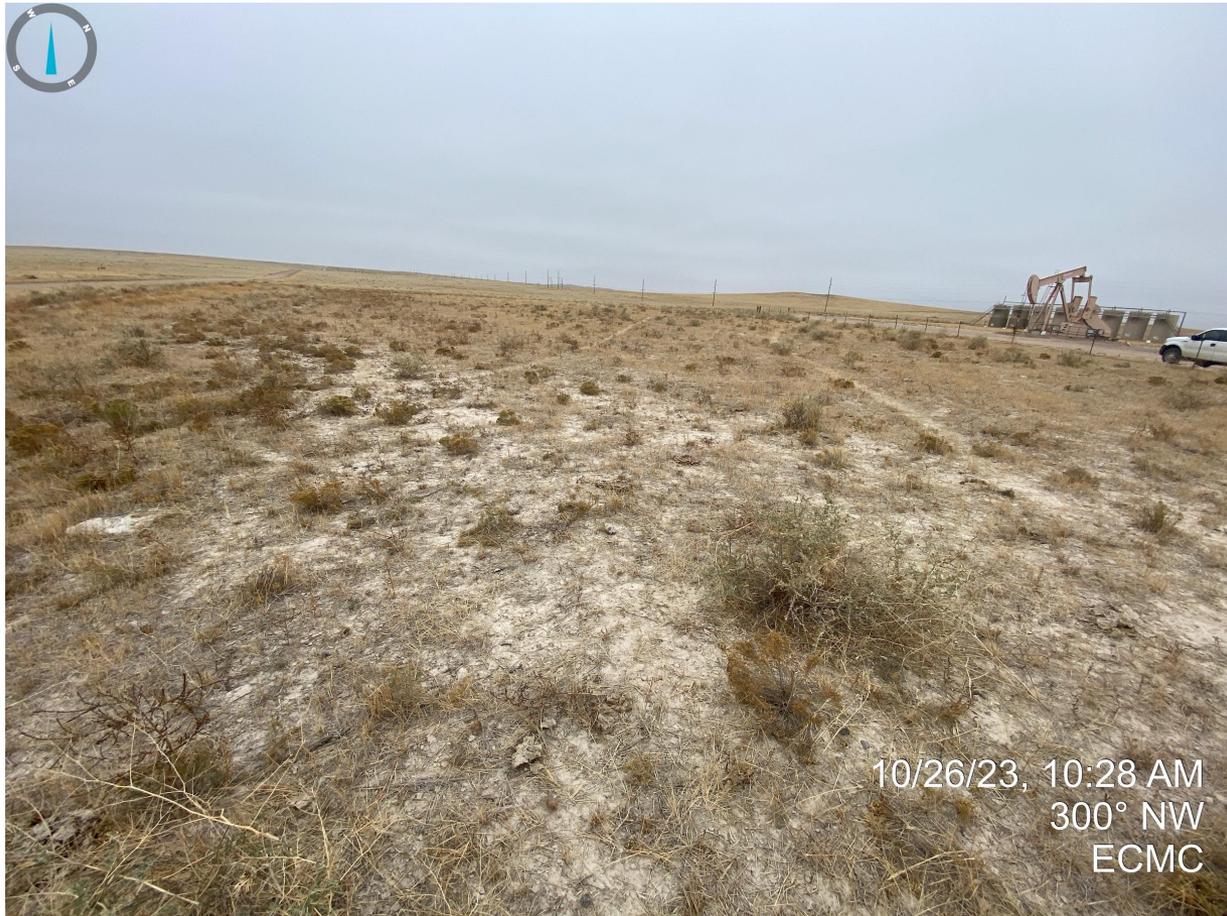
Photo 1. Taken from the southern portion of the location, near the entrance. Photo illustrates non-uniform vegetative cover resulting in areas of bare/exposed soils.

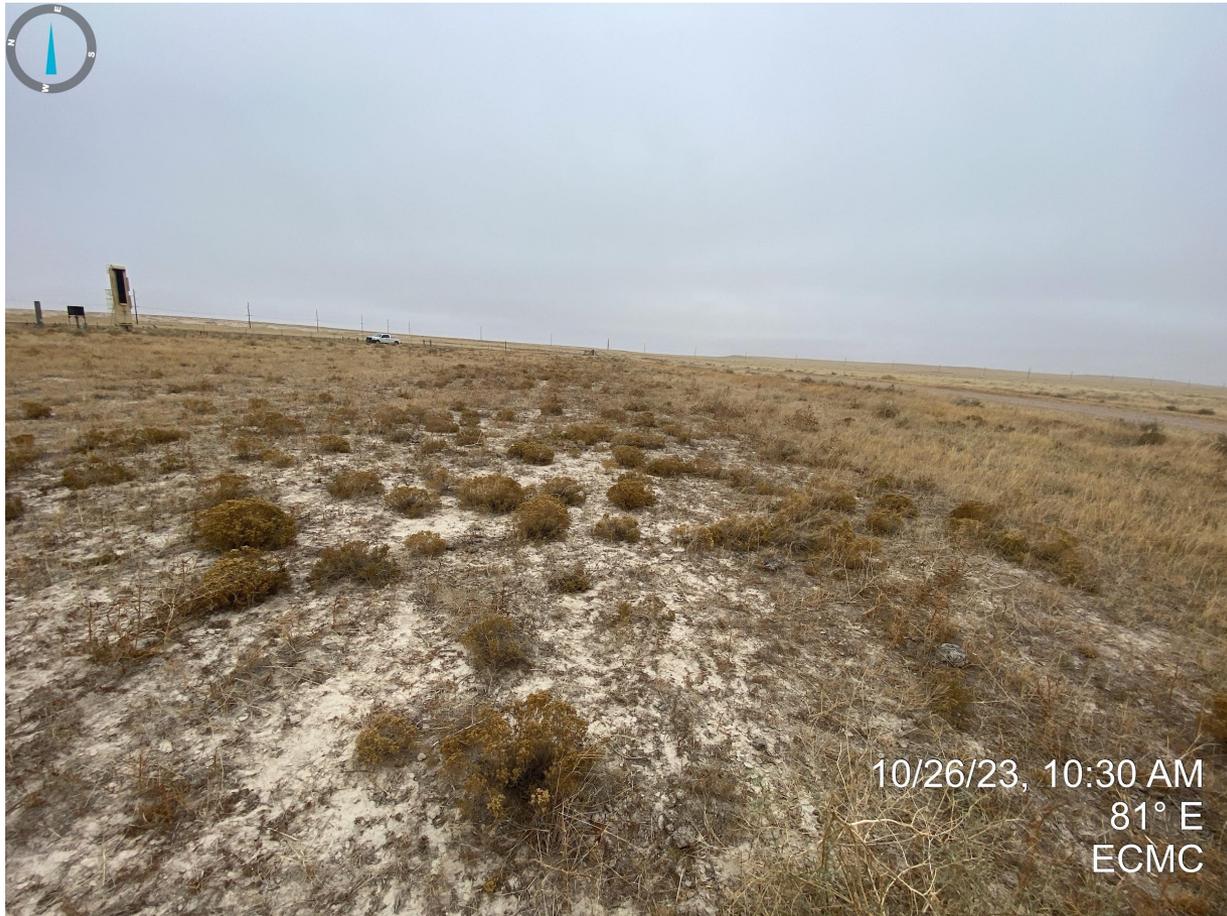
Photo 2. Taken near the southwest corner of the location. See comments in Photo 1.

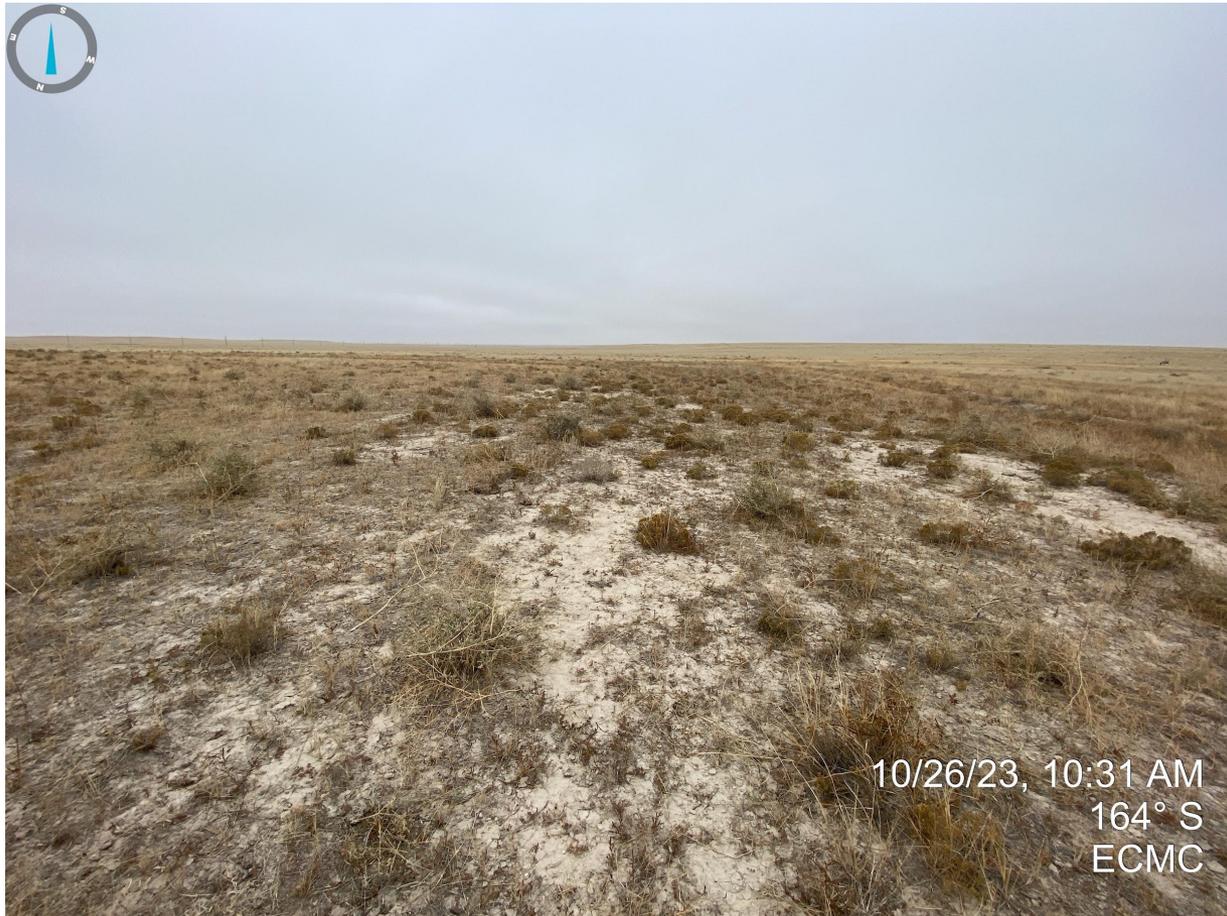
Photo 3. Taken from the western portion of the location. See comments in Photo 1.

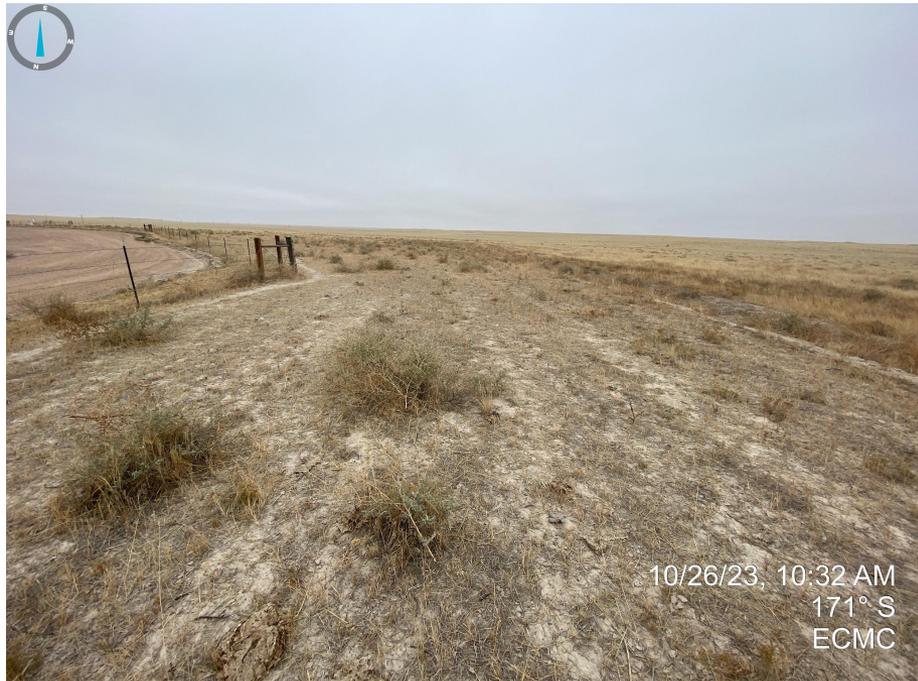
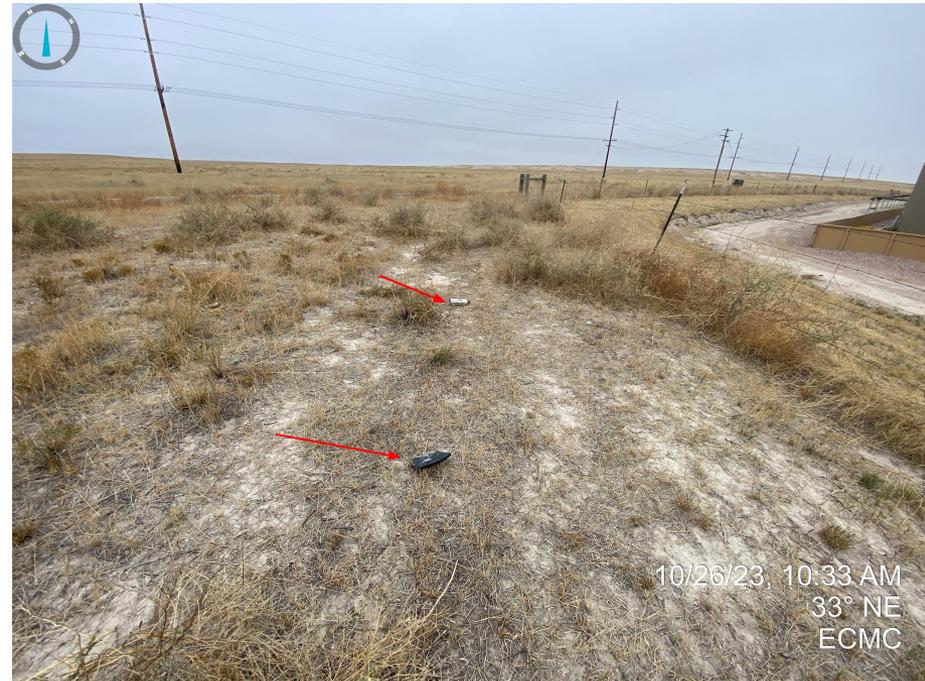
Photos 4 & 5. Taken near the northwest corner of the location. Photo illustrates non-uniform vegetative cover and the presence of trash on location (red arrow).

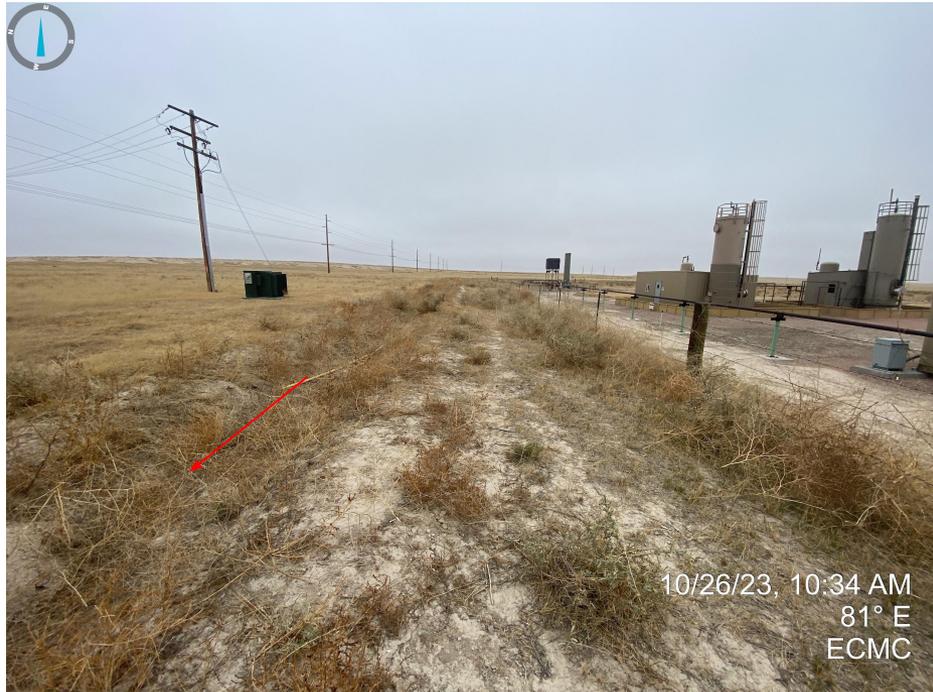
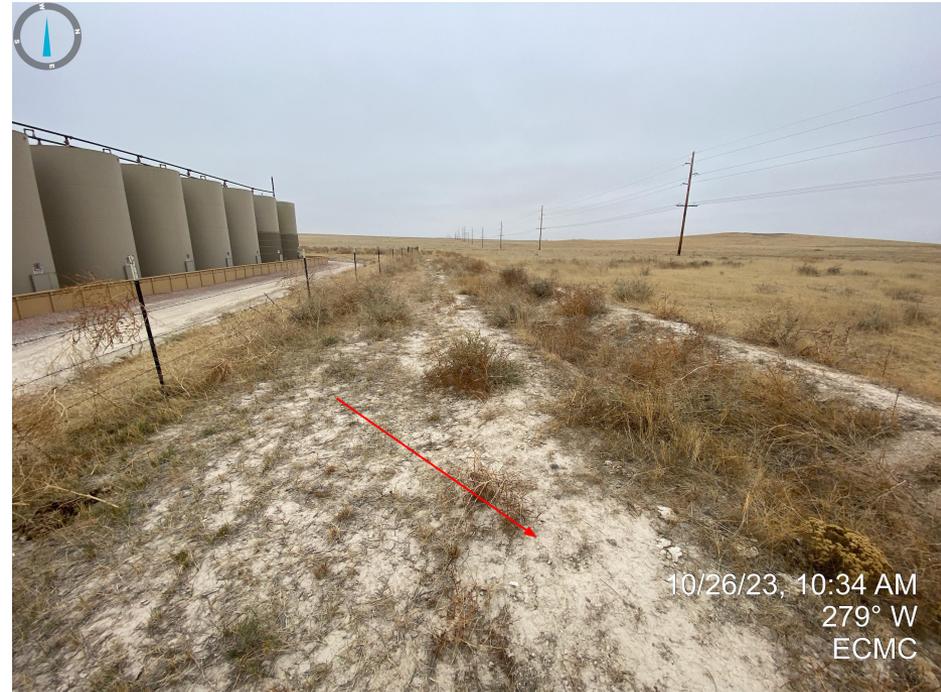
Photos 6 & 7. Taken from the northern portion of the location. Photo illustrates non-uniform vegetative cover resulting in bare/exposed soils, and the presence of undesirable vegetation (e.g. russian thistle).

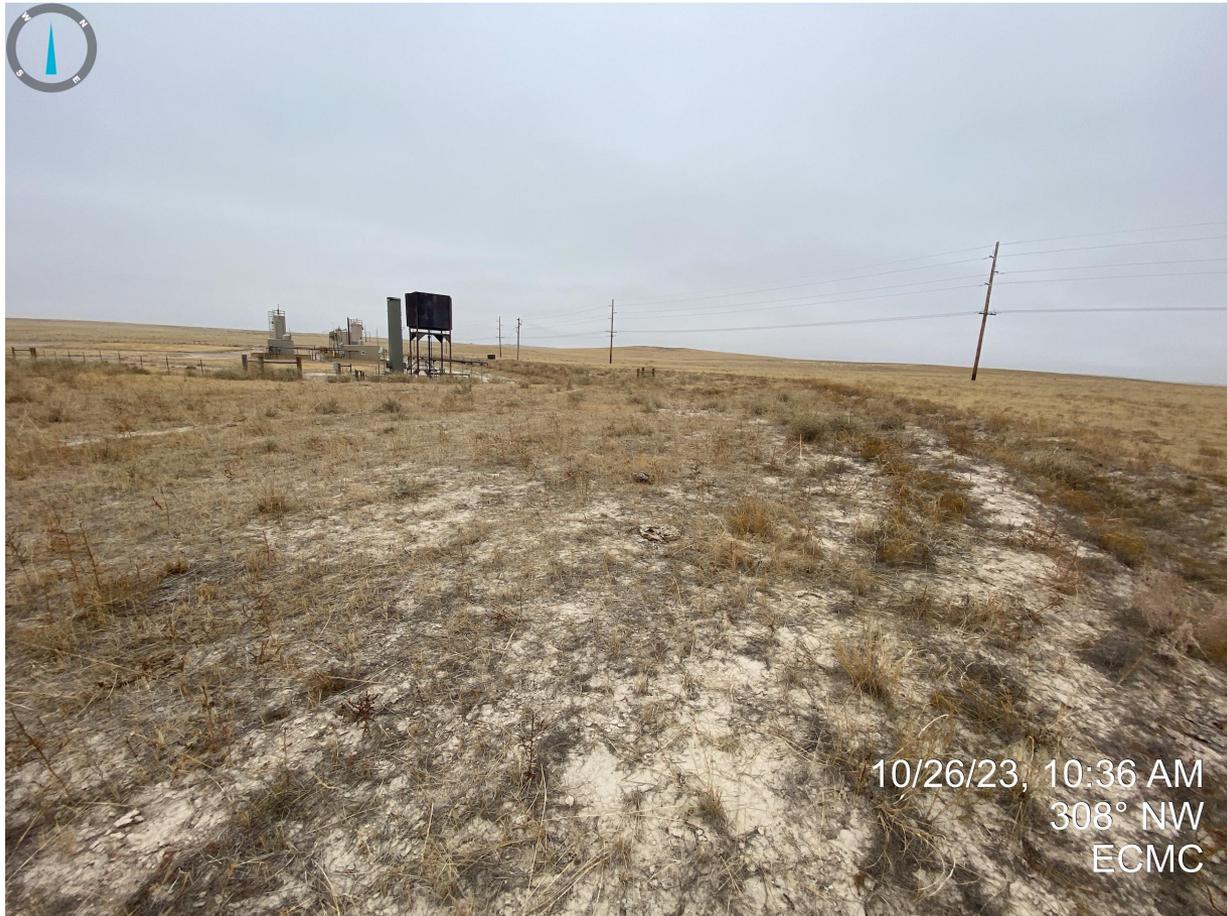
Photo 8. Taken near the northeast corner. Photo illustrates non-uniform vegetative cover resulting in bare/exposed soils, and the presence of undesirable vegetation (e.g. russian thistle).

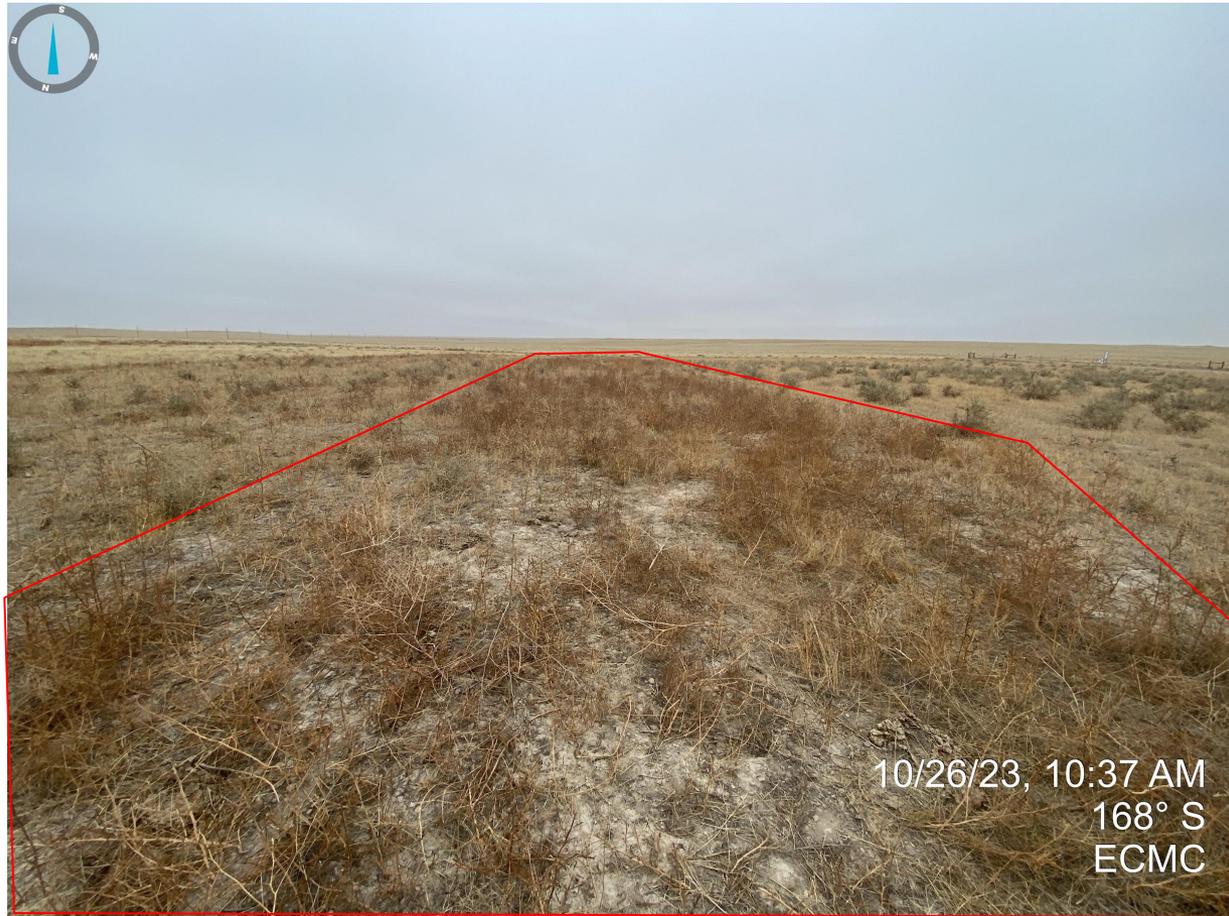
Photo 9. Taken from the eastern portion of the location. Photo illustrates undesirable vegetation (e.g. russian thistle) throughout the topsoil stockpile area.

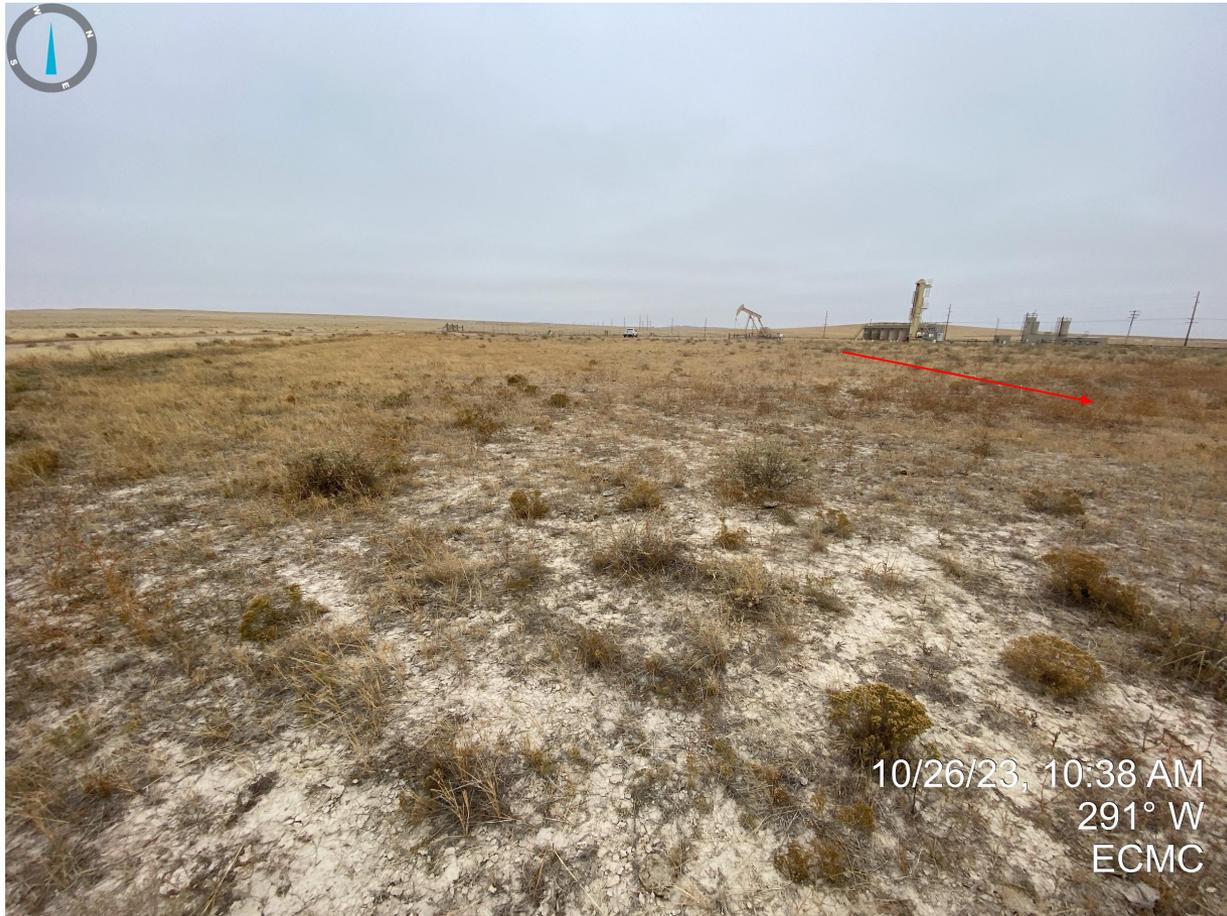
Photo 10. Taken near the southeast corner of the location. Photo illustrates non-uniform vegetative cover resulting in bare/exposed soils, and the presence of undesirable vegetation (e.g. russian thistle indicated by red arrow).
