# Inspection Photos

Loc: 321139

Operator: **LORENTZ OIL & GAS LLC**

Inspection Date: 10/31/2023

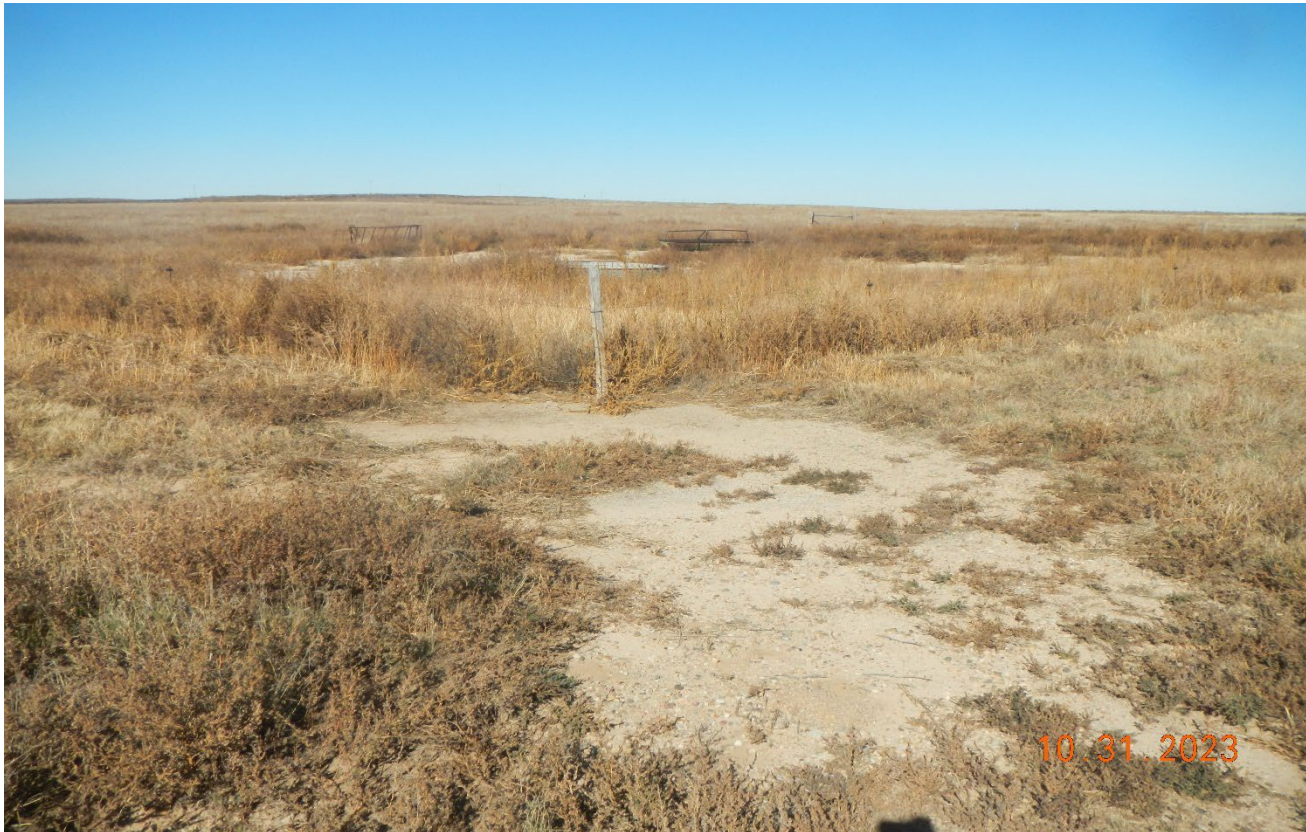
**Photo 1.** Facing northwest at the abandoned wellsite. This are bare of vegetation is where the well was located. There are likely impacted soils preventing vegetation growth.

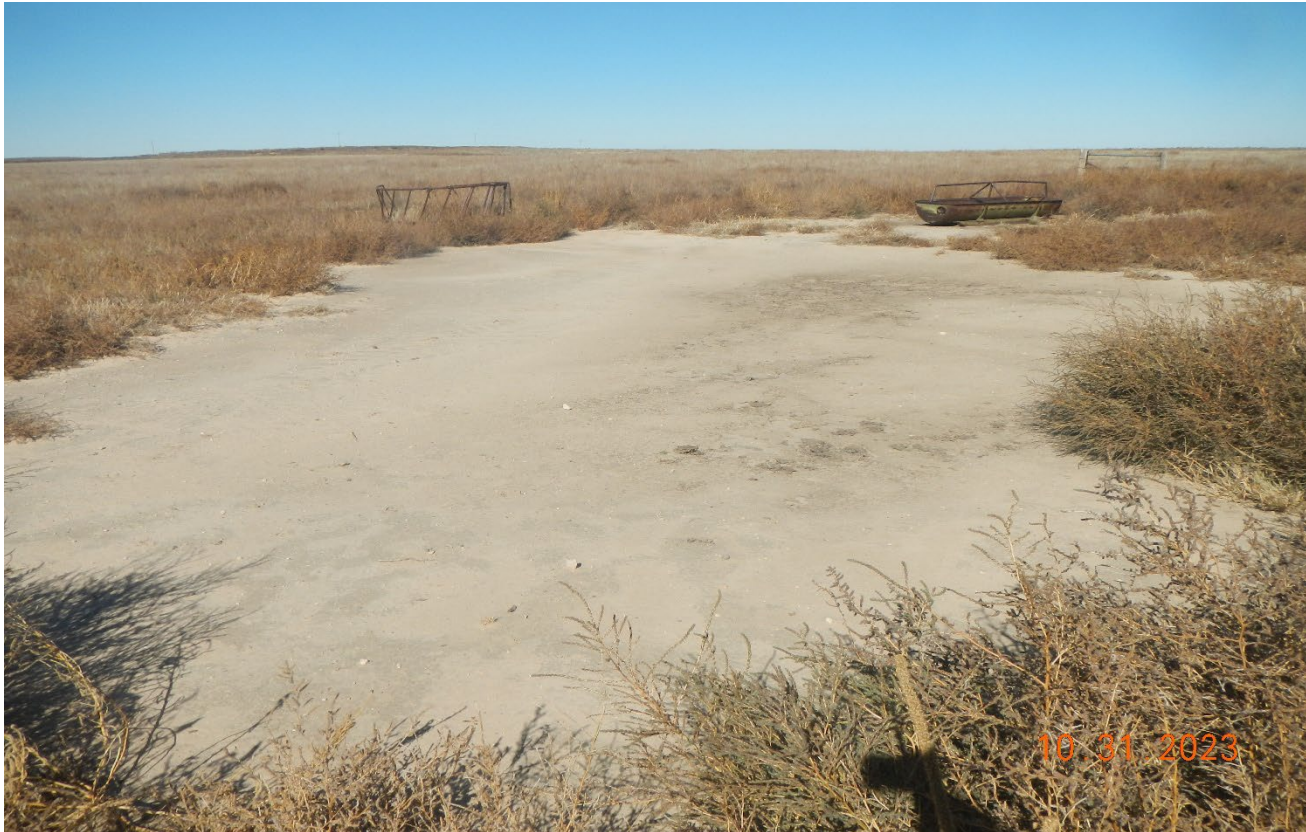
**Photo 2.** South side of the location facing northwest. This area with no vegetation is approximately 120'x80'. There are likely impacted soils preventing vegetation growth

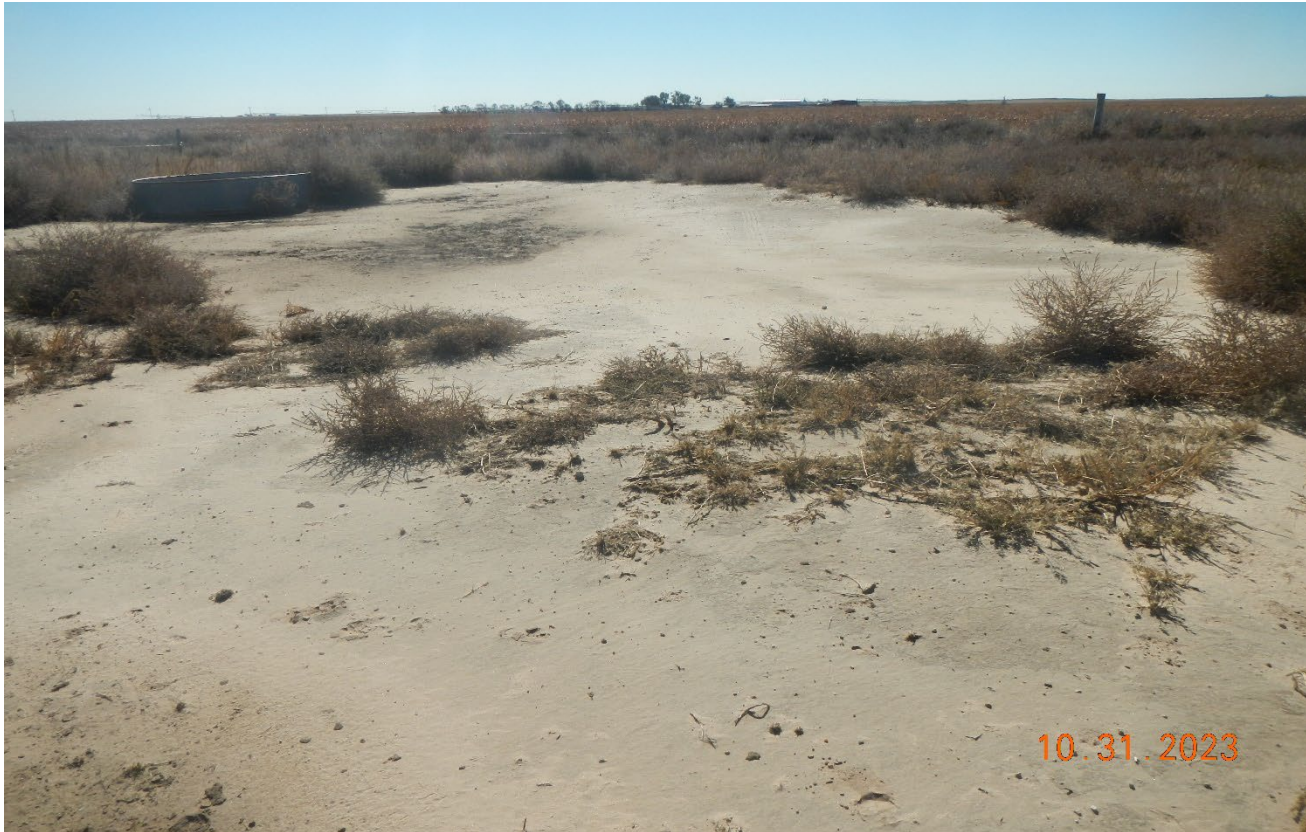
**Photo 3.** North side of the location facing southeast. This area with no vegetation is approximately 120'x80'. There are likely impacted soils preventing vegetation growth

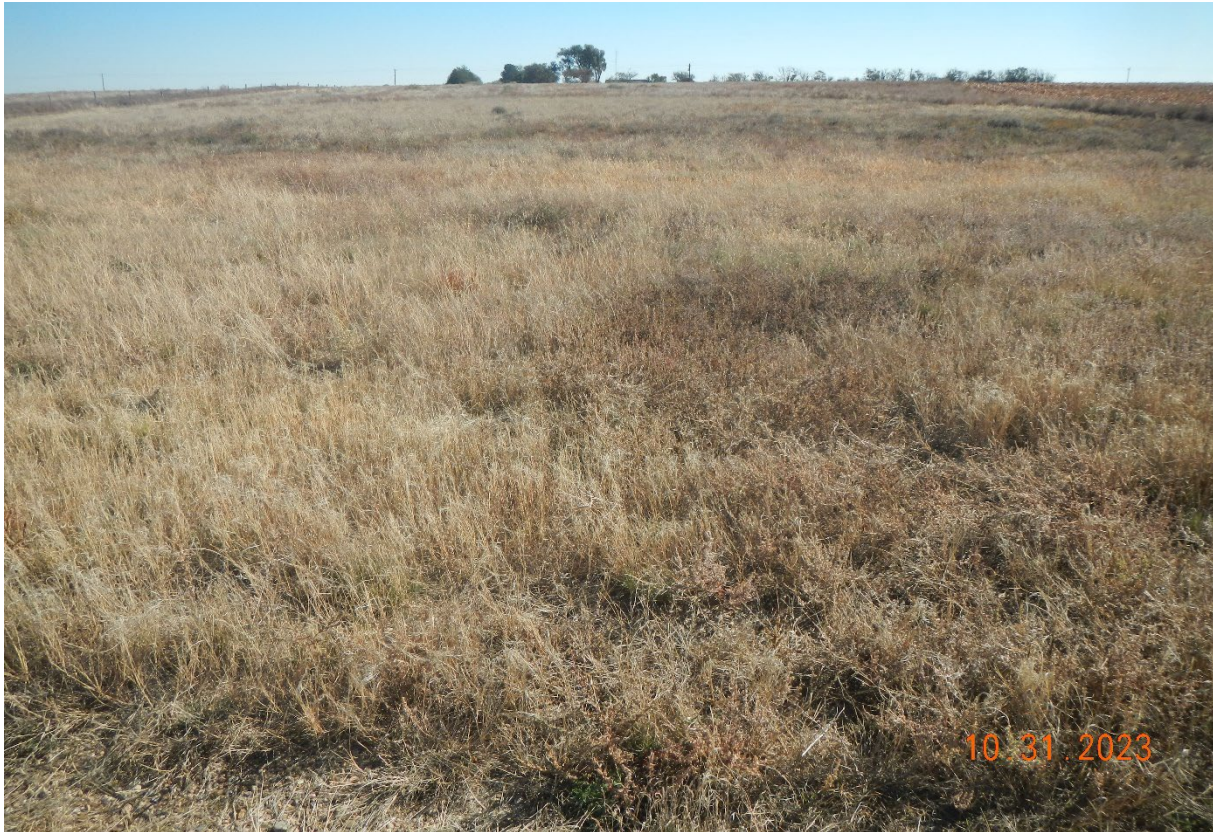
**Photo 4.** Facing east toward the surrounding reference area which consists of native Blue grama, Sand drpseed, ect.
