Interim & Stormwater Inspection

September 20, 2023

Operator: Renegade Oil & Gas # 74165

Location ID: 320644

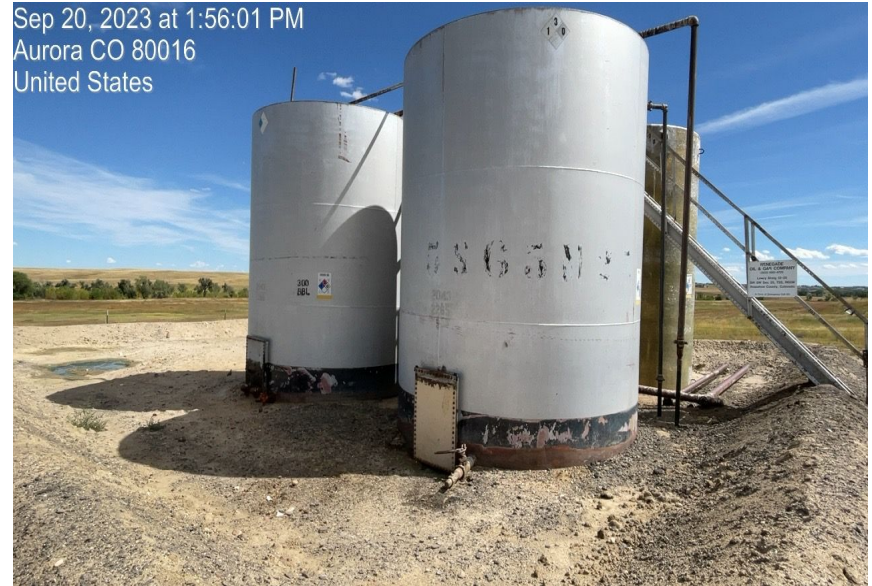
Photo 2. Photo of Tank battery. Photo taken facing east.

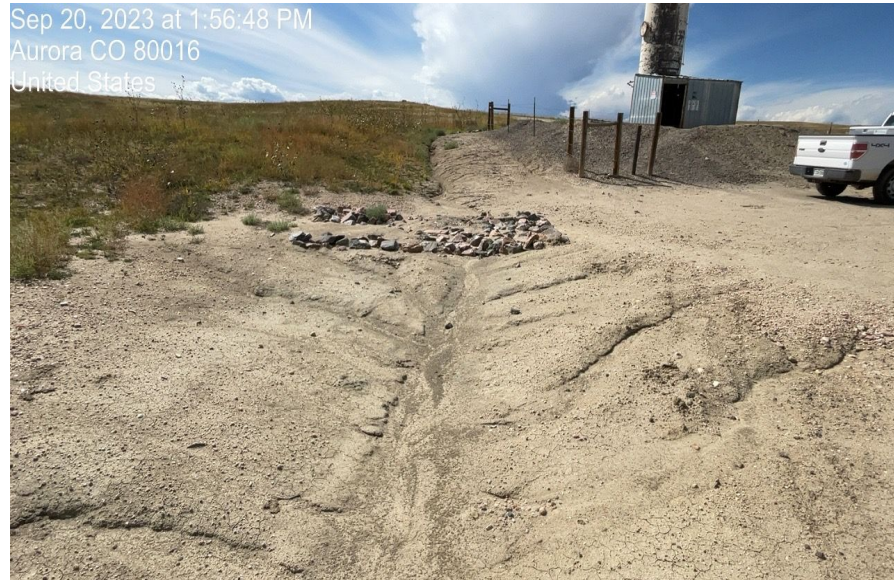
Photo 3. Photo of erosion from stormwater along tank battery south side. Photo taken facing west.

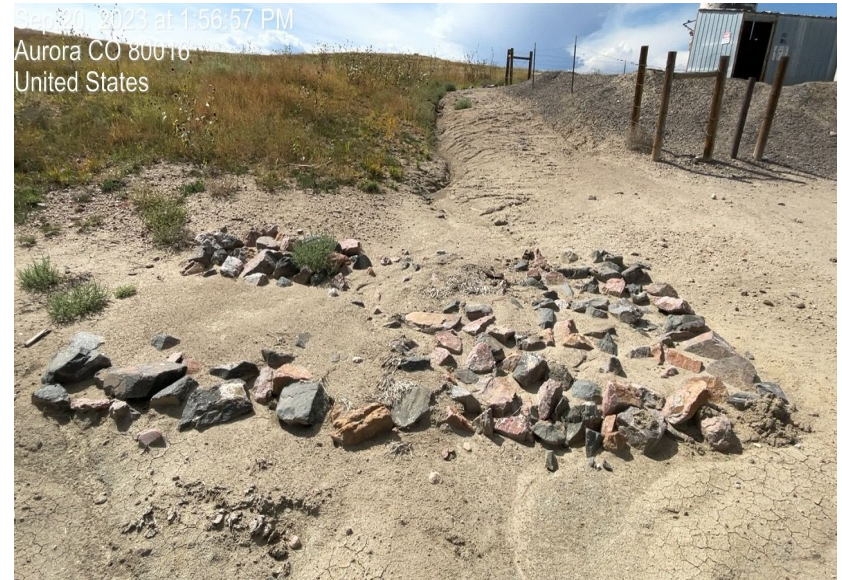
Photo 4. Photo of check dam filled with sediment from stormwater erosion along tank battery south side. Photo taken facing west.

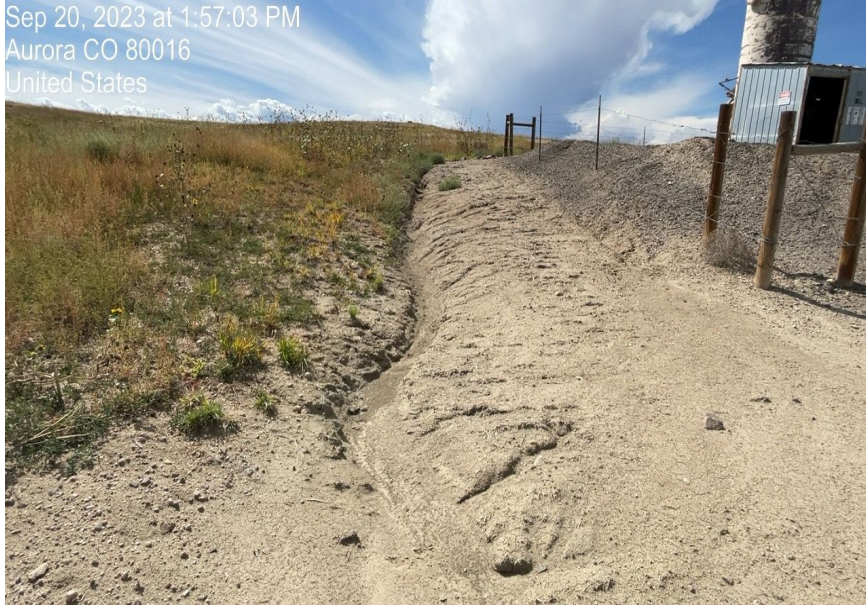
Photo 5. Photo of erosion from stormwater along tank battery south side, and weeds (kochia & russian thistle) . Photo taken facing west.

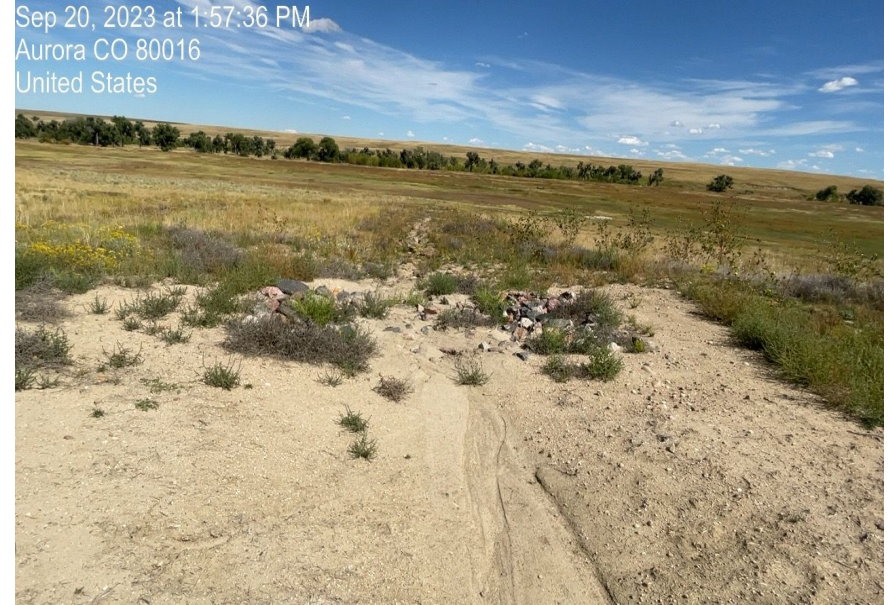
Photo 6. Photo of check dam filled with sediment from stormwater erosion along tank battery south side. Sediment observed leaving location. Photo taken facing east.

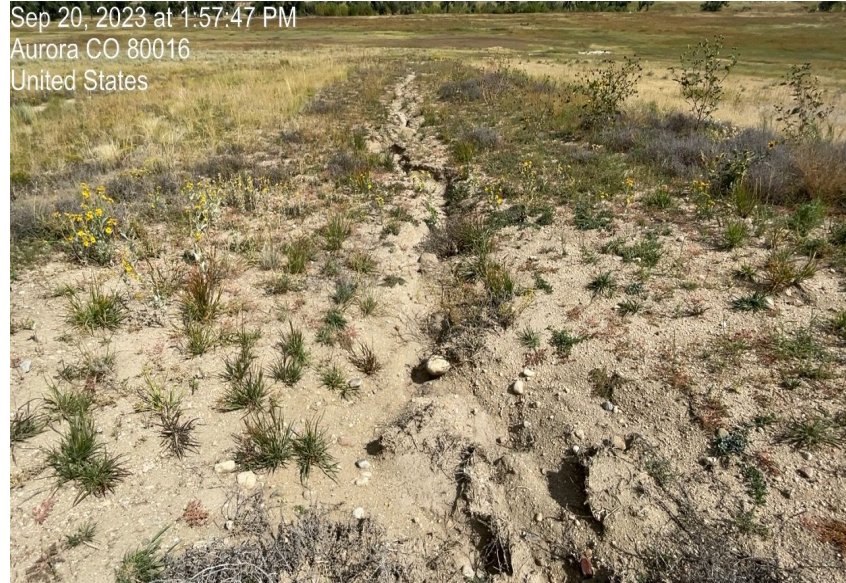
Photo 7. Photo of erosion from stormwater tank battery location onto adjacent lands. Photo taken facing east.

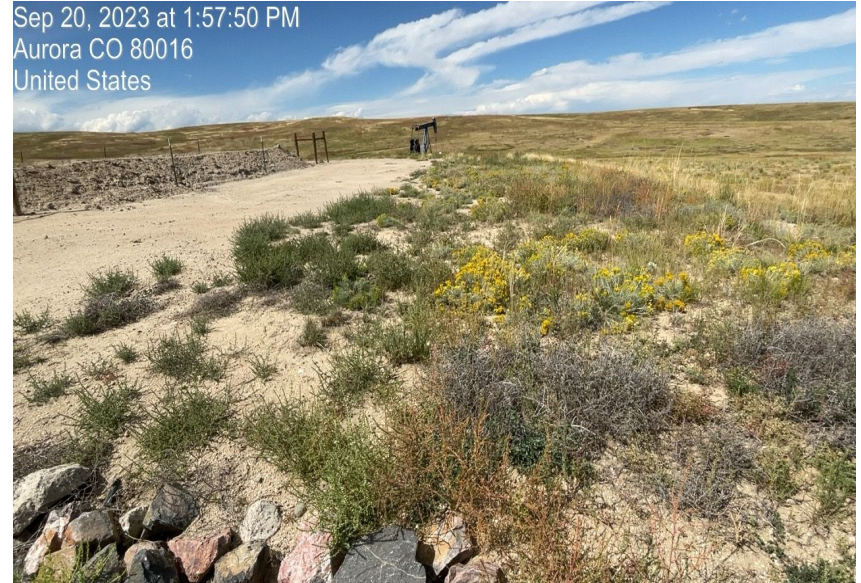
Photo 8. Photo of weeds (kochia & russian thistle) along edge of working pad and into interim reclaimed area. Photo taken facing northwest.

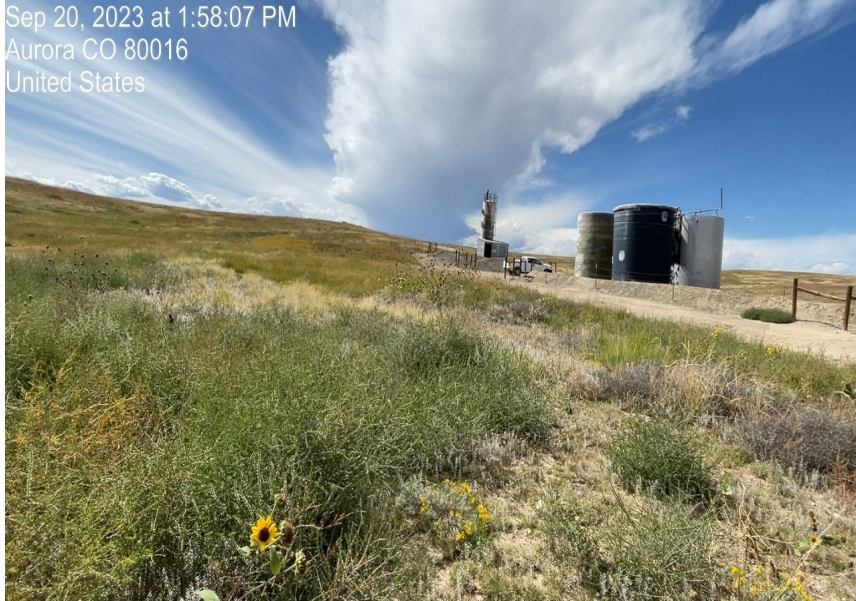
Photo 9. Photo of weeds (kochia & russian thistle) along the north side of pad in interim reclaimed area. Photo taken facing southeast.

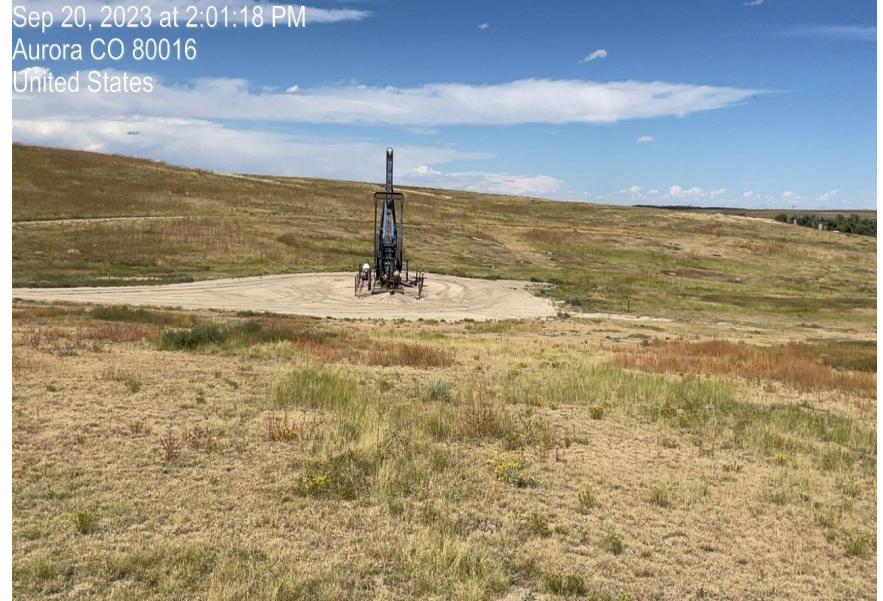
Photo 10. Photo of State 35-13 wellhead and weeds (kochia & russian thistle) in interim reclaimed area. Photo taken facing northeast.

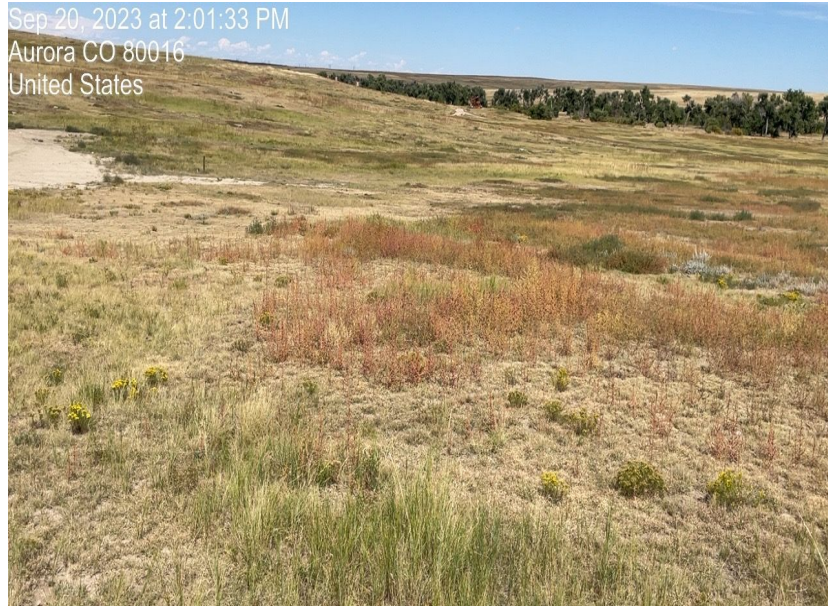
Photo 11. Photo taken of weeds (kochia & russian thistle) in interim reclaimed area from previous photo. Photo taken facing northeast.

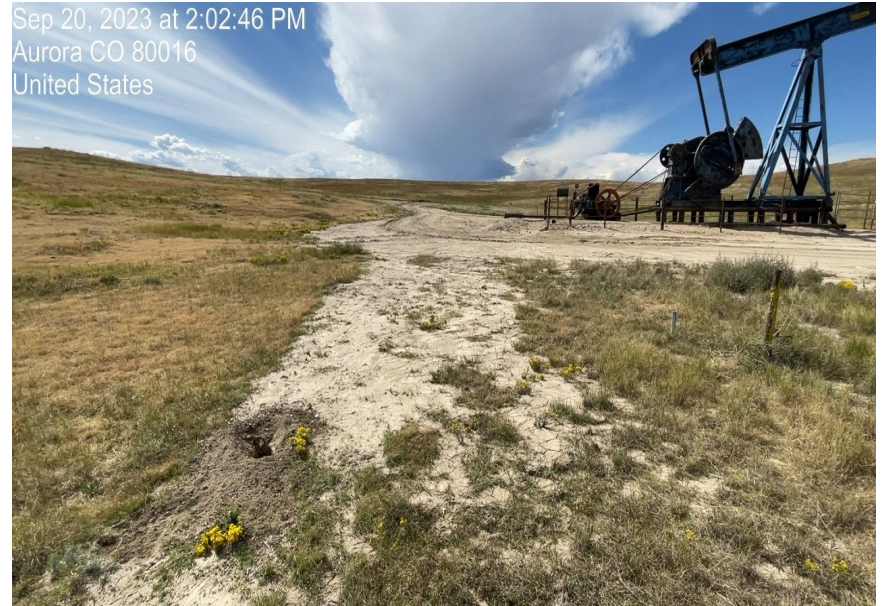
Photo 12. Photo of erosion from stormwater leaving well pad onto adjacent lands. Photo taken facing west.

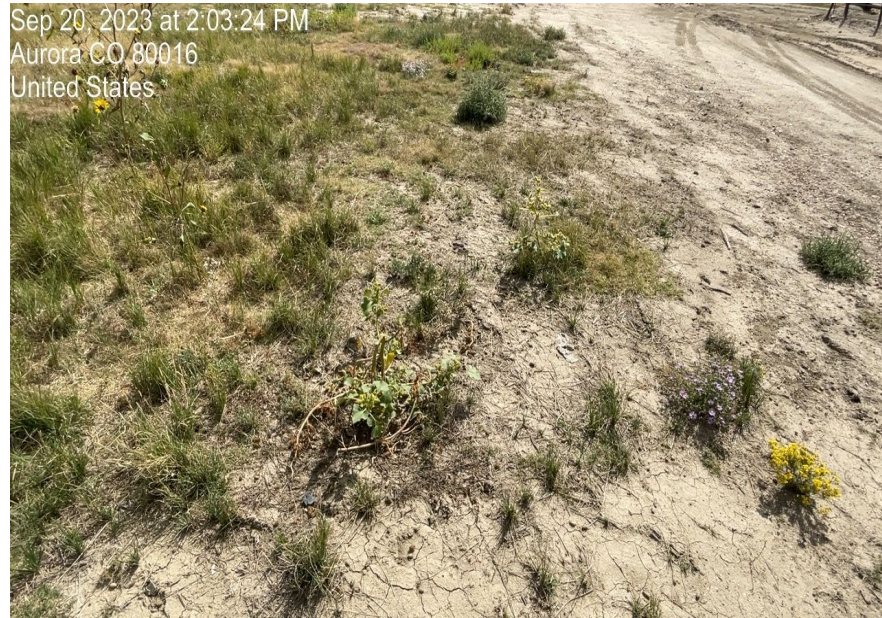
Photo 13. Photo taken of weeds (cocklebur, kochia & russian thistle) in interim reclaimed area near wellhead working pad. Photo taken facing southeast.

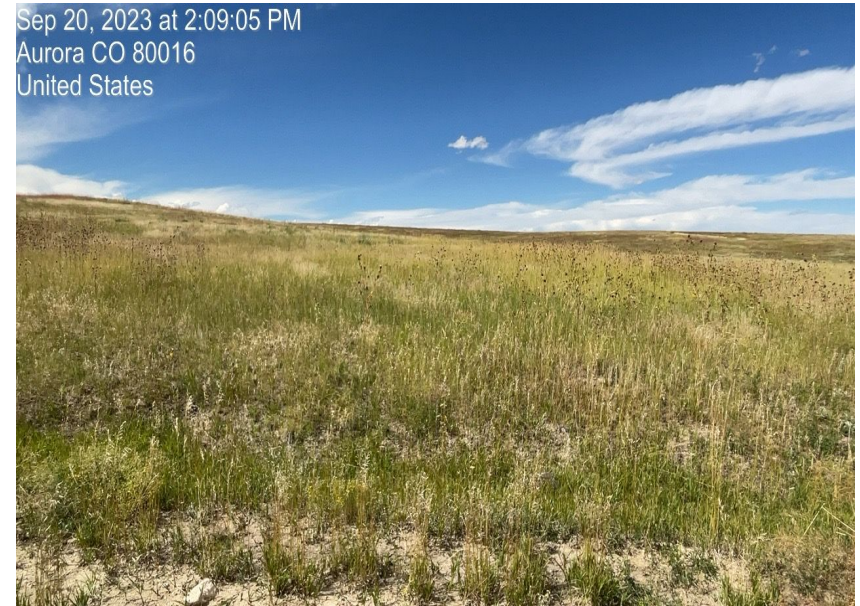
Photo 14. Photo taken of undisturbed area for reference and vegetation comparison. Photo taken facing northeast.
