Operator: CIVITAS NORTH LLC
Location Name: BASHOR-69N60W 18SWNW
Loc ID: 323023
Inspection: 708200677

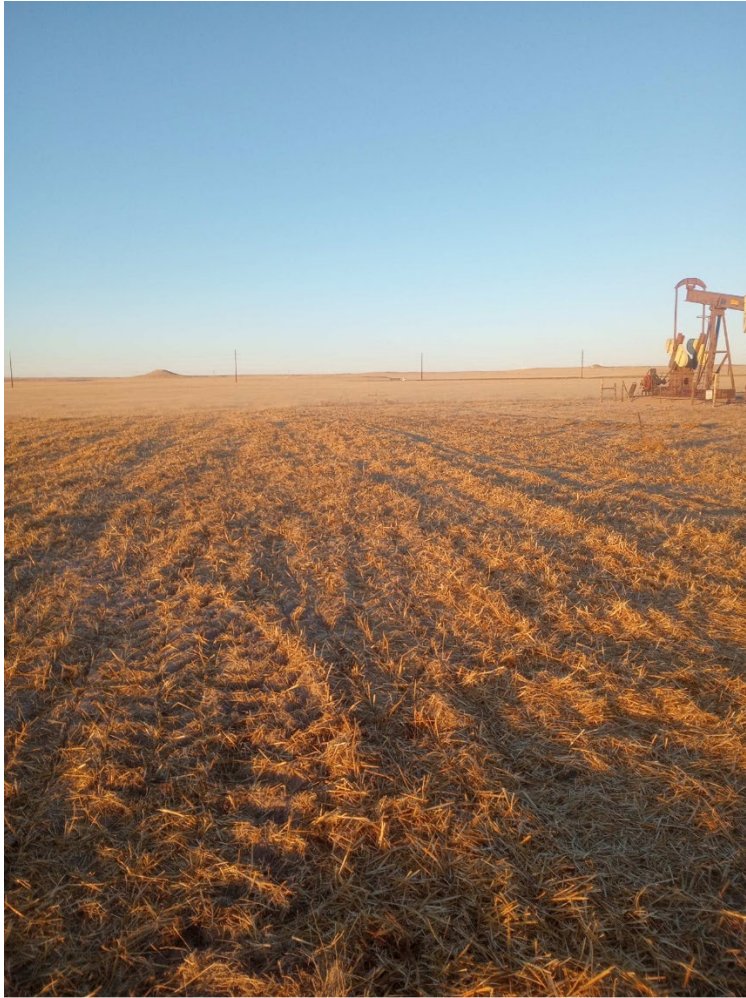
Exhibit A

CA: This location does not comply with Rule 1003. During this inspection, it was observed that areas within the interim reclaimed portions are not progressing towards reclamation standards with evidence of undesirable vegetation (e.g. kochia and Russian thistle) and areas of non-uniform vegetation cover resulting in bare/exposed soils. Additional reclamation activities are required. Operator submitted this location on Form 6A (doc no 403361744) Out of Service Designation and Plugging List, however, this location stills need to comply with ECMC Rules and Regulations prior to plugging and abandonment. Comply with Rule 1003. The location will remain out of compliance until corrective action has been resolved.

CA Resolution: Operator reported that the Field has appropriately complied with Rule 1003 by addressing/clearing all tumble weeds, mowing the location, prepping location and drilling/re-seeding area, and installing straw mulch. Field has also cleaned up trash and weeds that were identified around the equipment.
