# Interim Reclamation and Stormwater Inspection

Operator: WESTERN OPERATING COMPANY - 95620

Location ID: 312228

Inspection Photos  
Location Name: Propst C-1X  
Location ID: 312228

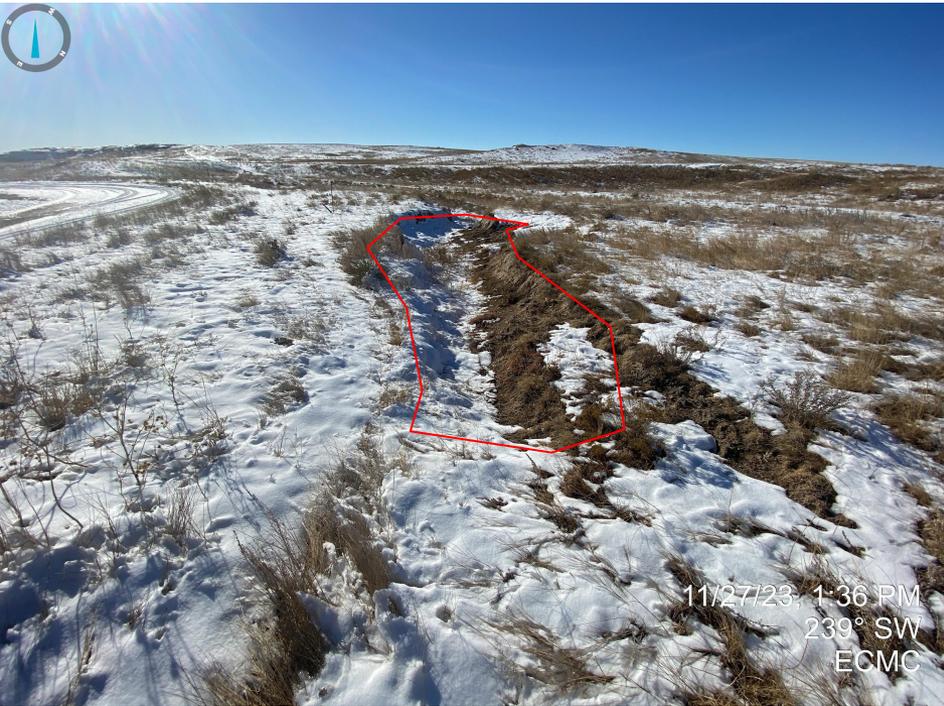
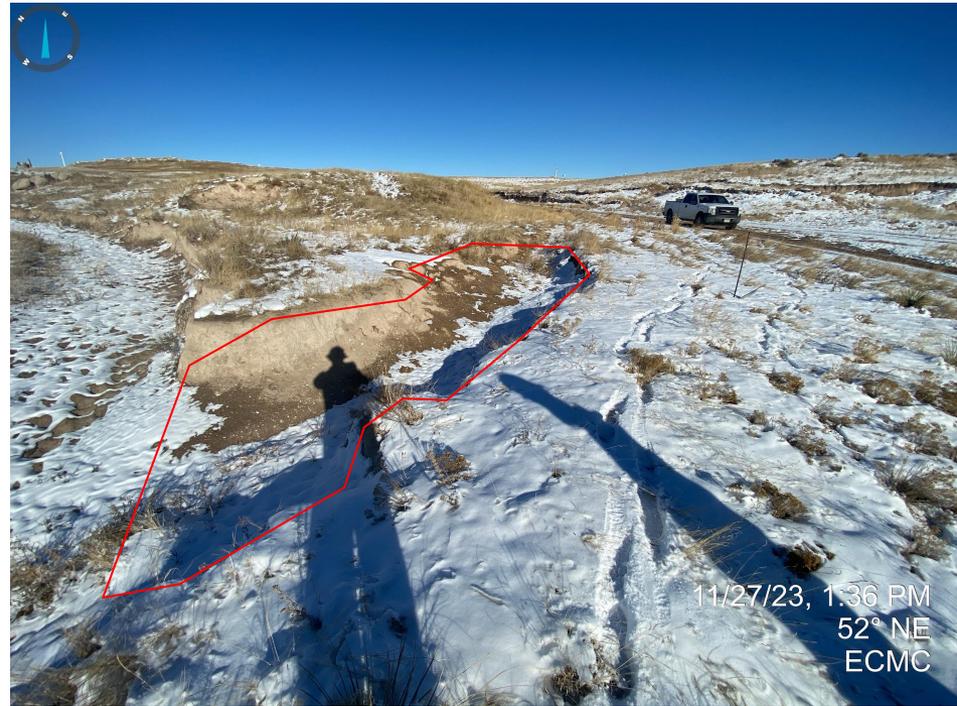
**Photos 1 & 2.** Erosion degradation (e.g. gullyng) evident on the western portion of the production areas. No apparent stormwater control measures/BMPs observed at the time of this inspection.

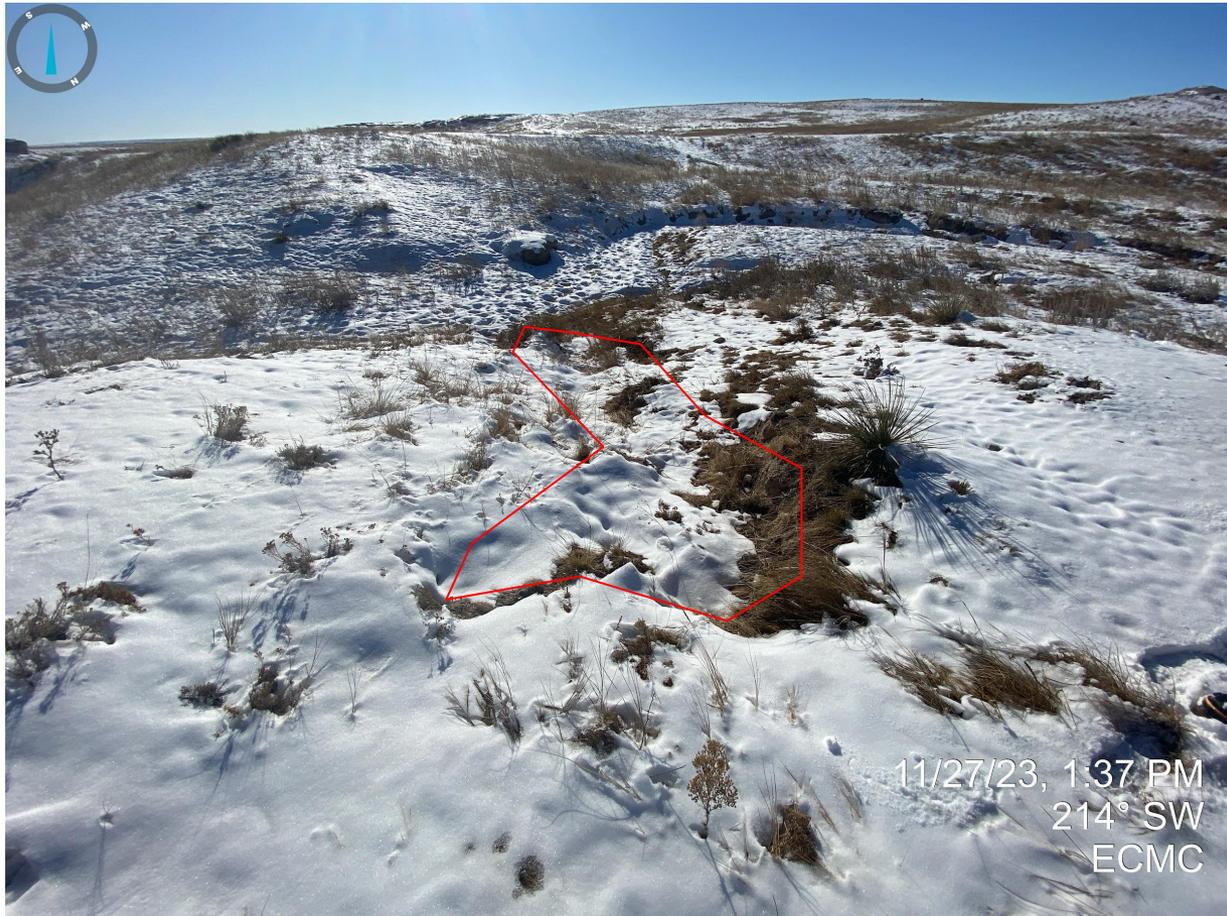
**Photo 3.** Erosion degradation (e.g. gully) evident on the southwestern portion of the production areas. No apparent stormwater control measures/BMPs observed at the time of this inspection.

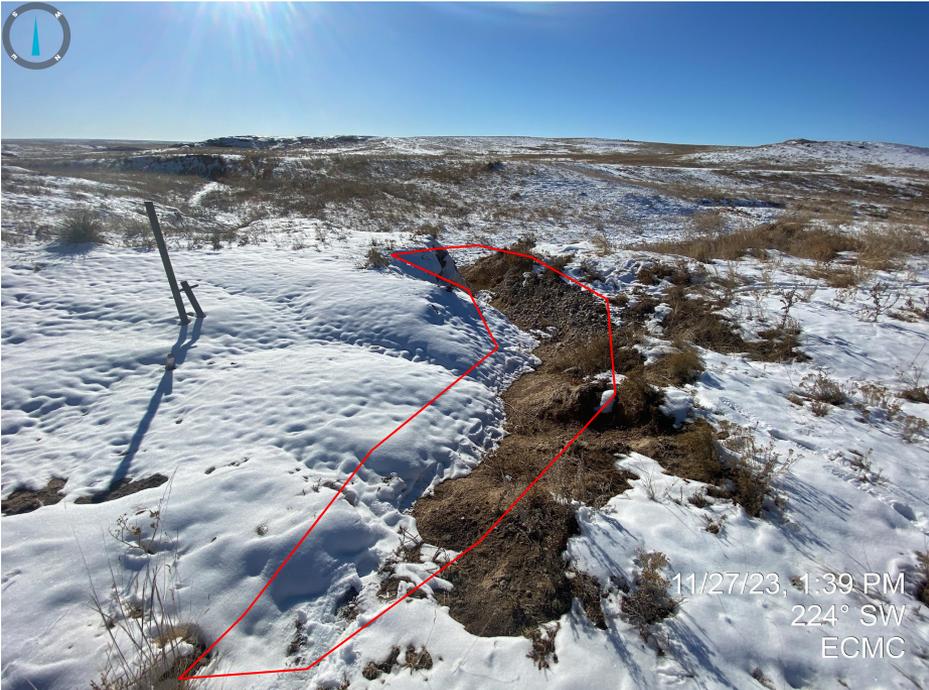
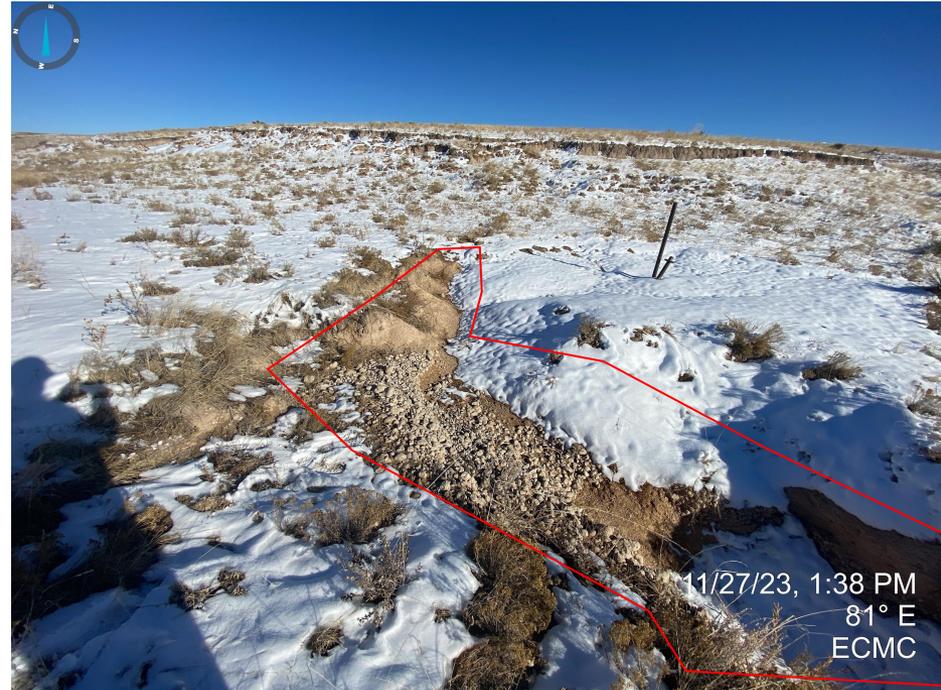
**Photos 4 & 5.** Erosion degradation (e.g. gullyng) evident on the southeastern portion of the production areas. No apparent stormwater control measures/BMPs observed at the time of this inspection.

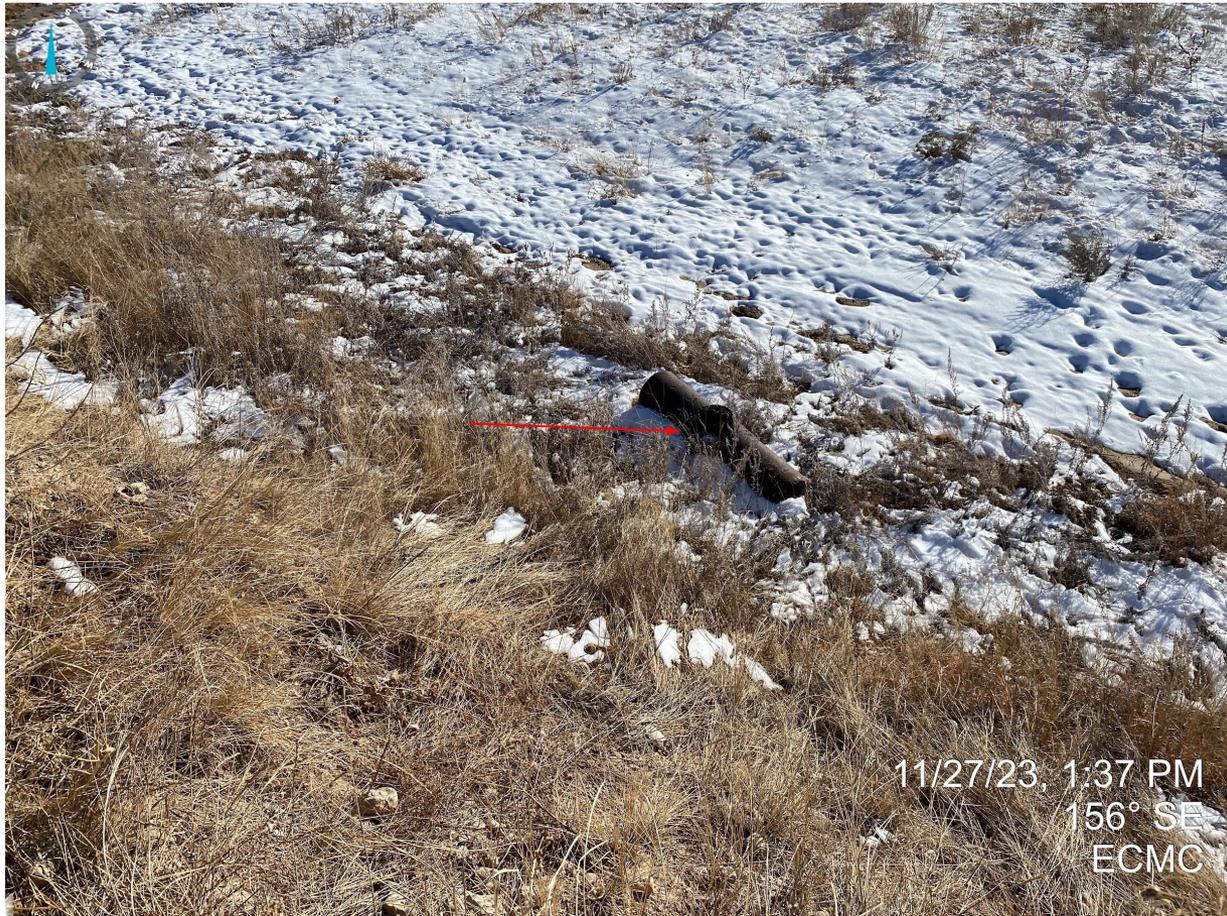
**Photo 6.** Debris (pipe) observed on the southern portion of the location.

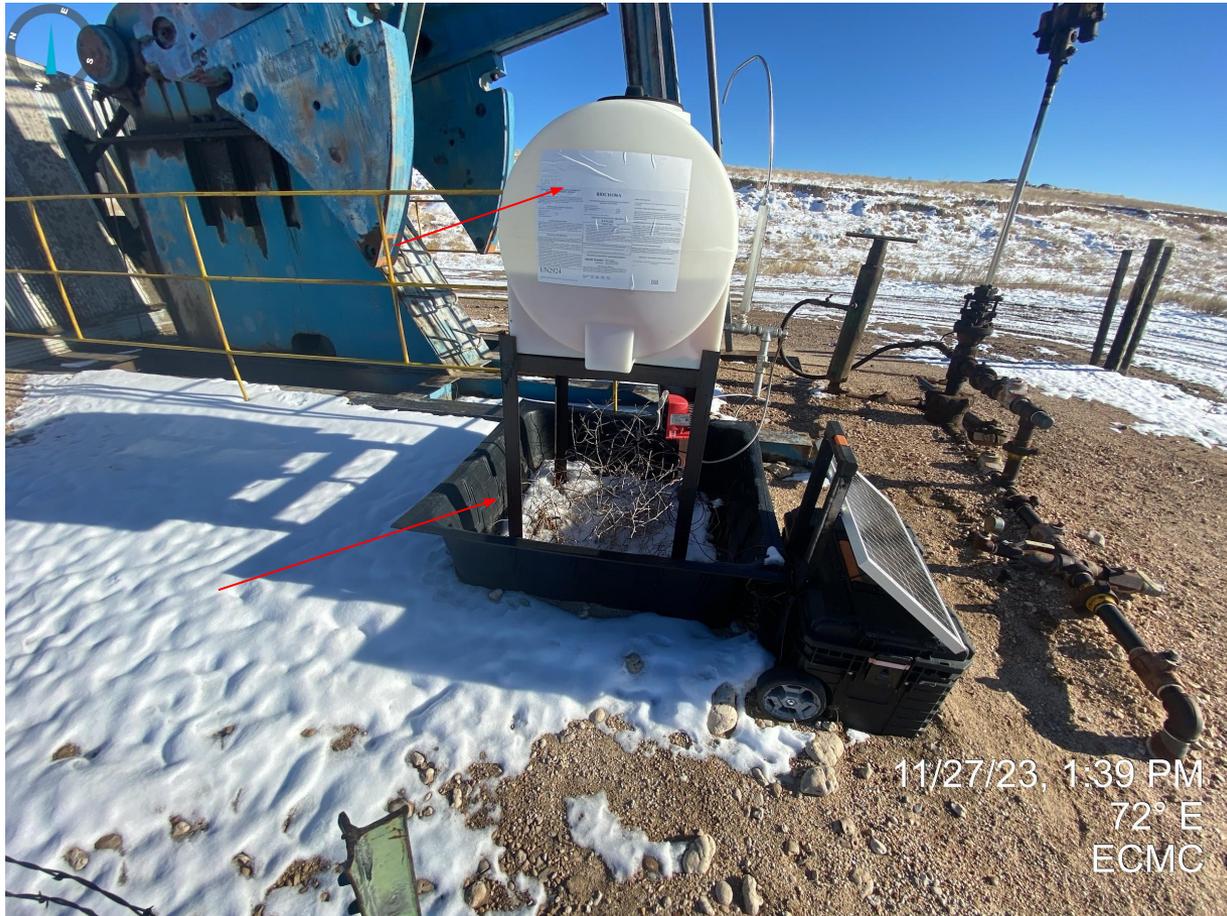
**Photo 7.** Day tank at wellhead does not have adequate wildlife exclusion device or NFPA placard.
