Final Reclamation and Stormwater Inspection

Operator: Noble Energy Inc. - 100322

Location ID: 329529

Inspection Photos
Location Name: Duncan D #11-14
Location ID: 329529

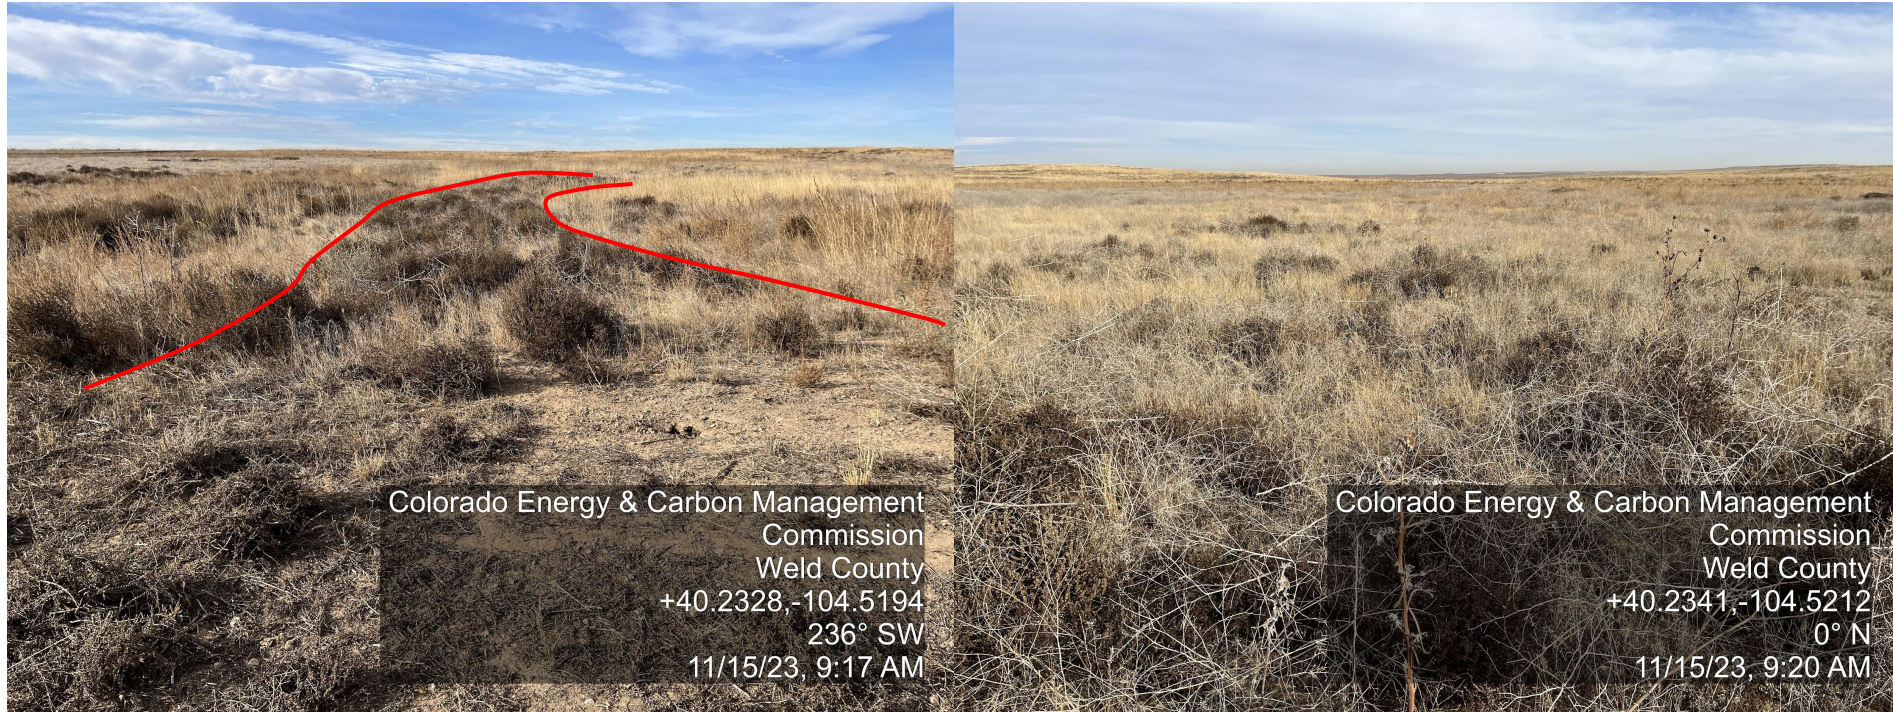
Photo 1. The photo was taken at the access road entrance facing Southwest. The photo illustrates the access road is dominated by russian thistle and cheatgrass.

Photo 2. The photo was taken at the well location facing North. The photo illustrates the location is dominated by russian thistle and cheatgrass with bunches of wheatgrass.

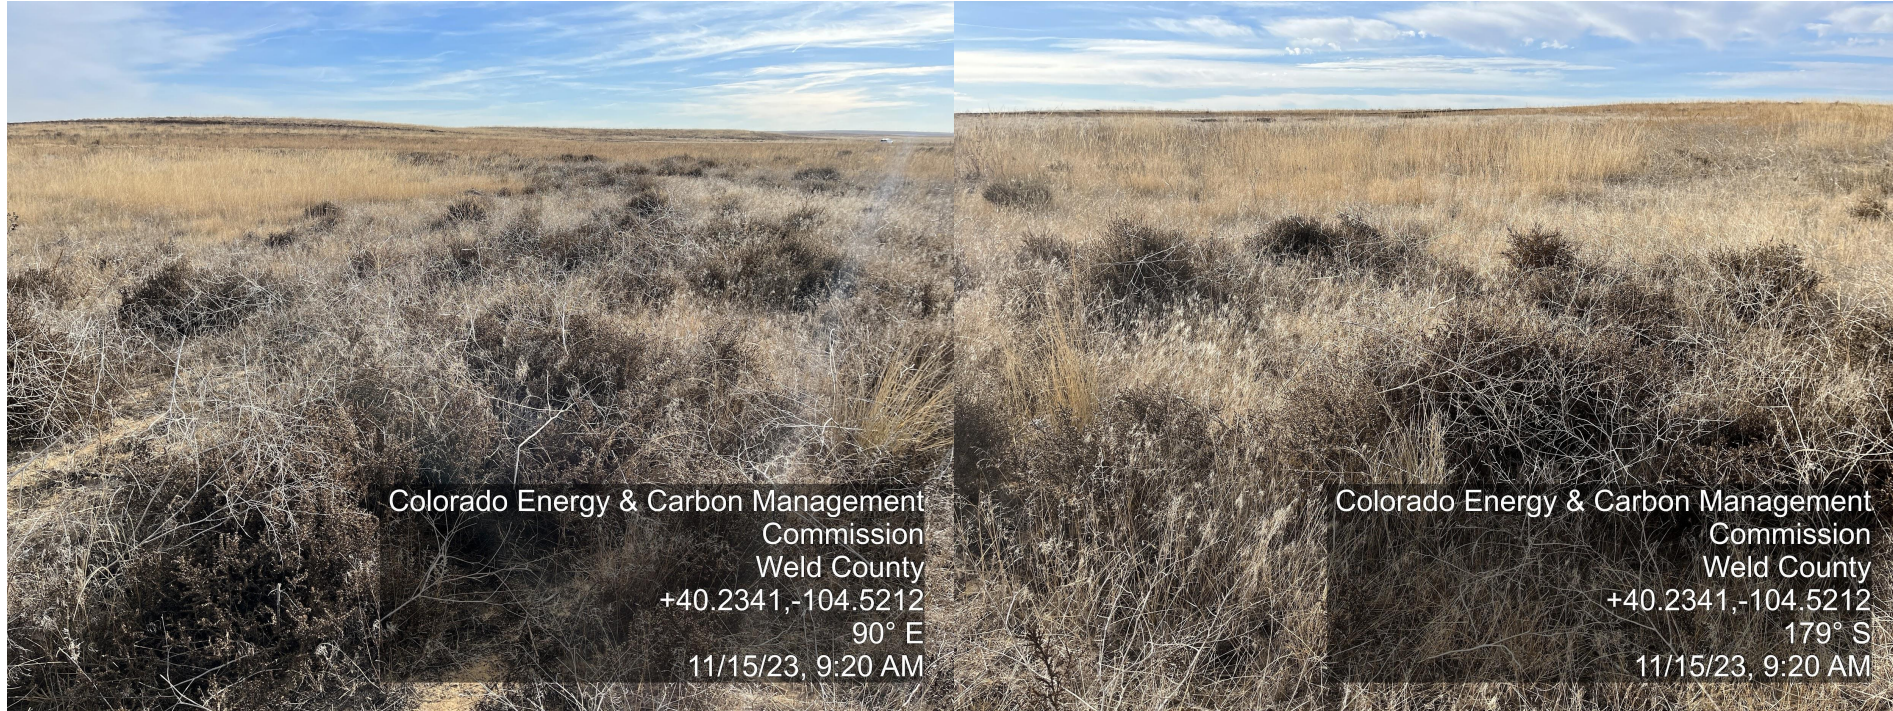
Photo 3. The photo was taken at the well location facing East.
Refer to the comments on photo 2.

Photo 4. The photo was taken at the well location facing East.
Refer to the comments on photo 2.

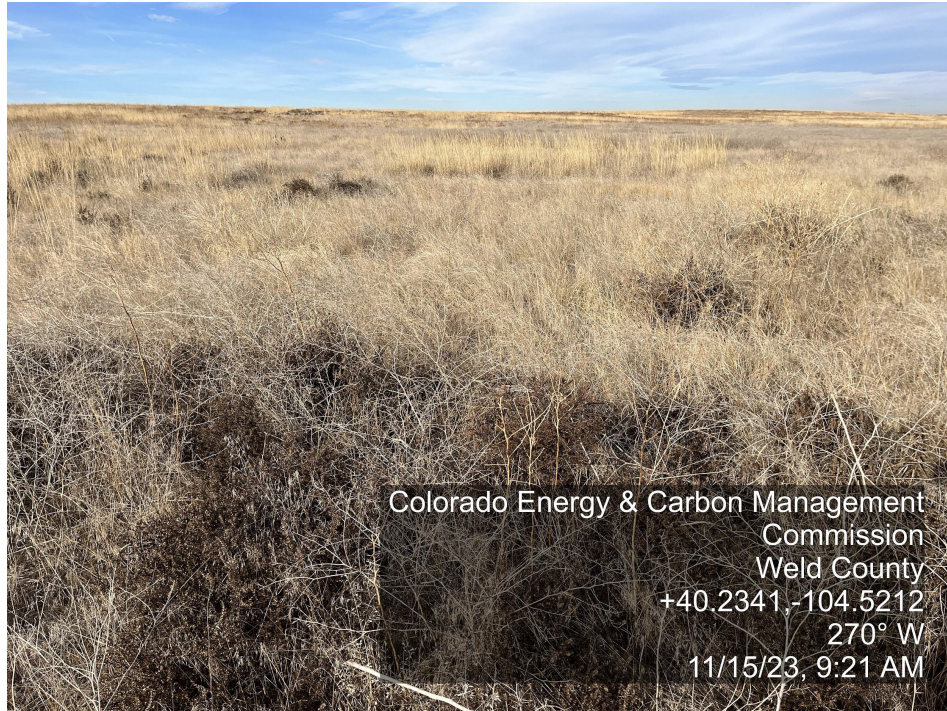
Photo 5. The photo was taken at the well location facing East. Refer to the comments on photo 2.

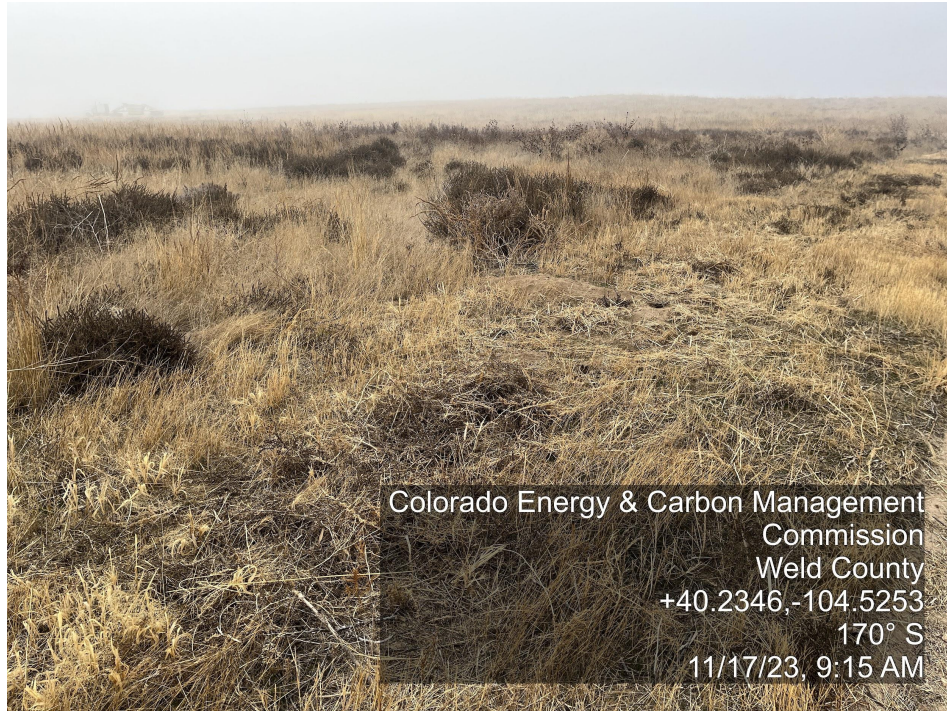
Photo 7. The photo was taken at the tank battery entrance facing South. The photo illustrates the area is dominated by russian thistle and kochia.

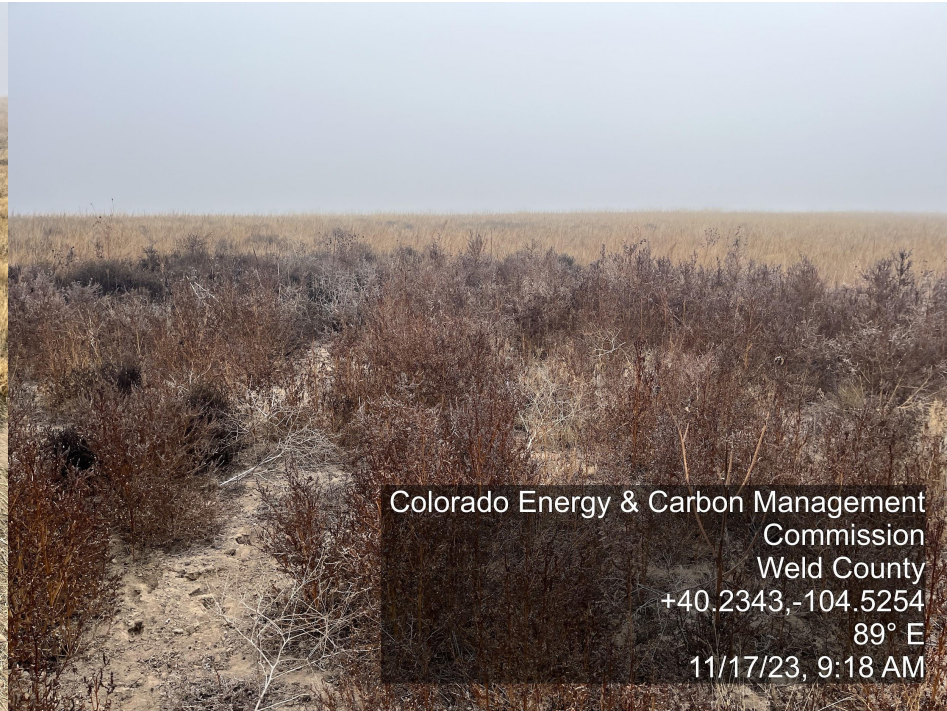
Photo 8. The photo was taken on the tank battery location facing East. The photo illustrates the location is dominated by bare soil, kochia and russian thistle.
