Interim Reclamation and Stormwater Inspection

Operator: Phoenix Resources LLC - 10691

Location ID: 420020

Inspection Photos
Location Name: Cass Farms #11-25H
Location ID: 420020

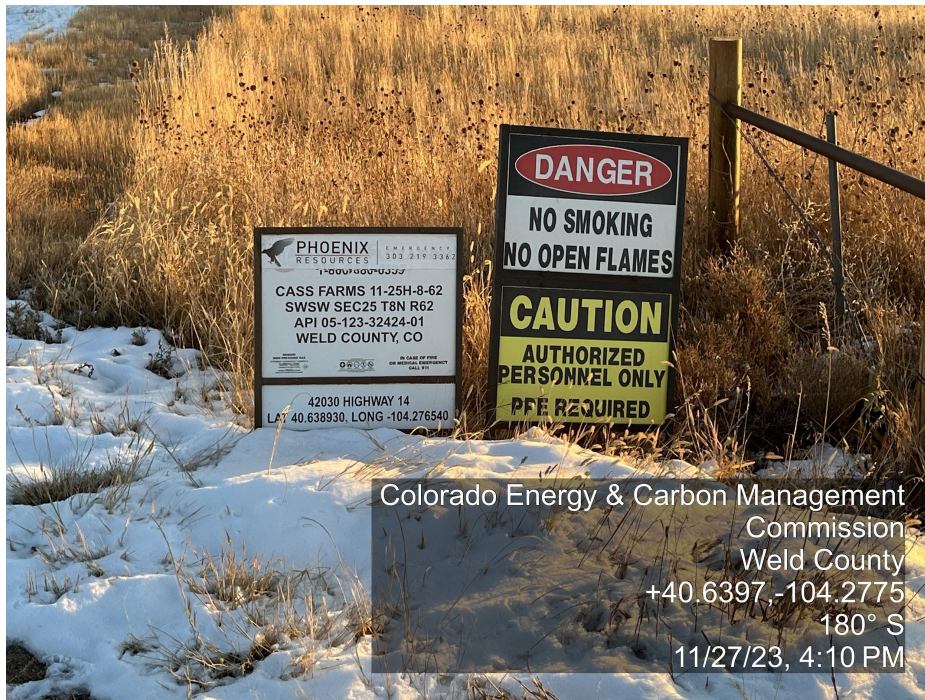
Photo 1. The photo taken from the entrance of the location illustrating the Operator signage.

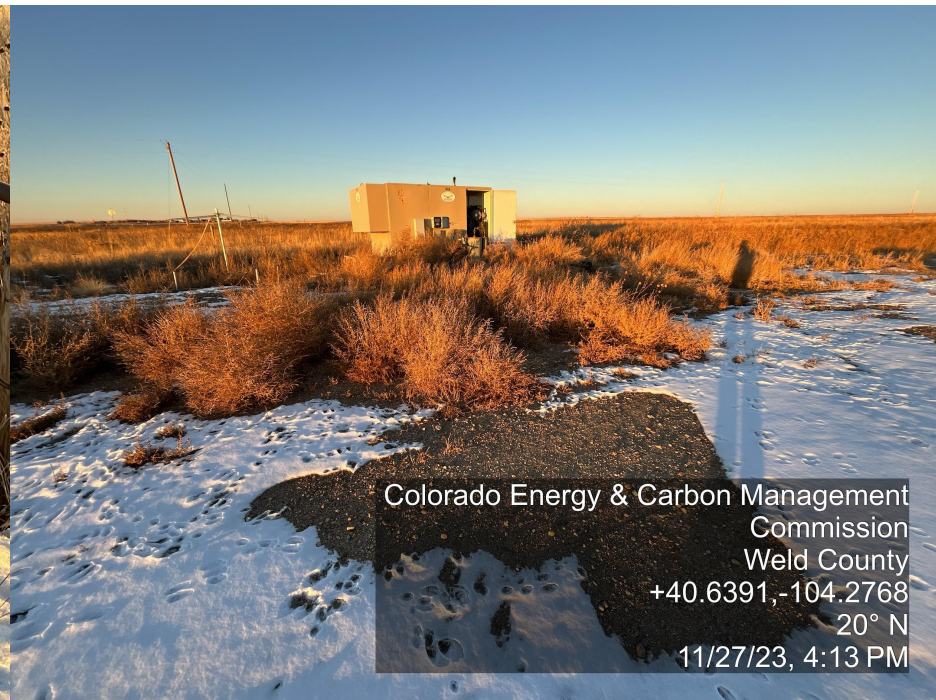
Photo 2. The photo was taken from the well location facing North. The photo illustrates weeds on the location have still been mostly unmanaged from the previous corrective action.

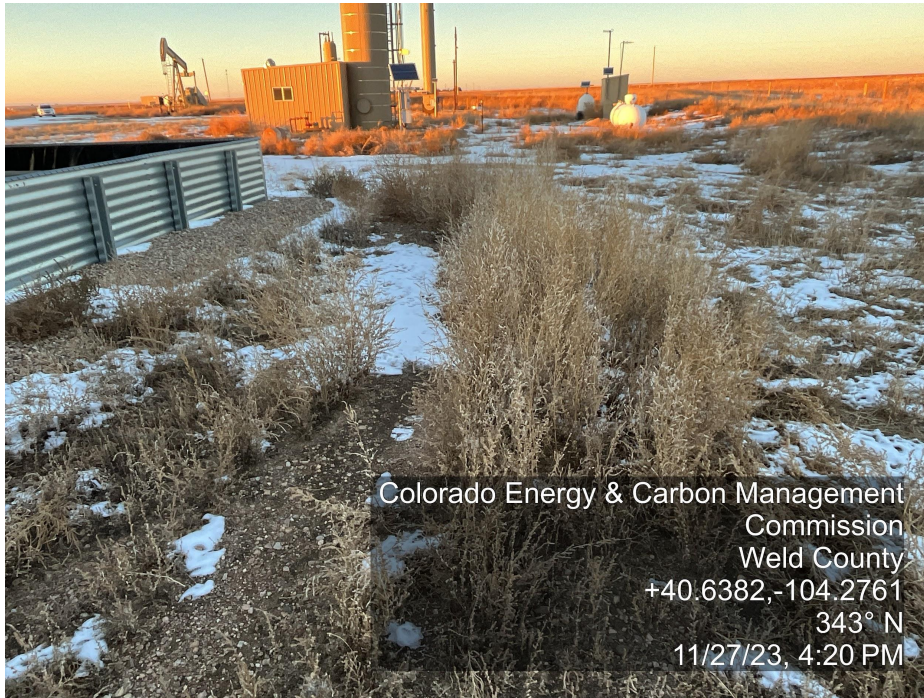
Photo 3. The photo was taken from the well location facing North. Refer to the comment for photo 2.

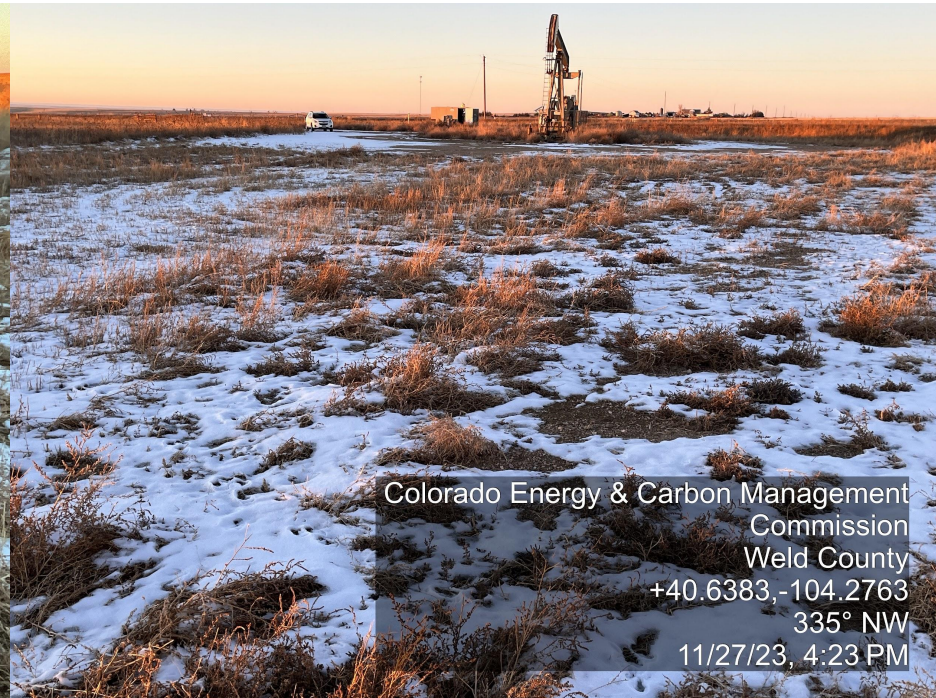
Photo 4. The photo was taken from the well location facing Northwest. The photo illustrates some weeds have been mowed.

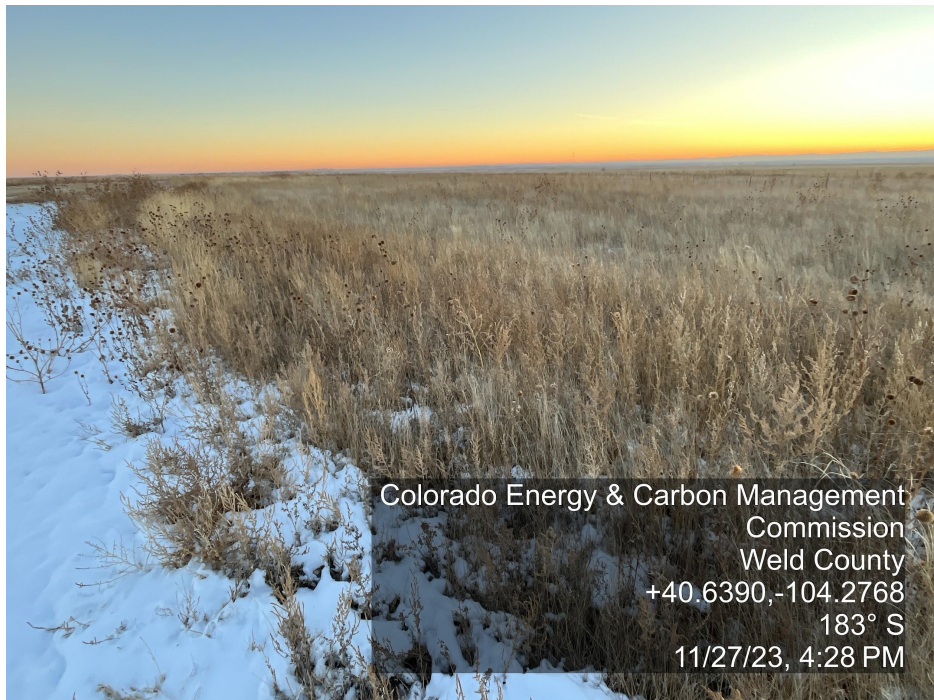
Photo 5. The photo was taken from the West side of the well location facing North. Refer to the comment for photo 2.

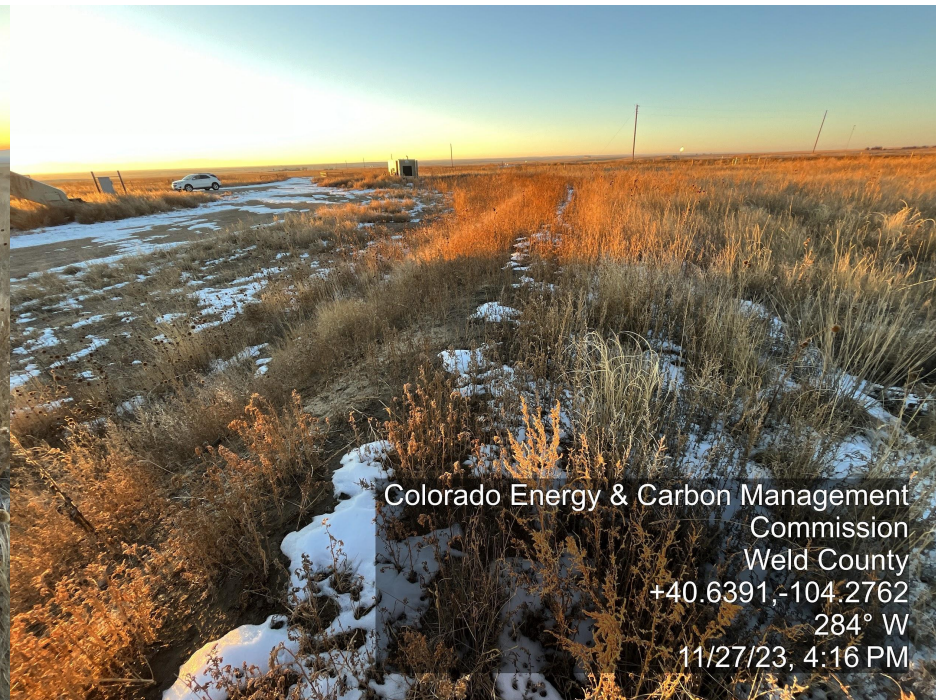
Photo 6. The photo was taken from the East side of the well location facing Northwest. Refer to the comment for photo 2.

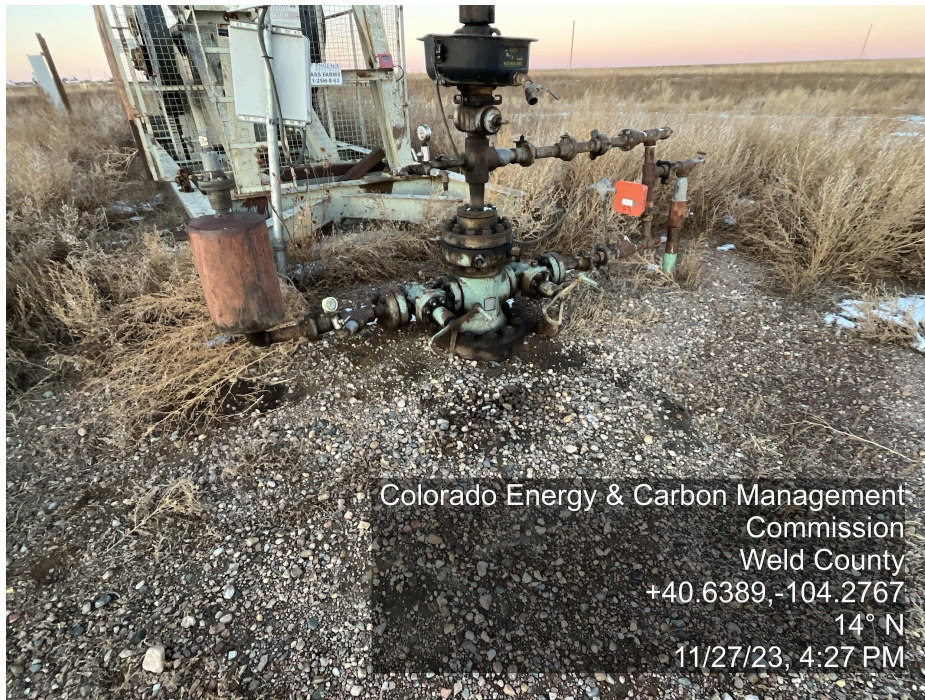
Photo 7. The photo was taken from the well location facing North. The photo illustrates stained soil from a previous corrective action that have not been corrected.

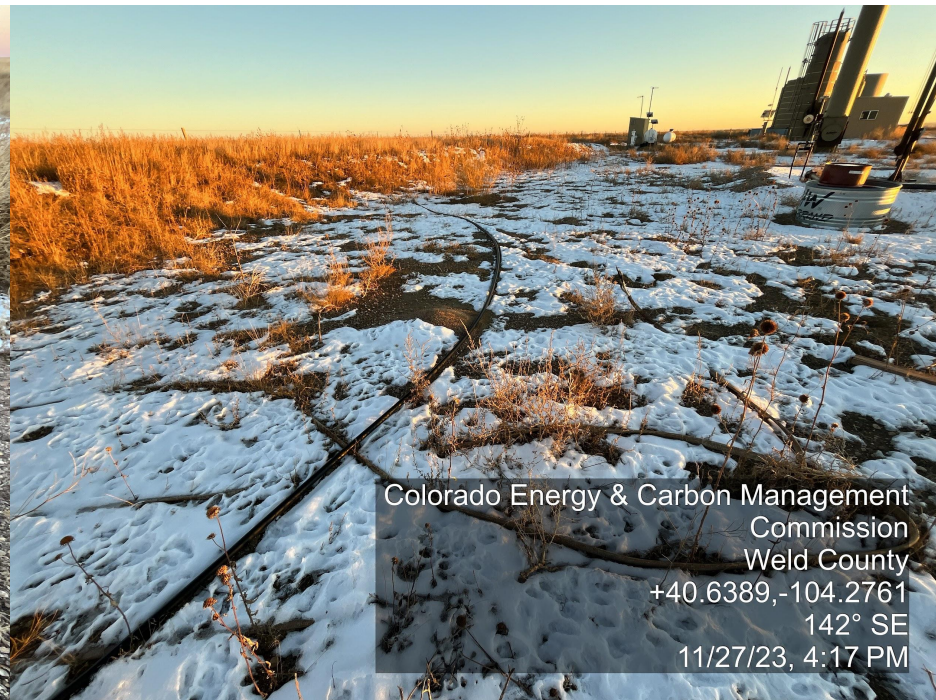
Photo 8. The photo was taken from the well location facing Southeast. The photo illustrates some of the trash that has not been picked up from a previous corrective action.
