# Inspection Photos

Loc: 309389

Operator: OGRIS OPERATING LLC

Inspection Date: 12/5/2023

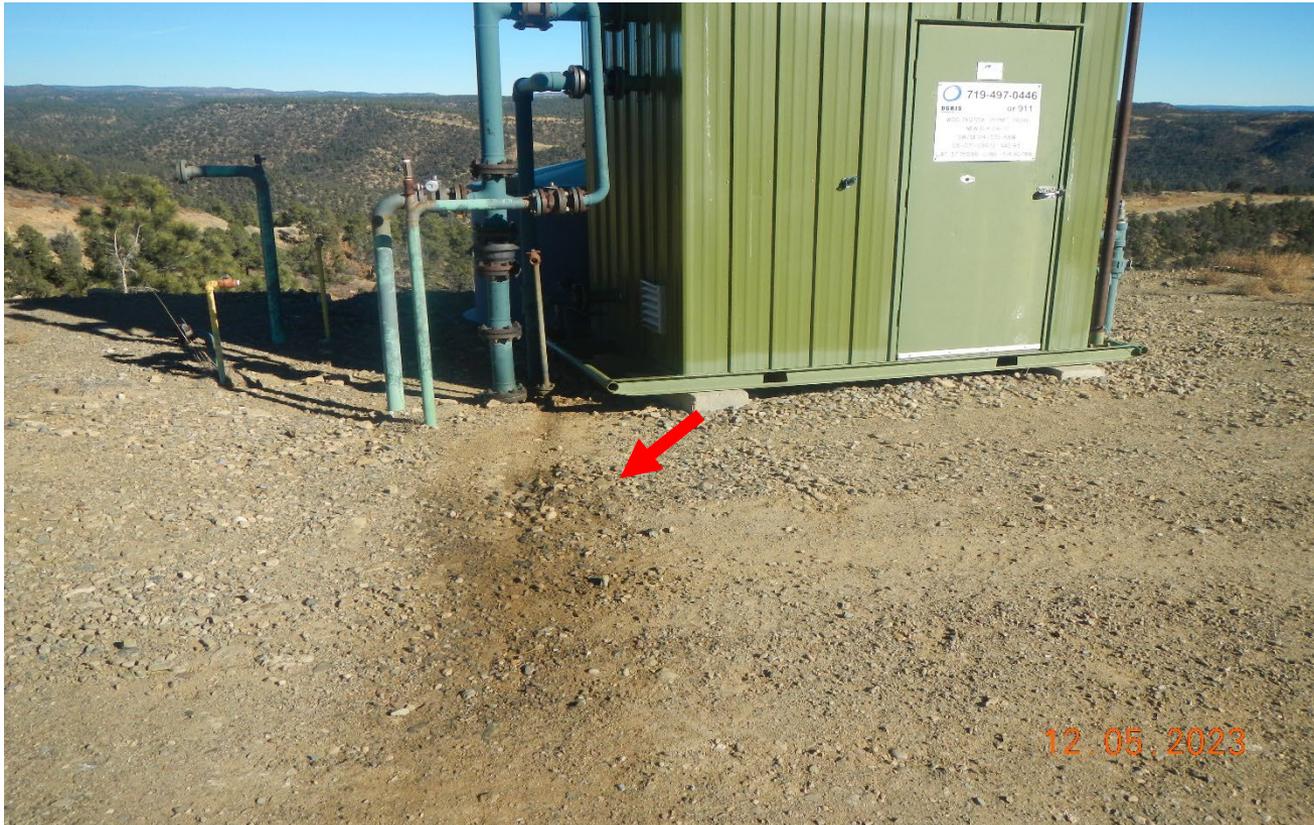
**Photo 2.** There is stained soil shown at red arrow that needs to be cleaned up. It appears fluids were released at this area.

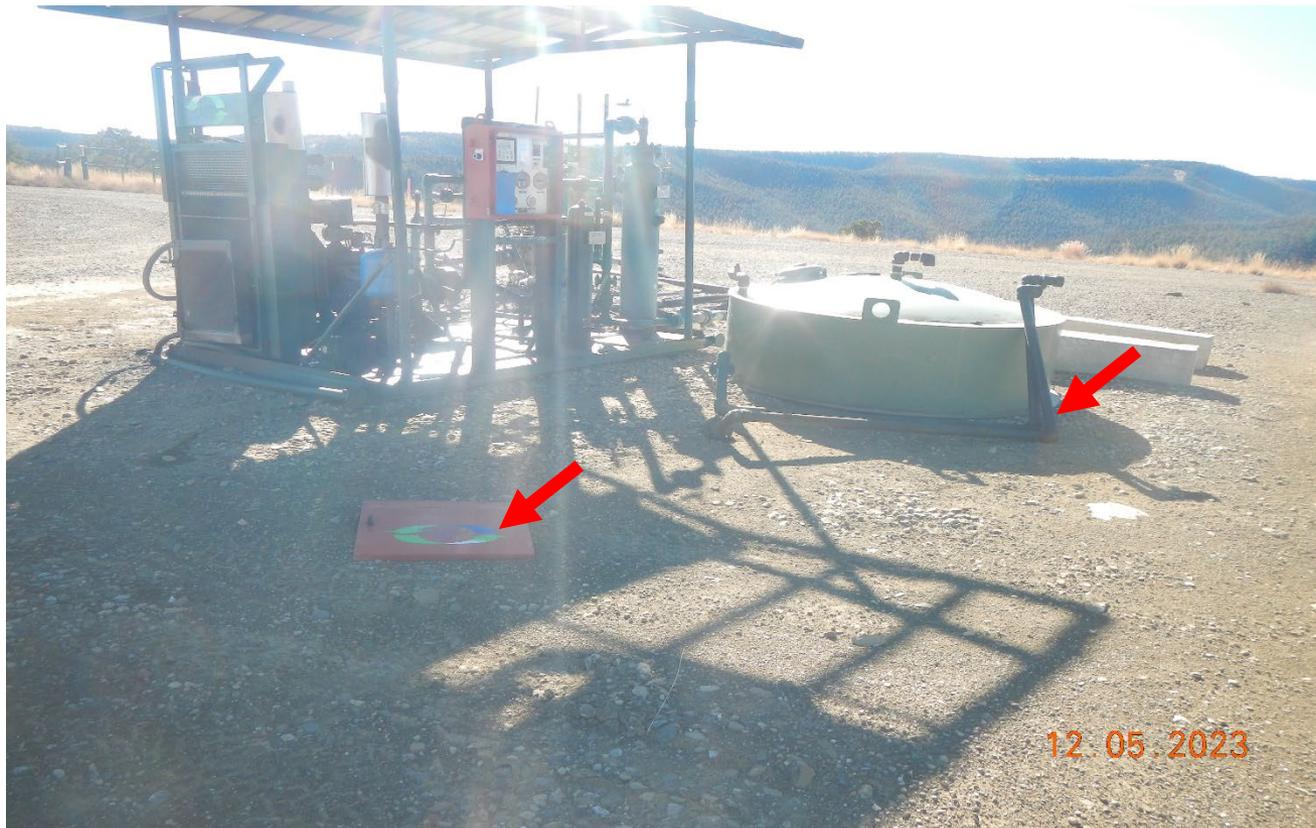
**Photo 3.** Facing toward the production equipment. There is a panel laying on the ground and unused piping at red arrows..

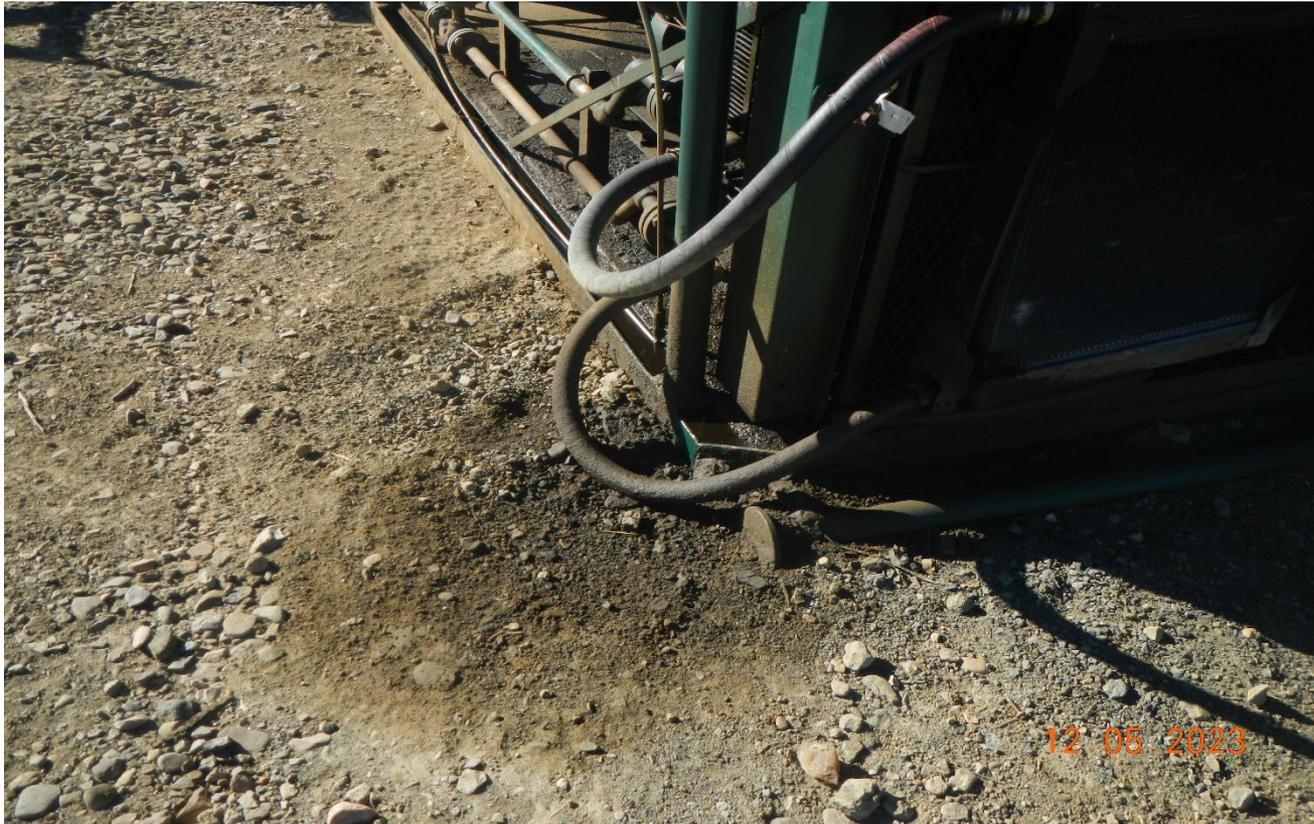
**Photo 4.** The engine skid is full of oil and has spilled onto the ground..
